**WAMBO COAL
WAMBO HOMESTEAD COMPLEX CONSERVATION
MANAGEMENT PLAN**

Document No. WA-ENV-MNP-511
May 2019

Document No.	WA-ENV-MNP-511
Title	Wambo Homestead Complex Conservation Management Plan
General Description	Conservation Management Plan for the Wambo Homestead Complex
Document Owner	Environment and Community Manager

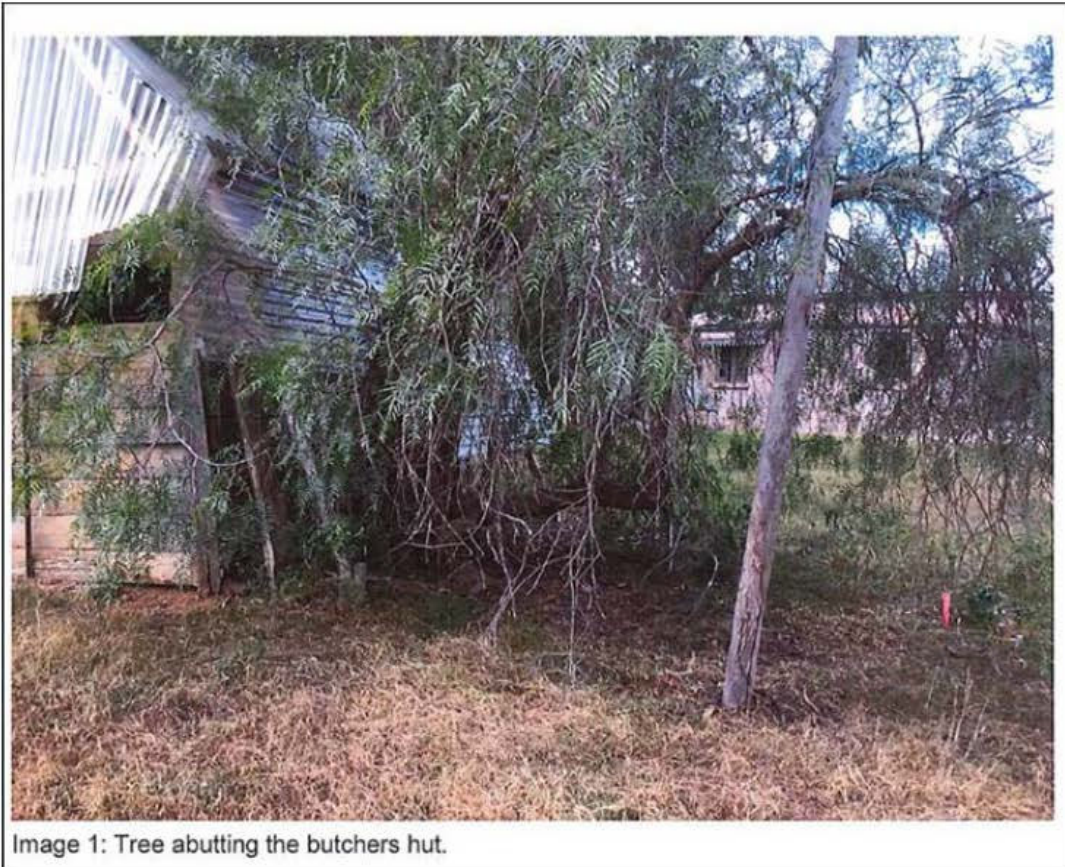
Image 1: Tree abutting the butchers hut.

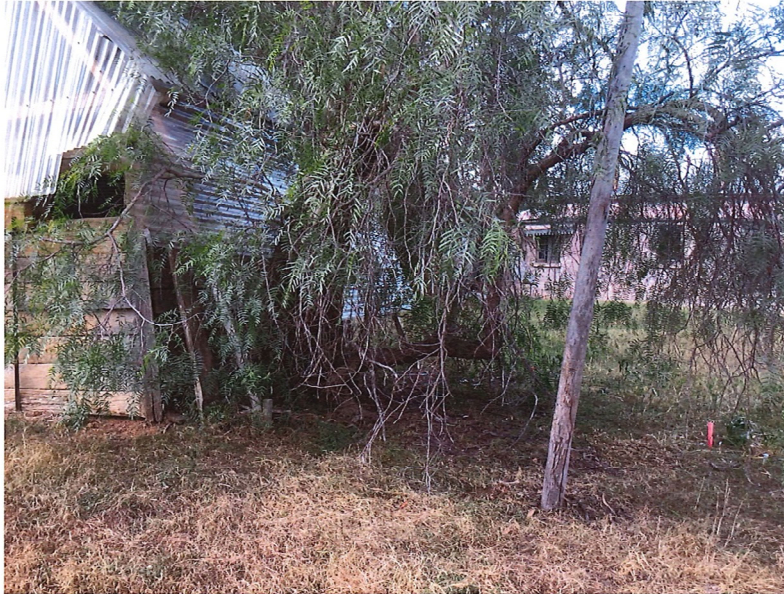
Image 1: Tree abutting the butchers hut.

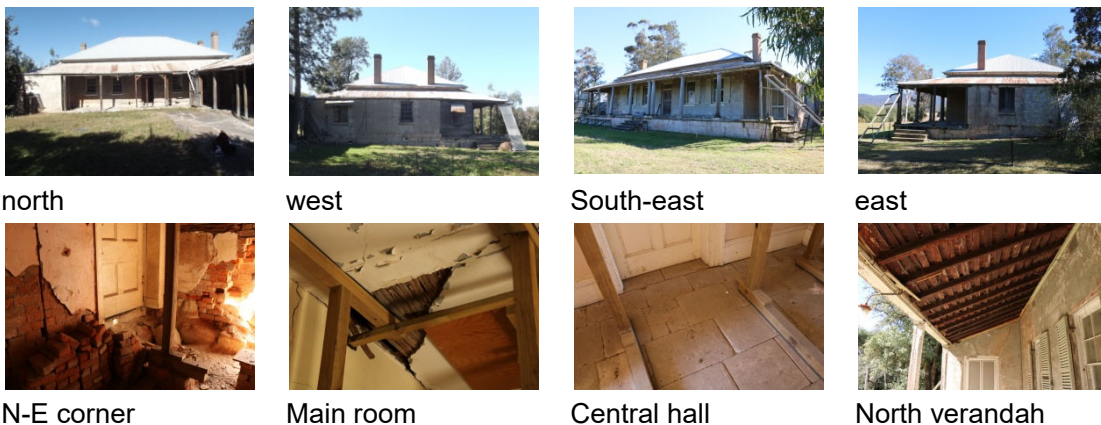
Figure: External and Internal views

There are now large timber sections used as props in most rooms, to support ceilings or archways. In the verandah room at the north-west corner large areas of ceiling has collapsed. The former verandah bathroom at the north east corner is a scene of destruction. Red brick dust has coated most surfaces after vertical control joints were sawn into the wall. The floor and framing are gone. The internal plaster is nearly all gone. There is remnant evidence of more recent linings now removed. Plumbing has been cut and fixtures removed.

This partial demolition and the removal of skirtings in other rooms has revealed evidence of original construction materials and techniques. This confirms the lack of knowledge and skill used for the original construction of the New House.

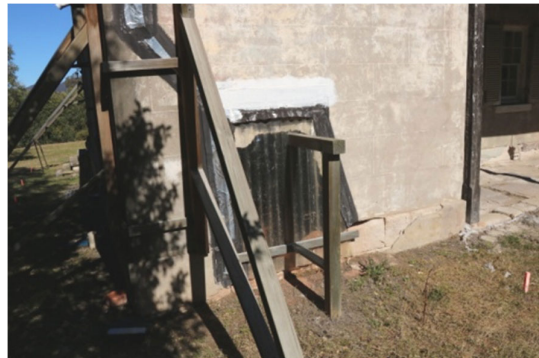
East wall, north corner (props and closures)

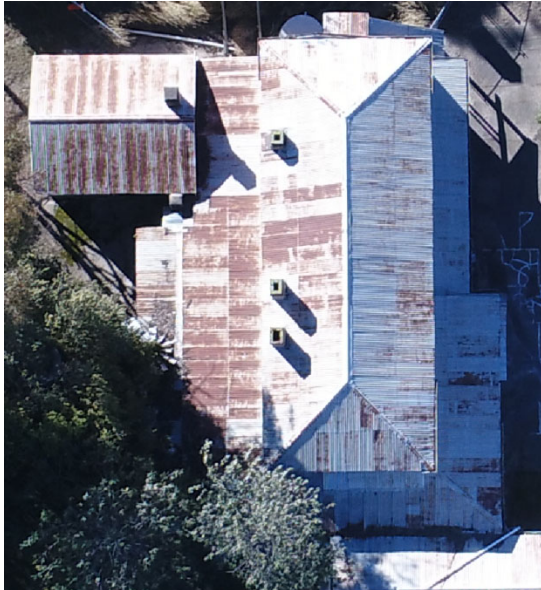
Figure: Kitchen Wing Roofs
Source: Peabody Energy 2017

Gutters are generally non-existent, fascia boards are weathered and loose (again, clear corrugated sheeting has been screwed over section of fascia); eaves linings are becoming detached and dropping away from framing, or missing. In places the external brickwork is open beneath the eaves (west elevation window head). This also applies to the Laundry addition. Remnants of guttering are at the north end of the main roof, held in position at the north-east corner. Most of the east edge of the roof is without a gutter. The eastern verandah roof changes in its reach, along its length. The materials are likely to date from the turn of the C19 and early C20, resulting in a mix, poor junctions, overlaps and a change in pitch. The flashings at the brick wall at the top of those roofs vary in age and length. The gutter at the northern end of that skillion roof is the older gutter remnant on the building. For the main roof above, the south-east corner has a length of gutter in two directions and one contemporary downpipe and spreader. The external steps at both ends of the building are roofed. The structure of the west skillion roof is bush carpentry using timber rounds.

At points where roof collected water is dumped to the ground, timber frames with clear corrugated roof sheeting have been installed to disburse that water further away from the building, to slow deterioration. The same sheeting has been tucked under and over roof sheeting to limit water damage. Where the verandah beams and post have rotted and failed, timber posts and lintels have been installed to 'true-up' the structure, support the remnants of beams and the roof. A bay of the south verandah soffit is lined with T&G boards.

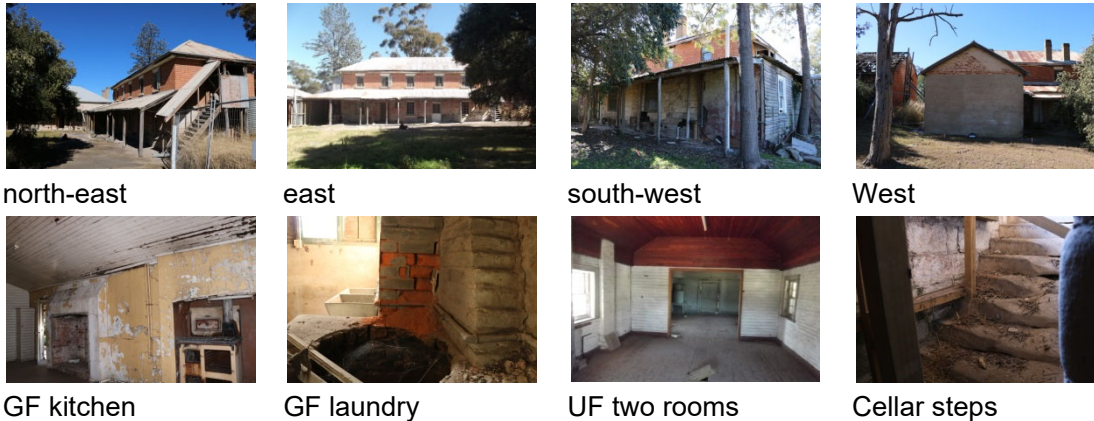
Figure: Exterior and Interior views

The stone above the windows of the ground floor walls is in two courses. Brick work commences from the top of that stone work. Rising damp and salt damage has led to serious deterioration of sandstone. This is localised, usually affecting three or four courses above the base, except where attempted repairs in cement rich plaster has forced the moisture and damage higher up the wall. In a number of places the extent of damage is reaching an extent where structural integrity is not reliable. There are openings in the walls at these levels, with stonework arching over the openings. Timber props are now in place to support masonry over openings created by erosion.

A galvanised wire mesh has been placed over some of these holes to deter entry by wildlife. The stone walls appear to have been painted (creams, red and grey layers are obvious).

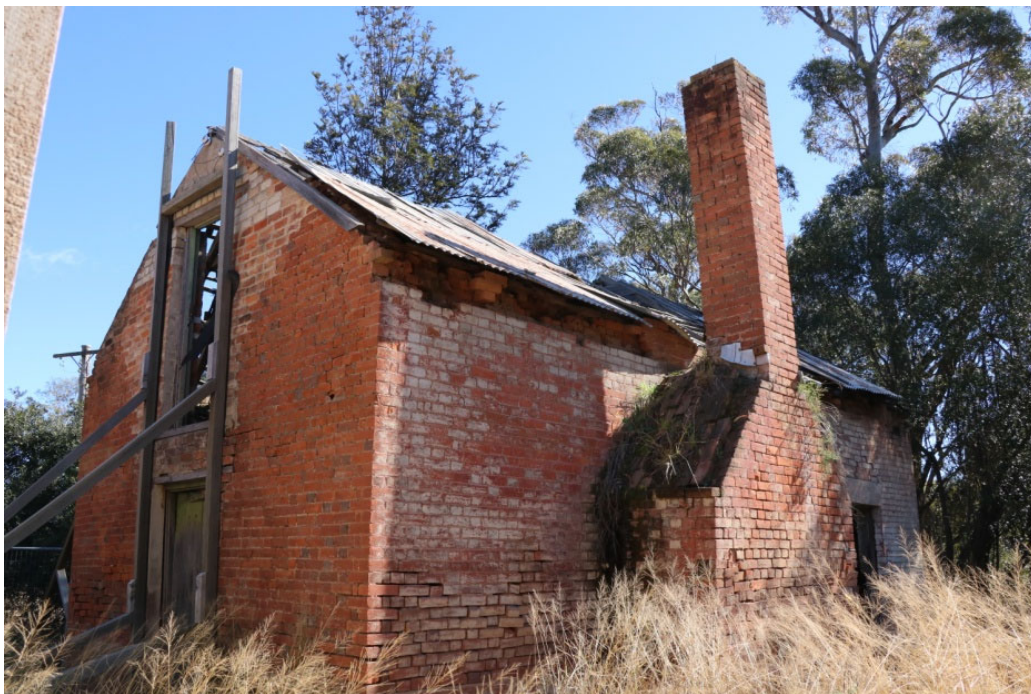
Figure: Advanced erosion of joints and loss of roofs 2017

The building is collapsing:

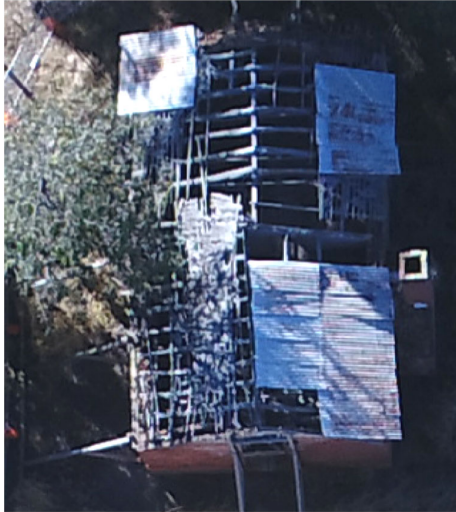
Figure: Servants' Wing Roof remnants.
Source: Peabody Energy 2017

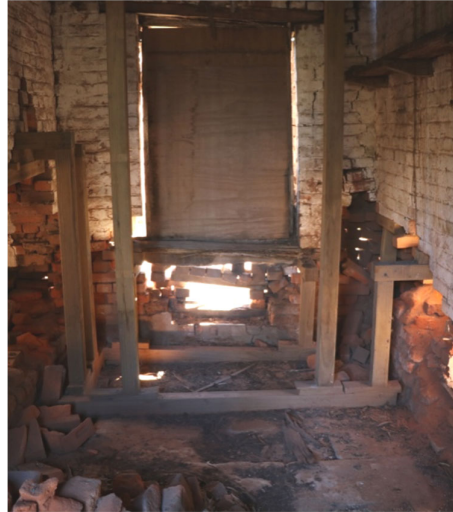
Figure: Collapsed brickwork and timber propping, north west corner.
Source: EJE 2017

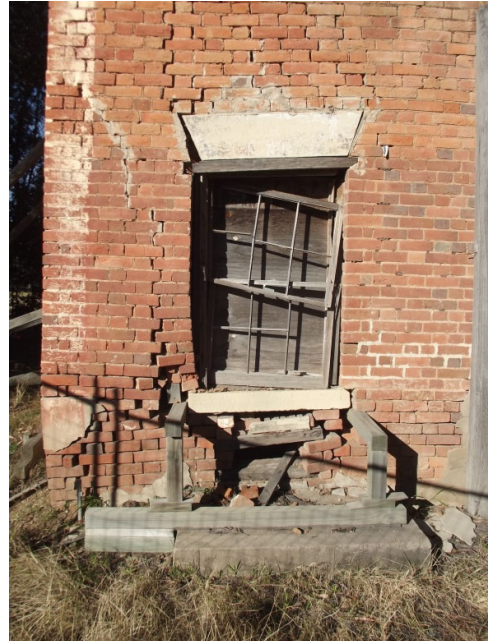
Figure: the north-west corner 2017
Source: EJE 2017
