Wilpinjong Coal Mine Aboriginal Rock Art Monitoring and Assessment Program

Report on Nov 2020 site inspections WCP152 and WCP153

Wilpinjong, NSW

March 2021

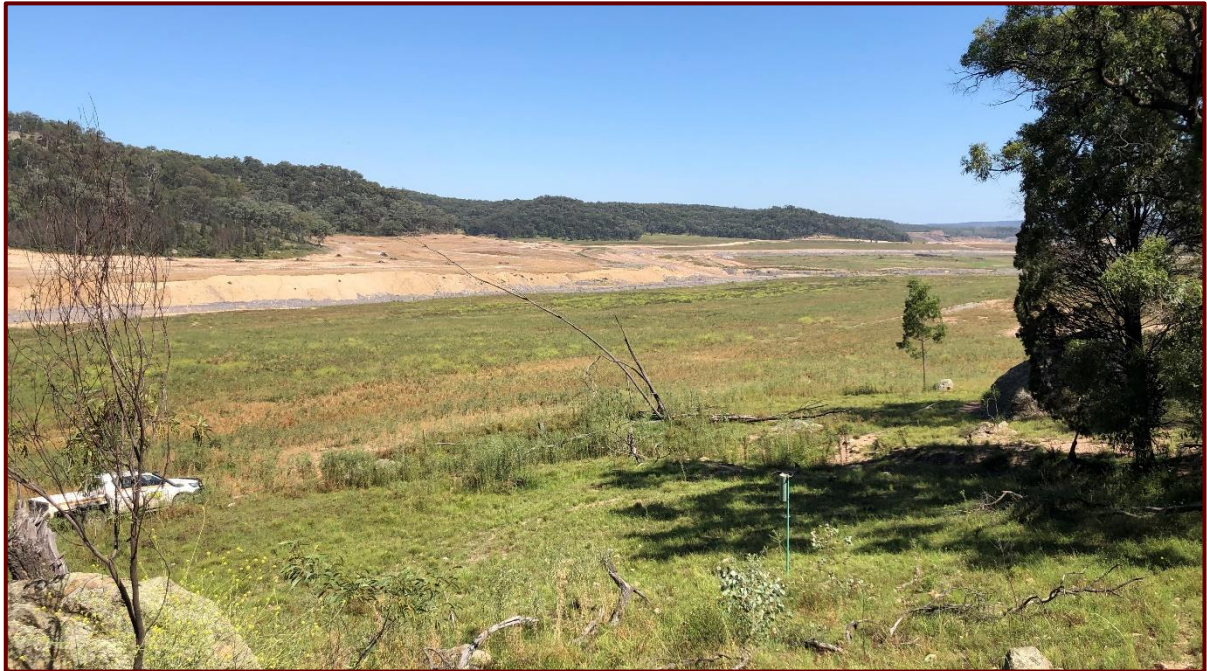
Figure 1 This monitoring assessment occurs at the completion of mining, backfilling and the restoration of surface contouring and topsoil adjacent to the WCP152 and 153 art sites. Looking northwest from basal slopes adjacent to WCP153 (image: Nov 2020).

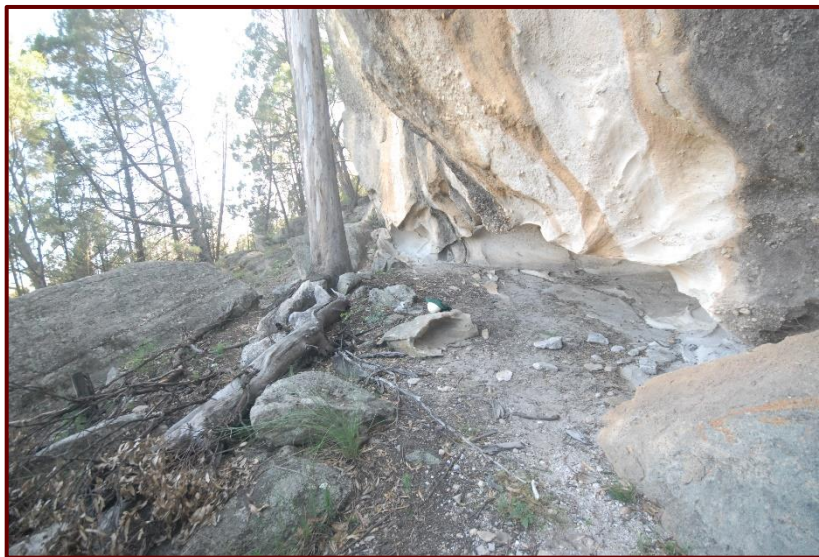
- A large canopy limb has fallen from the tree in front of the shelter entrance and constitutes a significant source of combustible material (**Figure 3**).
- There is a low to moderate build-up of combustible ground litter on the near-by slope adjacent to the shelter entrance (**Figure 3**).
- A previously noted resin footing for a former seismometer placement remains attached to the rock floor of the shelter at its southern end (**Figure 4**).
- A small fig tree, noted in 2006 and which may pose a long-term threat to the stability of the shelter, continues to grow on a high ledge above the shelter (**Figure 5**). The identified threat would be the introduction of water onto the shelter walls as a result of future root incursion widening rock fissures and bedding planes. The tree does not pose an immediate or short term threat to the shelter.

Figure 3 Views looking north (top) and south (right) across the build-up of combustible material on the slopes adjacent to the WCP152 shelter entrance (DSC_0294, & 0295).

The combustible material in the form of fallen branches and forest litter within approximately 10 m of the shelter entrance should be removed.

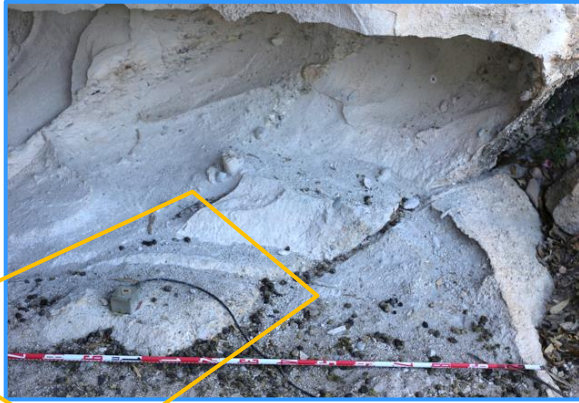
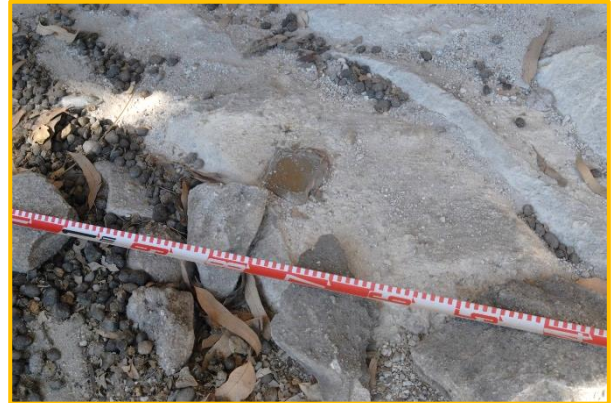
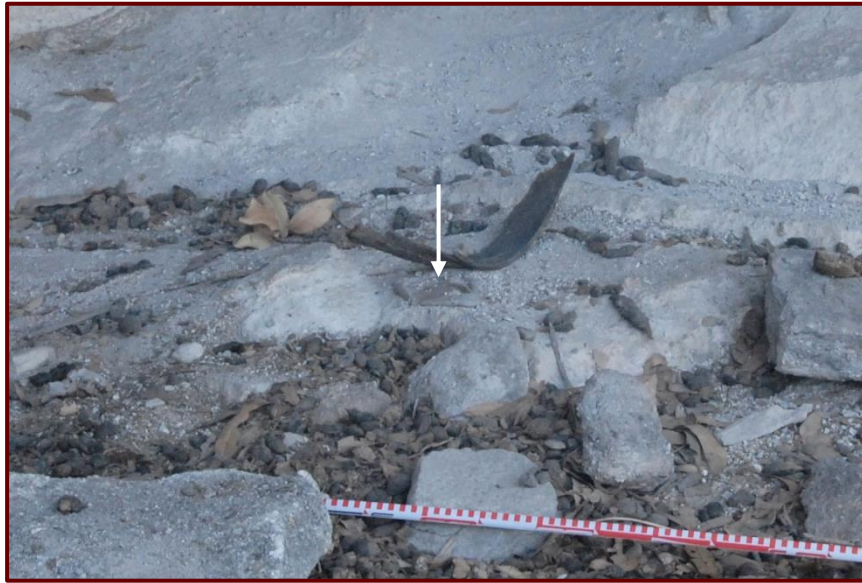
Figure 4 The former location of the WCP152 seismometer in 2014 (top left) (NOHC 2015: Fig 4.32), in 2017 (top right) (NOHC 2020: Fig 38) and during the present inspection (bottom, DSC_0315).

The resin pad from a former seismometer mounting should be removed from the shelter floor.

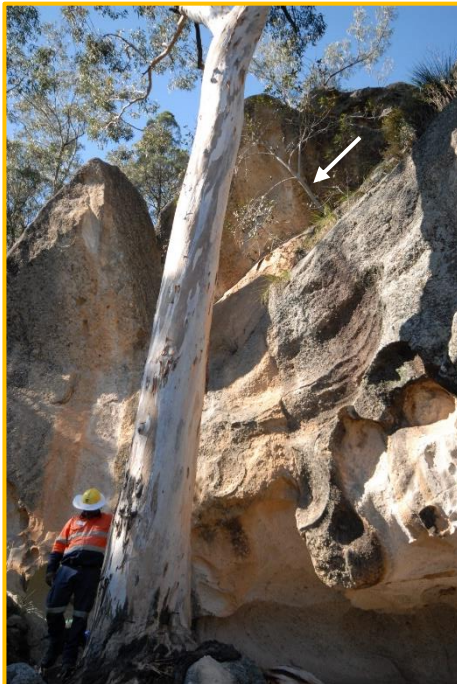
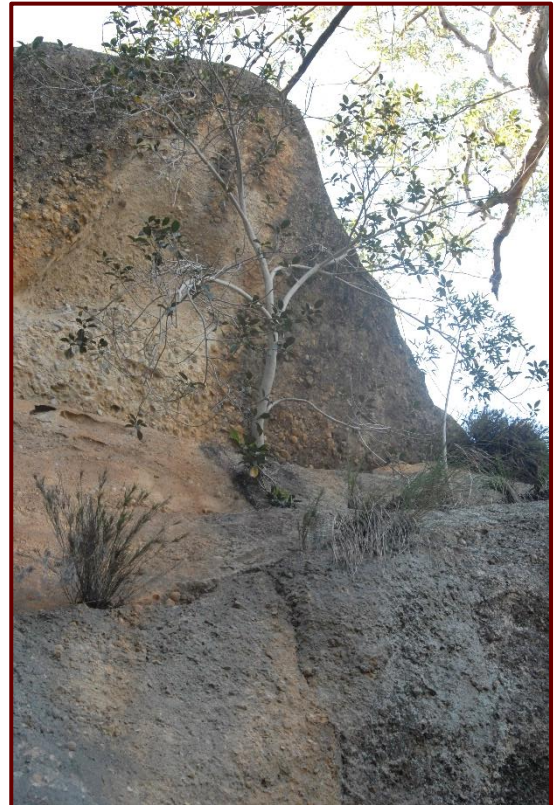
A small fig tree continues to grow on a rock ledge above the rock shelter. In the short and medium term, its small size precludes a significant risk to the stability of the rock shelter. In the long term however, the growth of its root system may cause rock displacement and cracking which could destabilise the underlying shelter and/or allow water to enter the shelter through enlarged fractures and bedding plains.

Figure 5 Images of a small fig tree growing within a ledge above the WCP152 shelter in 2017 (DSC_0304) and a close-up view during the present inspection (DSC_0344).

The growth of the fig tree should continue to be monitored.

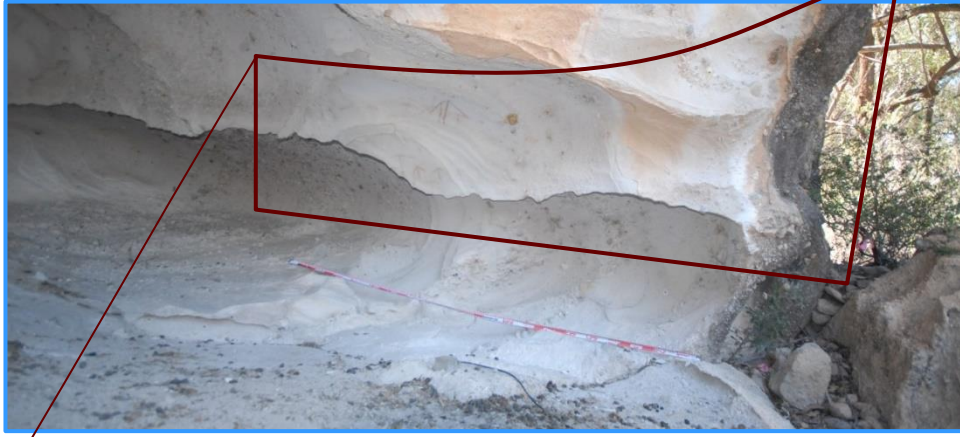
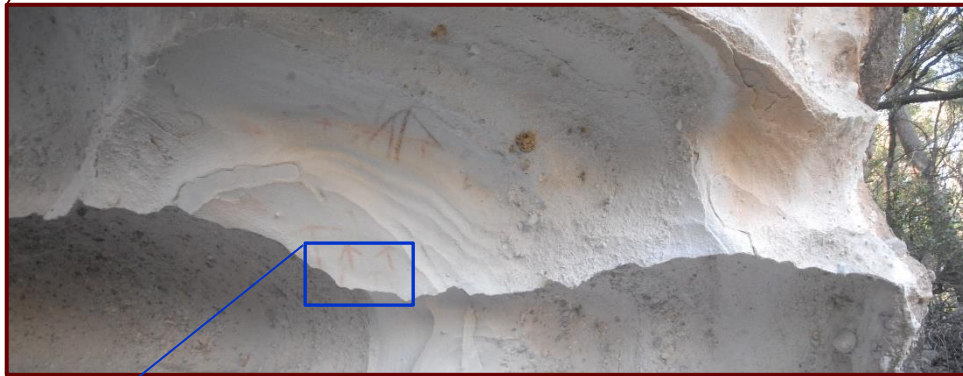
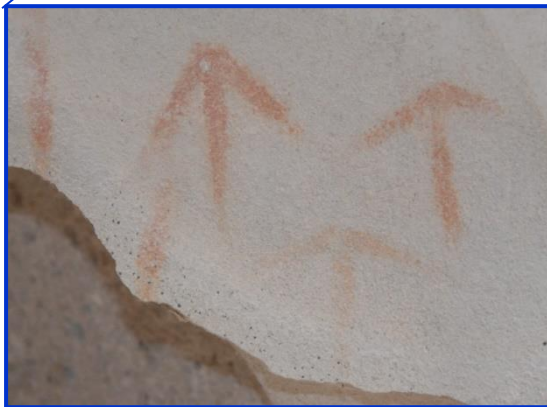
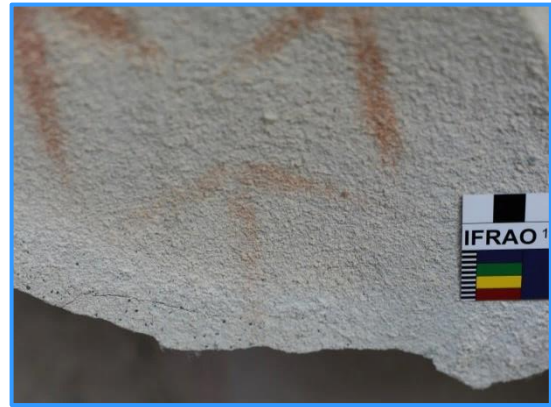
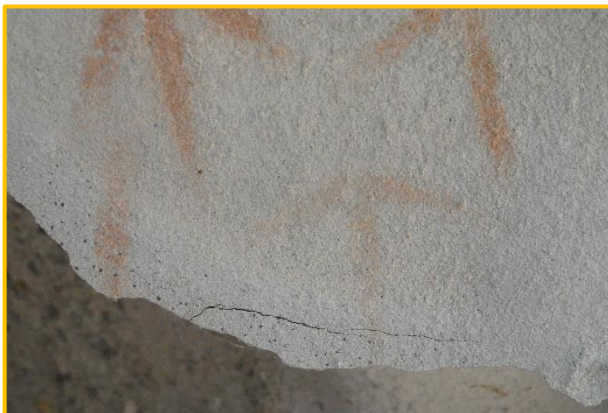
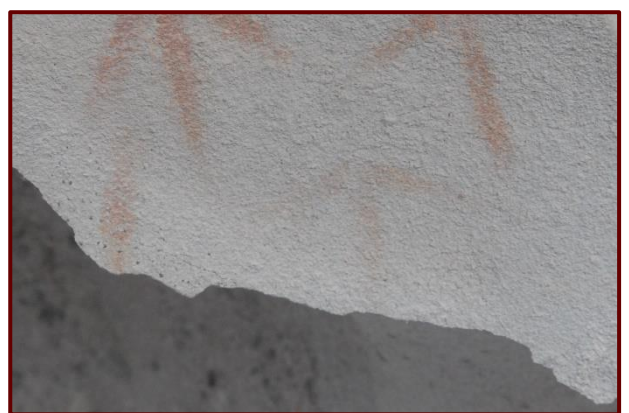
A small hairline crack was noted in the area of detachment in 2017 and relates to a natural erosion process. It appears likely that dislodgement was due to impact from an animal.

Figure 7 The lower edge of the art panel in WCP 152 consists of a narrow undercut edge which has been undercut by an actively eroding lower concave surface (top images). A portion of this edge, (shown in 2006, 2014, 2017 and in 2020), was noted as semi-detached in 2017 (bottom left), and has now detached and fallen to the shelter floor in 2020 (bottom right).

The 2017 monitoring assessment noted that, at that time, there was no discernible difference in the profile of the undercut edge and the 2006 baseline record. However, it was noted that a hairline fracture along the bottom edge of the 'trident' panel, (first recorded in 2014), had enlarged to a point where a small elongate section of the edge could be termed semi-detached. It was predicted that this section could detach in the foreseeable future. This section was noted to include a portion of a 'trident' motif (**Figure 7**).

The recovered detached panel edge-fragment should continue to be securely stored until an appropriate management response is determined through consultation with the project's Registered Aboriginal Parties. Potential options for consideration include:

- a) Permanent curation/storage at an off-site facility,
- b) Restoration by re-attaching the fragment using a suitable adhesive,
- c) Conducting microscopic inspection and non-impactive pigment analysis, prior to initiating a) or b), and
- d) Investigating the feasibility of preventing or discouraging animal use of the shelter space around the fragile lower edge of the art panel.

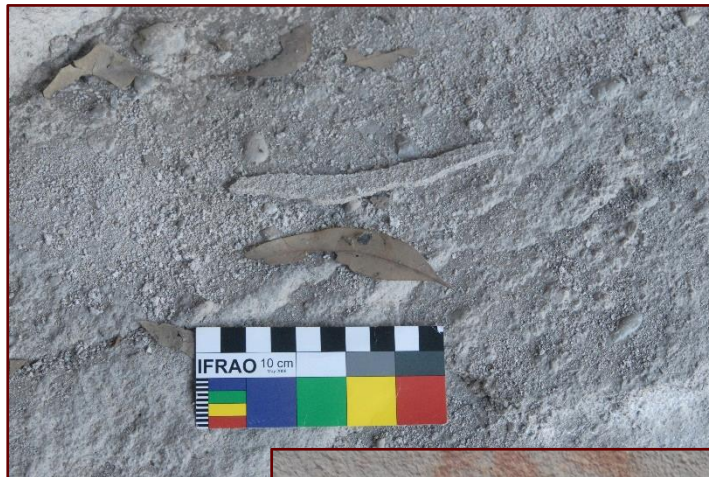
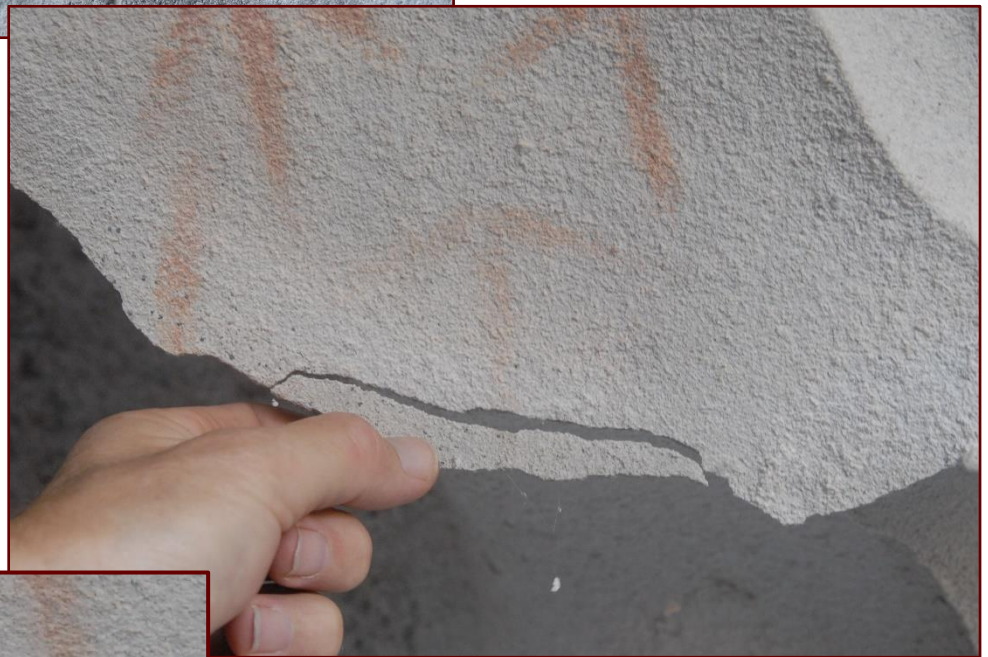
During the current inspection this formerly semi-detached section was noted to be missing from the panel and was identified on the shelter floor below the subject back-wall panel (**Figure 8**).

Figure 8 The position of the detached portion of art panel on the shelter floor, as found at the time of inspection (top), and the fragment held next to its original position. Note that a small spall from the middle of the fracture interval is missing.

Consistent with Registered Aboriginal Party comments during the 2017 monitoring program, (NOHC 2020:50), the detached spall was collected and is currently stored at the NOHC laboratory pending a stakeholder decision on a preferred course of action.

The absence of disturbance to these and semi-detached surfaces elsewhere across the shelter, strongly suggests that the detachment of the portion along the bottom edge of the 'trident' art panel was due to direct impact, such as from an animal, rather than mine-generated ground vibration which should impact more evenly across all vulnerable areas. The likelihood of animal impact as a cause is also supported by the location of the effected panel edge which is low down and situated towards the back of the shelter where animals such as wallabies would seek cover.

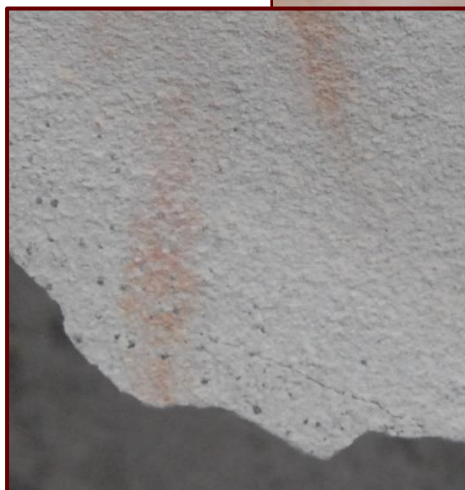
A new hairline crack situated immediately to the left of the previous panel loss is noted, indicating the development of a further semi-detached portion of the panel edge (**Figure 9**).

Figure 9 Detail of a newly noted hairline crack located immediately to the left of the recent detachment.

The condition and nature of the hairline crack and remaining semi-dislodged panel-edge fragment should continue to be monitored. In the event that a portion of the art panel becomes dislodged, the piece(s) should be collected and an appropriate management action followed, (if and when determined through consultation as previously outlined).

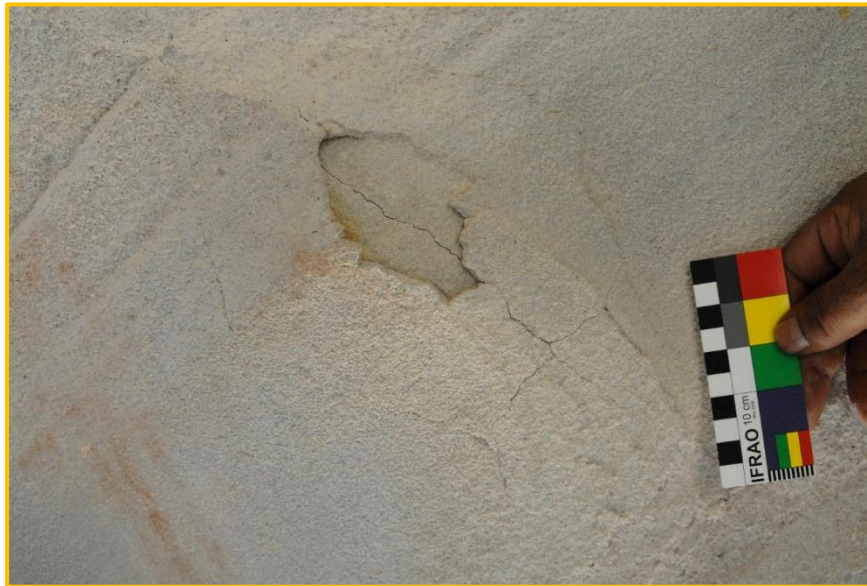
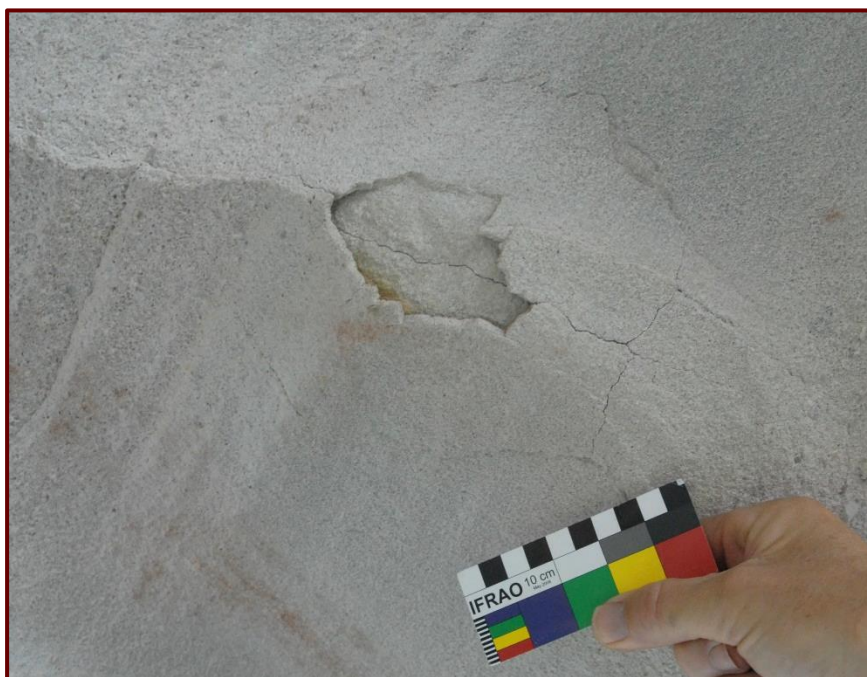
An inspection of other areas of fragile rock surface on the back wall and ceiling of the shelter revealed no change from 2017 records (**Figure 10**).

Figure 10 Comparative images of a fragile area of rock surface exfoliation on an art panel on the ceiling of WCP152, showing no changes since 2017.

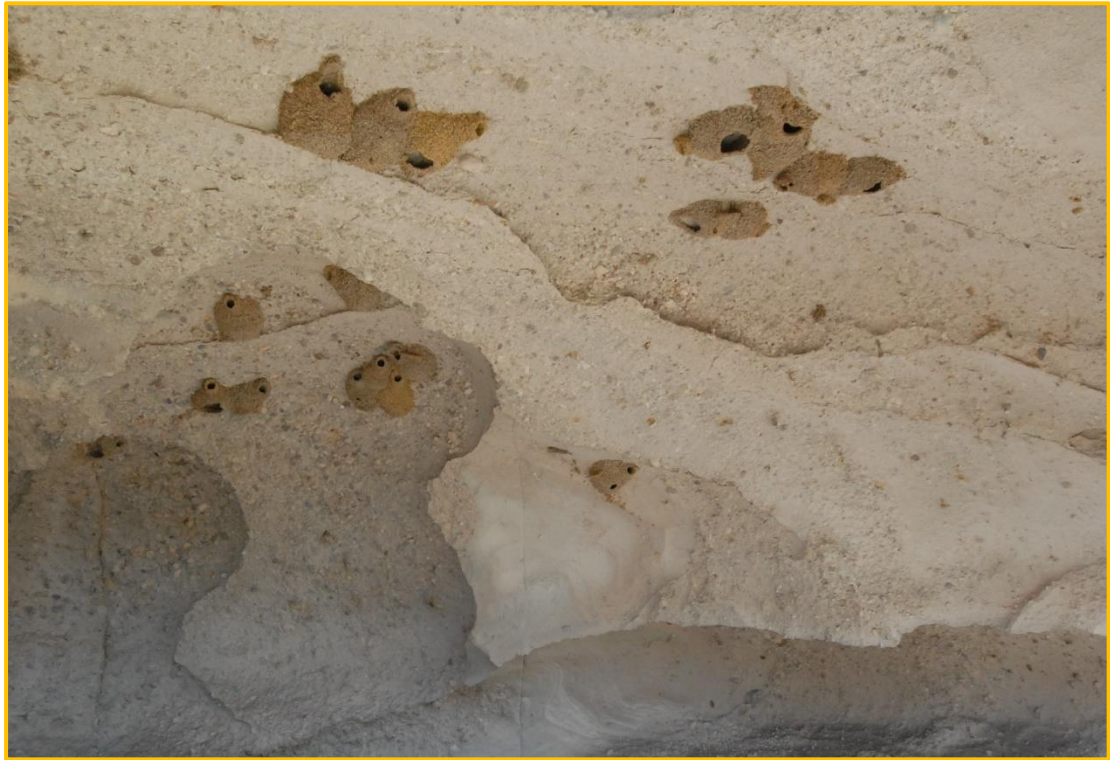
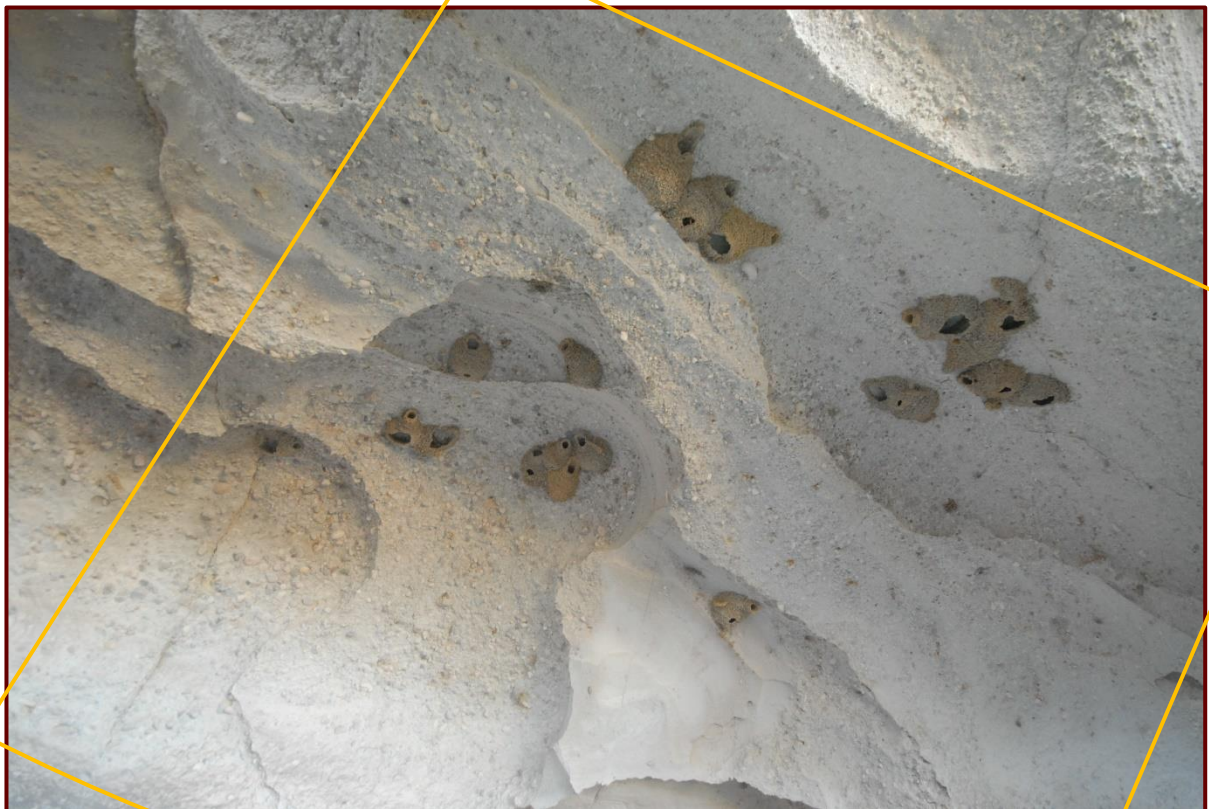
No new Fairy Martin mud bottle-nests were noted in the shelter. Some of the existing nests have deteriorated further since 2017 photography (**Figure 11**). No nest impact upon art pigments.

Figure 11 Comparative images of old Fairy Martin mud bottle nests in the ceiling alcoves of WCP152. No new nests were observed, together with further loss of wall fragments.

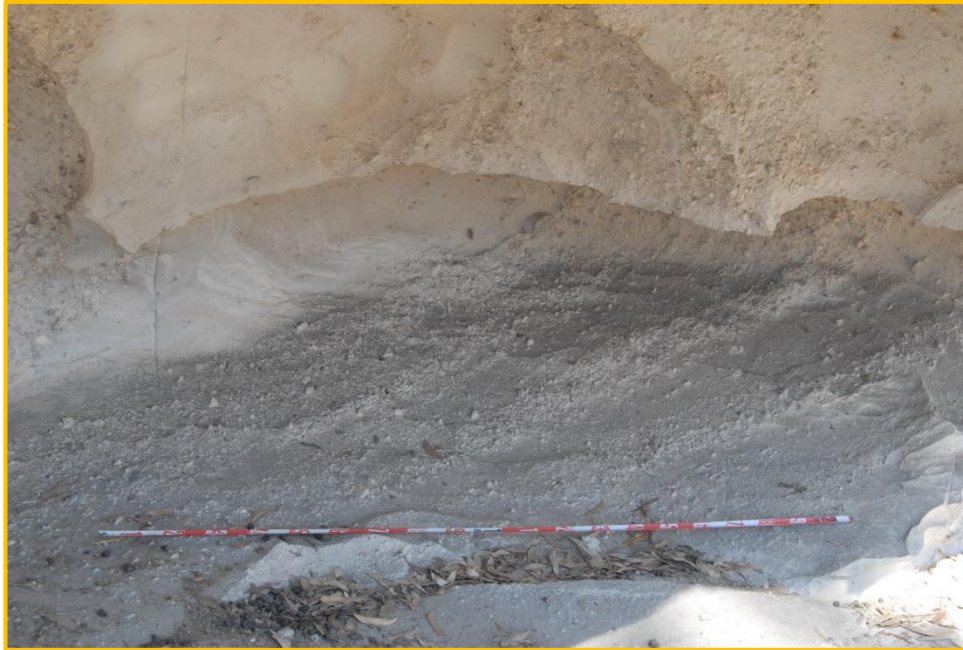
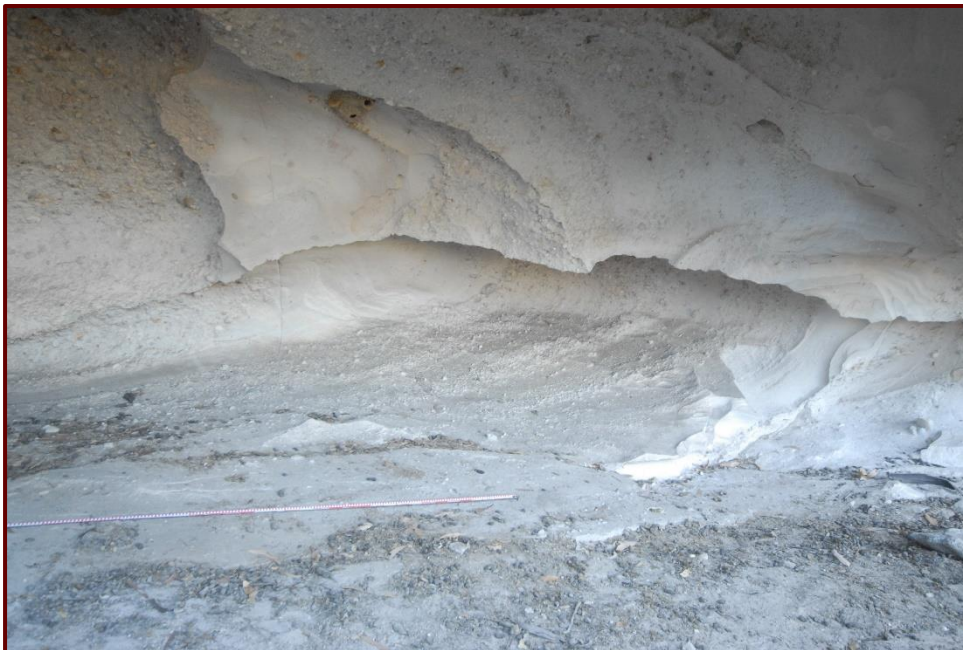
In 2017, it was noted that there was a noticeable darker grey hue to the dust deposits on upward facing surfaces across the shelter, notably the sloping rock back-floor. None of these areas support art pigments (**Figure 11**). Given the timing of these observations and the results of an analysis of similar dust deposits in WCP72 (NOHC 2016b), it was concluded that the darker hue was the result of recent deposition of airborne coal dust, generated from the adjacent coal mining. It was noted that the darker coloured was not bonded to the underlying rock surface and could be easily dislodged by blowing.

Allowing for variation in natural lighting and humidity, no difference between the 2017 record and the appearance of the current (2020) dust deposits could be discerned (**Figure 11**).

The cumulative monitoring record of dark-hued dust accumulation in this shelter, suggests that deposition rates peaked during the time of closest mining activity (which occurred within 150 m of the shelter). This allows the drafting of a model proposing that the visually obtrusive dark-hued dust noted in the rock shelter is a consequence of a larger-sized fraction of quarry-generated airborne particles which fall out of air-suspension within a relatively small radius (within at least 200m) of their point of projection into the air. If a smaller size fraction was responsible, (which presumably would remain airborne longer and travel further), the deposition of dust would be expected to be more gradual and related to the overall life of the mine, rather than periods of close mining activity.

Figure 12 Comparative images showing the colour of dust deposits across the rock floor of WCP152. No difference from the 2017 record, which could not be related to natural lighting conditions, was discernible.

The condition of the dust deposits across the shelter should continue to be monitored.

Consideration should be given to removing the dark-hued dust across the upward facing shelter surfaces as part of the same program and using the same methodology as the planned removal of dust from WCP72. The possible benefits should be balanced with the risk of accidental damage to the fragile lower edge of the art panel in this shelter, and the fact that no dust deposits are obscuring art pigments in this shelter.

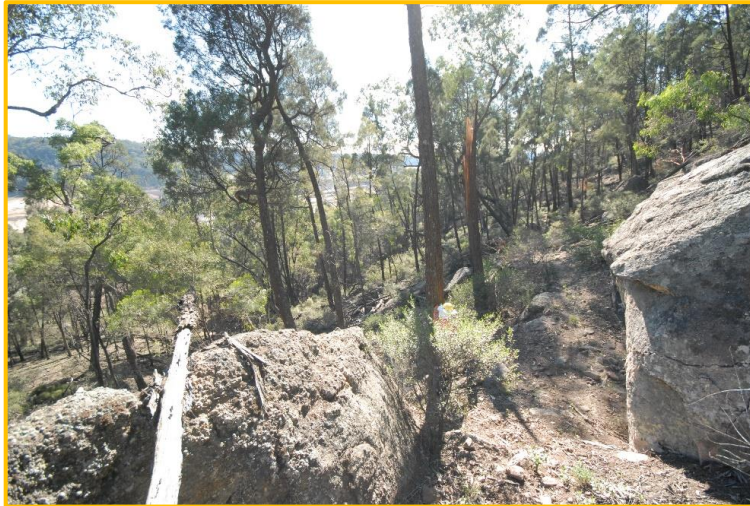
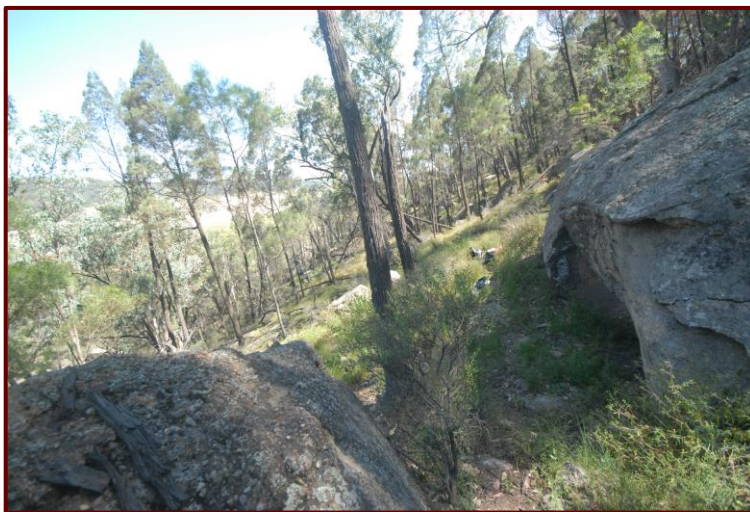
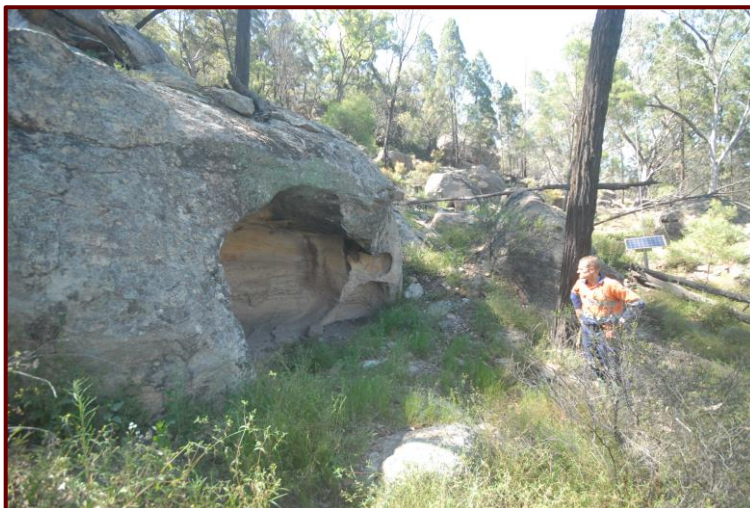
At the time of inspection, the shelter context was characterised by a considerable degree of green, ground storey grasses and shrubs (**Figure 13**). No human footprints were noted prior to the inspection.

Figure 13 General context of shelter WCP153, showing the marked increase in green ground storey vegetation compared to 2017 (top).

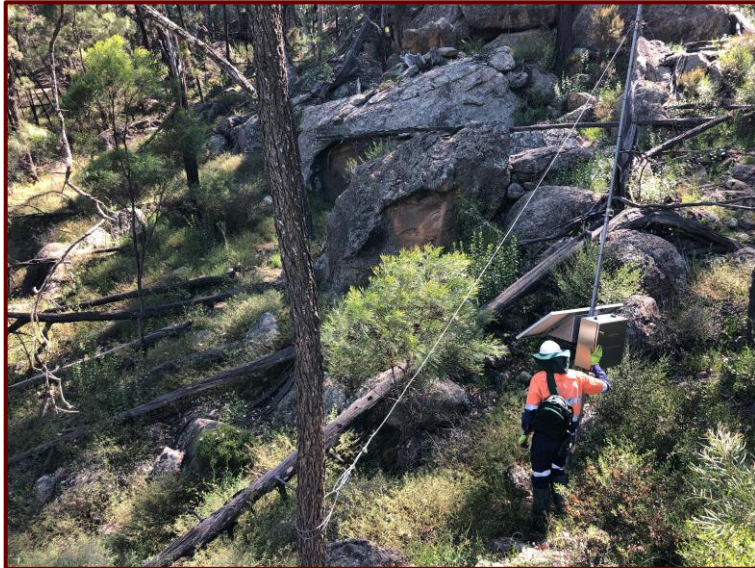
A dead and still standing Callitris pine just downslope of the shelter, uprooted and fallen trees on adjacent slopes, and a fallen trunk and standing stump, above the shelter, all pose a combustion hazard to the art site in the event of a wildfire (**Figure 15 & Figure 15**).

Figure 14 General context of the WCP153 shelter showing the number of uprooted and fallen *Callitris* pines on the surrounding slopes (IMG_4432).

The combustible material in the form of fallen and standing dead trees, and forest litter within approximately 10 m of the shelter entrance should be removed.

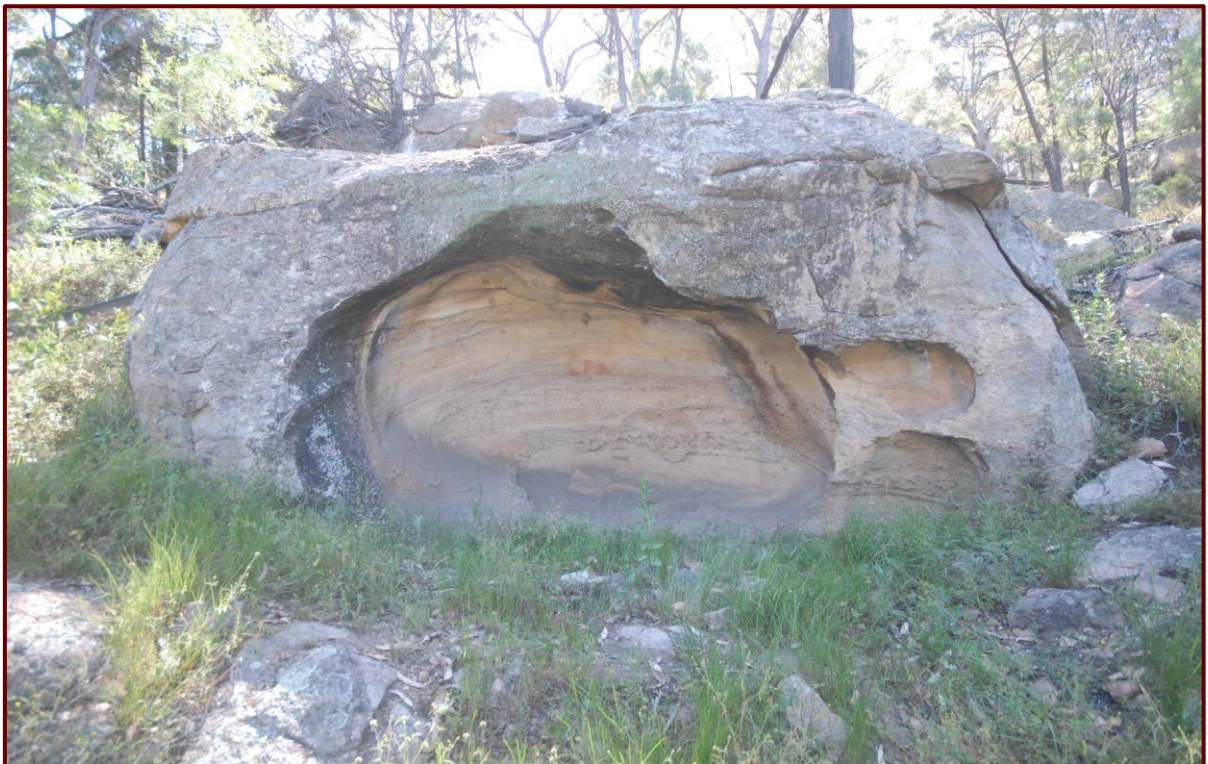
Figure 15 General view of WCP153 shelter, looking east. Note fallen tree debris above shelter (DSC_0349).

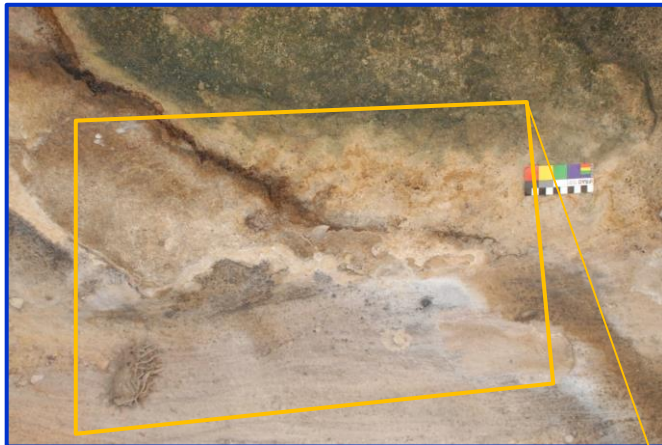
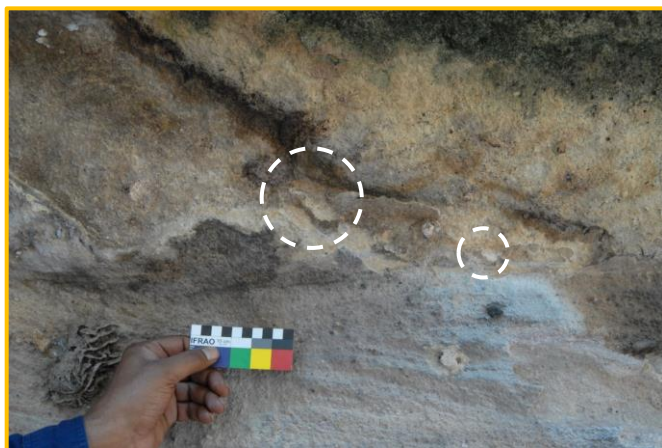
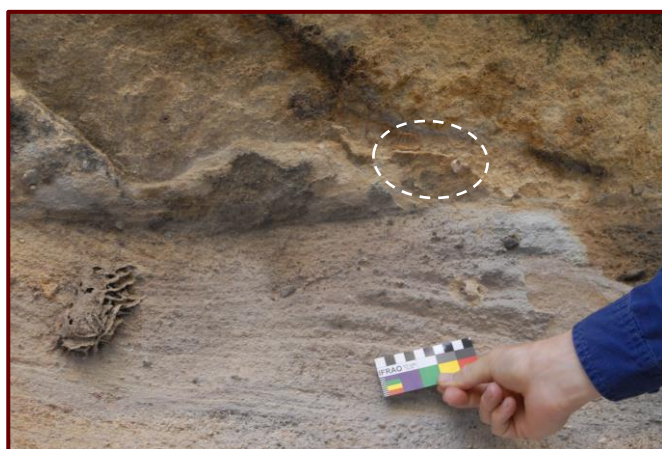
Further loss of small, formerly semi-detached exfoliation spalls was noted from an area where similar loss was noted in 2017 (**Figure 16**). This area is characterised by changes in surface colour/mineralisation around moisture zones associated with the ceiling dripline were noted. These changes do not impact any art pigments and relate to natural erosion processes.

Figure 16 Comparative images showing small areas of minor exfoliation (circled) and changes in surface colour/mineralisation across moisture zones associated with the WCP153 ceiling dripline.

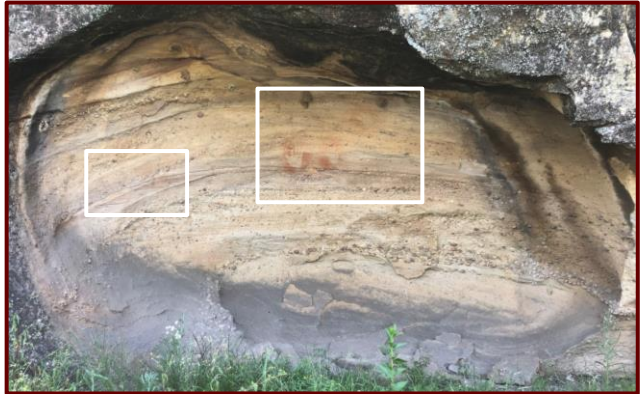
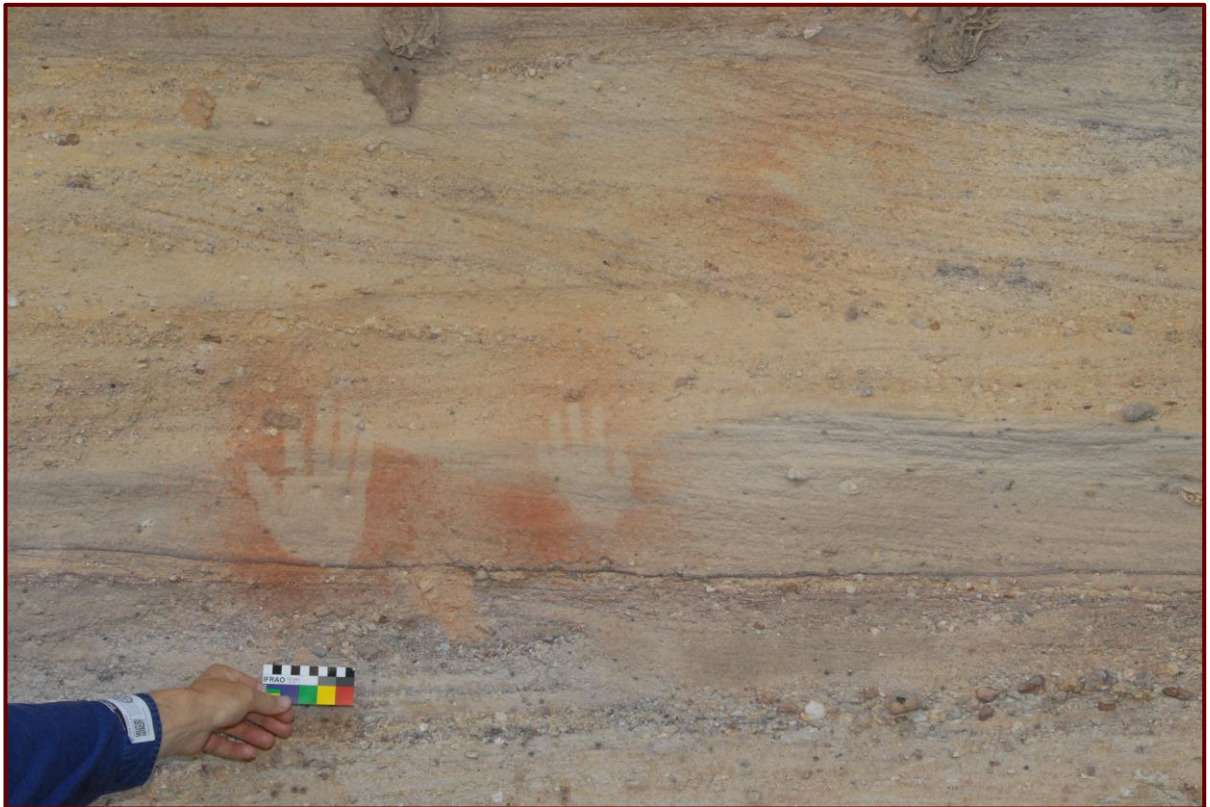
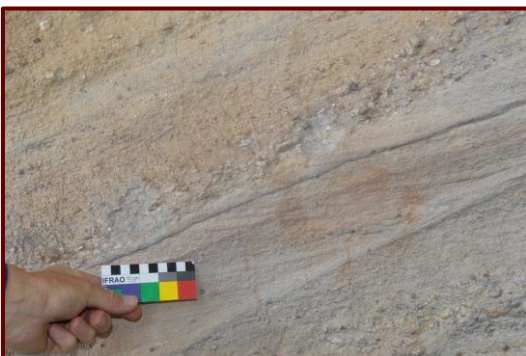
No visually discernible deterioration in the condition of the art pigments and their rock supports was noted (**Figure 17**).

Figure 17 There are no visually discernible differences in the art pigments or supporting rock matrix since the baseline record in 2006.

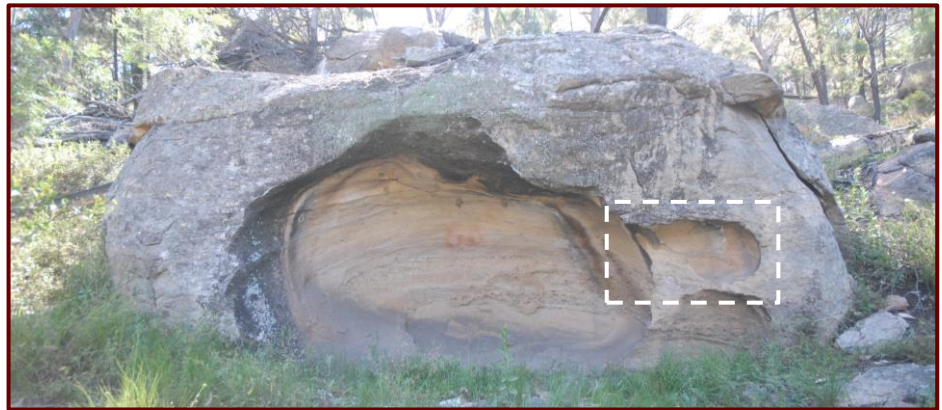
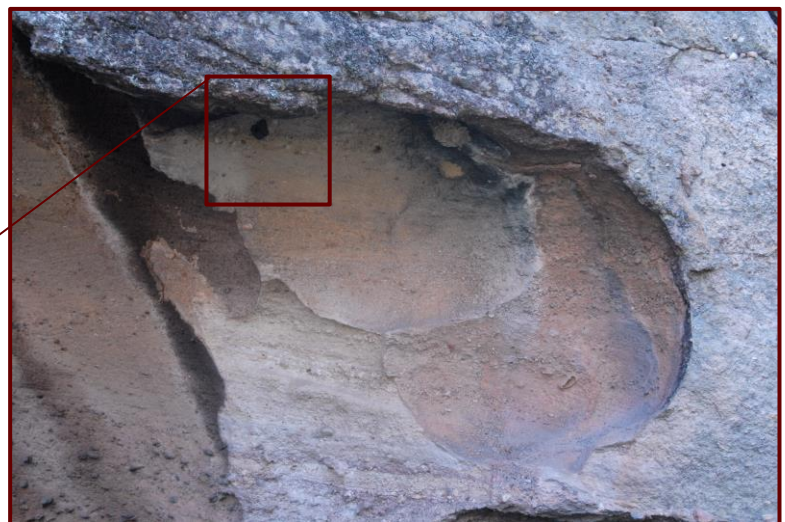
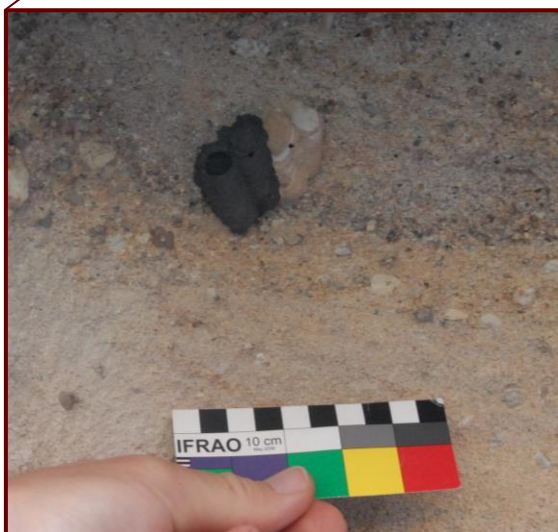
A new mud-daubing wasp nest consisting of two chambers was noted in a small back wall alcove at the far right of the overhang. The nests are constructed from a dark grey/brown sediment, probably related to materials created as a result of mining (**Figure 18**). This nest does not impact upon art pigments.

Figure 18 Images and location of a new mud-daubing wasp nest in a back wall alcove of WCP153.

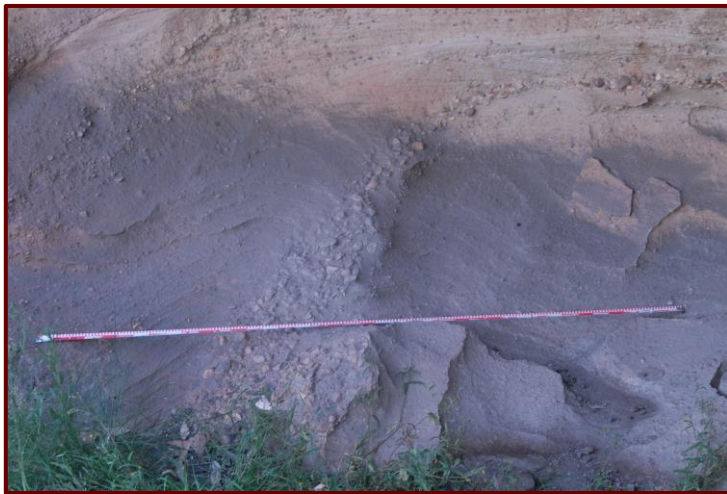
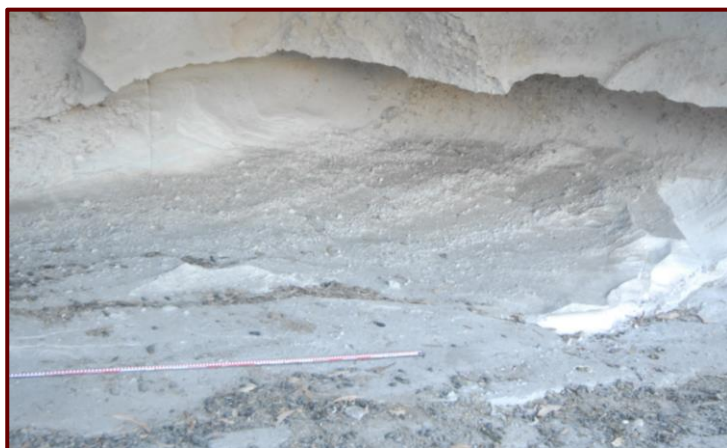
Figure 19 A contemporary comparison of darker-hued dust deposits on the floors of WCP153 (top) and WCP152 (bottom). The deposits in WCP153 appear to be darker and denser and this may be due to the shallower nature of the overhang, the shorter distance to the mining pit (around 100m), and the narrower band of intervening (filtering) vegetation.

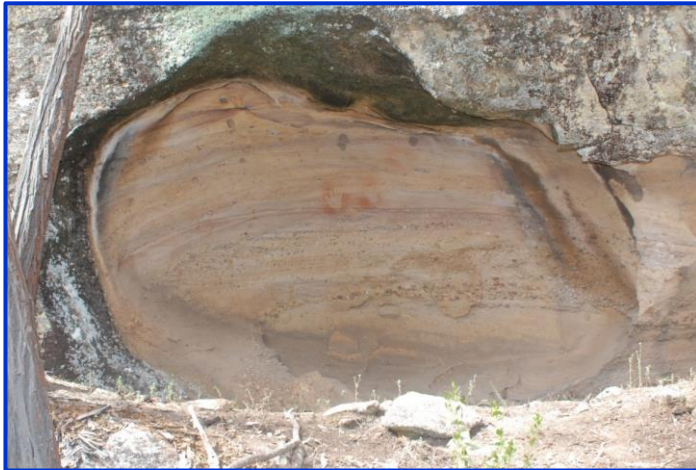
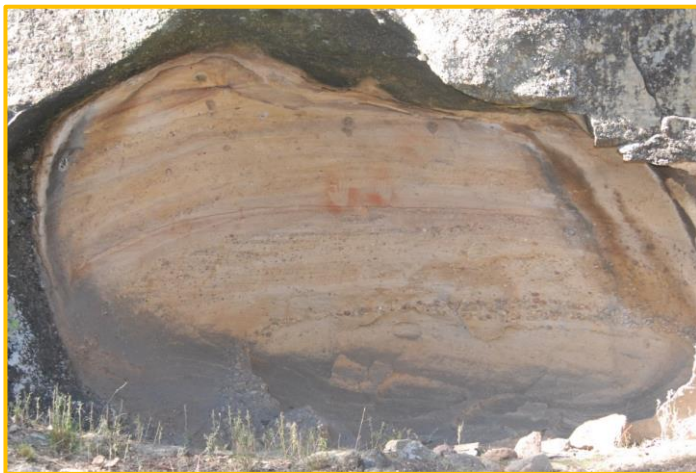
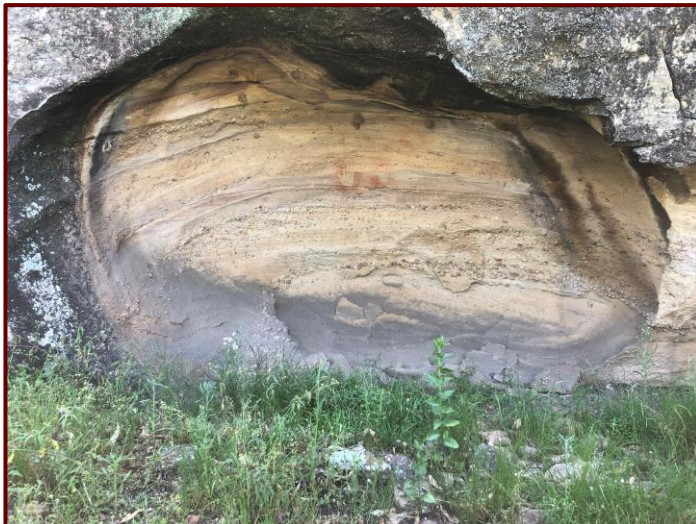
In 2017, a markedly darker grey hue to the dust was observed across the dust affected surfaces. None of these areas support art pigments (**Figure 20**). Although also noted in WCP152, the dust evident in WCP153 appears darker and denser (**Figure 19**). A similar phase of dust deposition was noted in a larger art site within the Wilpinjong Coal lease, 'The Castle' (WCP72). A subsequent study at this site determined the origin of the dark-hued dust to be air-borne particulate matter containing coal and generated from nearby coal mining areas (NOHC 2016b). It was concluded that the darker hued dust on the WCP153 shelter floor was the result of recent deposition of airborne coal dust. It was noted that the darker coloured dust was not bonded to the underlying rock surface and earlier dust deposits and could be easily dislodged by blowing.

Allowing for variation in natural lighting and humidity, no difference between the 2017 record and the appearance of the current (2020) dust deposits could be discerned (**Figure 20**).

The cumulative monitoring record of dark-hued dust accumulation in this shelter, suggests that deposition rates peaked during the time of closest mining activity (which occurred within 100 m of the shelter). This allows the drafting of a model proposing that the visually obtrusive dark-hued dust noted in the rock shelter is a consequence of a larger-sized fraction of quarry-generated airborne particles which fall out of air-suspension within a relatively small radius (within at least 200m) from their point of projection into the air. If a smaller size fraction was responsible, (which presumably would remain airborne longer and travel further), the deposition of dust would be expected to be more gradual and related to the overall life of the mine, rather than periods of close mining activity.

Figure 20 Comparative images of dust deposits across the WCP153 back wall. Note the distinct change in hue from light yellow-brown to dark grey noted in 2017 and no discernible change (apart from lighting and humidity changes) between 2017 and 2020. Airborne dust from the formerly nearby open cut pit is the likely source of this material.

The condition of the dust deposits across the shelter should continue to be monitored.

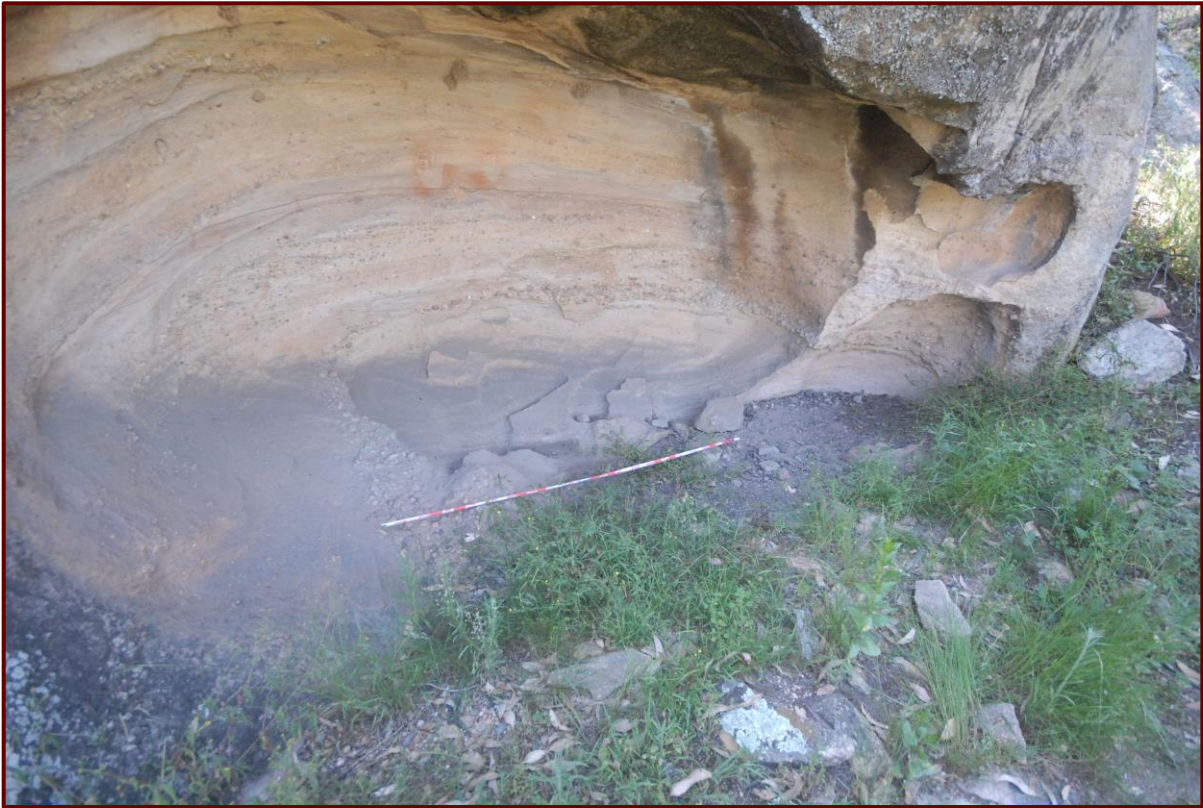
The shelter deposit remains in a similar condition to that recorded in 2017 except for the growth of herbs and grasses across approximately 50% of the sedimentary deposit under the overhang.

Figure 21 General view of the WCP153 floor, growth of herbs and grasses, and previously noted loose tabular surface rock, sourced from adjacent side slopes (DSC_0353).
