APPENDIX 5
BIODIVERSITY

Biodiversity Offset Strategy

WILPINJONG COAL MINE

Wilpinjong Coal Mine
2022 Channel Stability Monitoring

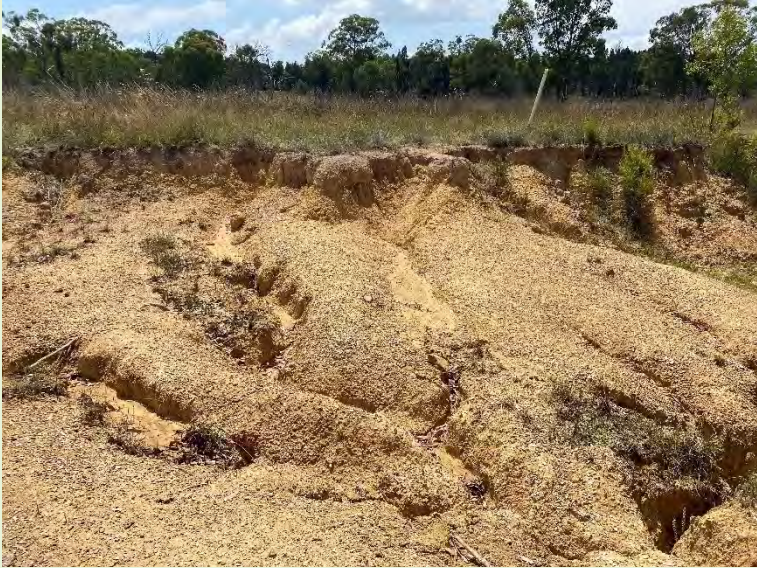
Erosion point	Image	Notes / suggested works
E1 (768557, 6422438)	 	<p>Mass wasting has occurred at top of bank. Reshaping and contouring of bank and revegetation (Section 4.3).</p>
E2 (768469, 6422527)

<p>Rills continue to form on exposed bare soil. Mass wasting has occurred, with erosion point spreading to edge of track. Revegetation and mulching (Section 4.3).</p>

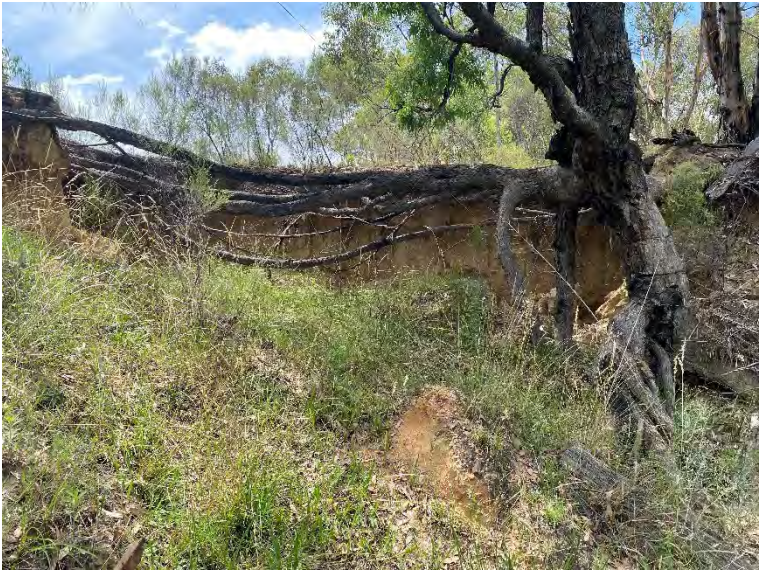
Erosion point	Image	Notes / suggested works
<p>E3 (768558, 6422432)</p>

<p>Evidence of mass wasting at top of bank, and soil run off from rainfall events.</p> <p>Reshaping and contouring of bank and revegetation (Section 4.3).</p>
<p>E4 (768614, 6422382)</p>

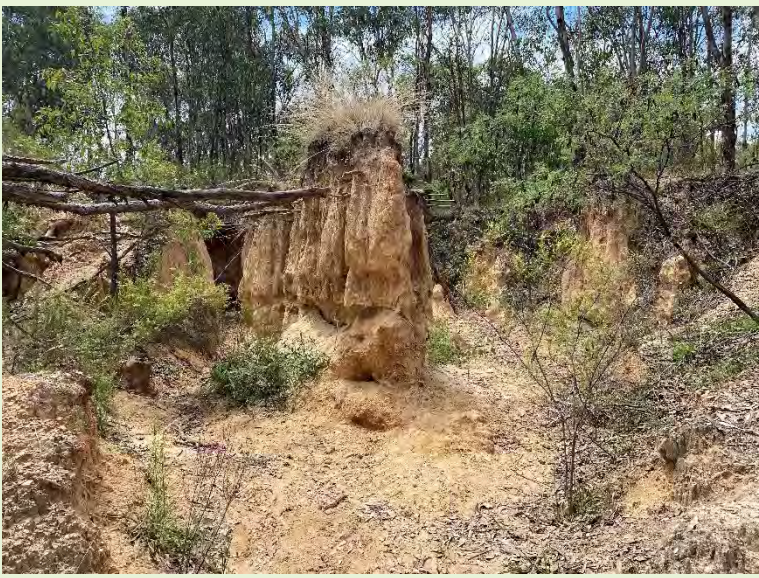
<p>Mass wasting evident at top of bank, with soil run off from rainfall events.</p> <p>Reshaping and contouring of bank and revegetation (Section 4.3).</p>
<p>E6 (772166, 6420287)</p>

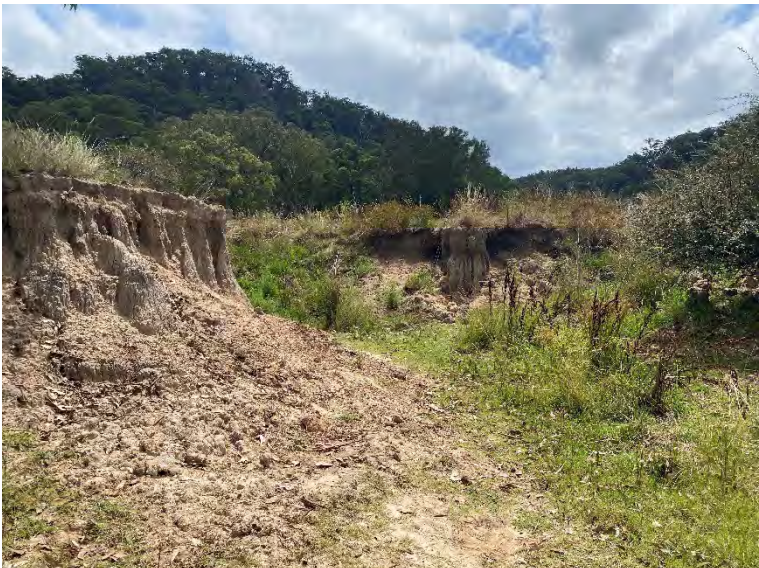
<p>Erosion has been active over past year, with minor undercutting. Western side of erosion point has had soil run off, with vegetation cover through the middle of the gully likely preventing further high soil run off.</p> <p>Reshaping and contouring of bank and revegetation (Section 4.3).</p>
