# WAMBO COAL PTY LIMITED

# WAMBO COAL MINE LONGWALL 24 TO 26 MODIFICATION

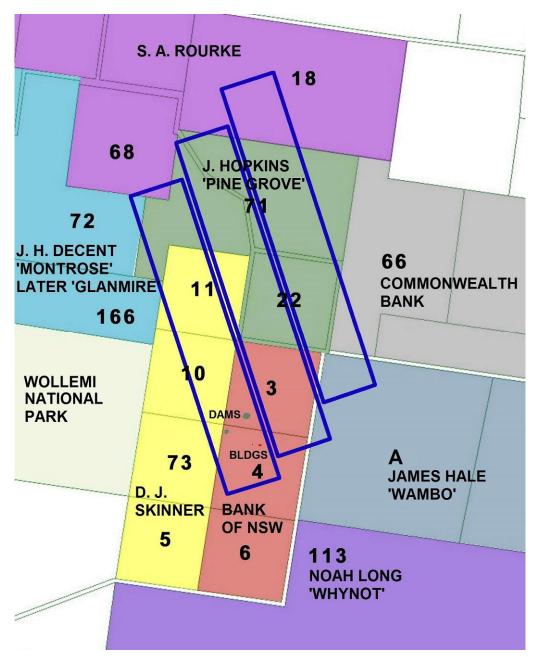
Figure 6: Diagram showing historical ownership of the allotments affected by the Longwall 24-26 Modification. The only remnant buildings (red dots), structures, dams (blue dots) and objects are located on allotments 3 and 4 previously owned by the Bank of NSW

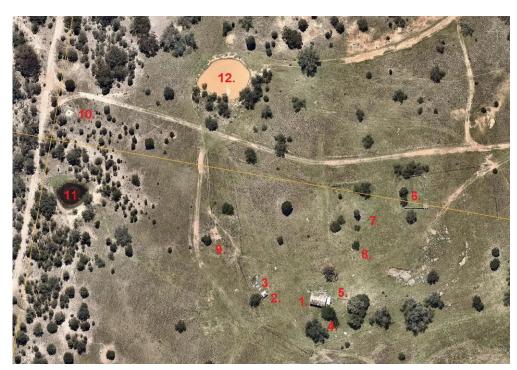
Figure 7: Aerial photo showing the extent of the remnant buildings and structures. They are numbered as follows: 1. Hayshed and Slab Dwelling, 2. Small Shed, 3. Chicken Coop / Rabbit Hutch, 4. Pump Shed, 5. 'House' Yard, 6. Yards, 7. Workshop, 8. Tractor, 9. Dairy, 10. Pen, 11. Small Dam, 12. Large Dam. Source Nearmap (by license) Annotated by EJE

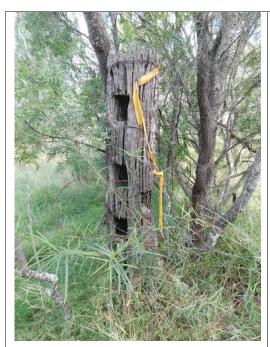
Figure 51: Fencepost discovered at the corner of Hopkins, Skinner, and the Bank of NSW site. The post is clearly substantial but no identifying marks were found.

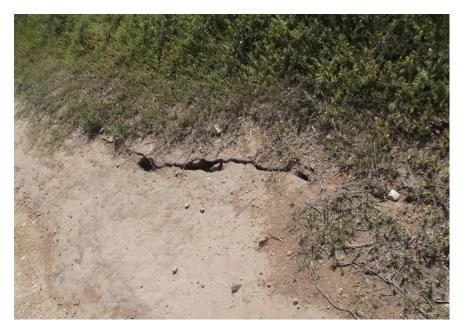
Figure 54: Cracking effect shows the elongated fissure opening into a deep cavity below.

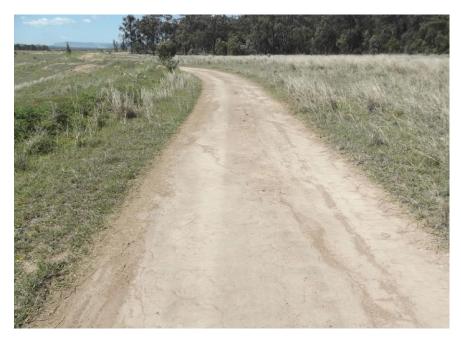
Figure 55: An uplift effect has caused the ground to rise in relation to its original position.
