## METROPOLITAN COAL

### LONGWALLS 301-303

## BUILT FEATURES MANAGEMENT PLAN TELSTRA

June 2018

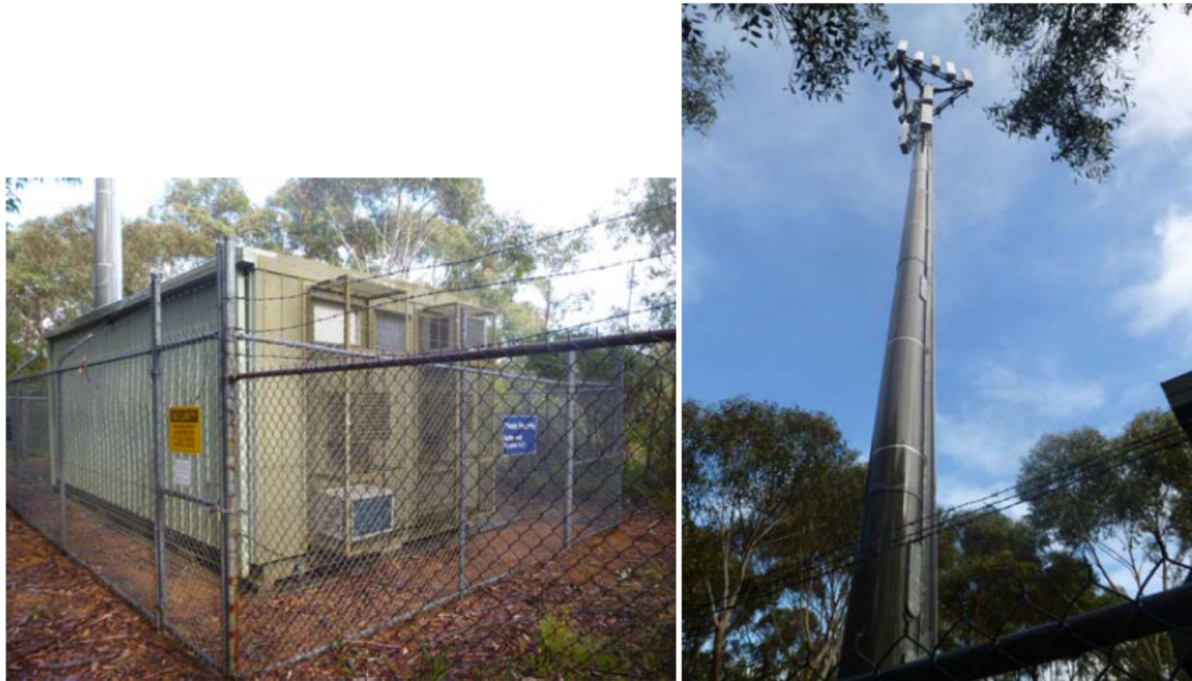
**Plates 1 & 2 – Telecommunications Tower and Compound (Source: MSEC, 2016)**

The telecommunications tower and compound are shown on Plates 1 and 2.

An audit and site inspection of the Telstra assets including inspection of the cable lines and entries to the hut and condition of the cable was conducted.

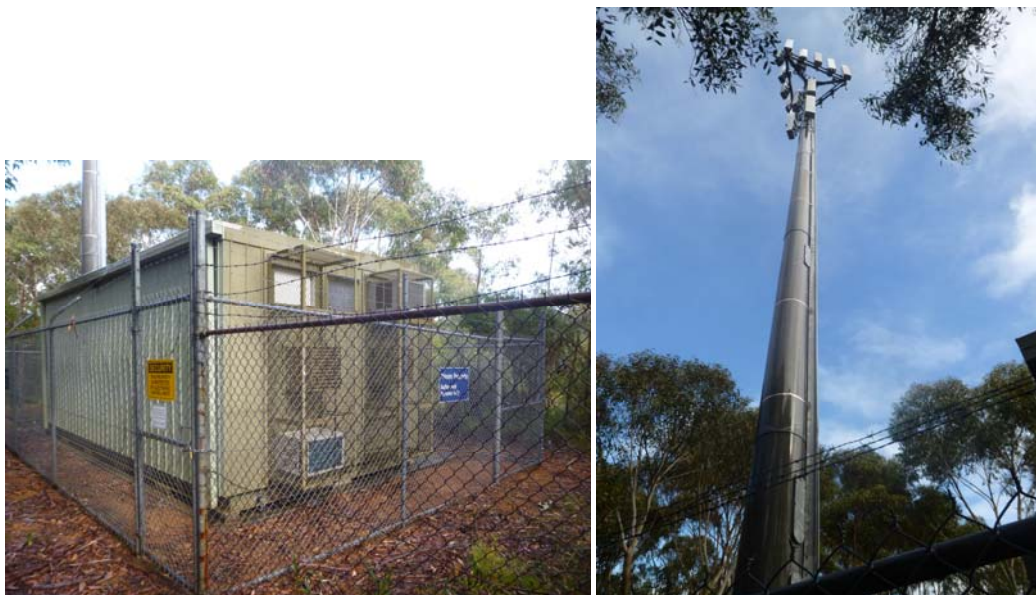
**Figure 1 Telecommunications Tower and Compound**

A telecommunications tower and compound are located above Longwall 303. Photographs of this installation are provided in Figure 1.

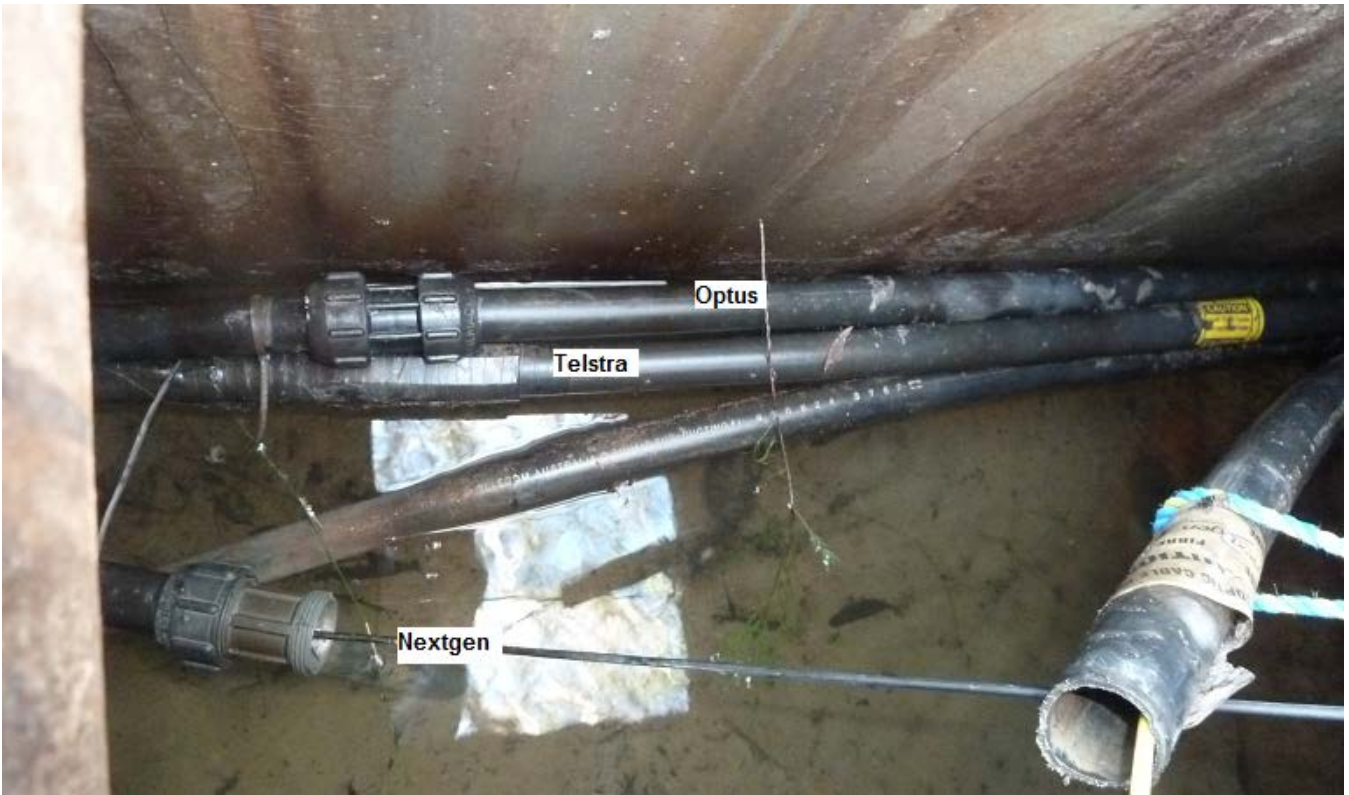
Plate 2

This early design cable however is installed in 32mm diameter sub-duct and then installed in 100mm PVC pipe across LW301 it is therefore relatively isolated from ground movement that may impact primarily on the conduit installation. However due to the relatively high risk presented from high strain

levels predicted, combined with the presence of sub-duct and conduit, it is possible that there may be some impact on this sensitive cable. Additionally since the cable is installed in very rocky isolated terrain where anomalous surface movement may damage the network, as a precautionary measure it is recommended that the cable line is physically inspected to ensure that there are no adverse ground impacts occurring as subsidence develops at the south-east finishing end of LW301. The added precaution of using OTDR monitoring of the cable condition over the relevant cable section from Engadine to Helensburgh exchanges is also recommended.

View of optical fibre cables through manhole at approximately 650m north of the Princes Highway underpass of the Southern Freeway M1. There is no joint at this location and the next joint north of the Princess Highway is in the Motocross Track area approximately 800m north and outside the mining area to the east of LW301.

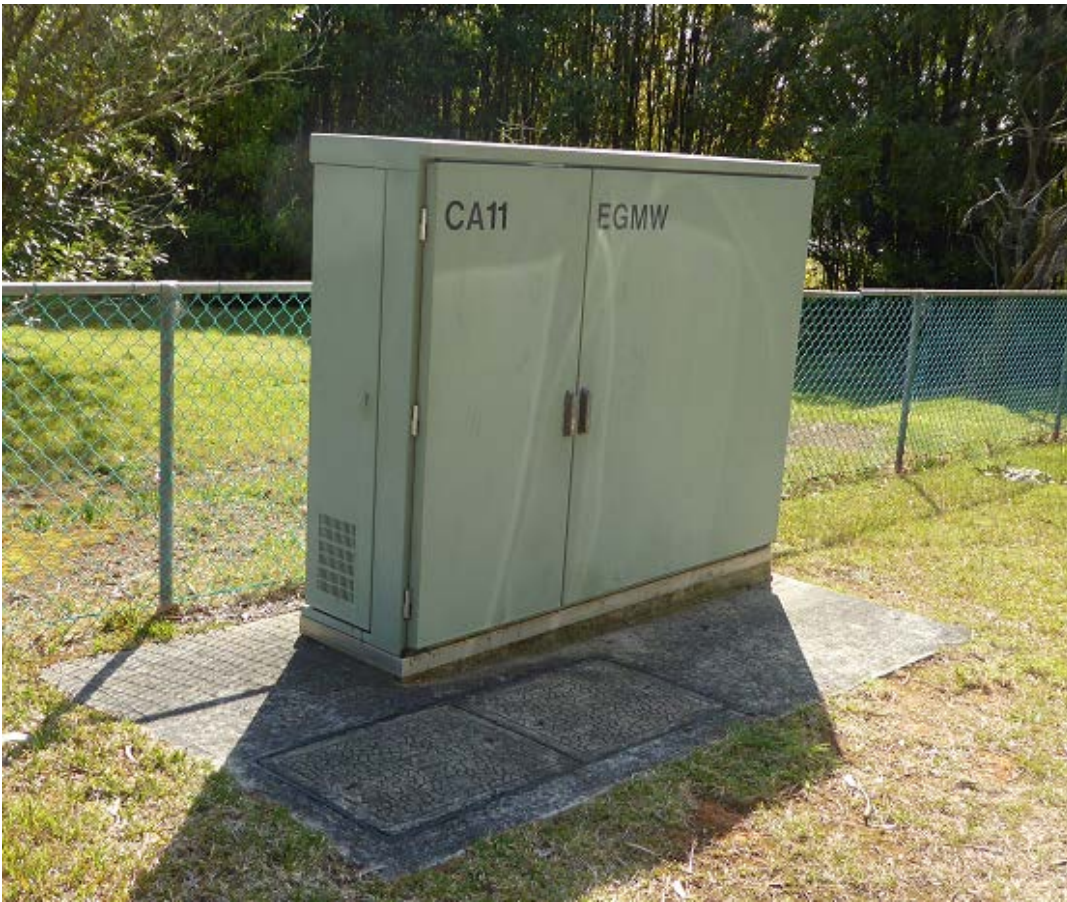
Plate 3:  
RCM cabinet  
'EGMW' located  
on the access  
road to the  
Hospital.  
Provides copper  
cable customer  
services from  
optical fibre  
transmission

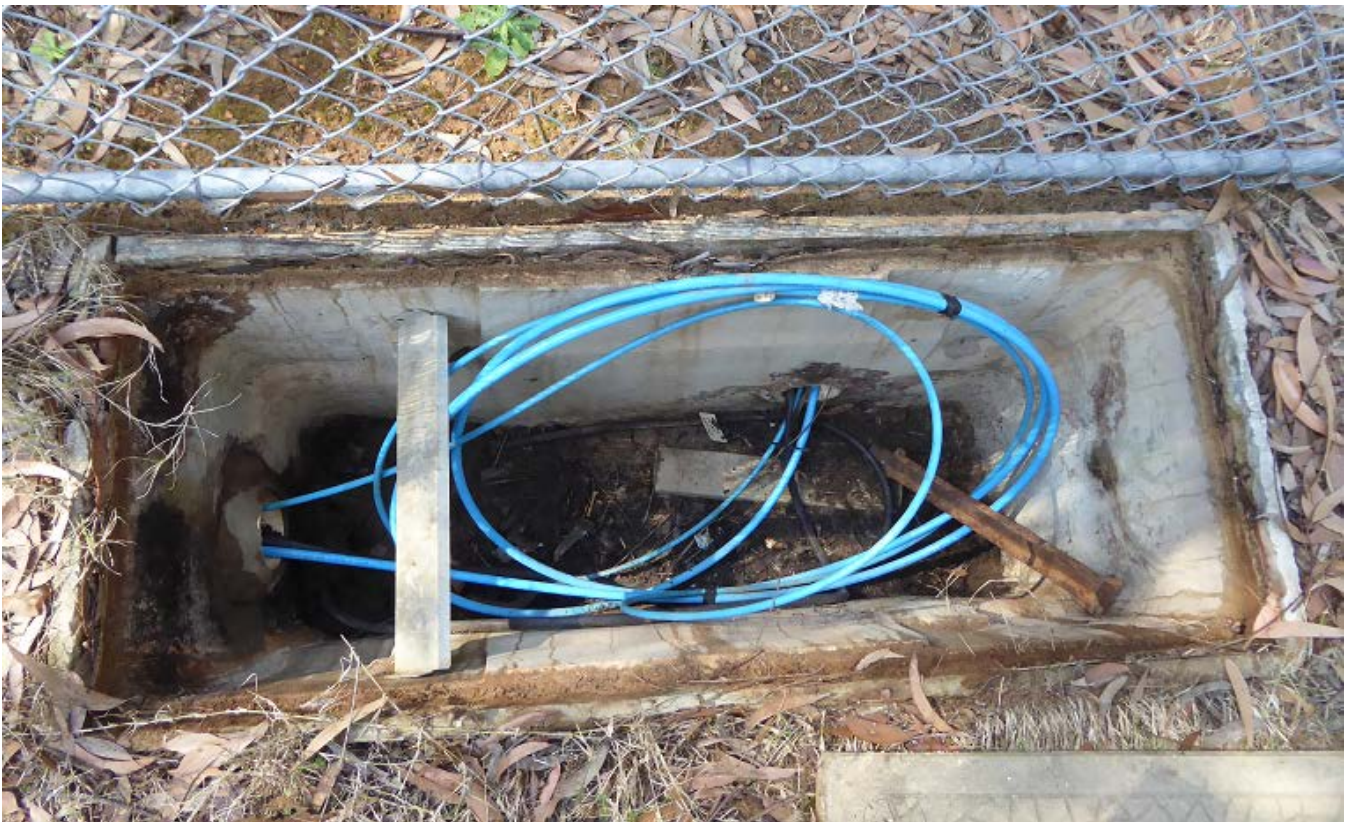
Plate4:  
Cable entry to Mobile Telephone Tower Hut showing two optical fibre cables into the Hut the larger diameter cable is F ENGA 3005 and the smaller diameter cable is the more vulnerable cable F ENGA 3001.

As shown in Appendix B the two cables are only exposed to around 50m of mining extraction at the northern commencing end of LW303 and approximately 350m within the Study Area. Since the cables are located at the northern location, full ground subsidence and ground strain development is not anticipated to develop. Accordingly the Risk Factor is considered to be **Moderate** an Unlikely event with Moderate consequences.

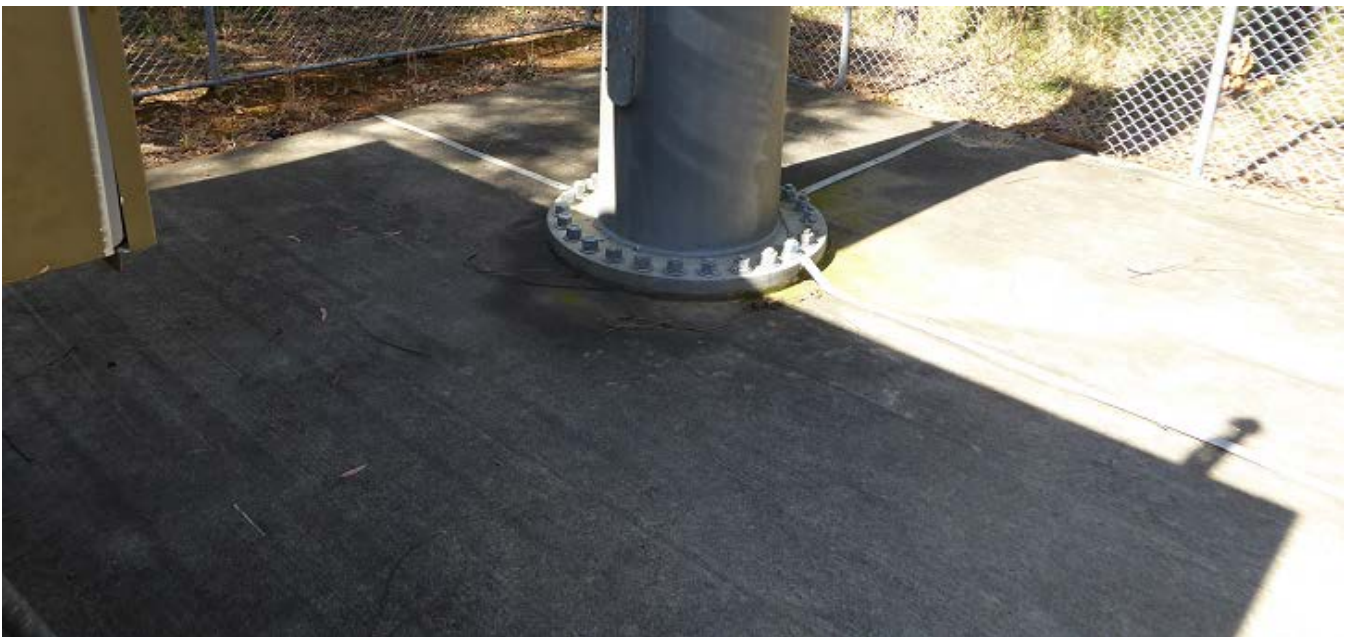
Plate 5:

The Mobile Telephone Tower as with the optical fibre cables which feed to the Tower is located at the northern end of LW303 approximately 50m from the north goaf edge. Accordingly the risk is that the Tower structure and hut will be subject to tilt which is predicted to be a maximum of 1.5mm/m with 150mm of subsidence.

View of Tower base structure showing base ring of 24 x 24mm dia bolt cage to secure the base of the 25m steel monopole.

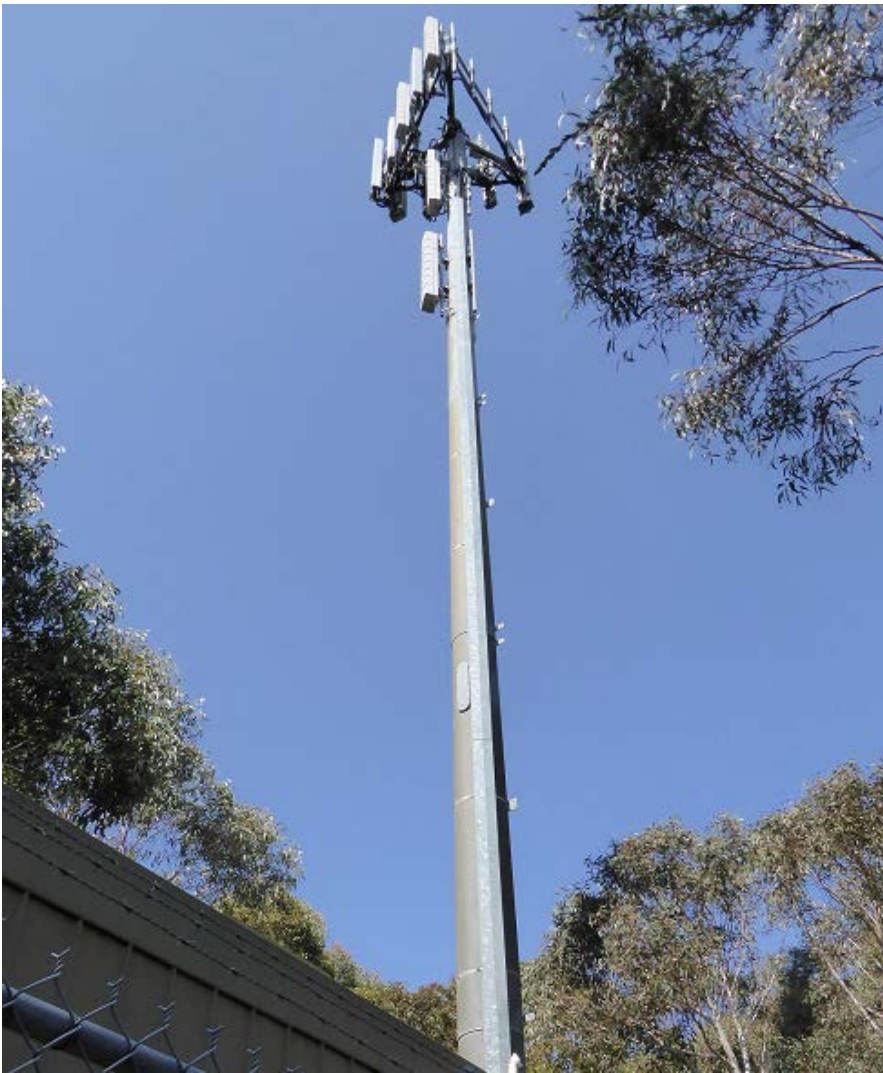
Plate 6:  
View from western side of 25m  
steel monopole  
showing transmission  
array on north and  
eastern faces  
projecting signal  
towards M1

This particular tower does not use microwave dishes for any support functions such as back-up systems signalling and as such is not particularly sensitive to tilt occurring. The accepted standard for Telstra towers at Douglas Park and Tahmoor, subject to mining is a tilt level of less than 1 degree. Hence for the 25m tower this would be a tilt at the top of around 45mm. At a predicted maximum ground tilt of 1.5mm/m this would provide a tilt of around 37mm within the accepted limit. The details for this particular tower will be requested from Telstra to verify that this level of ground movement is acceptable.

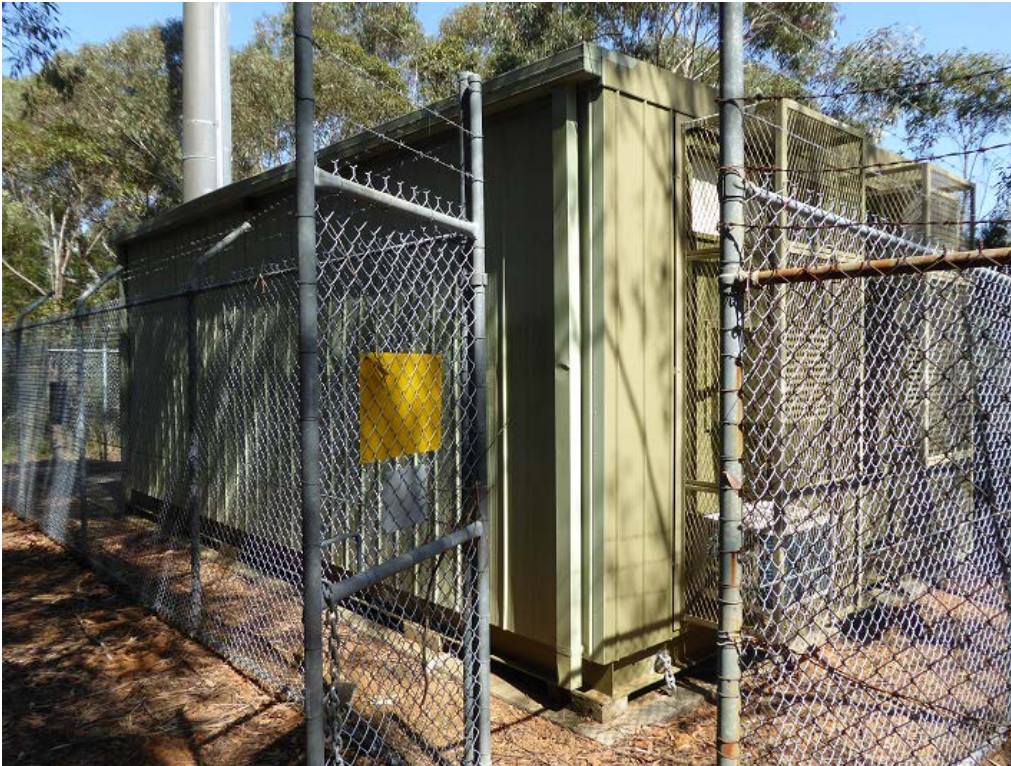
The Hut at the base of the tower carrying the transmission equipment is a 2000 line transportable exchange building also used for housing rural exchanges. Since the building is transportable it has a torsionally rigid base frame suitable for lifting onto trucks and then placing on blocks on site. Therefore the building is able to accept a reasonable degree of movement. However it does sit on a concrete base slab with penetrations around the building for cable entries, earthing cables and waveguides to the tower transmission aerials. Therefore these penetrations into the building should be monitored along with any obvious movement of the slab and supporting blocks to ensure the building is adequately supported at all times.

The Risk Factor for the Tower and Infrastructure is considered as Moderate an unlikely event with moderate consequences.

Plate 7:  
View of Hut at Tower base housing all the transmission equipment for the support of the Mobile Telephone Tower. There is a very heavy battery array at the north end and a check should be maintained that the building is adequately supported at all times
