APPENDIX 4
BIODIVERSITY

Peabody
 WILPINJONG COAL MINE
 Project Area and
 Biodiversity Offset Strategy

Monitoring of Microbats at Slate Gully Adit (Pit 8), Wilpinjong Coal Mine, NSW for 2025

2025 Channel Stability Monitoring Report

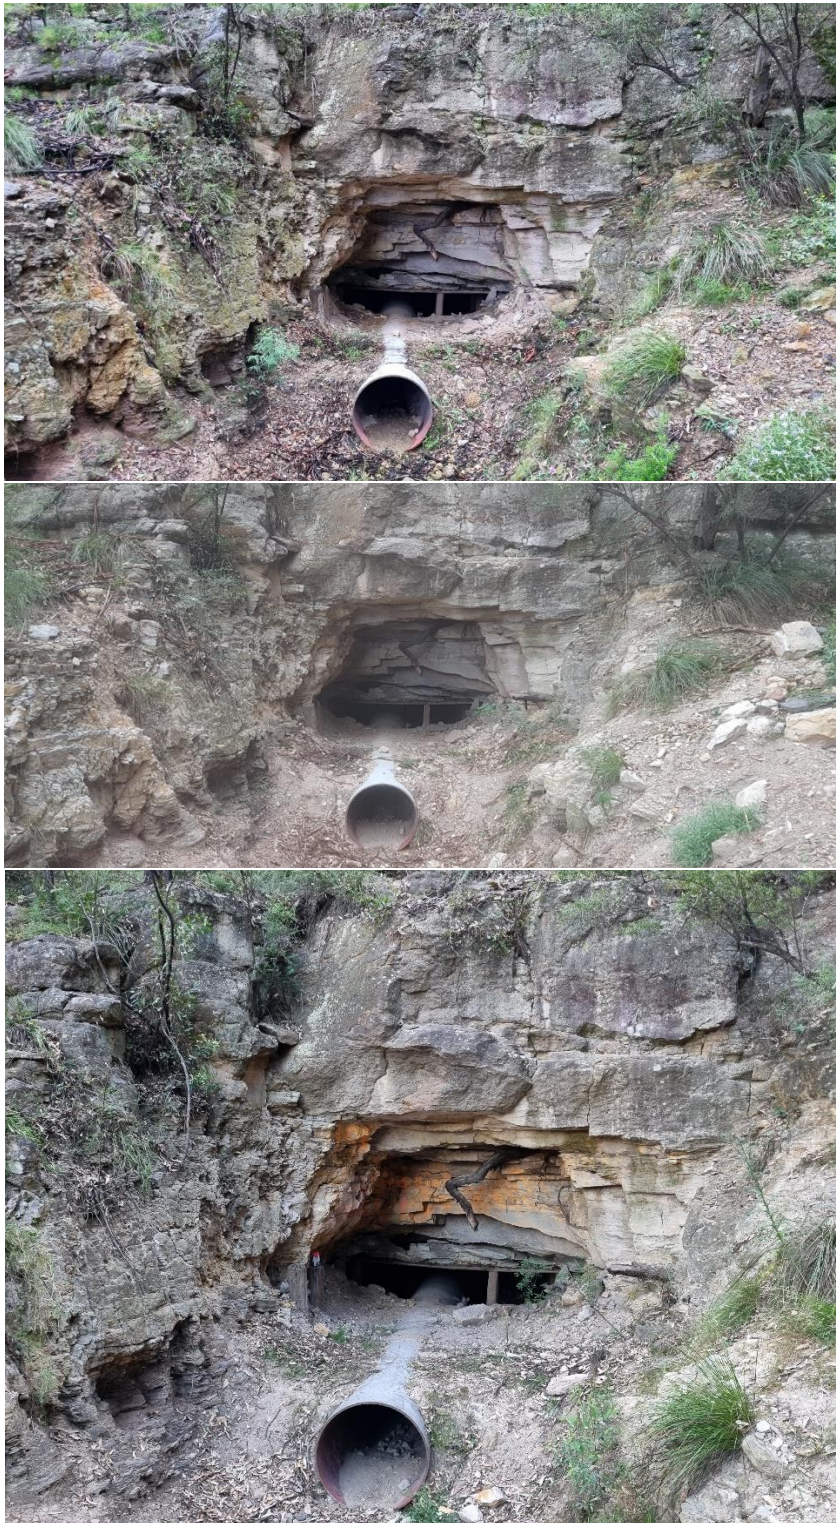
Plate 5-A: Periodic monitoring photo of adit entrance from February 2021 (top), January 2022 (middle) and December 2022 (bottom) showing lack of substantial change

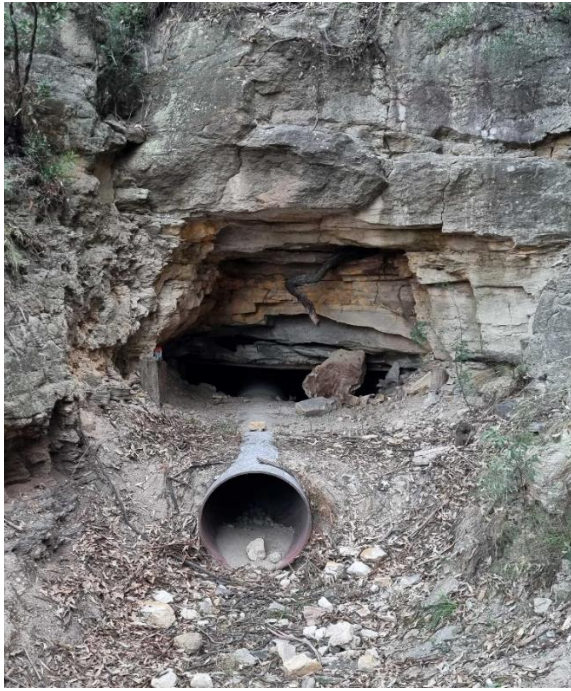
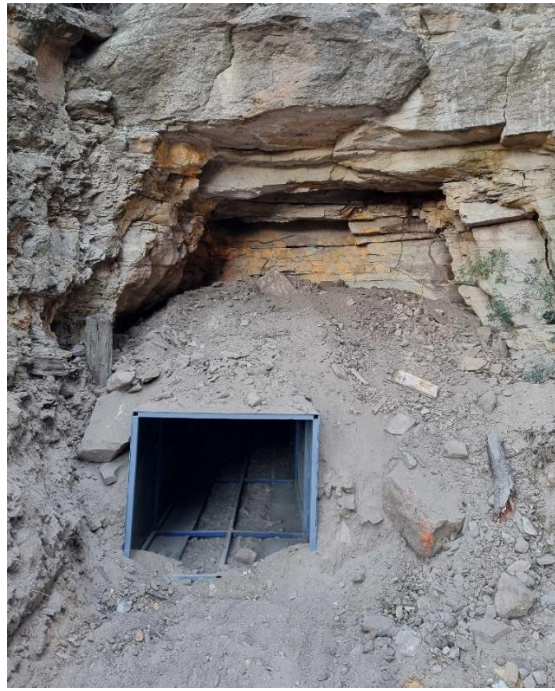
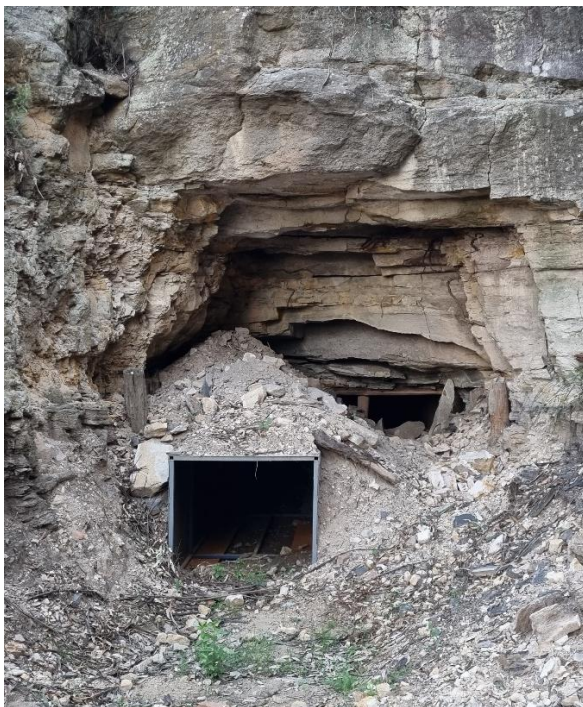
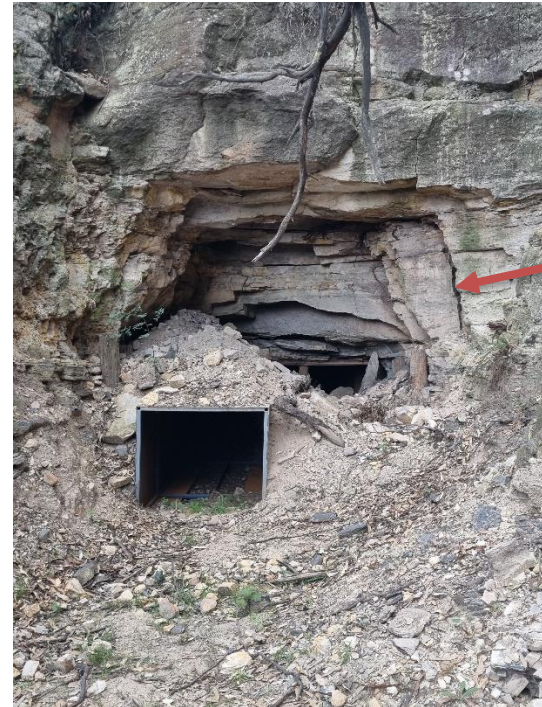
On 26 April 2023, the steel pipe was removed from the adit and replaced with a larger aperture square steel box tunnel (see **Plate 5-2**). This was in response to the beginning of signs of rock fracture around the adit entrance. The rock around the adit entrance was sprayed with marking paint in September 2022 to facilitate identification of rock that had dislodged from the adit entrance. Minor rock falls (football sized) were observed in December 2022, February 2023, August 2023, September 2023 and April 2025. A larger block (esky sized) was observed to have dislodged from the right hand side of entrance in March 2023. The new tunnel (measuring 1.1m high x 1.3m wide) was constructed of steel plate with the inner surface a combination of painted and bare steel. The old pipe had a cross sectional area of approximately 0.64m², while the new tunnel had a sectional area of 1.43m². This better suits the requirements of Large Bent-winged Bat flight, with few (if any) bats ever observed using the round pipe. The April 2023 count was conducted on the night of the tunnel installation. Dirt had been piled up on top of the tunnel in an attempt to stabilise the tunnel and close the adit in (forcing bats to use the tunnel). On counting the exit, a small aperture was obviously present in the top of the dirt pile, as approximately 90% of the bats exiting the adit that night used the top rather than the tunnel. Forcing large numbers through a small aperture also meant the exit took longer than it had previously. The author proposed that the mine remove some of the dirt on top of the pipe to allow bats to use their preferred flight path, and reduce the risk of predation by a cat or fox standing in front of the small aperture. In May 2023, the space above the tunnel had been expanded to avoid funnelling bats through a tiny aperture.

Plate 5-B: Monitoring photos of adit entrance pre culvert installation (March 2023 – top left), afternoon of installation (April 2023 – top right), nine months after installation (January 2024 – bottom left), and 20 months after installation (December 2024 – bottom right). This shows progression of pipe to tunnel with small aperture, tunnel with large aperture. Large crack forming on western side shown with red arrow.

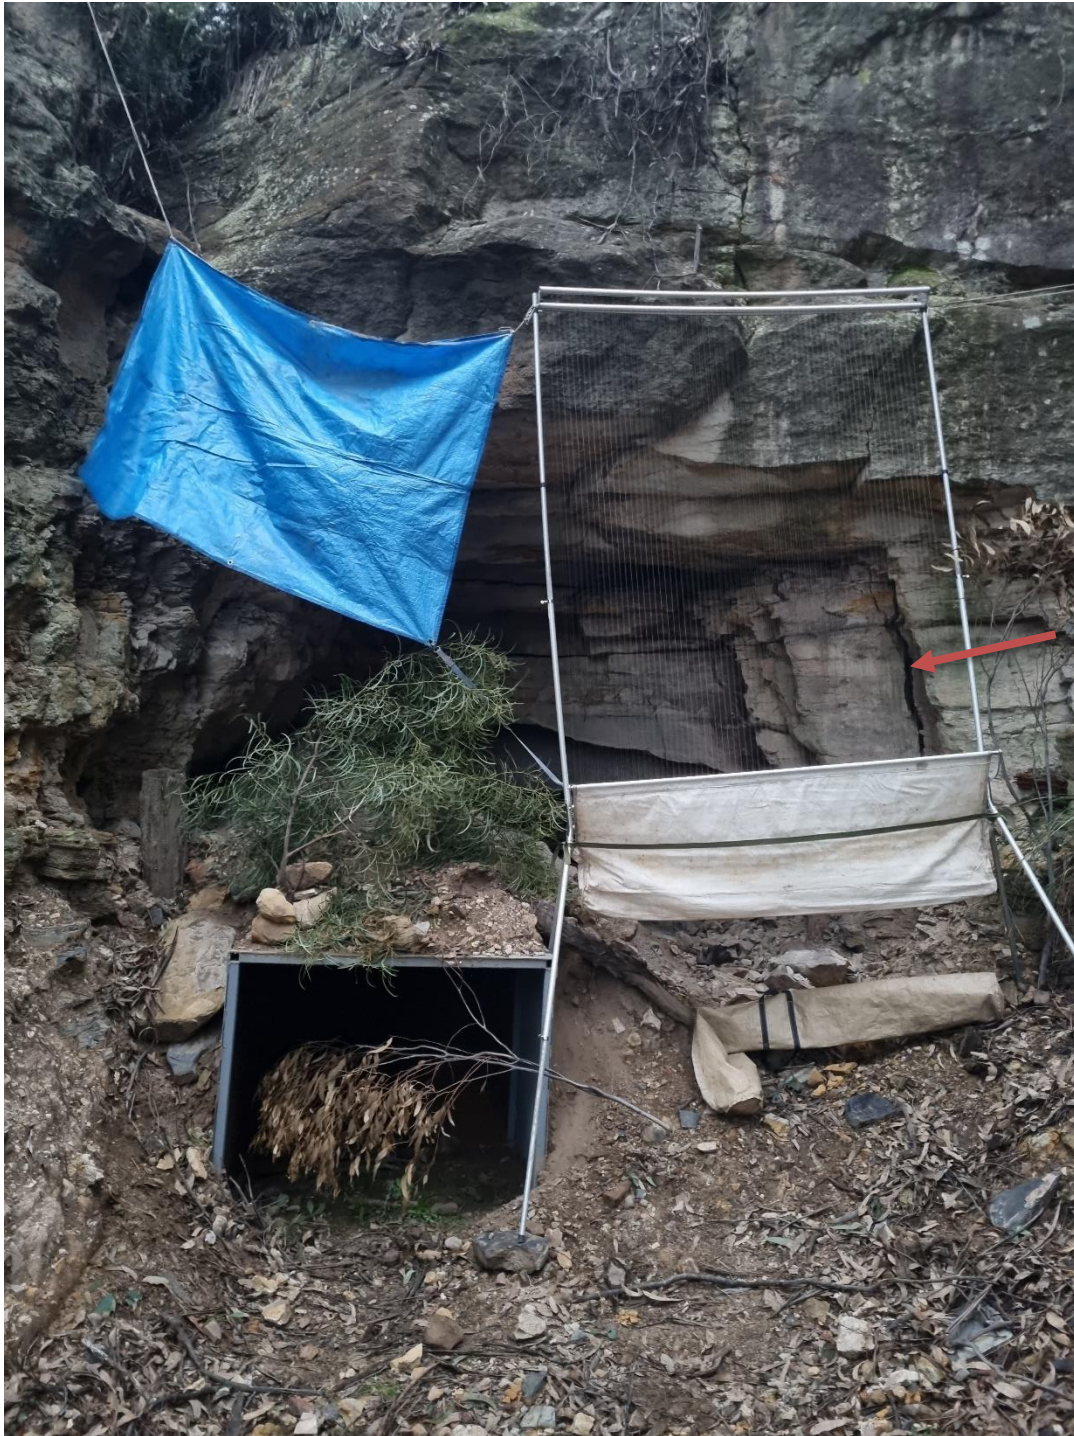
Some very small rocks were observed dislodged from the roof in October 2024, but the main concern in 2024 was the widening of the crack in the wall on the right hand side (western side) of the entrance (**Plates 5-2** and **5-3**). A large acacia fell across the entrance in February 2024, but small branches were pruned so it did not obstruct exiting bats.

Plate 5-C: Monitoring photos of adit entrance 15 months after installation (July 2024). Harp trapping was conducted to get an update on roost status (species present, sex ratios and recapture of banded individuals). Large crack forming on western side shown with red arrow.

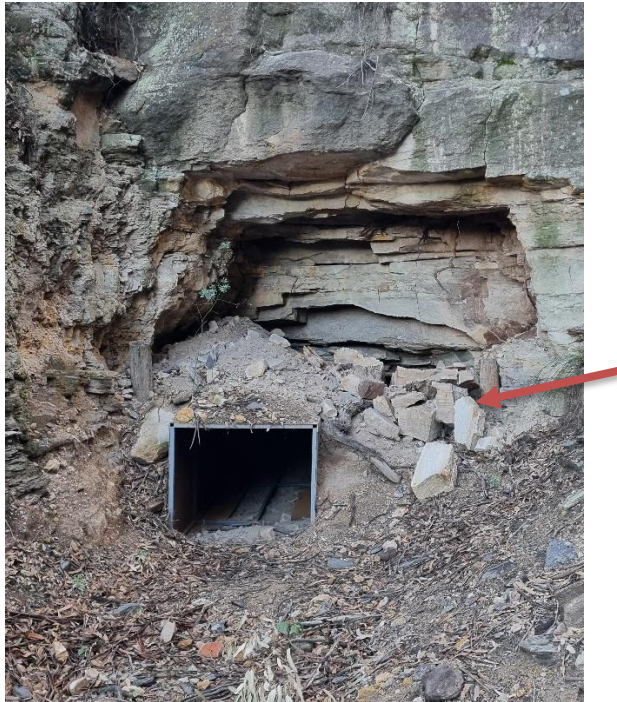
Plate 5-D: Monitoring photo of adit entrance almost three years after installation (April 2025). Shows rock collapse in bottom right (western side – red arrow).

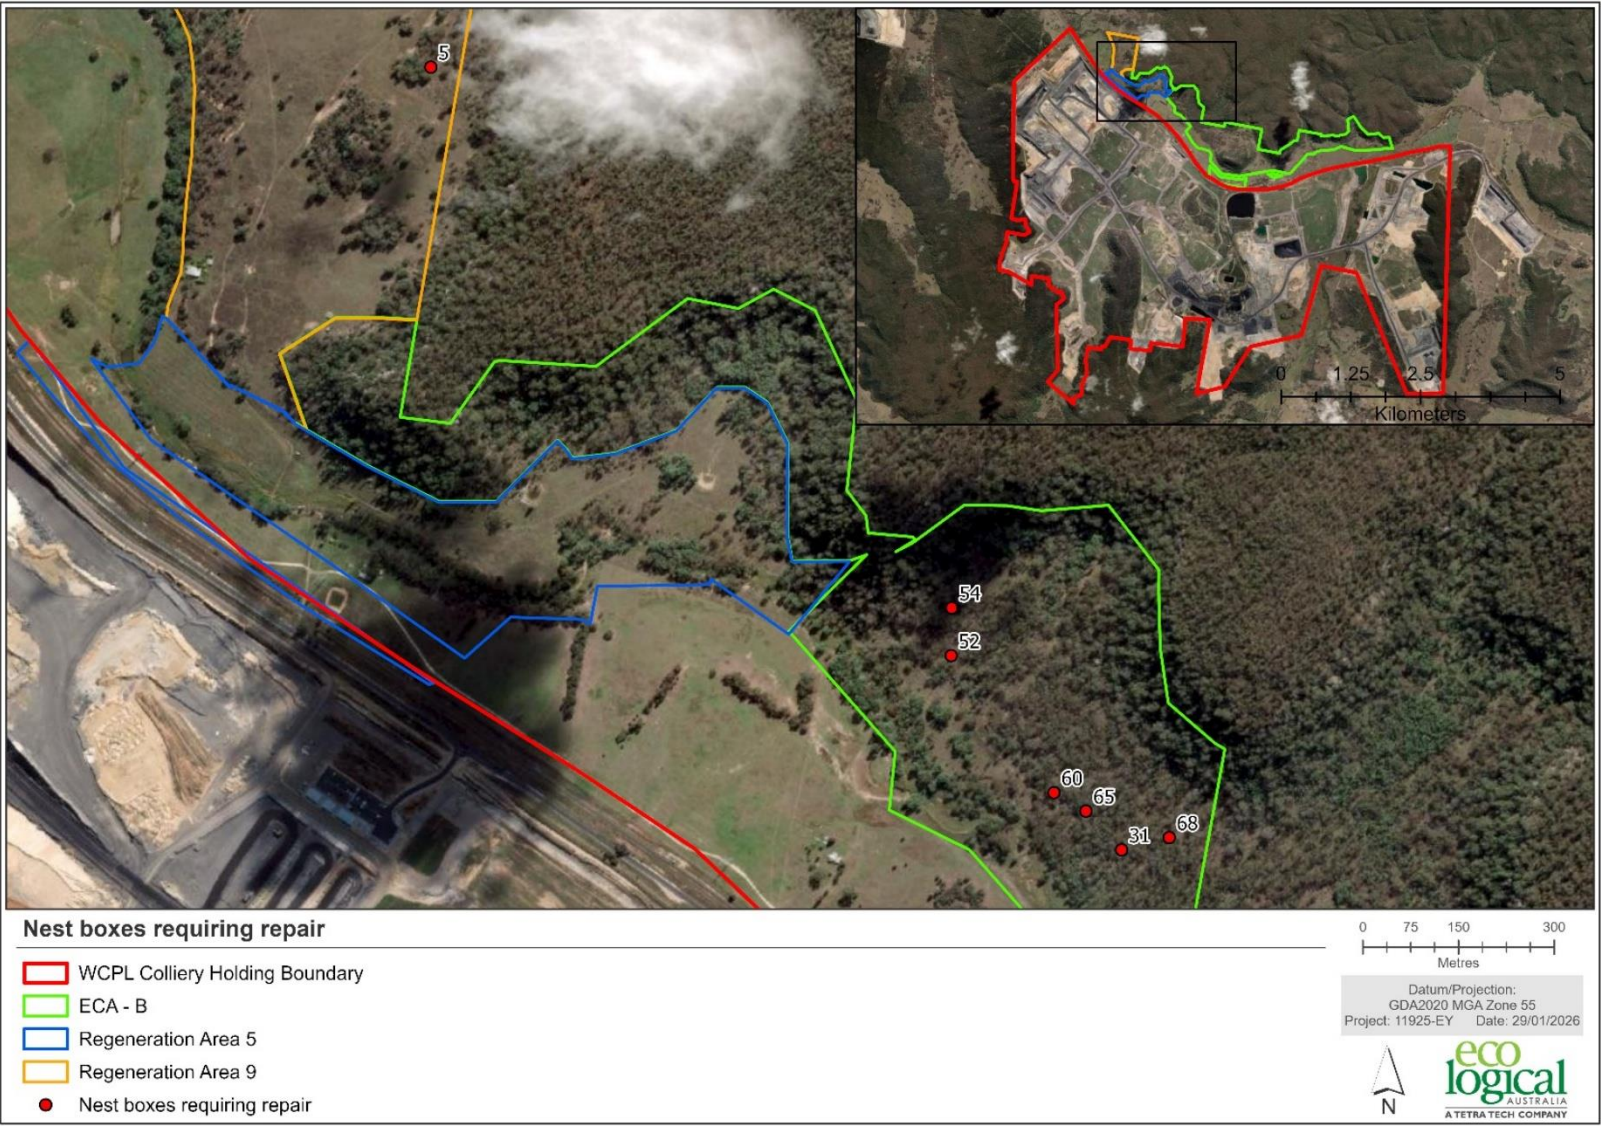
Figure 2: Nest boxes requiring repair

Seven nest boxes were identified as needing repairs (Plate 1):

- Nest box 31 has fallen down the trunk of the tree from its original position, however, is still positioned in a lower fork in the tree, though appears potentially unstable
- Nest box 68 has fallen completely off the tree and onto the ground
- The side of nest box 65 is partially open
- Nest box 60 has broken apart and is lying on the ground
- The side of nest box 52 is partially open
- Side door on nest box 54 needs to be closed and re-screwed
- Nest box 5 has fallen forward on the tree, is potentially unstable and its tie-wire requires tightening.

Repairs and maintenance as per the suggestions above is recommended, as well as the continuation of annual inspections.

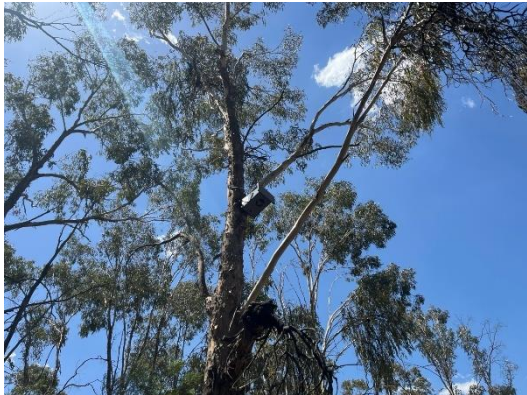
Nest box 5

Plate 1: Nest boxes requiring repair

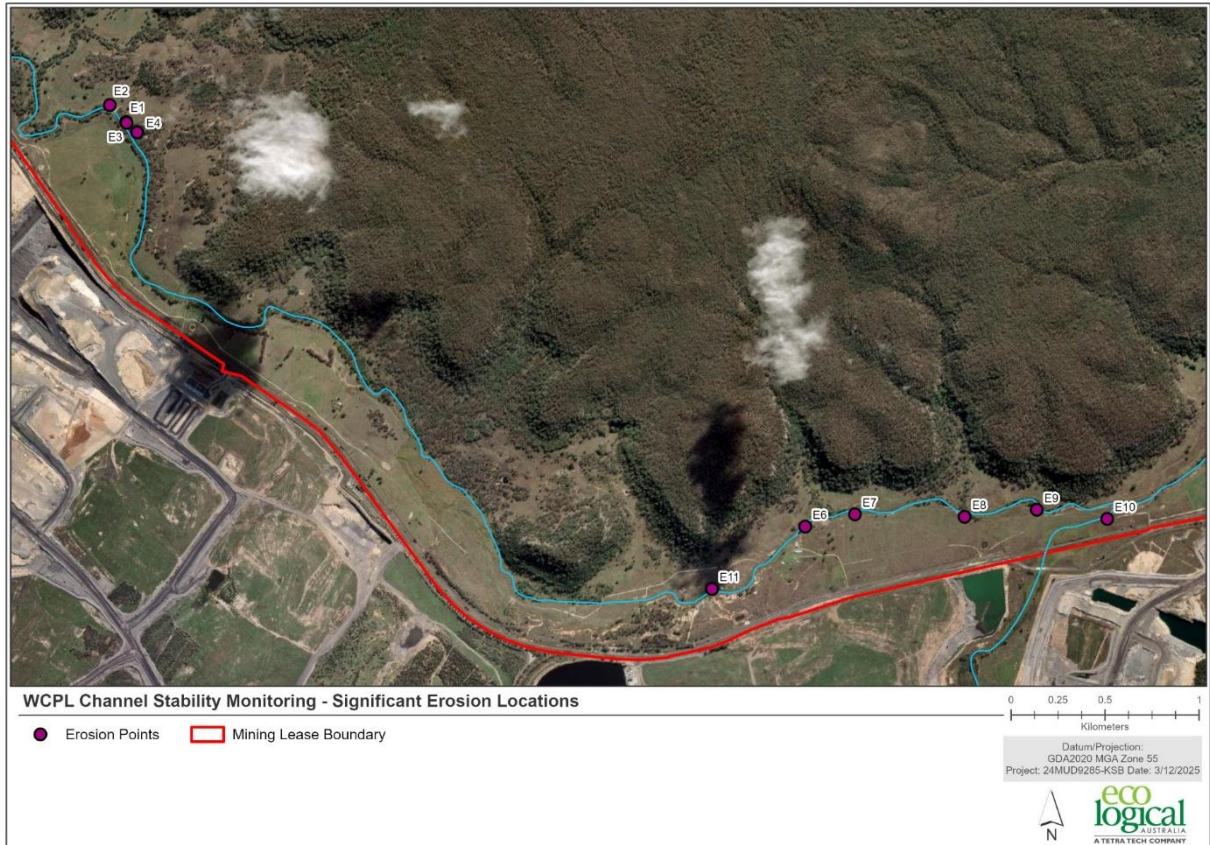
Figure 2-2:). These are in areas with moderate to severe erosion and are monitored to determine the presence and extent of on-going erosion. Management issues and threatened species were recorded opportunistically throughout the surveys, to highlight areas where management intervention is recommended.
