# METROPOLITAN COAL LONGWALLS 308-310

## BIODIVERSITY MANAGEMENT PLAN

### BIODIVERSITY MANAGEMENT PLAN

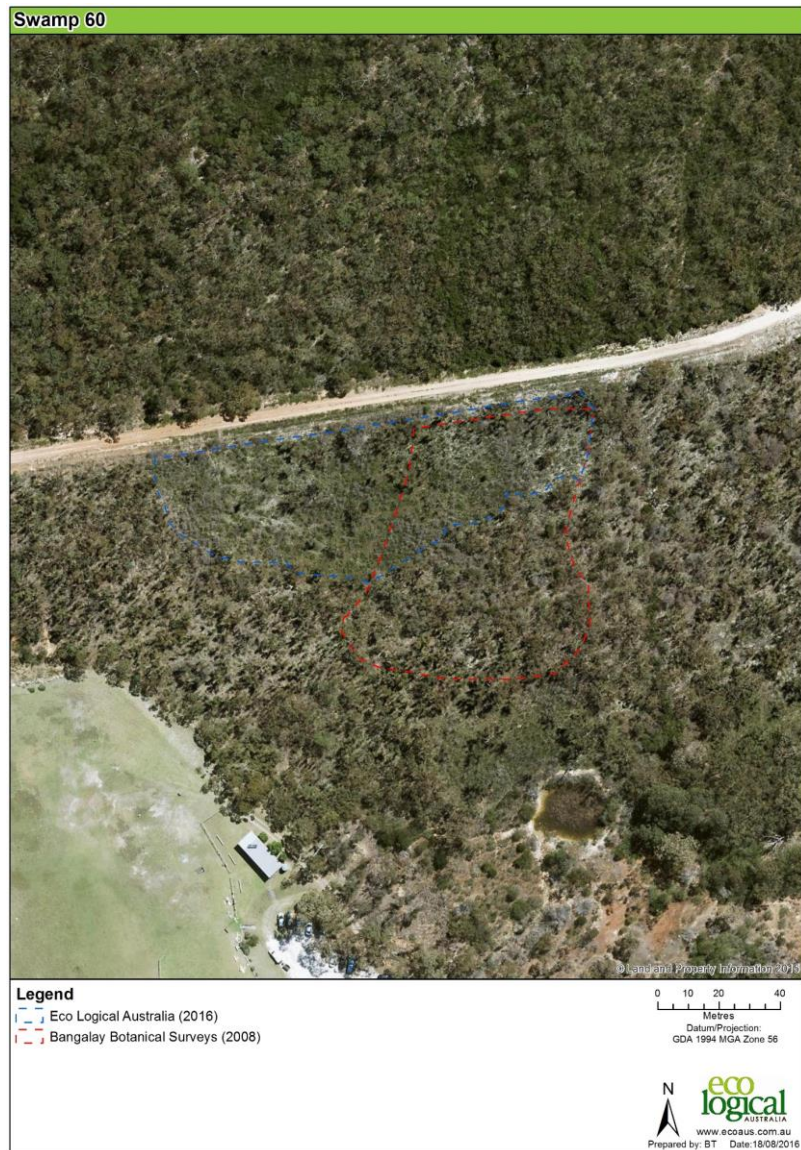
- Swamp 60 is a valley side swamp.
- Swamp 60 was previously mapped as Sedgeland-heath Complex by Bangalay Botanical Surveys (2008) and field inspections confirmed the presence of this community across the entire revised extent of this swamp.

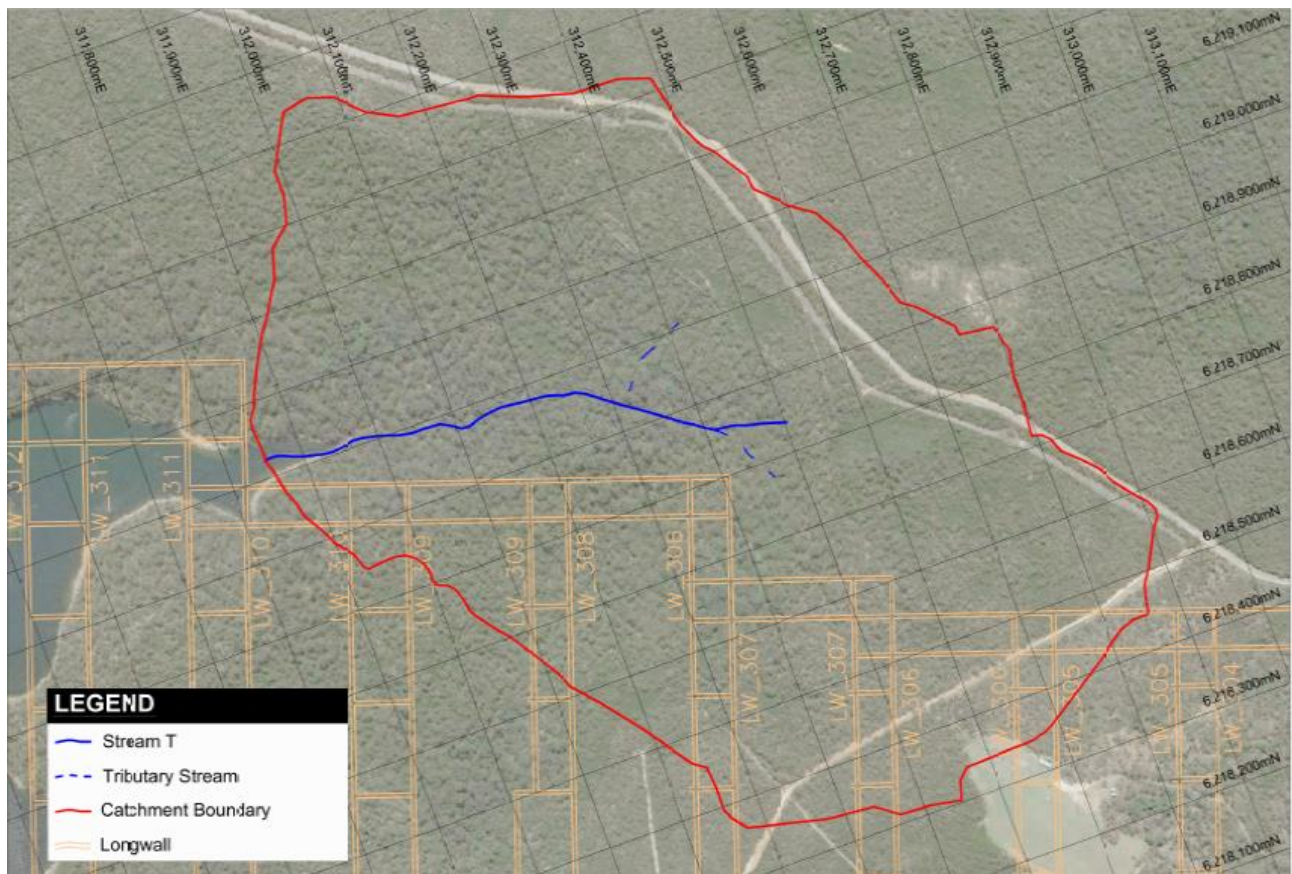
**Figure 17 Stream T Catchment**
