**WAMBO COAL PTY LTD  
2018 ANNUAL REVIEW**

1 January – 31 December 2018

<b>Name of operation</b>	Wambo Coal Mine
<b>Name of operator</b>	Wambo Coal Pty Ltd
<b>Development consent /Project Approval #</b>	DA305-7-2003, DA177-8-2004, EPBC 2003/1138, EPBC 2016/7636, EPBC 2016/7816
<b>Name of holder of development consent</b>	Wambo Coal Pty Ltd
<b>Title/Mining lease #</b>	CL365, CL374, CL397, CCL743, ML1402, ML1572, ML1594, A444, EL7211
<b>Name of holder of mining lease</b>	Wambo Coal Pty Ltd
<b>Water licence #</b>	As per <b>Table 3</b>
<b>Name of holder of water licence</b>	Wambo Coal Pty Ltd
<b>MOP start date</b>	1 January 2018
<b>MOP end date</b>	31 December 2020
<b>Annual Review start date</b>	1 January 2018
<b>Annual Review end date</b>	31 December 2018
<p><b>I, Albert Scheepers, certify that this audit report is a true and accurate record of the compliance status of Wambo Coal Mine for the period 1 January 2018 to 31 December 2018 and that I am authorised to make this statement on behalf of Wambo Coal Pty Ltd.</b></p>

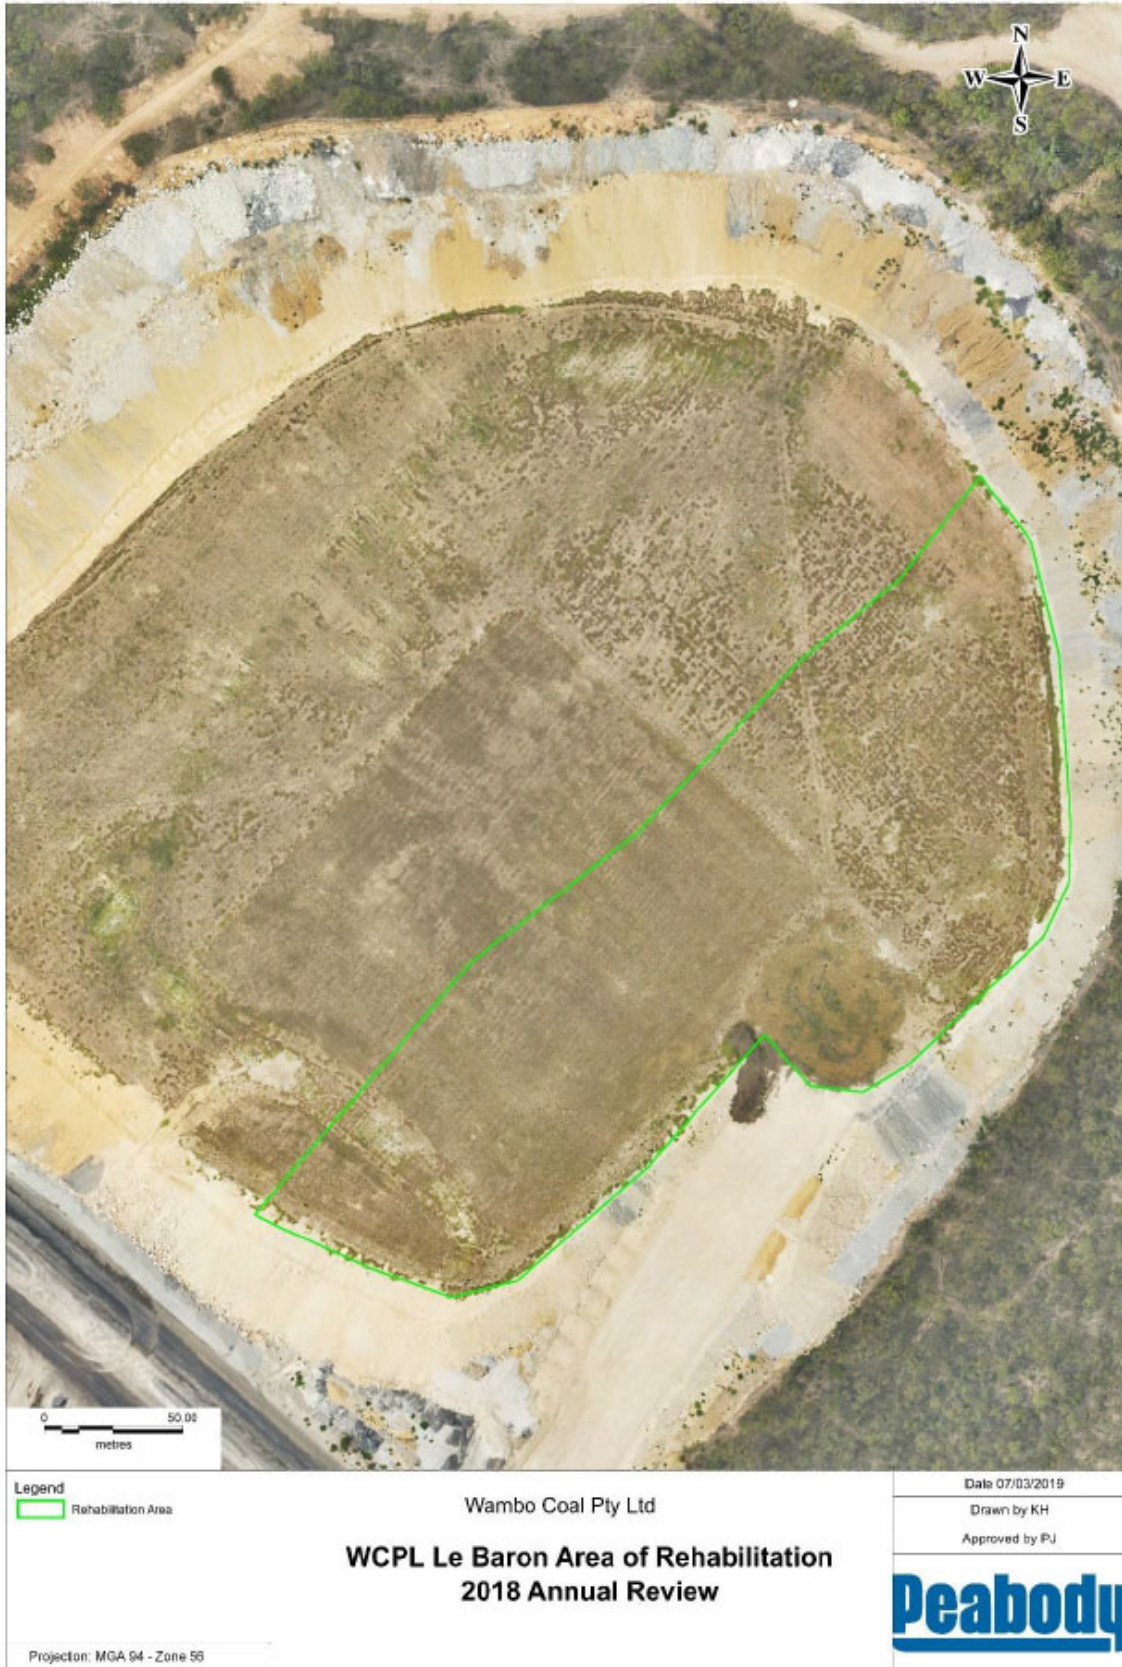
**Figure 17: 2018 Le Baron Rehabilitation**

Bulk push of overburden material began in January and final seeding of the Le Baron rehabilitation area (**Figure 17**) was completed in April 2018.

Topsoil was delivered through a 939 loader and open cut Cat truck fleet from topsoil stockpiles located on the Wombat Dump. Topsoil was spread by D10 dozers to a depth between 100 mm to 200 mm. The area was trimmed with a D6 dozer and gypsum applied at 6 t/ha. OGM was applied at 100 t/ha. The area was chisel ploughed and the pasture seed mix was broadcast by New Holland tractor.

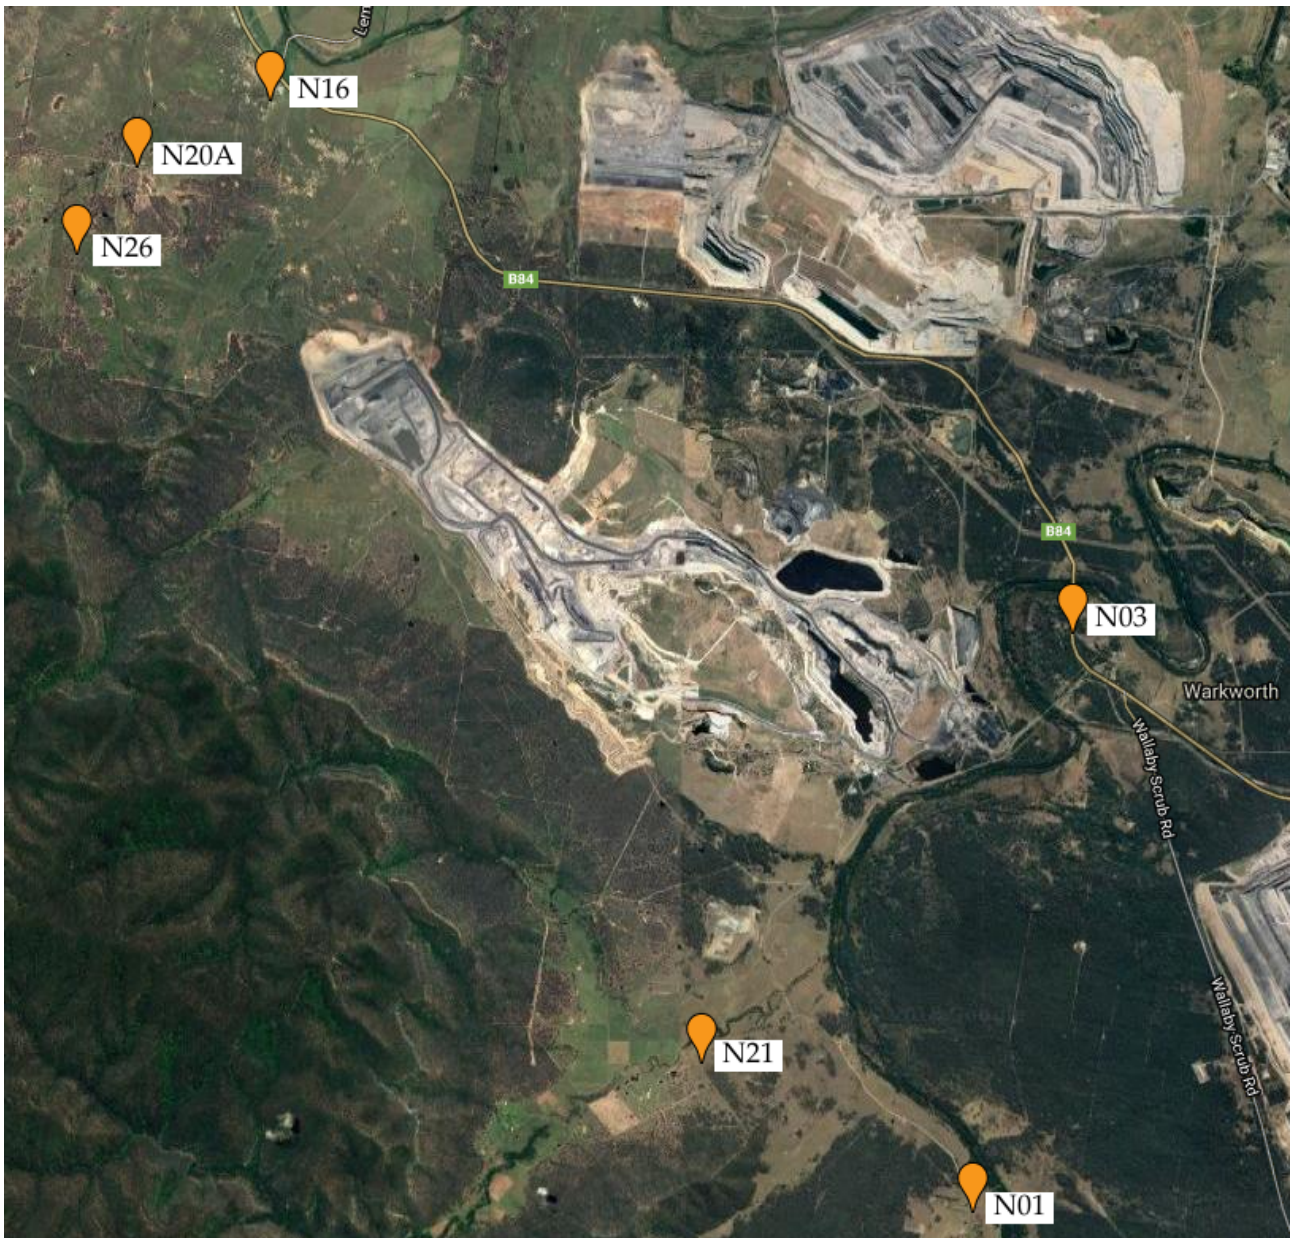
**Figure 1: WCM Attended Noise Monitoring Sites**

1. Sourced from the Wambo Coal Noise Monitoring Plan -EMP011, February 2014 and NMP – WA-ENV-MNP-503, January 2018;
2. Attended locations are shown in italics;
3. Monitoring at this location occurred January 2018 only; and
4. Monitoring at this location commenced February 2018.

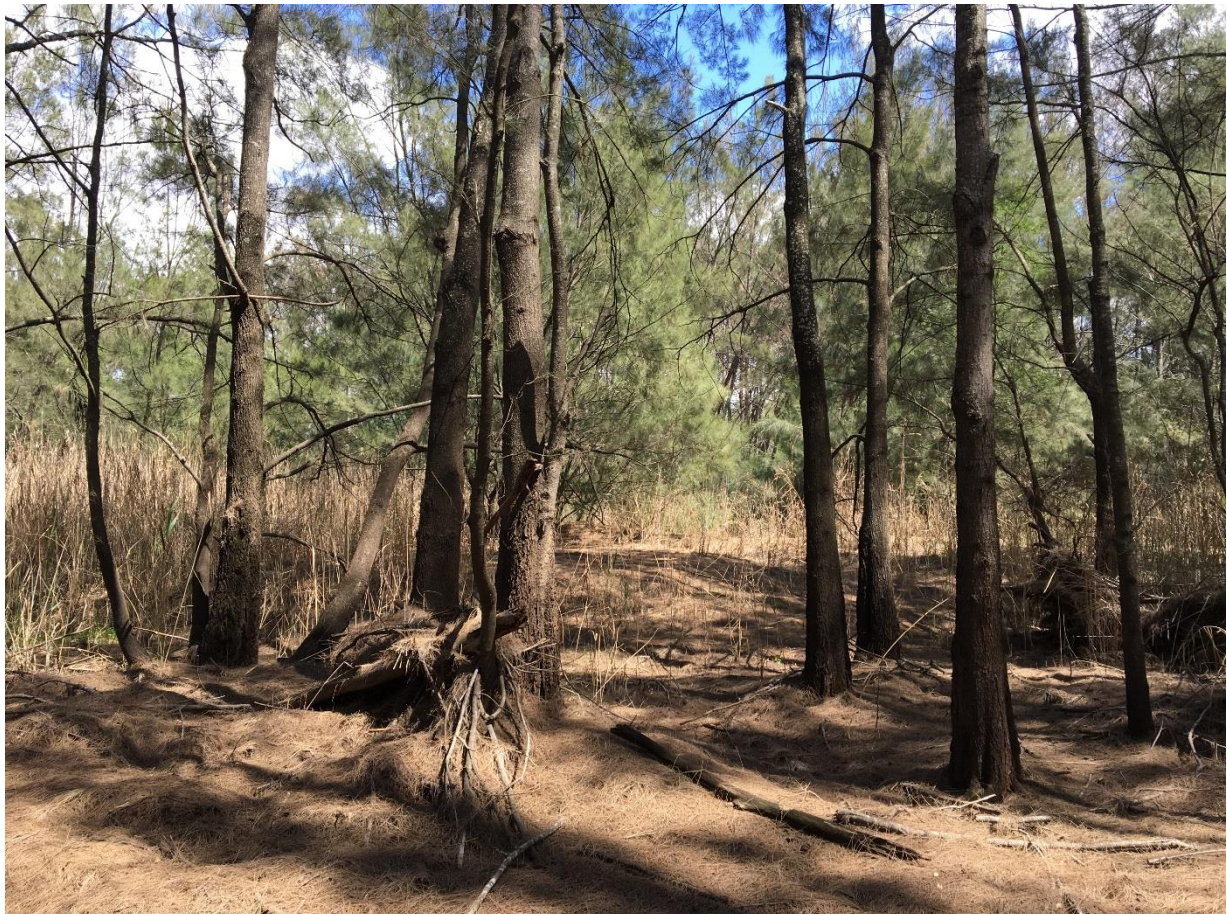
The River Red Gum / River Oak riparian woodland at WCPL is typical of other remaining stands throughout the Hunter Valley, with generally a high cover of weed species and a reduced number of native species (**Plate 1**).

**Plate 1: River Red Gum / River Oak riparian woodland wetland on North Wambo Creek**

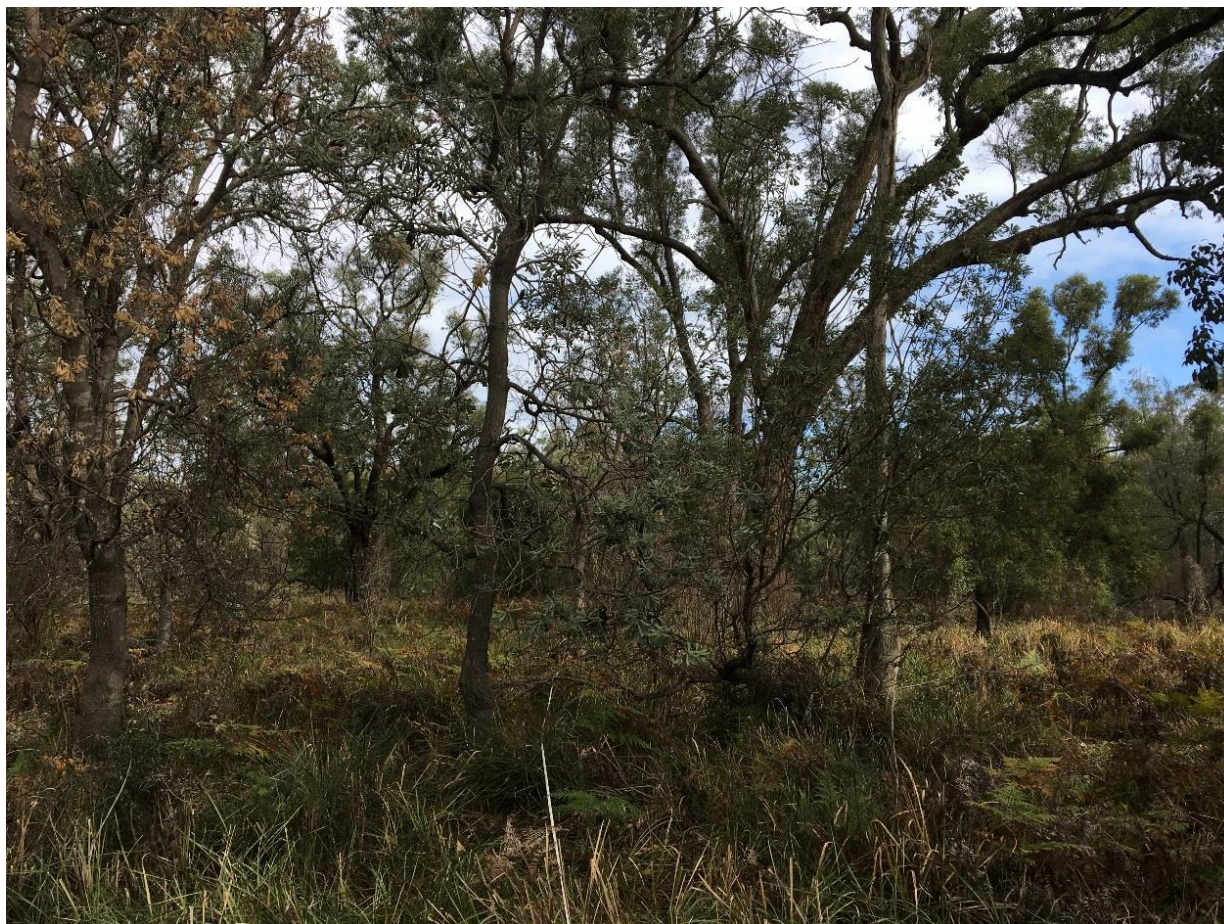
Within WCPL owned land, this community is mostly restricted to the eastern side of Wollombi Brook, primarily within the RWEA area A (**Plate 6**). This PCT forms the Commonwealth EPBC Act listed Critically Endangered Ecological Community (CEEC) *Warkworth Sands Woodland of the Sydney Basin Bioregion* and is also listed under the NSW BC Act. This PCT occurs on aeolian sand deposits and is restricted to the Warkworth area.

**Plate 6: Warkworth Sands Woodland within RWEA A**

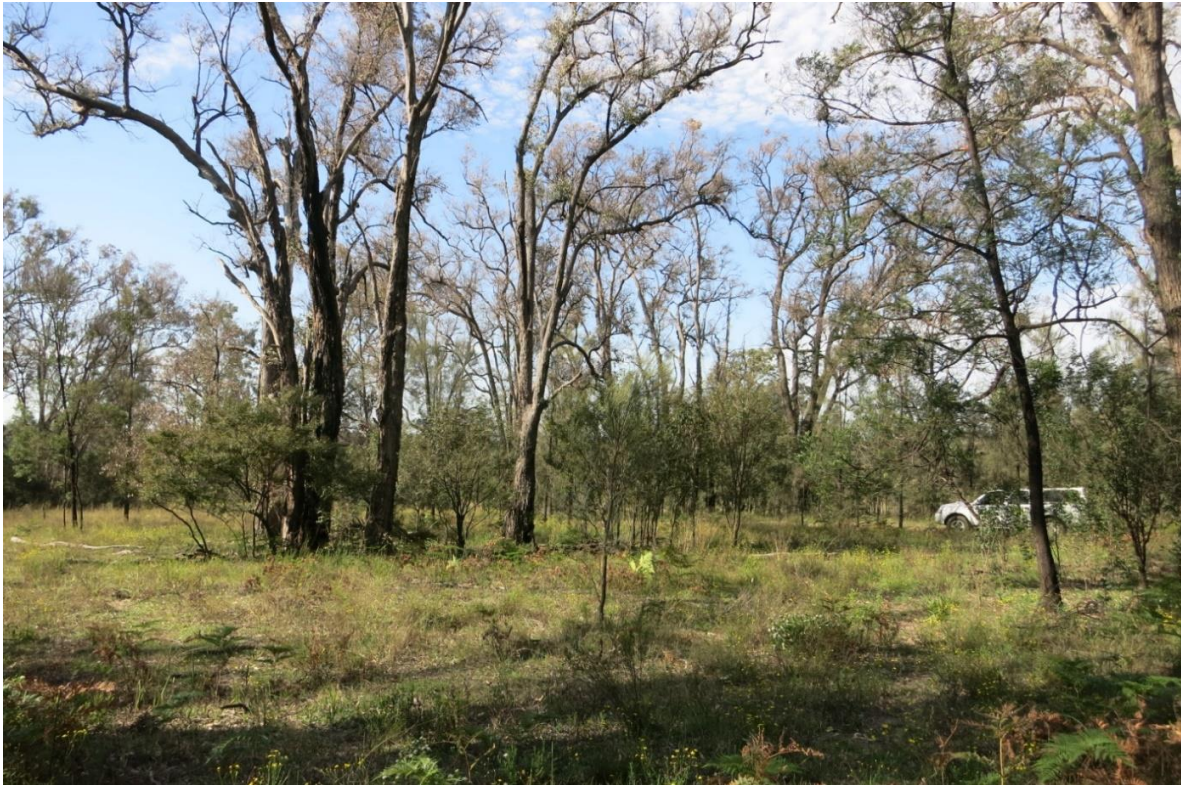
**Plate 9: Severe *Angophora floribunda* canopy dieback in parts of Warkworth Sands Woodland in RWEA A during 2016**

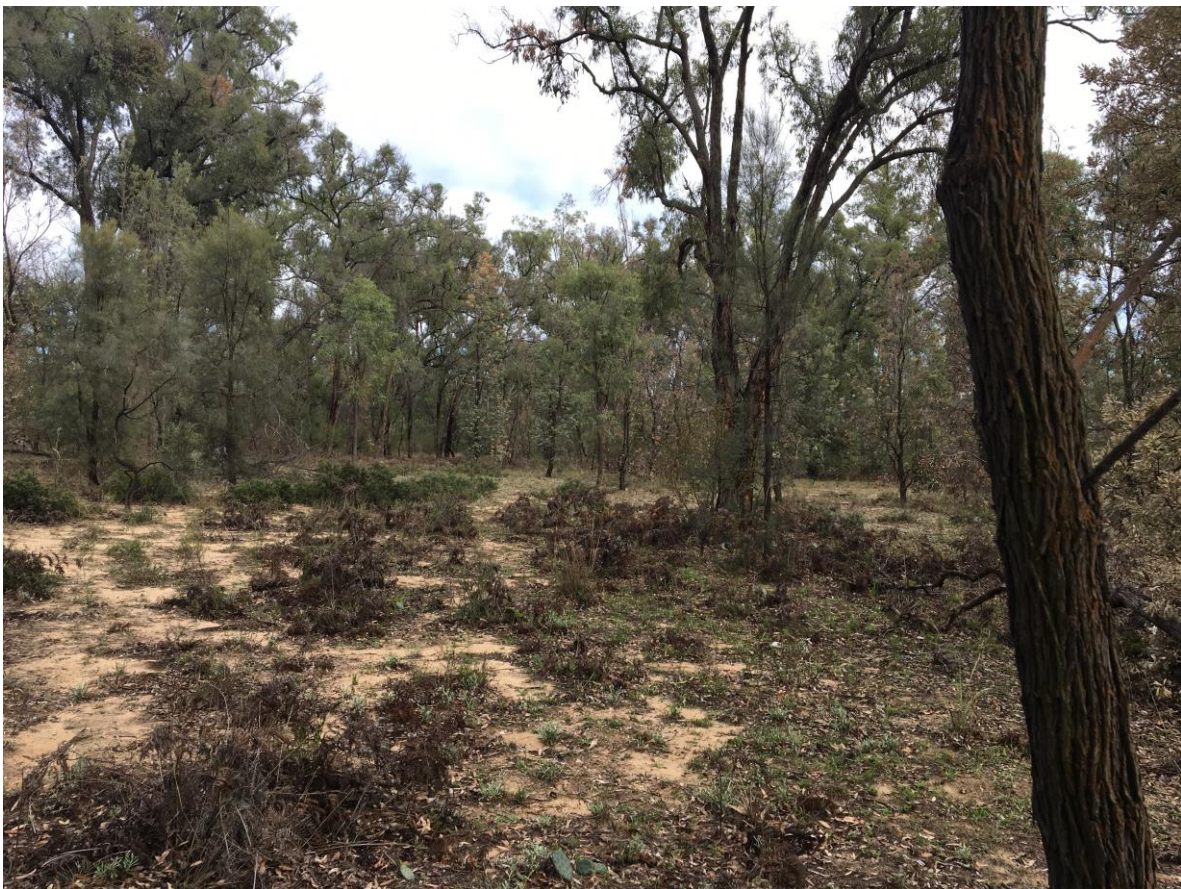
**Plate 10: Recovery of *Angophora floribunda* canopy dieback during 2018**

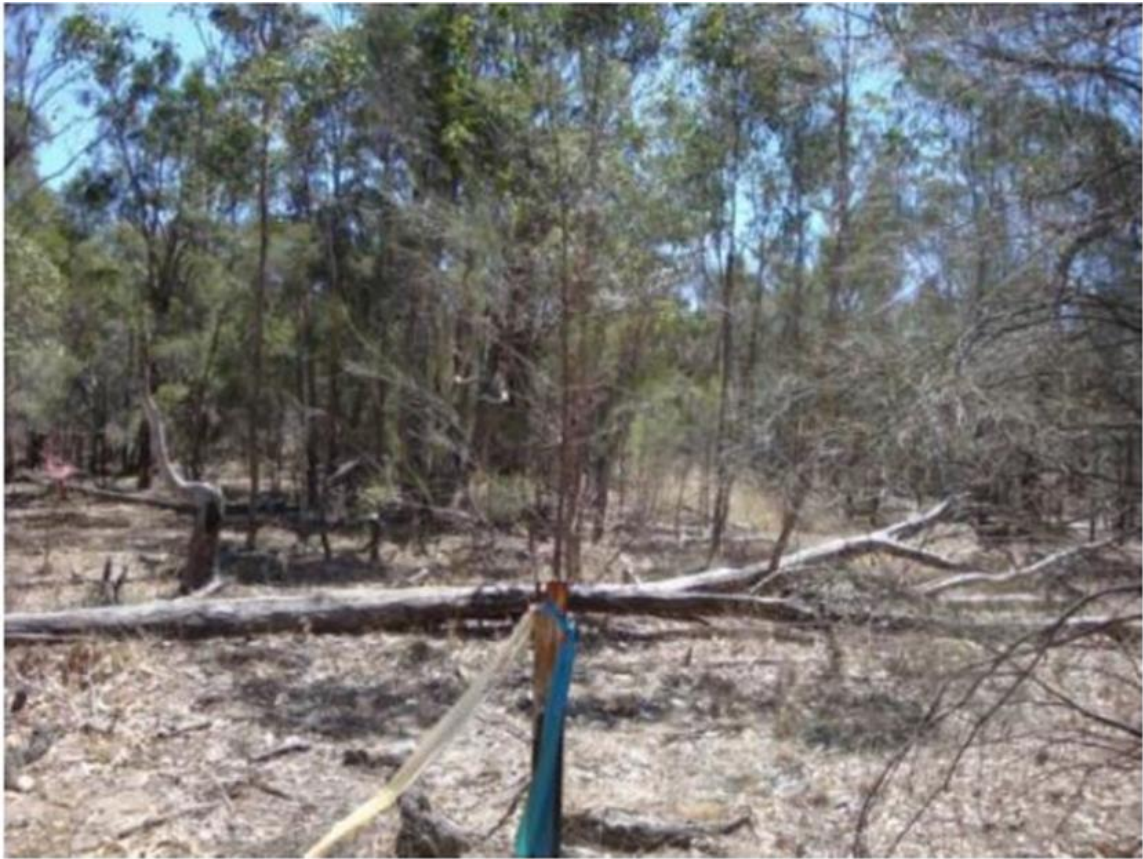
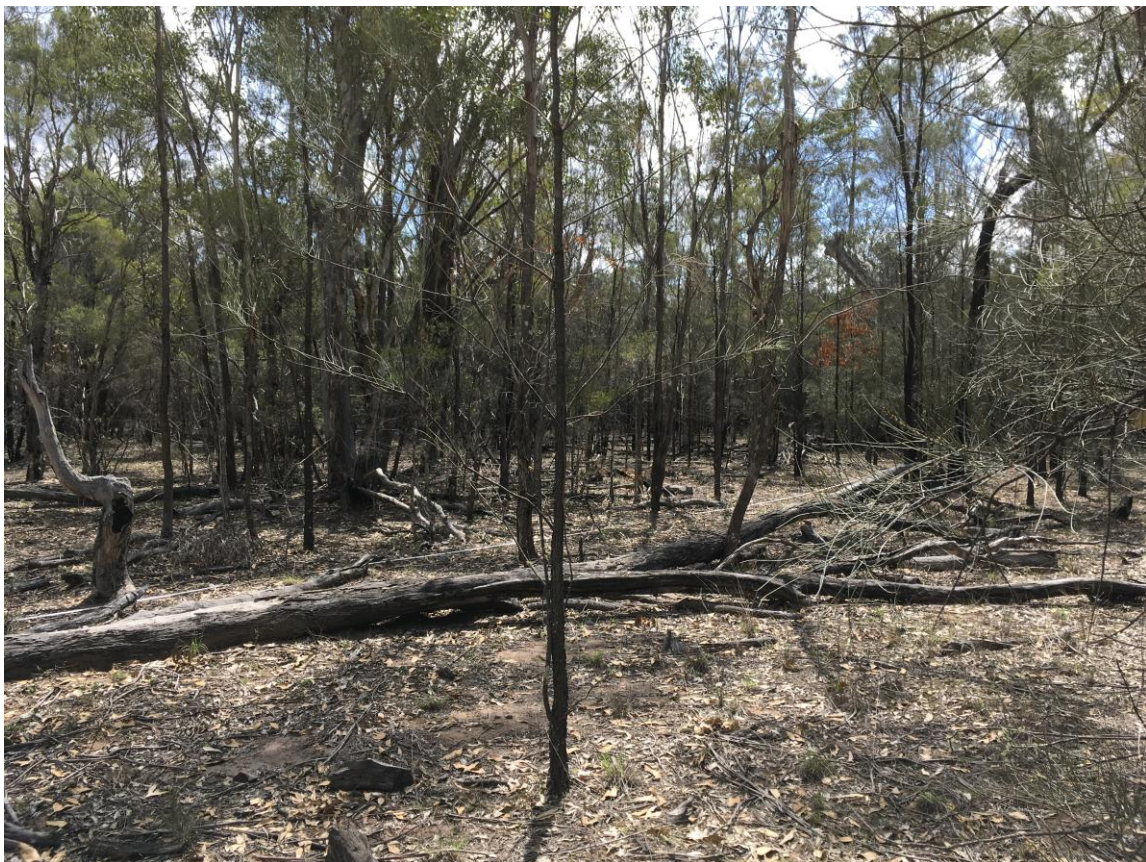
This community appears to be performing well with generally very low cover of exotic species and high diversity of native species present at each monitoring plot. The number of native species recorded in 2018 was higher than in the previous year at most of the monitoring sites in this community, and the average score achieved the target for the performance criteria for this attribute (Table 7). Performance criterion were met for all other attributes, except for Native Ground Cover Shrubs, which despite being higher than in 2017 was still below the target. Examination of biometric data reveals that no significant changes in exotic cover, canopy or mid-storey have occurred in the majority of these monitoring plots since 2014 when biometric data was first collected. This stability over time can be seen in the photo monitoring point A4 (**Plates 12-13**) with no major changes visible between the 2013 and 2018 monitoring periods.

Plate 12: Photo-monitoring point A4 during 2013

Plate 13: Photo-monitoring point A4 during 2018

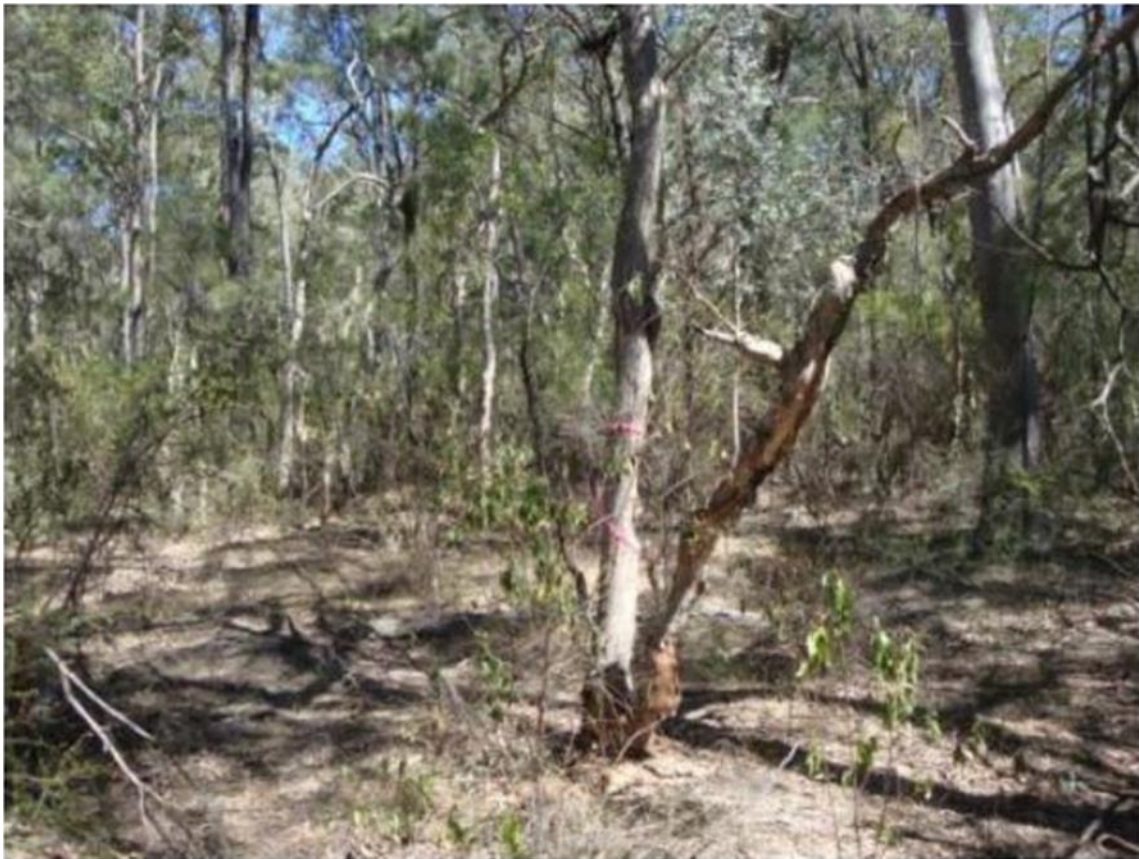
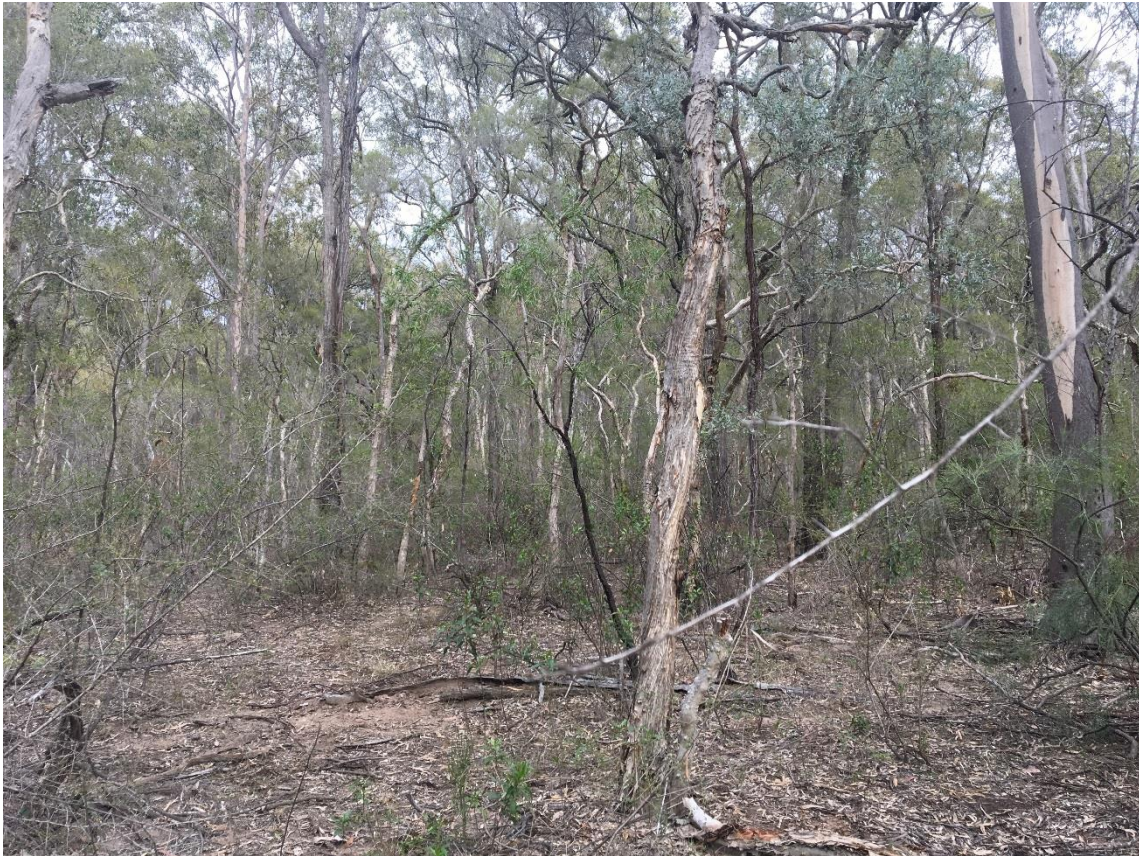
Photo-monitoring points in this community show little change in vegetation structure between the 2013 and 2018 monitoring periods (**Plate 14 & Plate 15**).

**Plate 14: Photo-monitoring point B2 during 2013**

Plate 15: Photo-monitoring point B2 during 2018

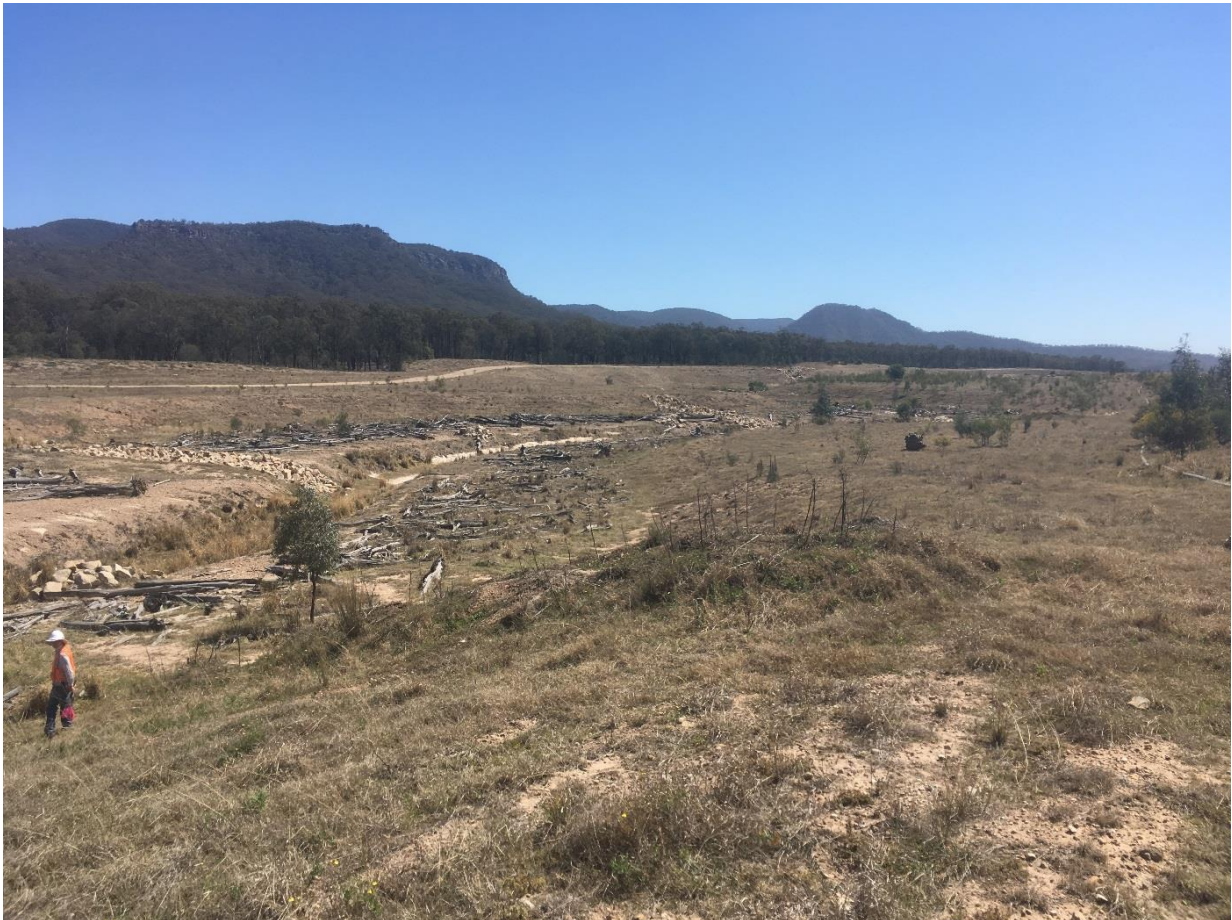
Monitoring sites within the North Wambo Creek Diversion area are variable in condition with monitoring sites described in **Table 15**. All monitoring sites are open pasture areas and generally have few native plant species and consist of predominantly low pasture, primarily *Cynodon dactylon* (Common Couch), with tussocks of *Chloris gayana* (Rhodes Grass) and *Setaria* species (**Plate 20**). However, as observed in 2017, promising signs for the future of the diversion area are present, with *Acacia* and *Eucalyptus* sp. seedlings and shrubs observed in the south of the diversion area as a result of direct seeding works. Natural establishment of *Casuarina cunninghamiana* and *Eucalyptus* sp. in the creek bed, particularly in the north of the creek diversion, also continues (**Plate 21**).

Plate 19: North Wambo Creek Diversion during 2018 at site 26R

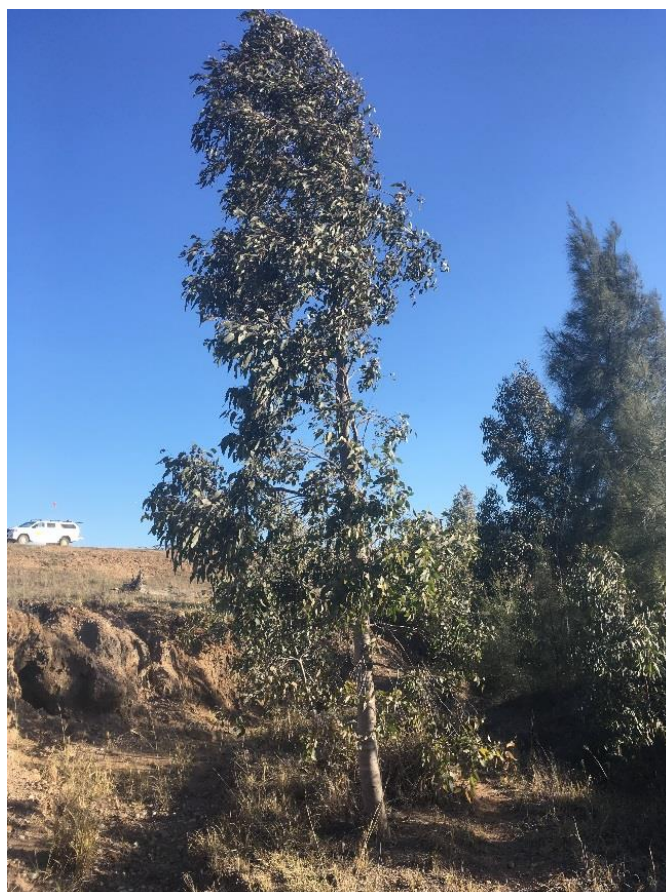
Plate 20: Redgum and River Oak establishing within the diverted creek channel on North Wambo Creek (site 23R)

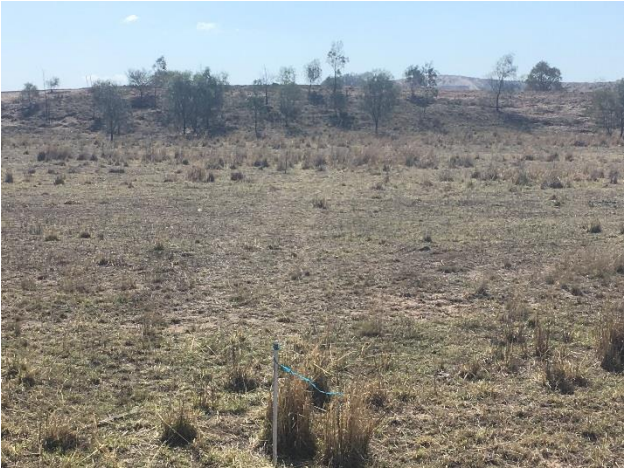
19R	<p>Transect relatively flat and comprised primarily of low grass (54%) dispersed with patches of bare soil (46%). A 17% increase in bare soil from 2017 has resulted in a lower LOI score for this site. The increase in bare soil may be associated with the dry conditions causing the grass to die off. Young <i>Eucalyptus</i> and <i>Acacia</i> species are growing on creek banks downstream. Recent ripping activities have taken place near this transect.</p>

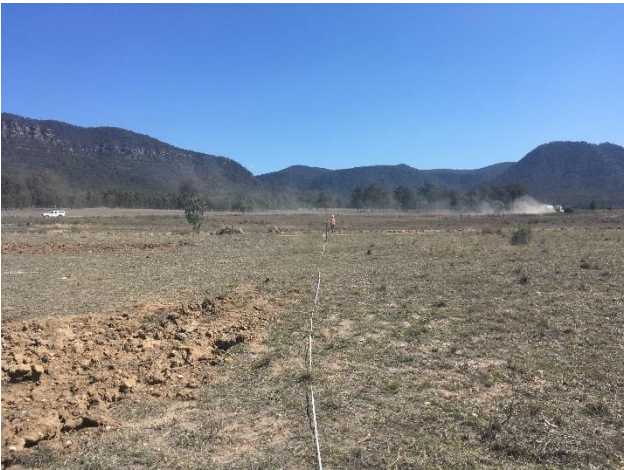
Transect	Notes	Photograph
21R	<p>Transect relatively flat grassland dominated by low grass (57%) and bare soil (25%). Patches of the exotic <i>Galenia pubescens</i> are also present (3%). Bare soil has increased by 11% from 2017.</p>	 
23R	<p>Low grass occurs over 36% of the transect, an increase of 11% from 2017. Large bare patches of stony soil occur towards the middle and end of transect and bare soil patches cover 53% of the area. Some areas of active erosion including some 30cm deep rills occur in the surrounding area. The creek bank in this area has been undercut and slumping on western bank. A stand of ~ 5m tall <i>Casuarina cunninghamiana</i> and seedlings and some young Eucalypts are growing on creek banks.</p>

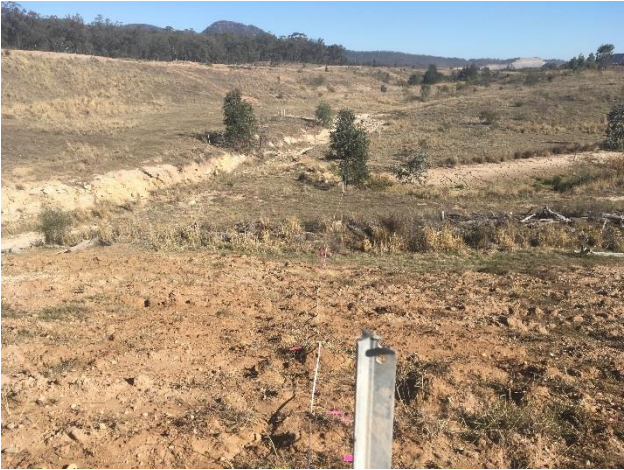
27R	<p>Transect samples the relatively steep western bank of the cutting. The majority of this transect was ripped to control <i>Galenia pubescens</i> and erosion prior to the 2017 monitoring. Low sparse grasses and logs dominate the flat area adjacent to the creek channel.</p> <p>Low grass covers 36% of the transect and bare soil 55%. Logs (6%) and litter (2%) comprise the remainder. The low grass <i>Cynodon dactylon</i> has established on the ripped bank and woodchip mulch has also help stabilise the soil and allow vegetation to establish, contributing to a 16% higher LOI score for this site.</p>

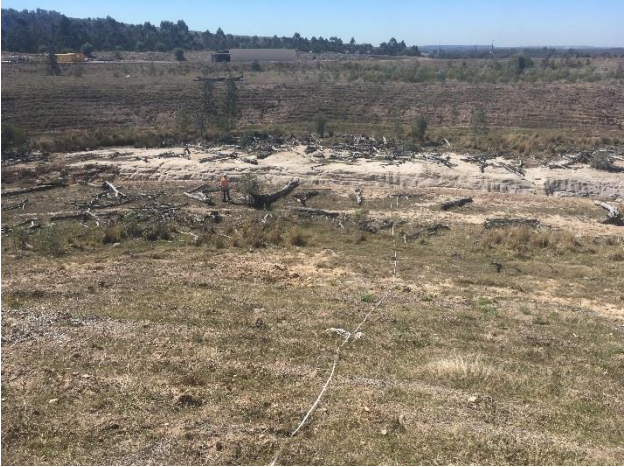
Transect	Notes	Photograph
26R	<p>Transect samples the relatively steep eastern bank to the edge of the creek channel. Low grass dominated this transect in 2018 covering 74% of the transect. Bare soil areas make up 19 % of the transect.</p> <p><i>Acacia</i> sp. shrubs are establishing on some sections of the bank near this transect.</p>

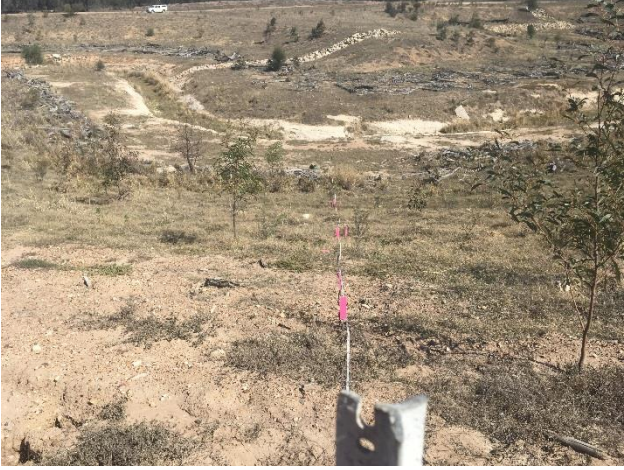
25R	<p>This slope is relatively steep with low grass dominating 61% of transect and having the highest contribution to soil stability. Bare soil is most prevalent at the top of transect where some minor erosion is occurring and makes up 30% of the transect.</p> <p>Large tussock grasses (<i>Chloris gayana</i>) and logs are present at the bottom of the transect near the creek channel.</p> <p><i>Acacia</i> sp. shrubs are establishing on some sections of the bank near this transect.</p>

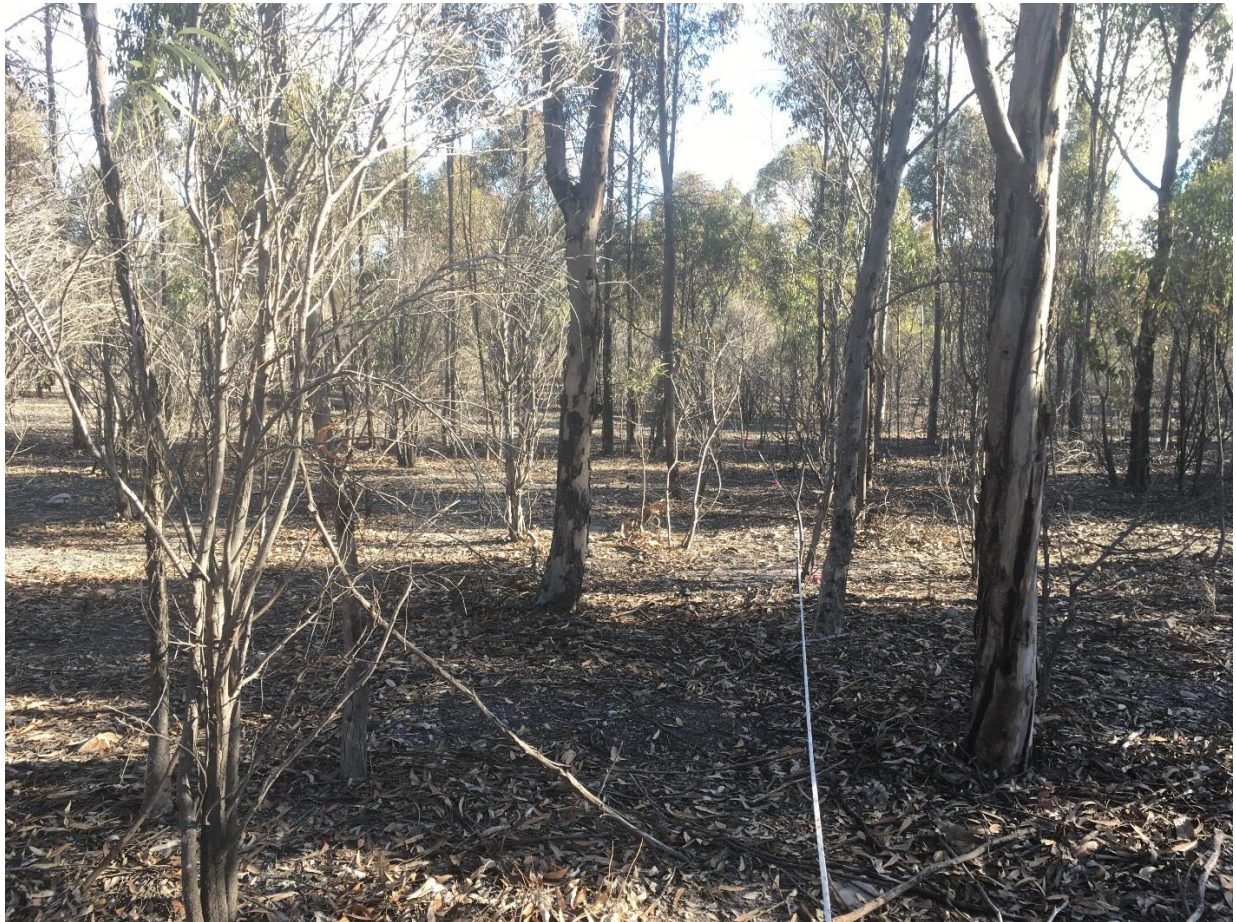
Plate 21: Woodland rehabilitation area dominated by *E. cladocalyx* at site 8R in 2018

Vegetation in woodland rehabilitation areas consisted primarily of *Eucalyptus cladocalyx* and occasionally *Corymbia maculata* (Plate 21). *Acacia saligna* (Golden Wreath Wattle) forms the dominant mid-storey species at site 4R and is also present at 8R, however, the previously observed die-off of this species continues. *E. cladocalyx* is native to South Australia and *Acacia saligna* is native to the south of Western Australia, but both have been planted widely in eastern Australia.

The substrate in these areas consists of fine grey sediment intermixed with rocks and forms a sandy clay, it appears topsoil was not used in the establishment of these woodland rehabilitation areas. As a result, the understorey in these areas remains very sparse with occasional native species present at low densities including *Enchylaena tomentosa* (Ruby Saltbush), *Calotis* spp. (Burr-Daisy) and several native grasses including *Cymbopogon refractus* (Barbed Wire Grass).

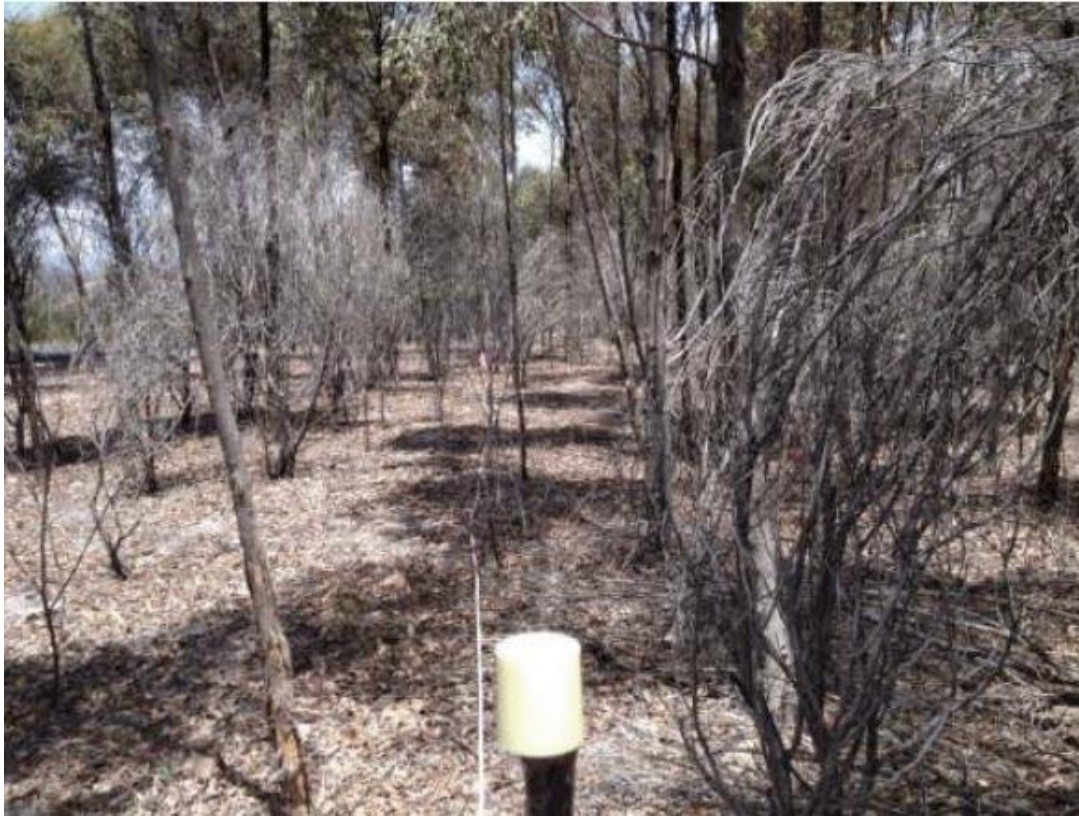
**Plate 22: Site 3R during 2014**

Both photos taken at the sites and collected data, show that these sites have remained quite stable over the last five years despite some dieback of *Acacia saligna* and growth of trees (**Plate 22 & Plate 23**). Some very low scores that are possibly erroneous are present in the provided database between the 2006 and 2008 monitoring periods. This has been discussed in previous monitoring reports. Average stability score was larger than in the previous three years, continuing a trend of a marginal increase each year since 2015, although higher scores were recorded in between 2012 and 2014. Nutrient and infiltration indices were lower than in 2017 but within the range of the previous three years.

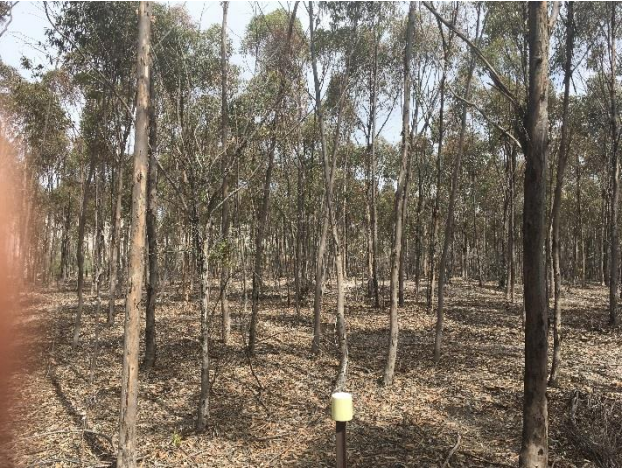
Transect	Notes	Photograph
3R	<p>A relatively flat transect through a planting of <i>Eucalyptus cladocalyx</i>. Scattered and sparse <i>Corymbia maculata</i> are also present. Three native groundcover species (<i>Enchylaena tomentosa</i>, <i>Cymbopogon refractus</i> and <i>Chloris divaricata</i>) were recorded in the 20 x 20 m plot, although the cover of these species remains very sparse. Leaf litter is the major patch type making up 68% of the LFA transect. Bare rocky soil areas make up 23% of the transect, and logs the remaining 9%.</p>

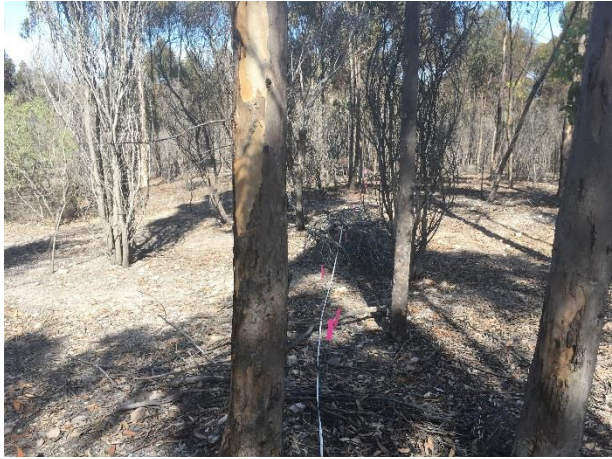
Transect	Notes	Photograph
.6R	<p>This site is the best performing woodland rehabilitation monitoring site. A canopy of <i>Eucalyptus cladocalyx</i> is present with several native mid-storey species and native grasses and herbs. The weed <i>Galenia pubescens</i> also occurs in small patches. A dense and deep cover of leaf-litter is present (81% of transect length) and is by far the major contributor to site stability, infiltration and nutrient cycling scores</p>

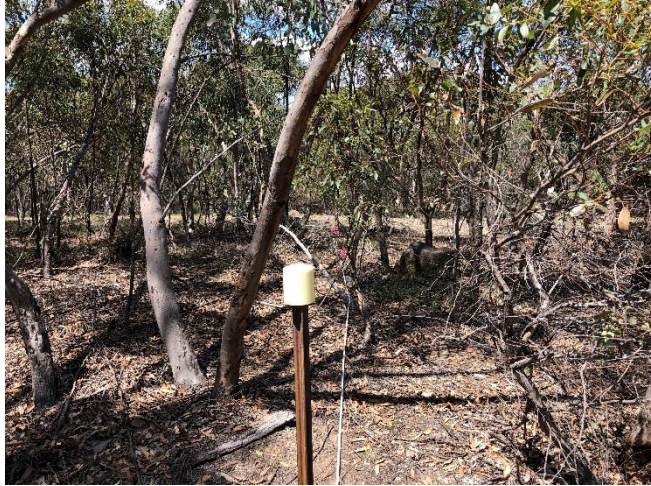
8R	<p>This transect is located on a lightly sloping site with plantings of <i>Eucalyptus cladocalyx</i> and <i>Corymbia maculata</i>. Leaf litter covers 67% of the transect length, with 29% bare soil and the remainder of rock.</p>

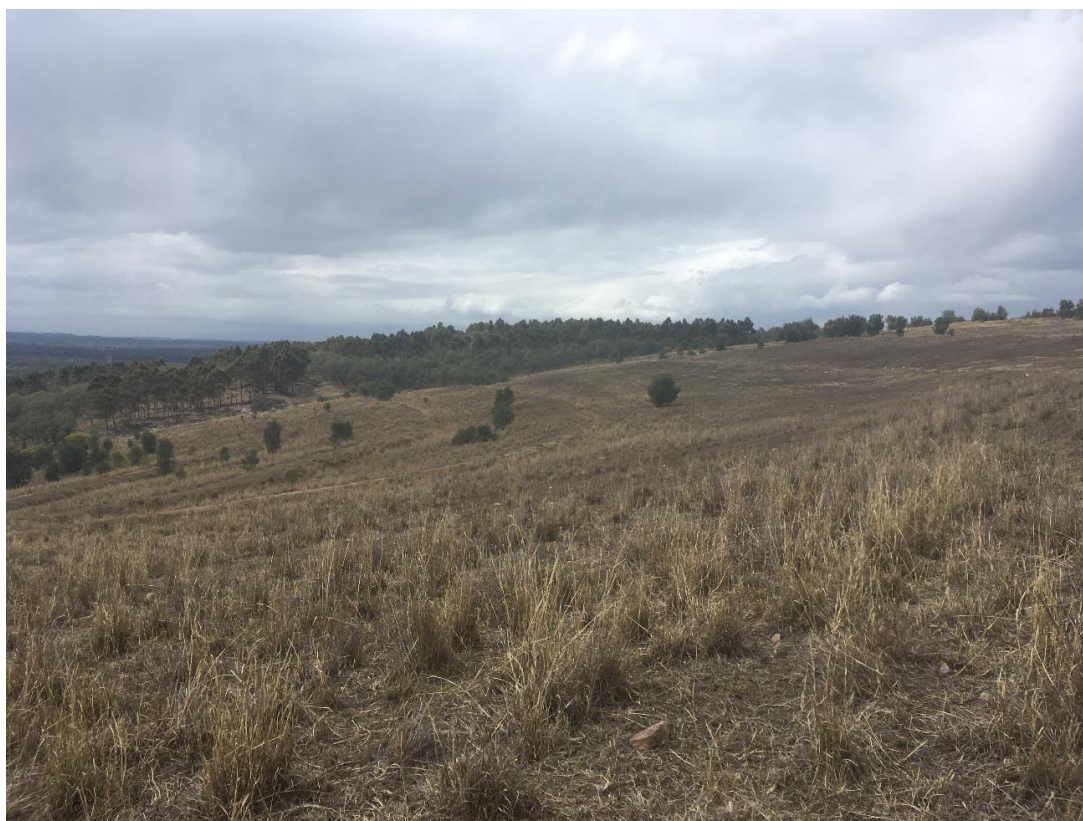
Plate 24: Pasture rehabilitation area dominated by *Chloris gayana* (Rhodes Grass), near site 33R in 2018

Pasture rehabilitation is currently meeting performance targets for all attributes with the exception of LOI, which still had a relatively high average score, with 76% of transect area covered by resource accumulating patches (**Table 19**). As reported in previous years, the average LOI was reduced by the influence of sites 2R and 5R, which performed the worst in terms of LOI with 52 and 53 % respectively of the transect being comprised of bare soil.

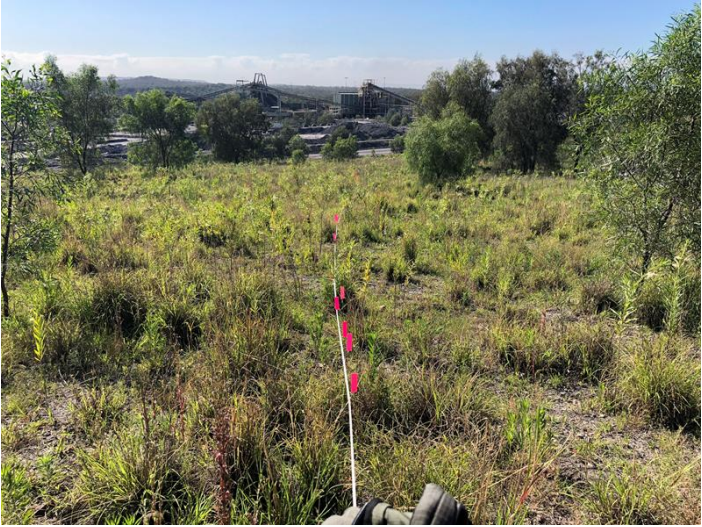
2R	<p>This transect runs down a very slight slope and was dominated by bare soil (52%), grassy patches (22%), tussocks (15%) and leaf litter (11%). Leaf litter was mostly dead exotic vegetation and grass that had died off with the dry climatic conditions at the time of survey. The large area of exposed bare soil and sparse cover within vegetated patches contributed to this site failing to meet performance criteria for all attributes.</p> <p>The soil in this area is local red/brown clay soil which has facilitated the colonisation of native species such as <i>Cymbopogon refractus</i> and <i>Acacia</i> spp. Comparison of photos from Niche (2014c) of this site, show <i>Acacia salicina</i> has become more abundant in the area over time.</p>

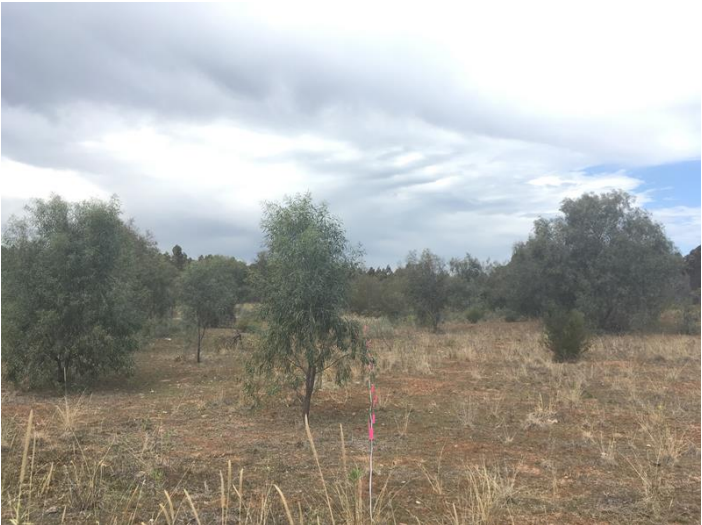
Transect	Notes	Photograph
5R	<p>This transect was moved slightly downhill from its previous location during 2017 as an access road had been constructed through the original transect. This site is dominated by bare soil areas (53%). As a result of the abundance of bare soil this site again had the lowest landscape organisation score. Exotic tussock grasses (<i>Setaria</i> sp.) (28%), litter (17%) and rocks (1%) make up the remainder of the transect. Some large <i>A. salicina</i> are present surrounding the transect area.</p>
