**WAMBO COAL PTY LTD  
2018 ANNUAL REVIEW**

1 January – 31 December 2018

<b>Name of operation</b>	Wambo Coal Mine
<b>Name of operator</b>	Wambo Coal Pty Ltd
<b>Development consent /Project Approval #</b>	DA305-7-2003, DA177-8-2004, EPBC 2003/1138, EPBC 2016/7636, EPBC 2016/7816
<b>Name of holder of development consent</b>	Wambo Coal Pty Ltd
<b>Title/Mining lease #</b>	CL365, CL374, CL397, CCL743, ML1402, ML1572, ML1594, A444, EL7211
<b>Name of holder of mining lease</b>	Wambo Coal Pty Ltd
<b>Water licence #</b>	As per <b>Table 3</b>
<b>Name of holder of water licence</b>	Wambo Coal Pty Ltd
<b>MOP start date</b>	1 January 2018
<b>MOP end date</b>	31 December 2020
<b>Annual Review start date</b>	1 January 2018
<b>Annual Review end date</b>	31 December 2018
<p><b>I, Albert Scheepers, certify that this audit report is a true and accurate record of the compliance status of Wambo Coal Mine for the period 1 January 2018 to 31 December 2018 and that I am authorised to make this statement on behalf of Wambo Coal Pty Ltd.</b></p>

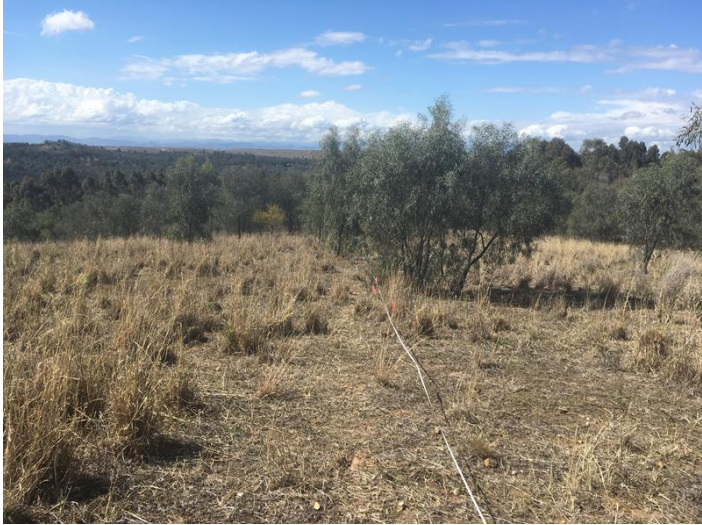
7R	<p>Transect was dominated by <i>C. gayana</i> tussocks (39%), bare soil (34%), litter (22%) and short grass (5%). The increase in bare soil corresponds to a reduction in short grass from 2017 and has resulted in the largest decrease in LOI score for any site in 2018 and has dropped to well below the performance criteria for this attribute. The locally native <i>Acacia salicina</i> continues to colonise the rehabilitation in this area.</p>

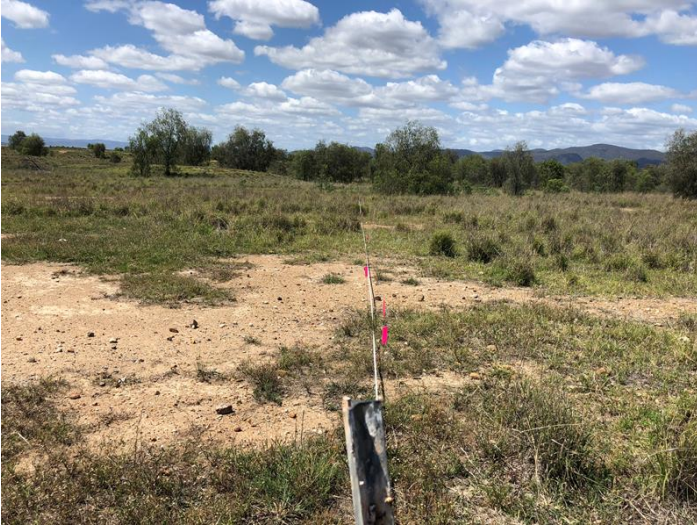
Transect	Notes	Photograph
9R	<p>A large rocky soil scald dominates the start of this transect, however an increase in short grass has resulted in an increase in the stability index for this site above the performance criteria. The scald and other bare patches cover 14% of the transect. Grassy patches (67%) and tussocks (19%) dominate the remainder of the plot. This site was surveyed in November 2018 after recent rainfall and therefore appears greener than sites that were surveyed in September.</p>

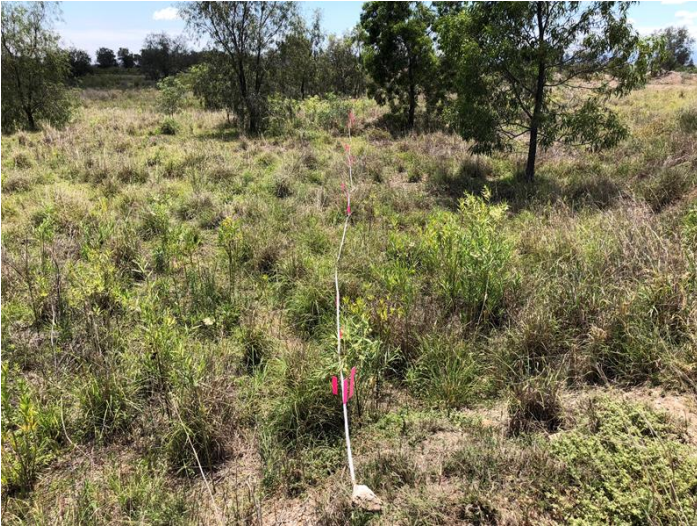
10R	<p>Dense tussocks of <i>Chloris gayana</i> (46%), leaf litter fallen from the dense tussocks and dry dead exotic perennial vegetation (27 %) and grassy patches (24%) made up the majority of this transect. Bare soil patches were minimal making up just 3% of the transect length. This site was surveyed in November 2018 after recent rainfall and therefore appears greener than sites that were surveyed in September.</p> <p>No star pickets are present at this transect.</p>

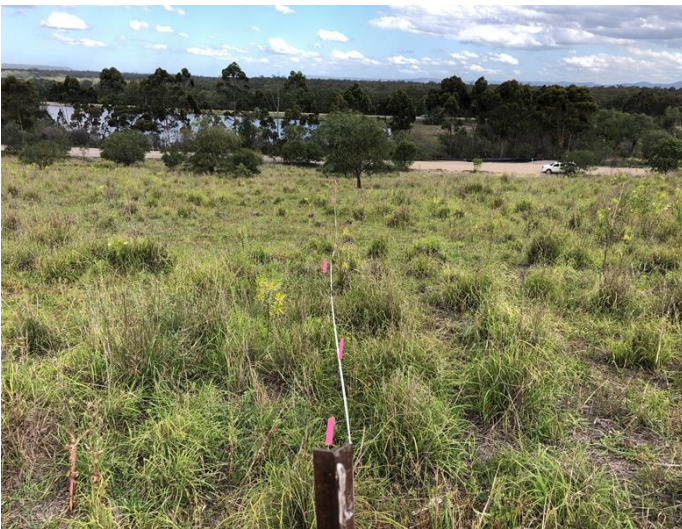
33R	<p>Transect primarily composed dense tussocks of <i>C. gayana</i> (72%), low grass and small patches of the environmental weed <i>G. pubescens</i> made up the remaining patches. Bare soil patches made up 12% of the transect. <i>C. gayana</i> grass tussocks were the main contributor to stability, infiltration and nutrient cycling scores for the site.</p>

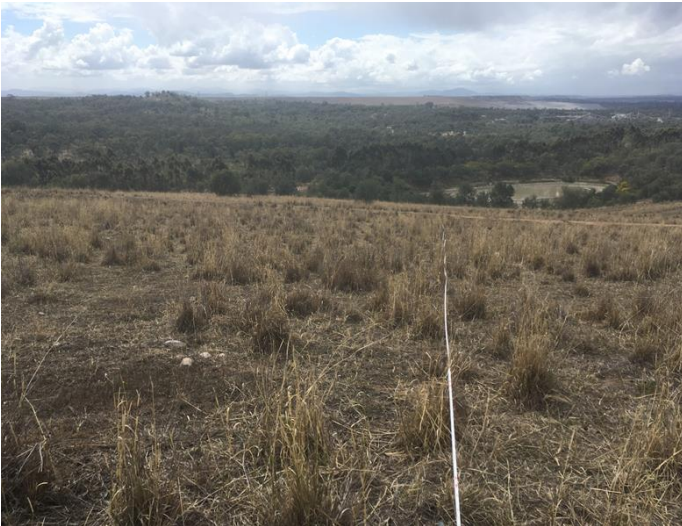
Transect	Notes	Photograph
34R	<p>Transect primarily composed of dense tussocks of <i>C. gayana</i> (29%) with fallen dead grass (leaf litter - 33%) and low spreading grassy patches (2.7%). Bare soil patches comprised 35 % of the transect length. Grass tussocks were the primary contributor to the site stability score.</p>

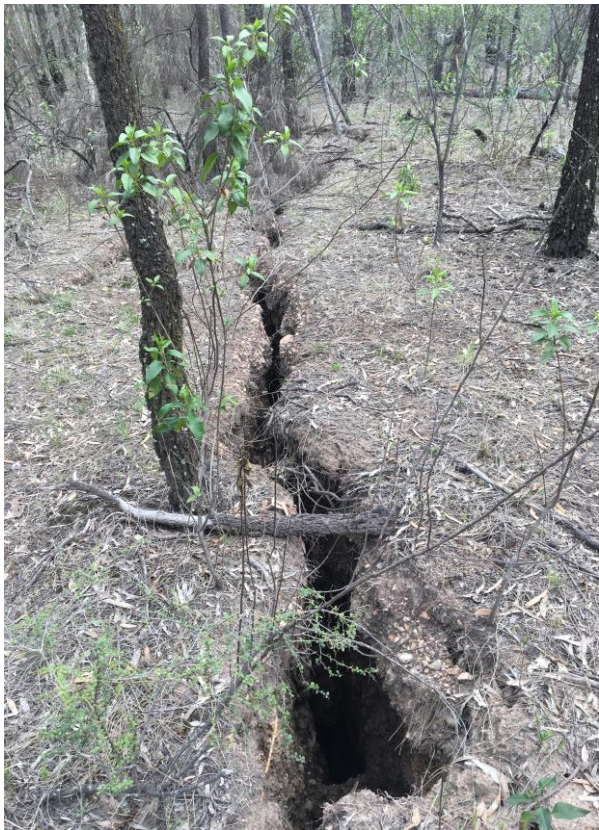
**Plate 25: Deep mine subsidence cracks near flora monitoring site V6-B1c**

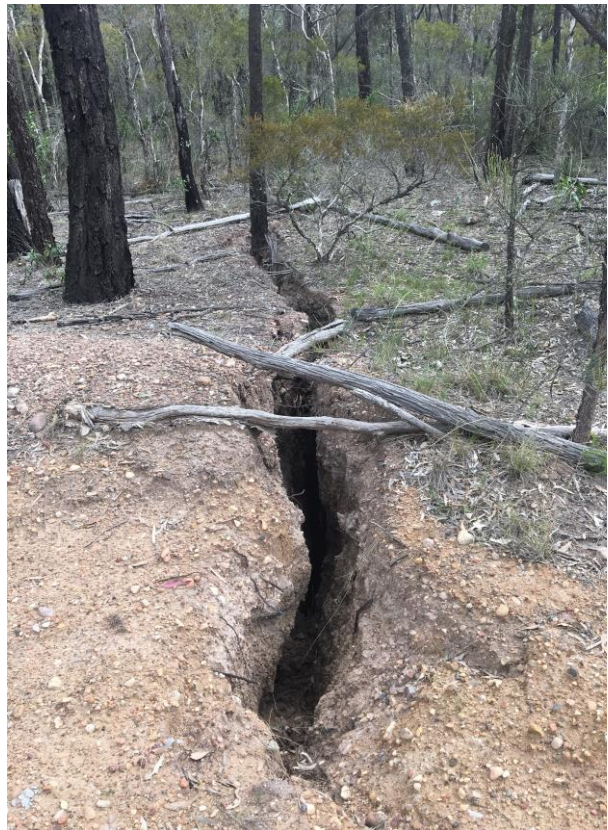
**Plate 26: Deep mine subsidence cracks near flora monitoring site V6-B1c**

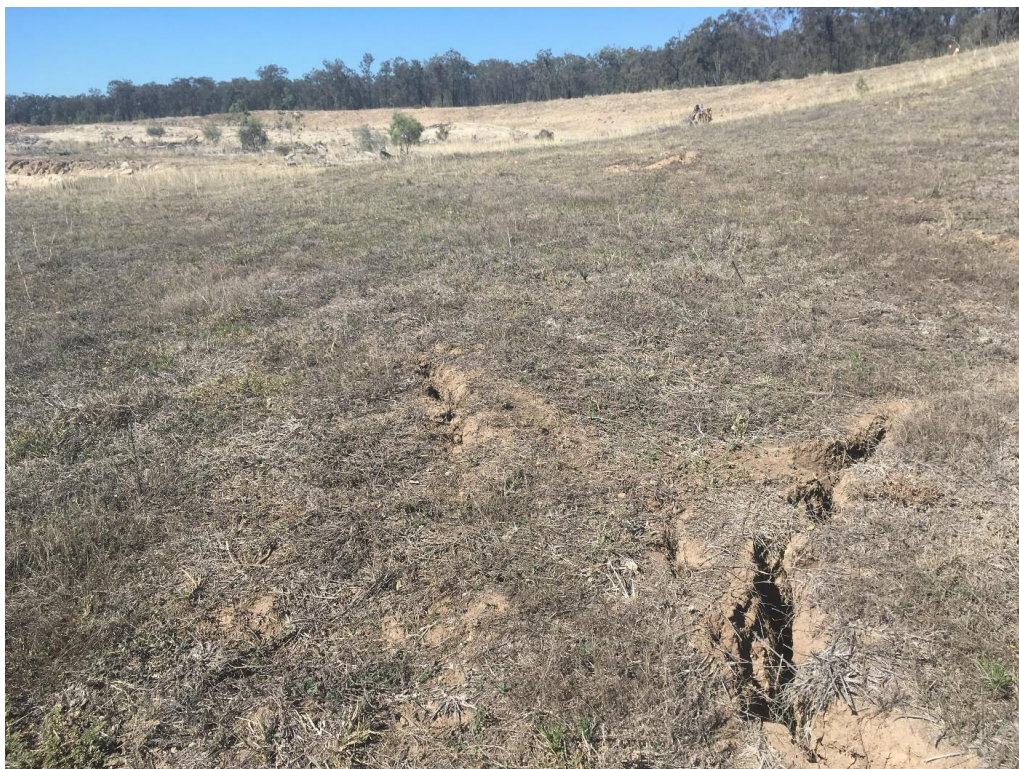
**Plate 27: Subsidence cracks near rehabilitation monitoring site 28R**

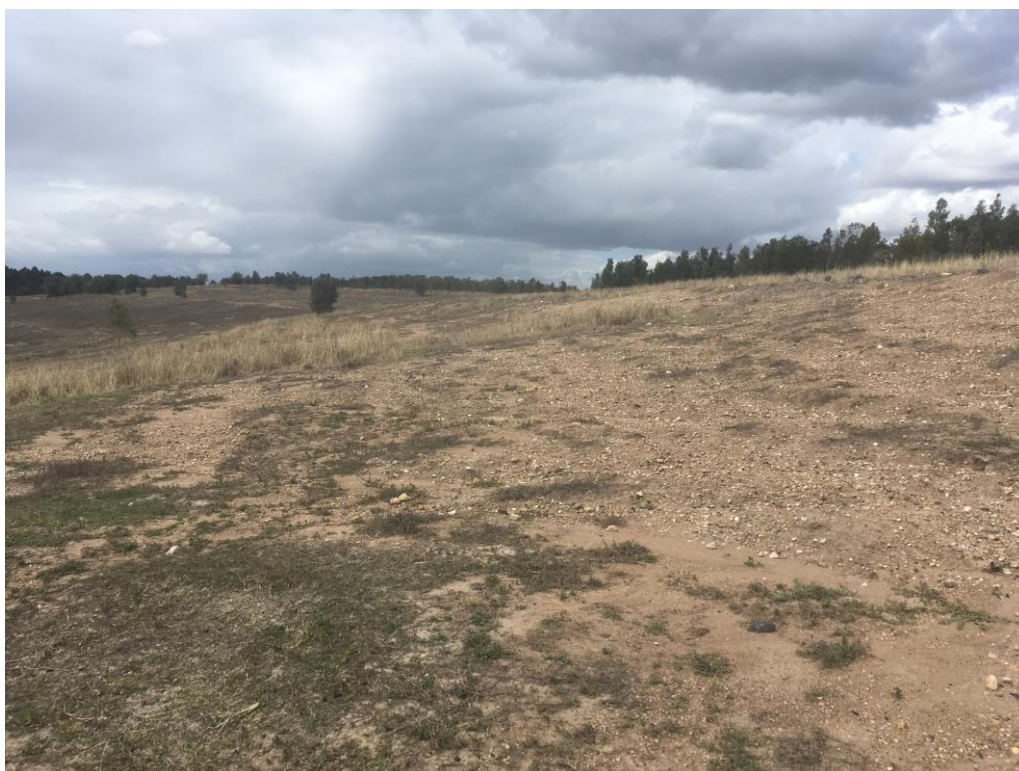
**Plate 28: A pasture rehabilitation area suffering from soil erosion issues between monitoring sites 33R and 7R in 2018**

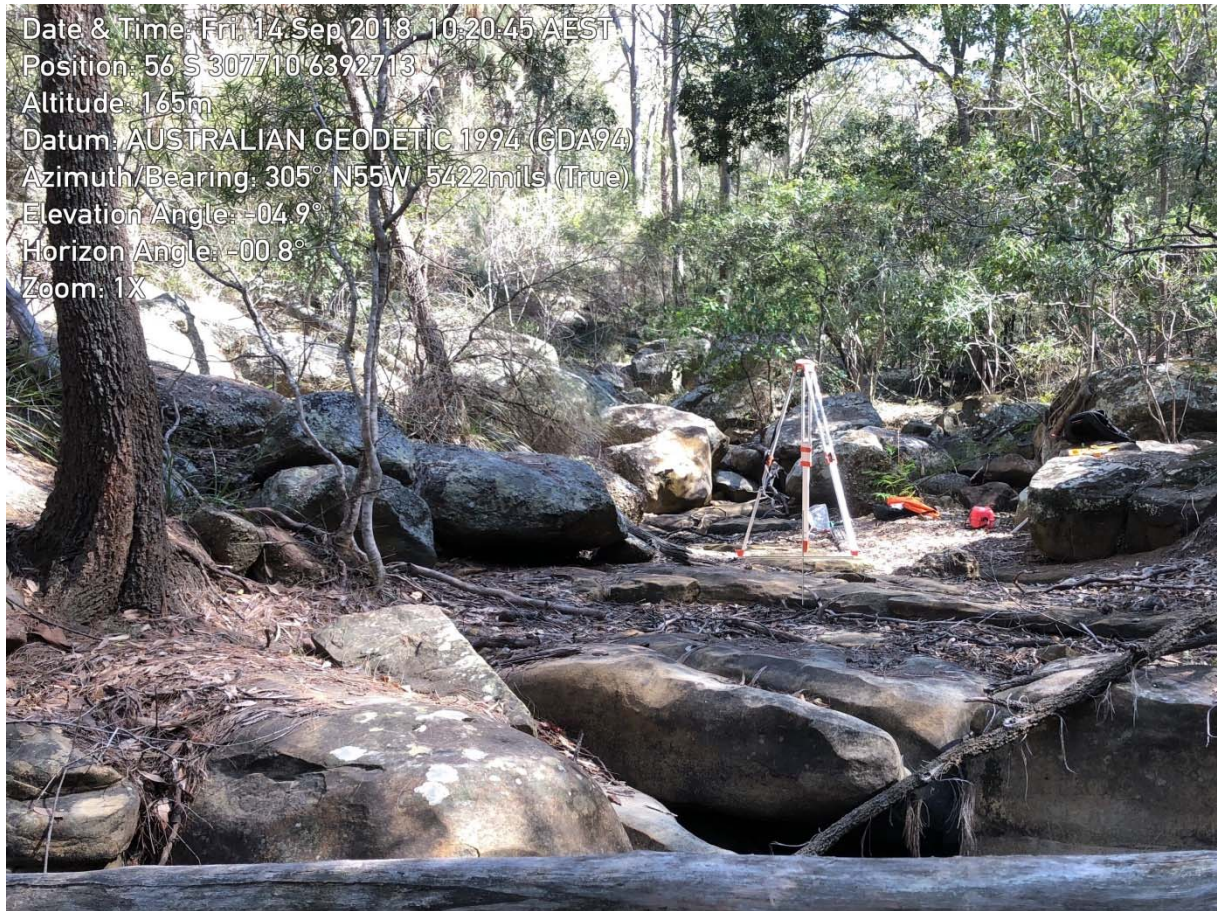
**Figure 1** below presents a view looking upstream of the new location of this flow monitoring station while **Figure 2** presents a view of the flow monitoring station's sensor housing with the sensor inside.

**Figure 1 Re-Located Flow Monitoring Station FM12 - Stoney Creek Up – Upstream View – September 2018.**

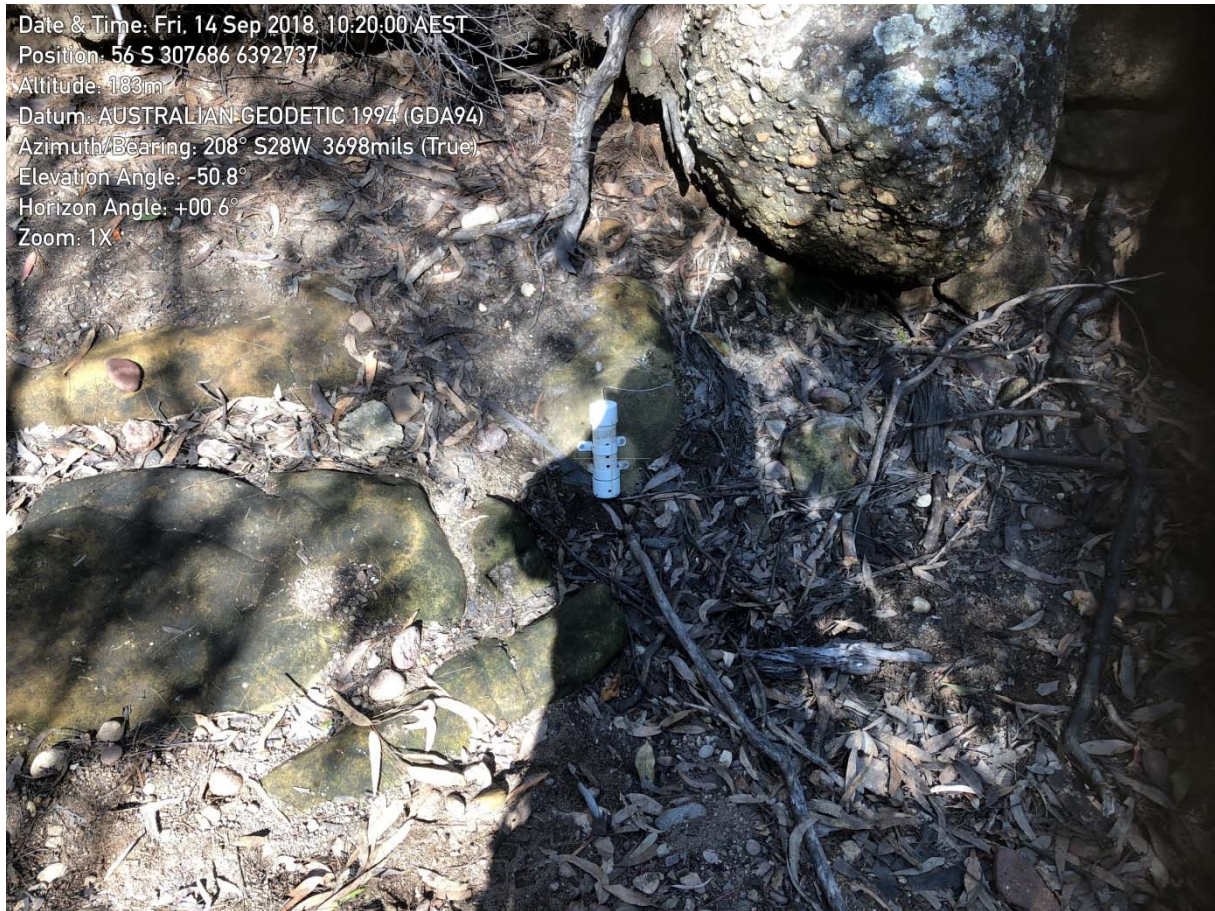
**Figure 2** Re-Located Flow Monitoring Station FM12 – Stoney Creek Up – Sensor Housing – September 2018.

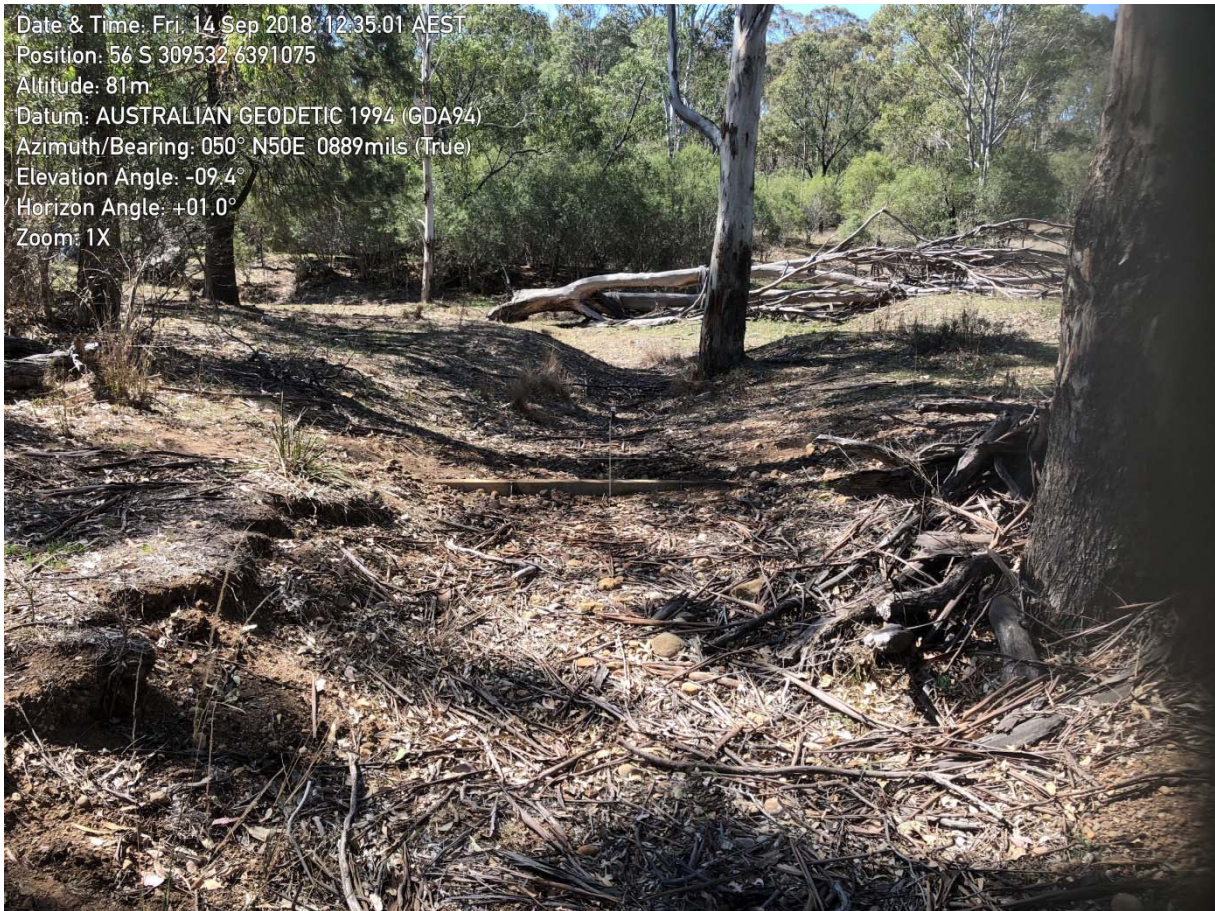
**Figure 3 Re-Located Flow Monitoring Station FM13 - Stoney Creek Down – Upstream View – September 2018.**

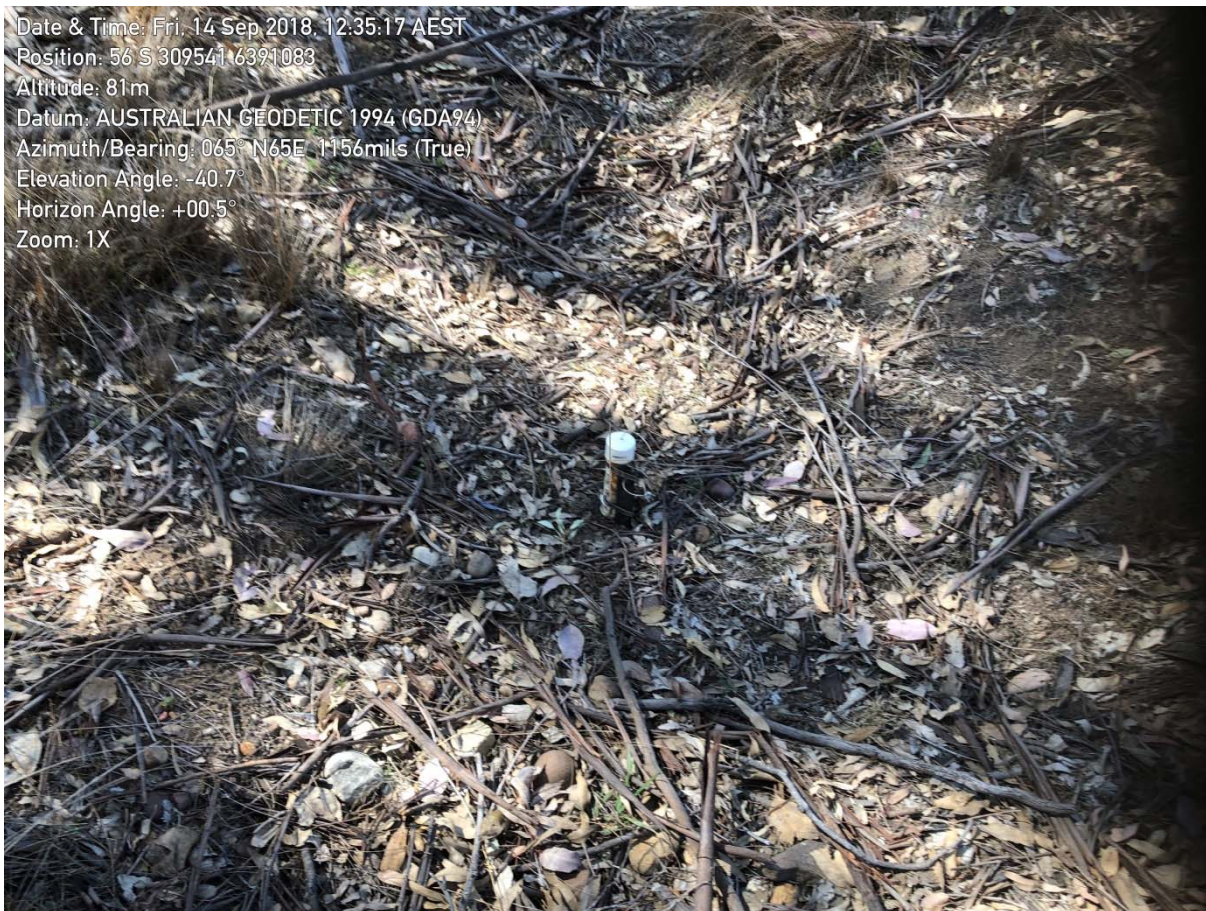
**Figure 4 Re-Located Flow Monitoring Station FM13 – Stoney Creek Down – Sensor Housing – September 2018.**
