# **WAMBO COAL PTY LTD 2020 ANNUAL REVIEW**

1 January – 31 December 2020

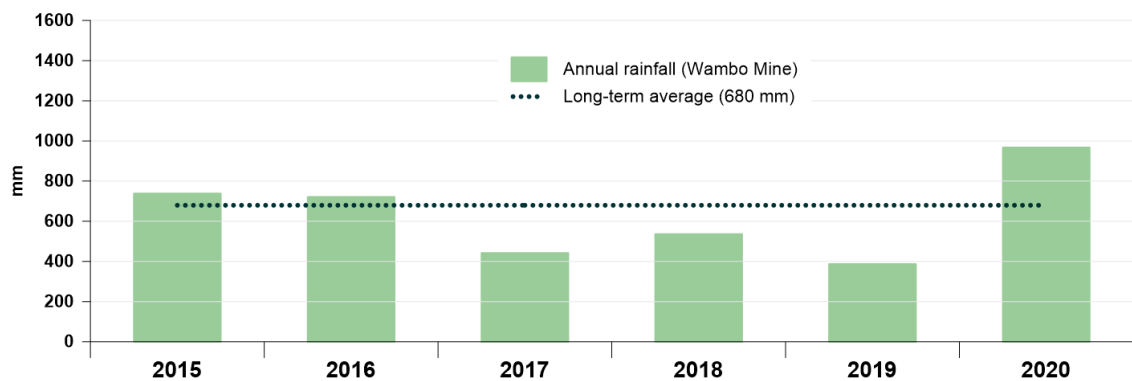
Figure 2 Annual rainfall from the Wambo Mine meteorological station

Meteorological conditions are important for determining the transport of emissions, and the potential influences on air quality. Rainfall can influence air quality conditions, particularly dust. Figure 2 shows the rainfall data collected by Wambo Coal in the past six years. Rainfall was well below the long-term average (which is 680 mm) in 2017, 2018 and 2019, coinciding with the drought, but exceeded the long term average in 2020.

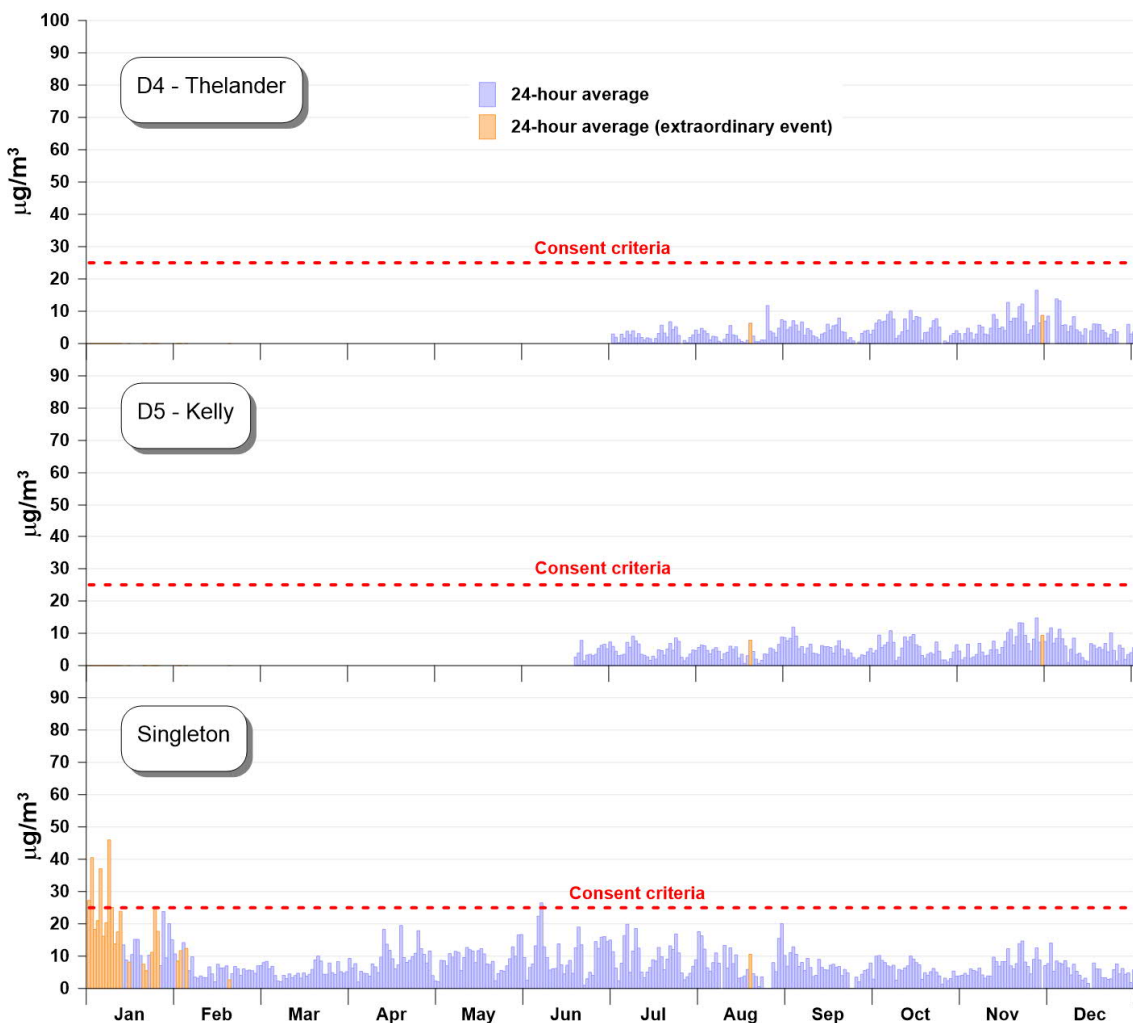
Figure 5 Measured 24-hour average PM<sub>2.5</sub> concentrations in 2020

Figure 5 shows the measured 24-hour average PM<sub>2.5</sub> concentrations in 2020 from data collected at the two Wambo coal monitors, as well as at Singleton. Extraordinary events have been identified.

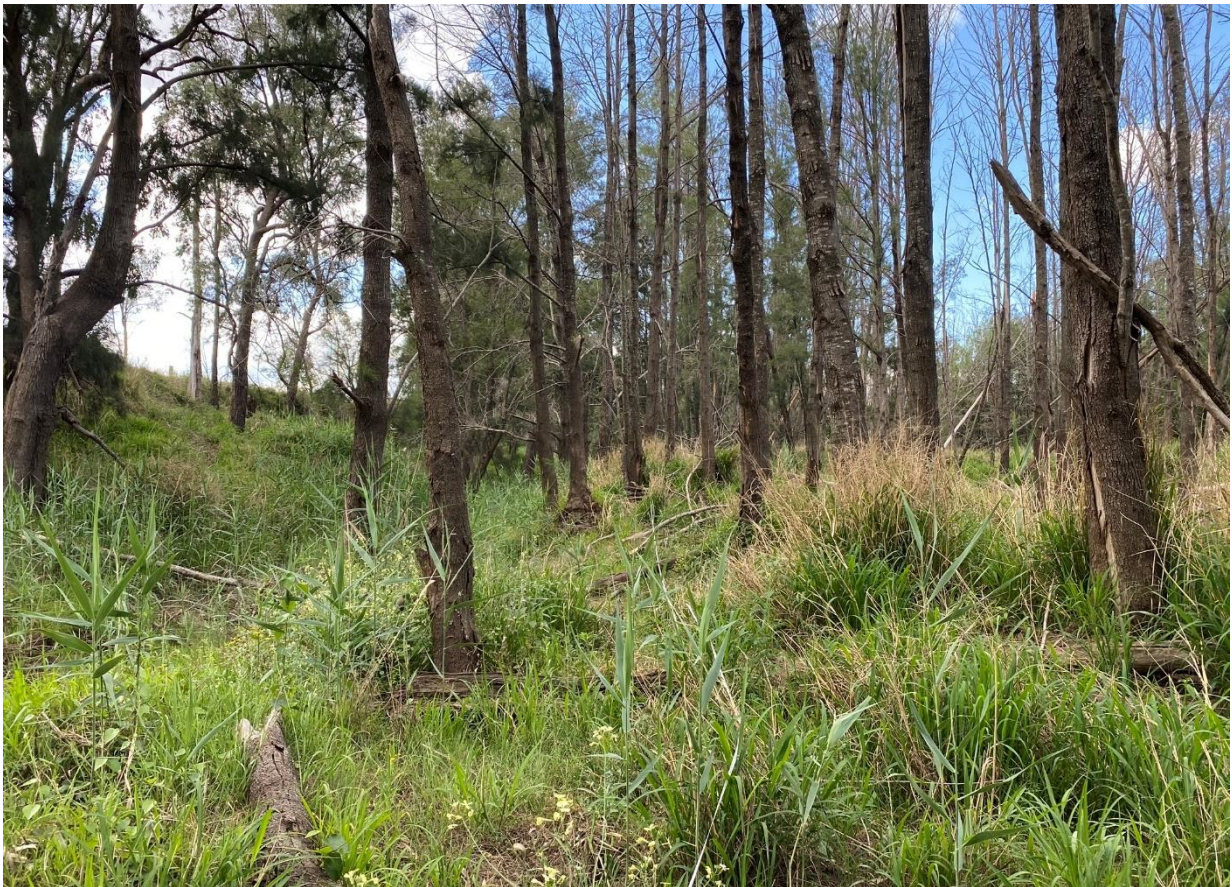
The River Red Gum / River Oak riparian woodland at WCPL is typical of other remaining stands throughout the Hunter Valley, with generally a high cover of weed species and a reduced number of native species (Photograph 1).

**Photograph 1: River Red Gum / River Oak riparian woodland wetland on North Wambo Creek in 2020 (Site V1-A1 within the Wollombi Brook channel)**

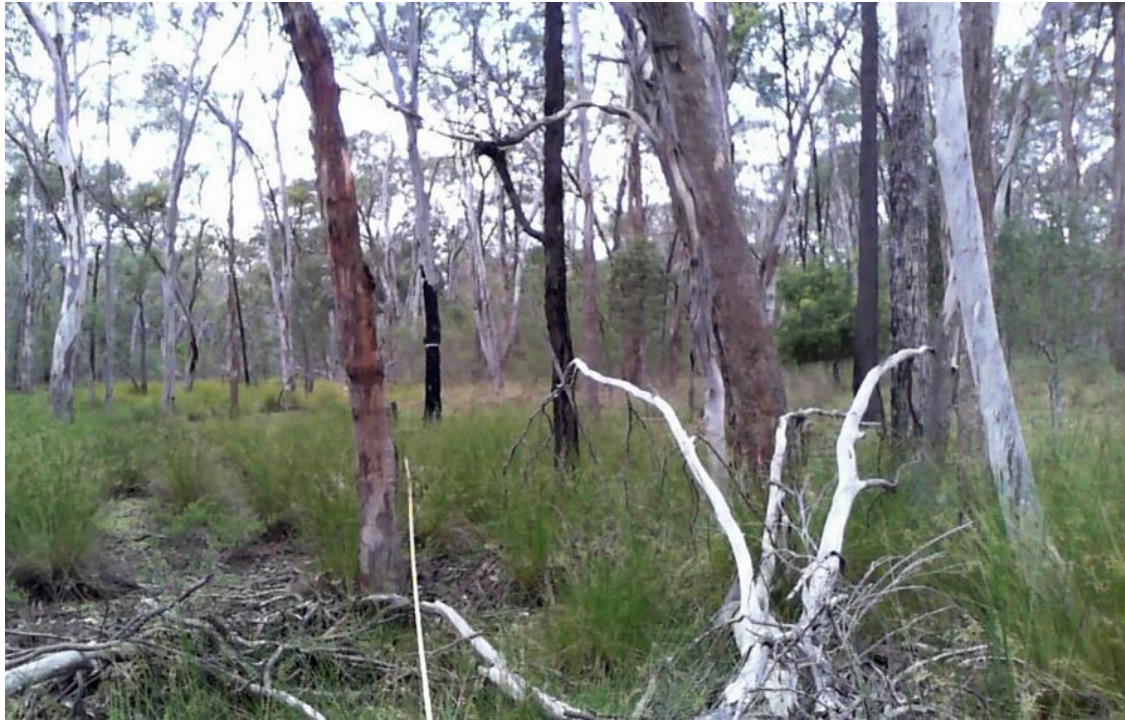
**Photograph 2: Flora monitoring site V3-B1 during 2015**

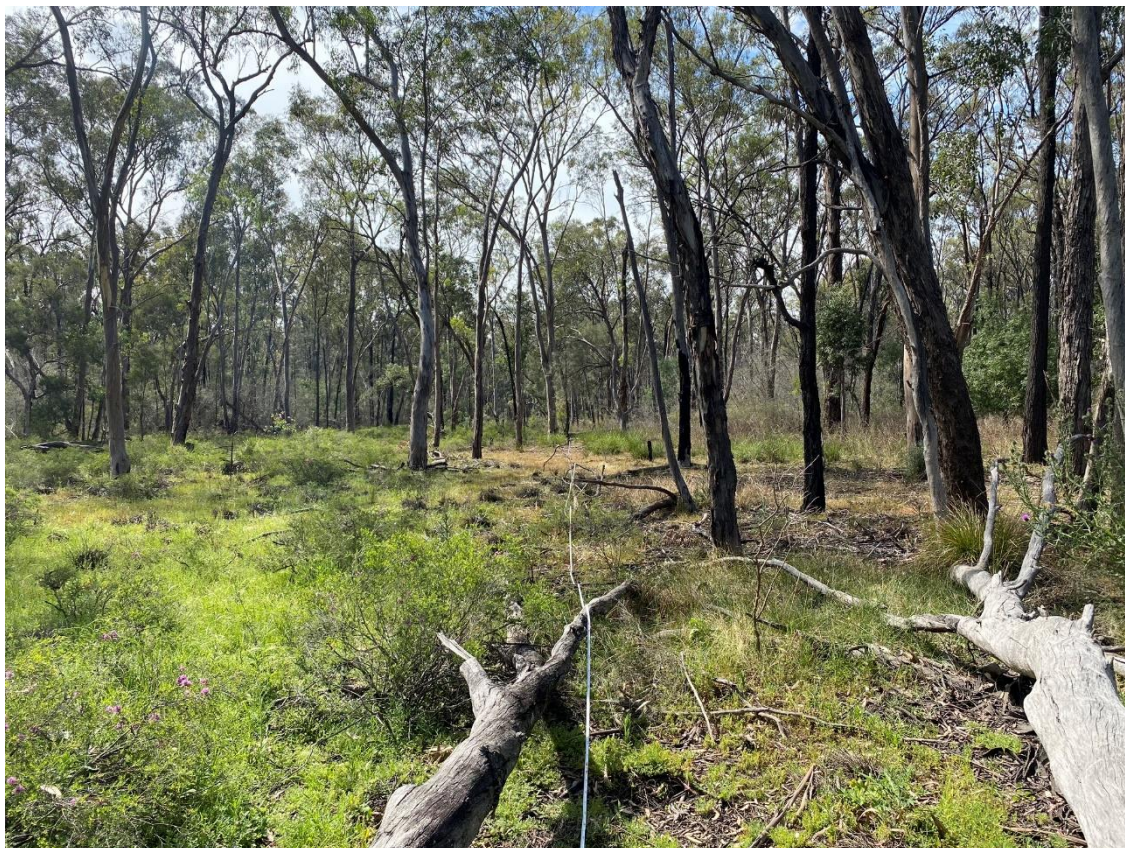
**Photograph 3: Flora monitoring site V3-B1 during 2020**

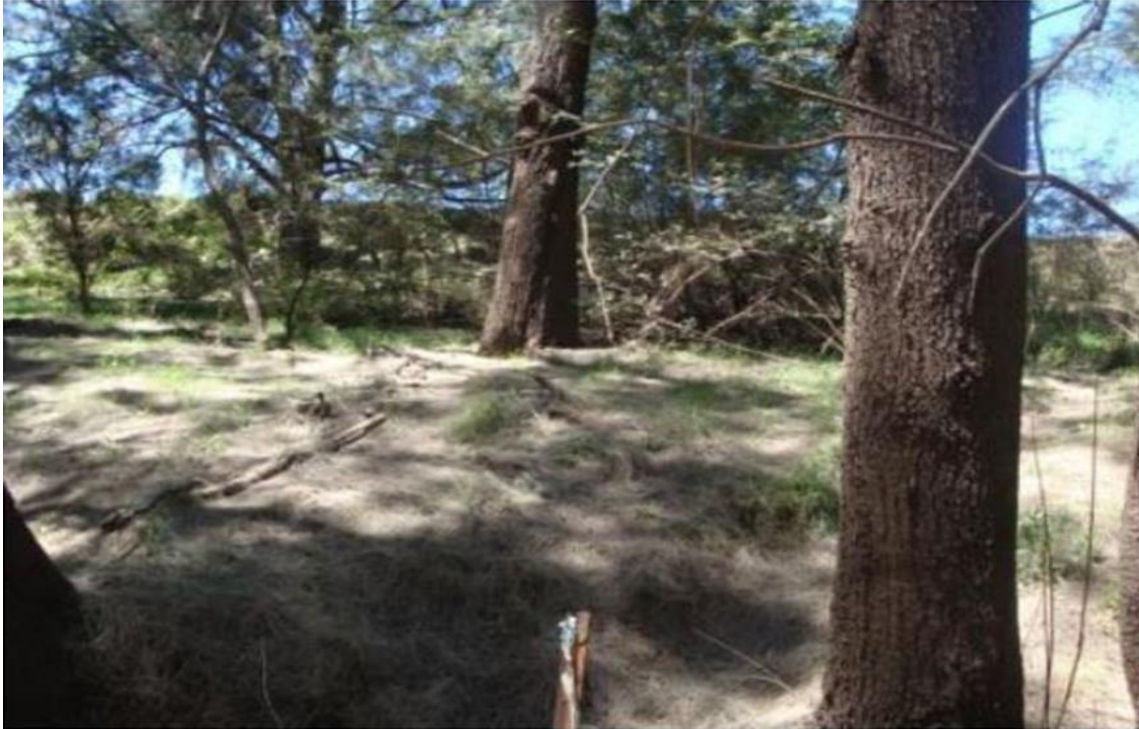
**Photograph 4: Monitoring site A3 during 2013**

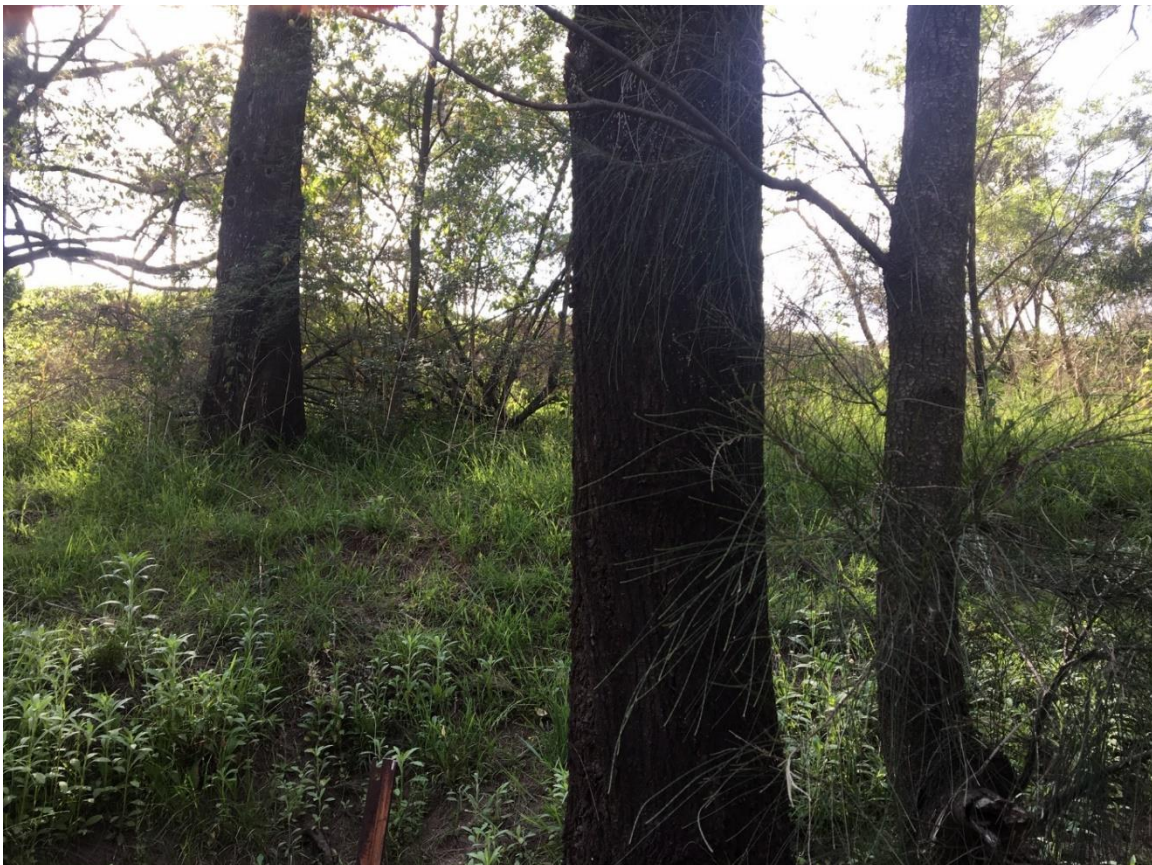
**Photograph 5: Monitoring site A3 during 2020**

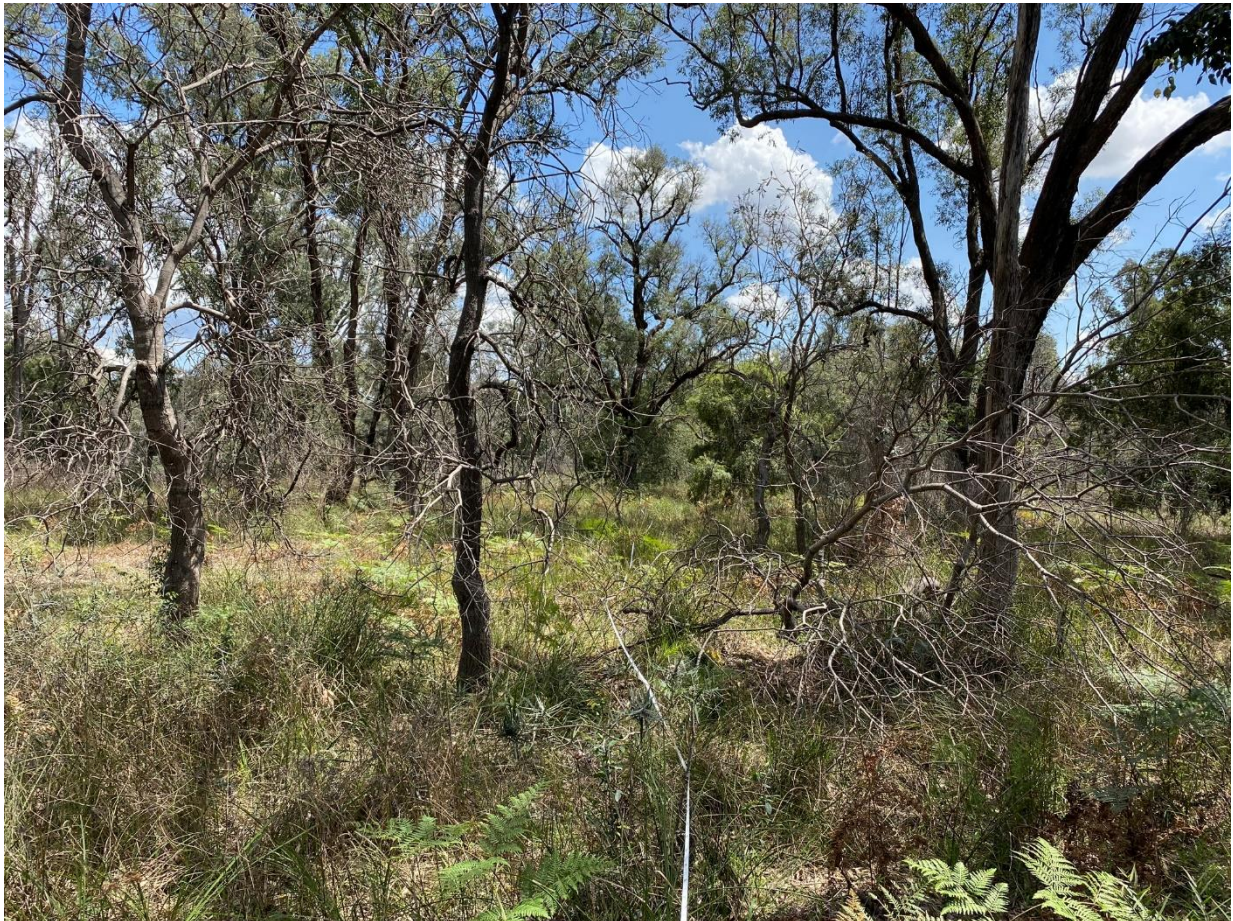
Within WCPL owned land, this community is mostly restricted to the eastern side of Wollombi Brook, primarily within the RWEA area A (Photograph 6). This PCT corresponds to the EPBC Act listed Critically Endangered Ecological Community (CEEC) *Warkworth Sands Woodland of the Sydney Basin Bioregion* and is also listed under the BC Act. This PCT occurs on aeolian sand deposits and is restricted to the Warkworth area.

**Photograph 6: Warkworth Sands Woodland within RWEA A in 2020 (Site V5-B2)**

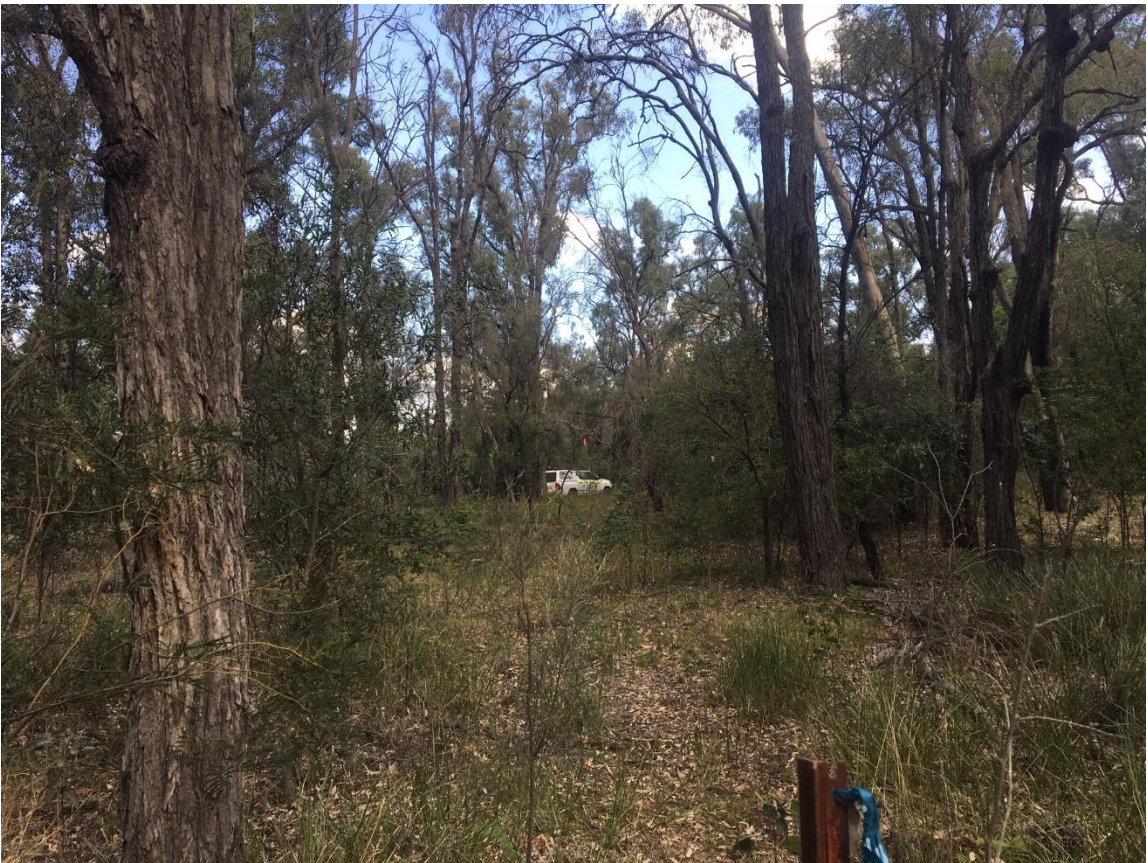
Photo-monitoring point A2 within this PCT shows a minor change in vegetation between the 2013 and 2020 monitoring periods, with a reduction in cover of *Pteridium esculentum* (Bracken) apparent (Photograph 7 and Photograph 8). Canopy dieback of *A. floribunda* in some areas of this community was observed during the 2016 monitoring program. These trees displayed abundant epicormic growth in 2017 and have since mostly recovered (Photograph 9 and Photograph 10). NOS and NMS collected by ELA from the 2015 to 2020 monitoring periods have remained generally similar between years.

**Photograph 8: Photo monitoring point A2 during 2020**

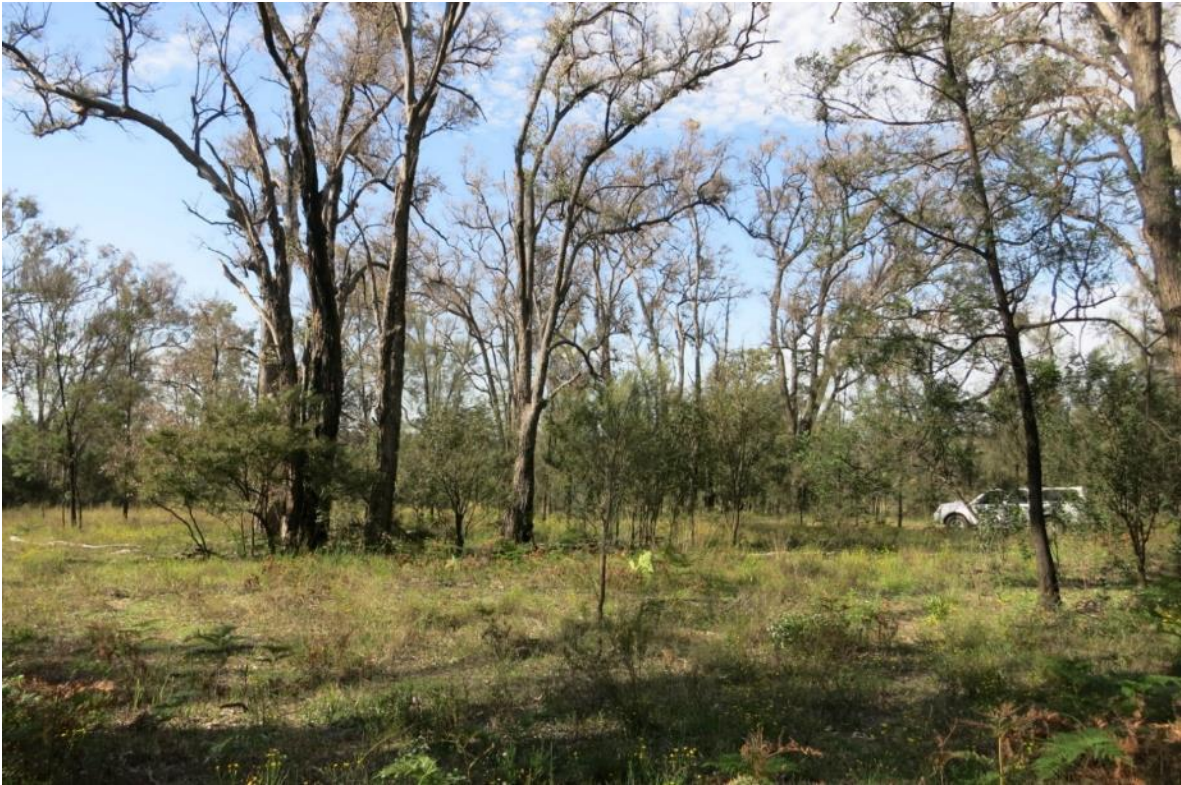
**Photograph 9: Severe *Angophora floribunda* canopy dieback in parts of Warkworth Sands Woodland in RWEA A during 2016**

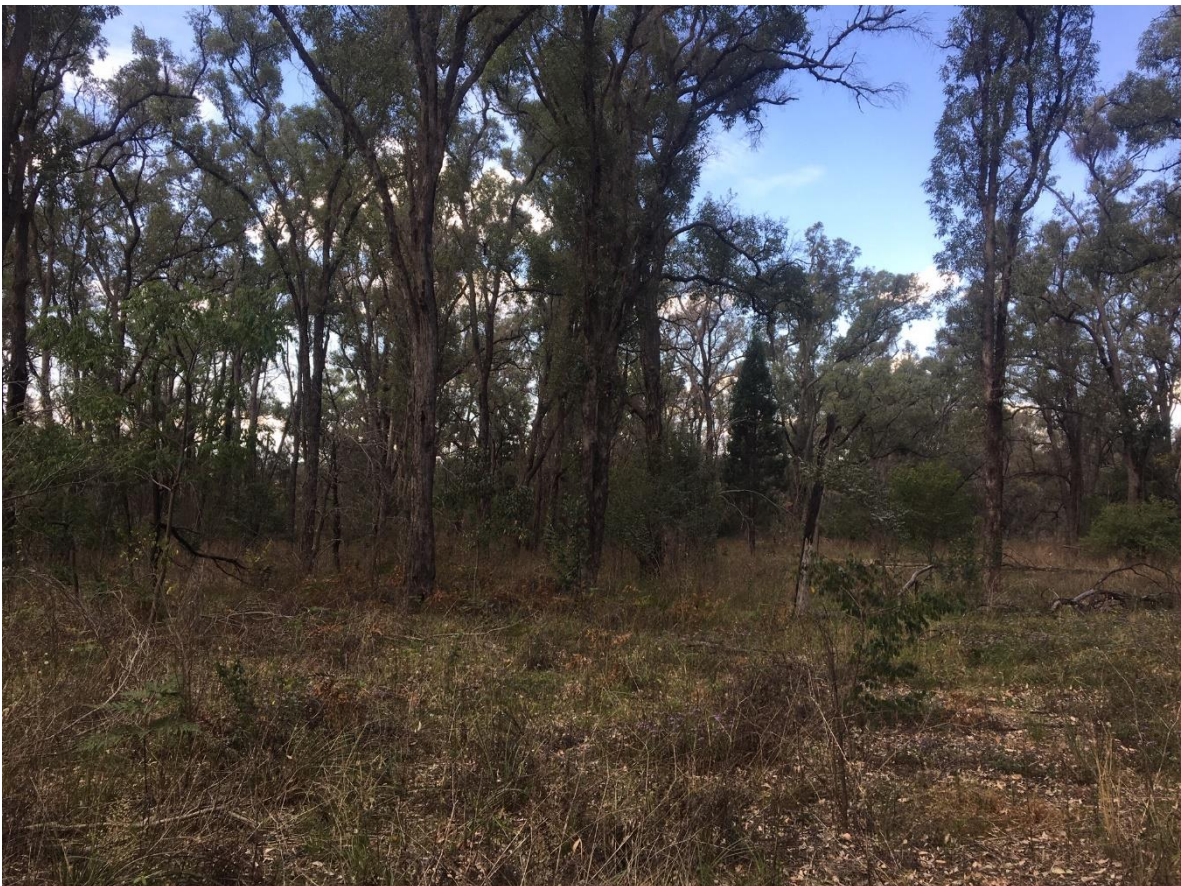
**Photograph 10: Continued recovery of *Angophora floribunda* canopy dieback observed in 2020**

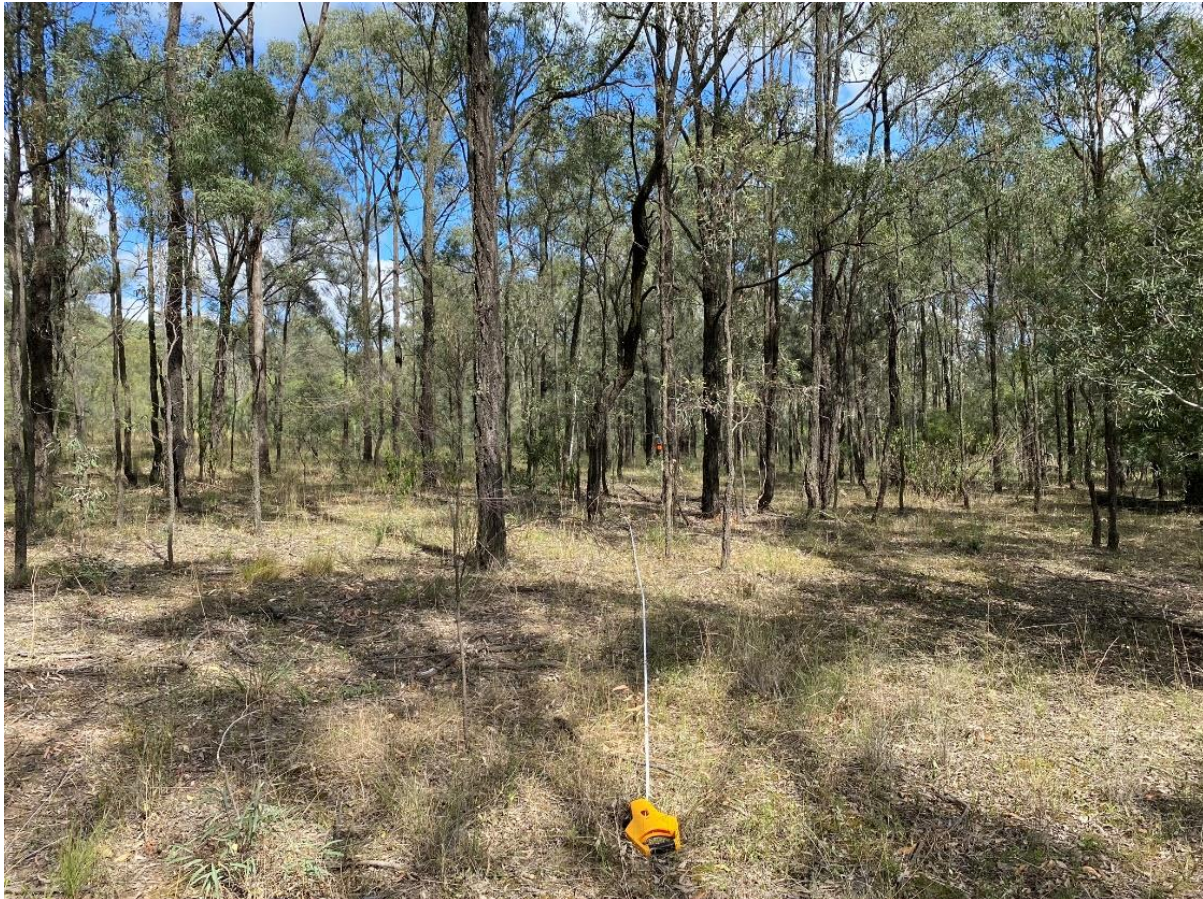
This community on land owned by WCPL is generally dominated by the canopy species *Eucalyptus crebra* (Narrow-leaved Ironbark) and occasionally *Eucalyptus moluccana* (Grey Box) (Photograph 11). A sparse mid-storey or shrub layer of *Allocasuarina luehmannii* (Bull Oak), *Bursaria spinosa* subsp. *spinosa* (Blackthorn) and *Notelaea microcarpa* var. *microcarpa* (Mock Olive), with a grassy understorey is often present. *Eucalyptus punctata* (Grey Gum) and *Melaleuca decora* also occur in some areas.

Photograph 11: Narrow-leaved Ironbark - Bull Oak - Grey Box shrub - grass open forest at WCPL (site V6-A3 in 2020)

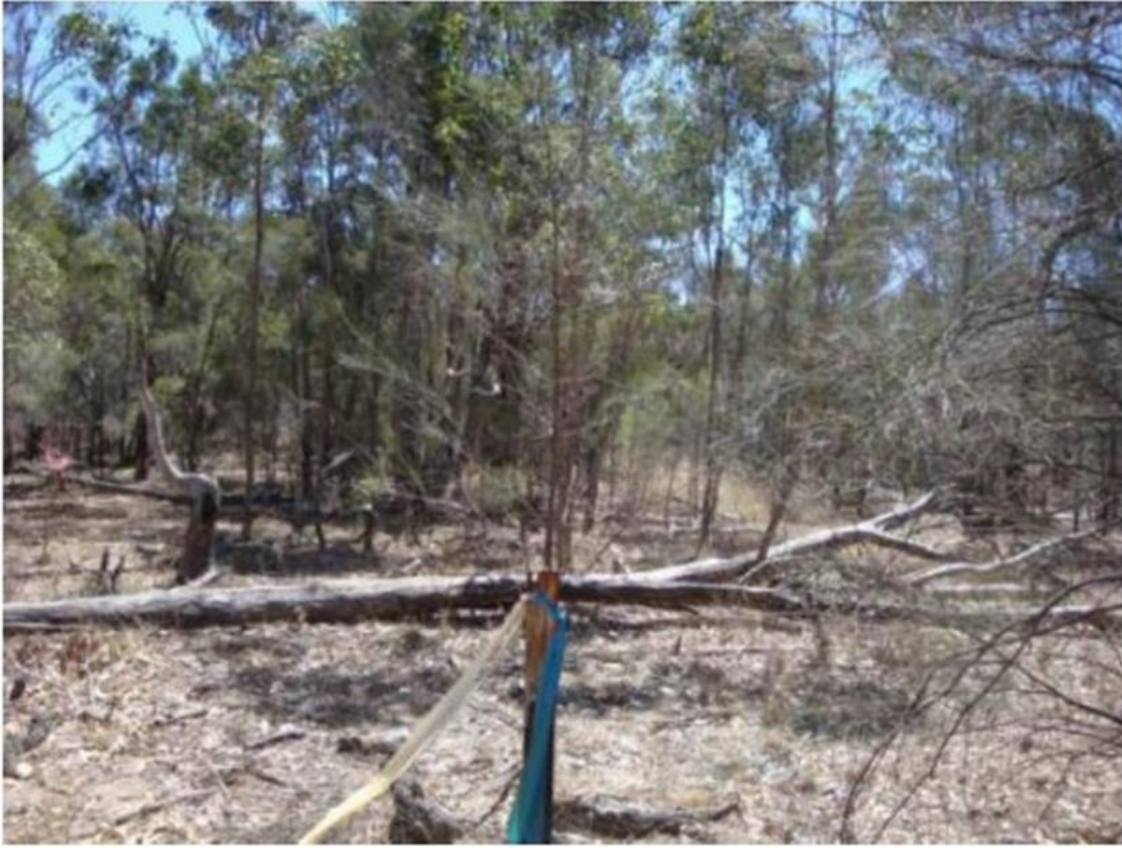
**Photograph 12: Photo-monitoring point A4 during 2013**

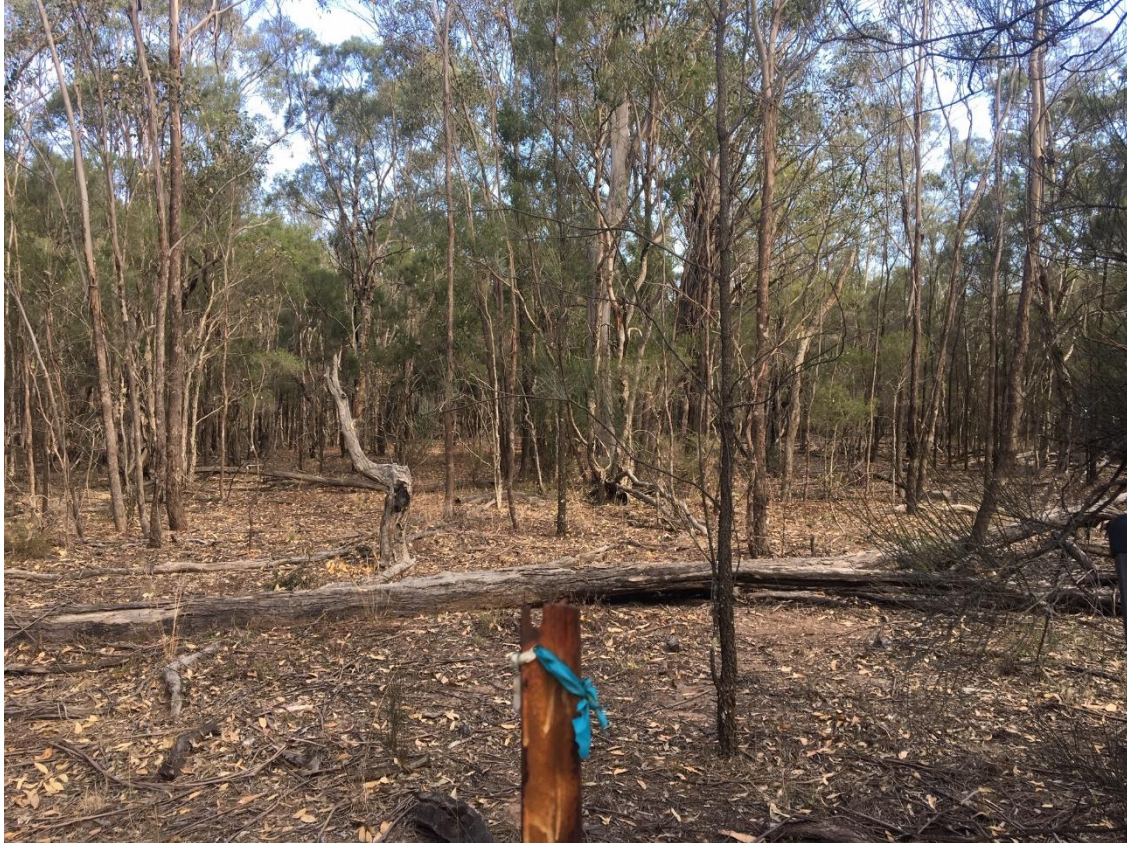
**Photograph 13: Photo-monitoring point A4 during 2020**

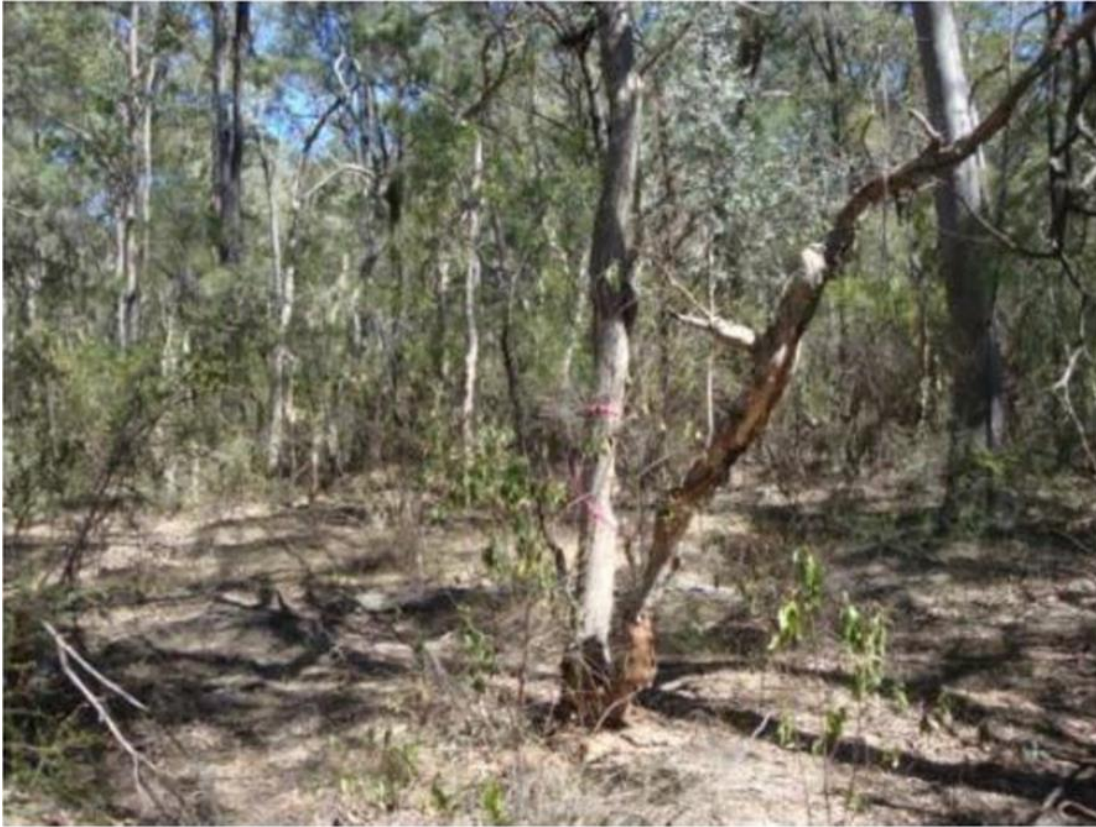
Photo-monitoring points in this community show little change in vegetation structure between the 2013 and 2020 monitoring periods (Photograph 14 and Photograph 15). Overall, this PCT is performing well and no additional management actions are required at this stage.

**Photograph 14: Photo-monitoring point B2 during 2013**

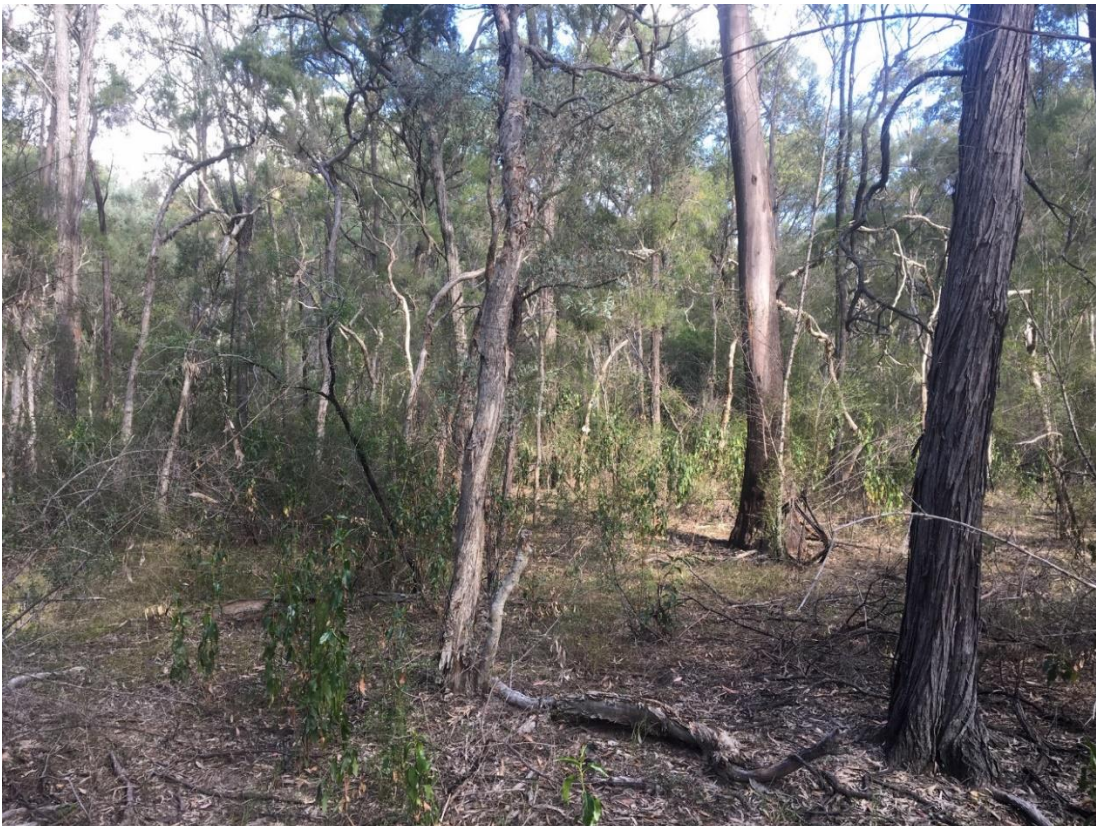
**Photograph 15: Photo-monitoring point B2 during 2020**

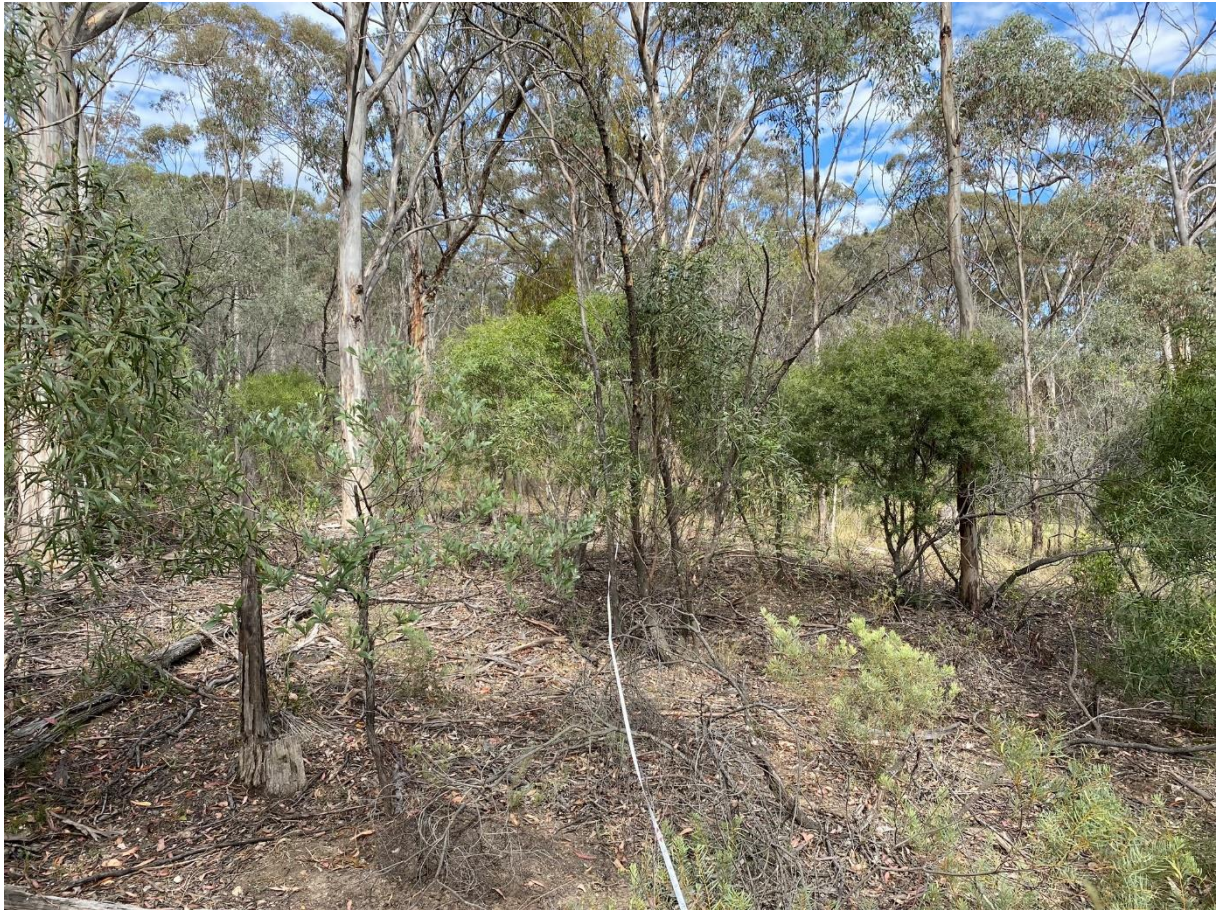
Photograph 16: A typical example of Slaty Box woodland at WCPL during 2020 (Site V10-B3)

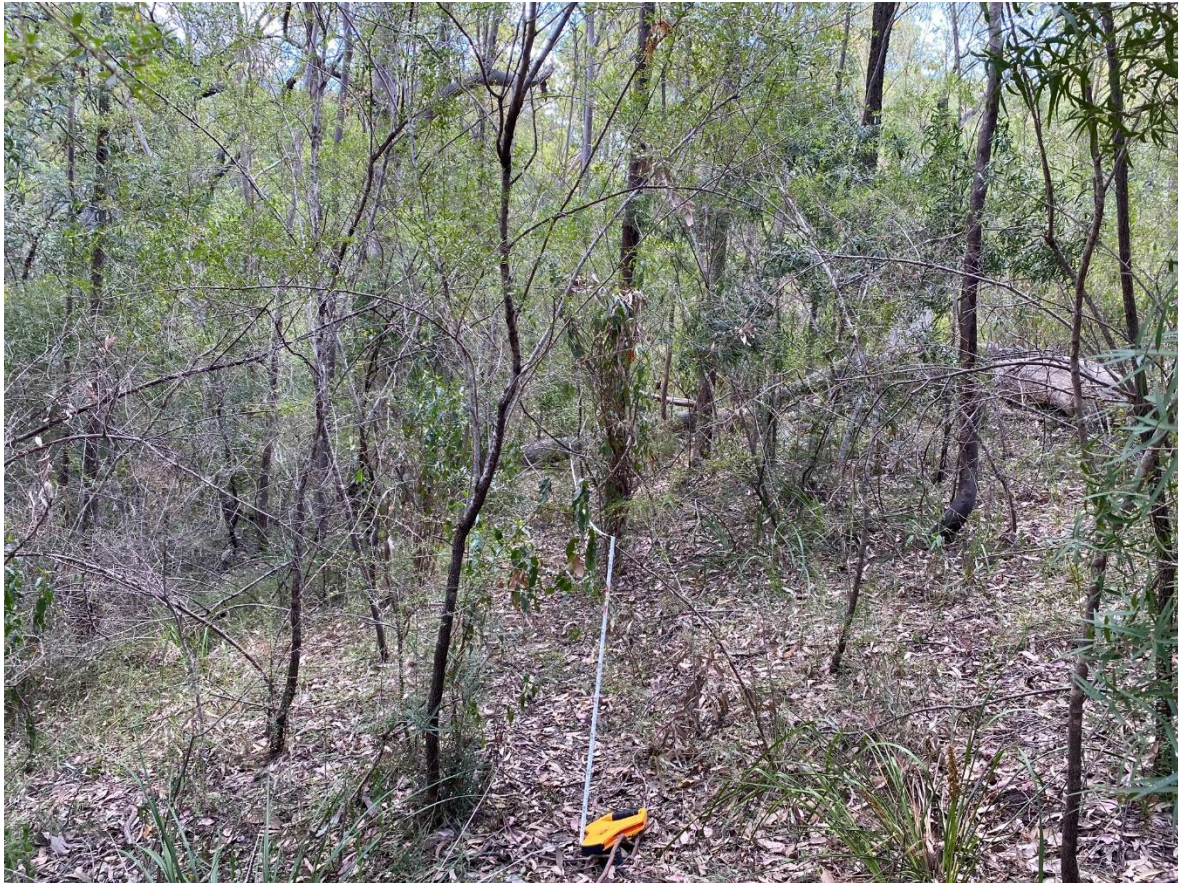
At WCPL, this community occurs along Stony Creek and is sheltered by steep sandstone escarpments to the south and a large ridgeline to the north. This PCT is in good condition with many native species and occasional large remnant trees with hollows. One monitoring plot (V13-B1) samples this PCT (Photograph 17).

Photograph 17: White Mahogany - Spotted Gum - Grey Myrtle forest at V13-B1 in 2020

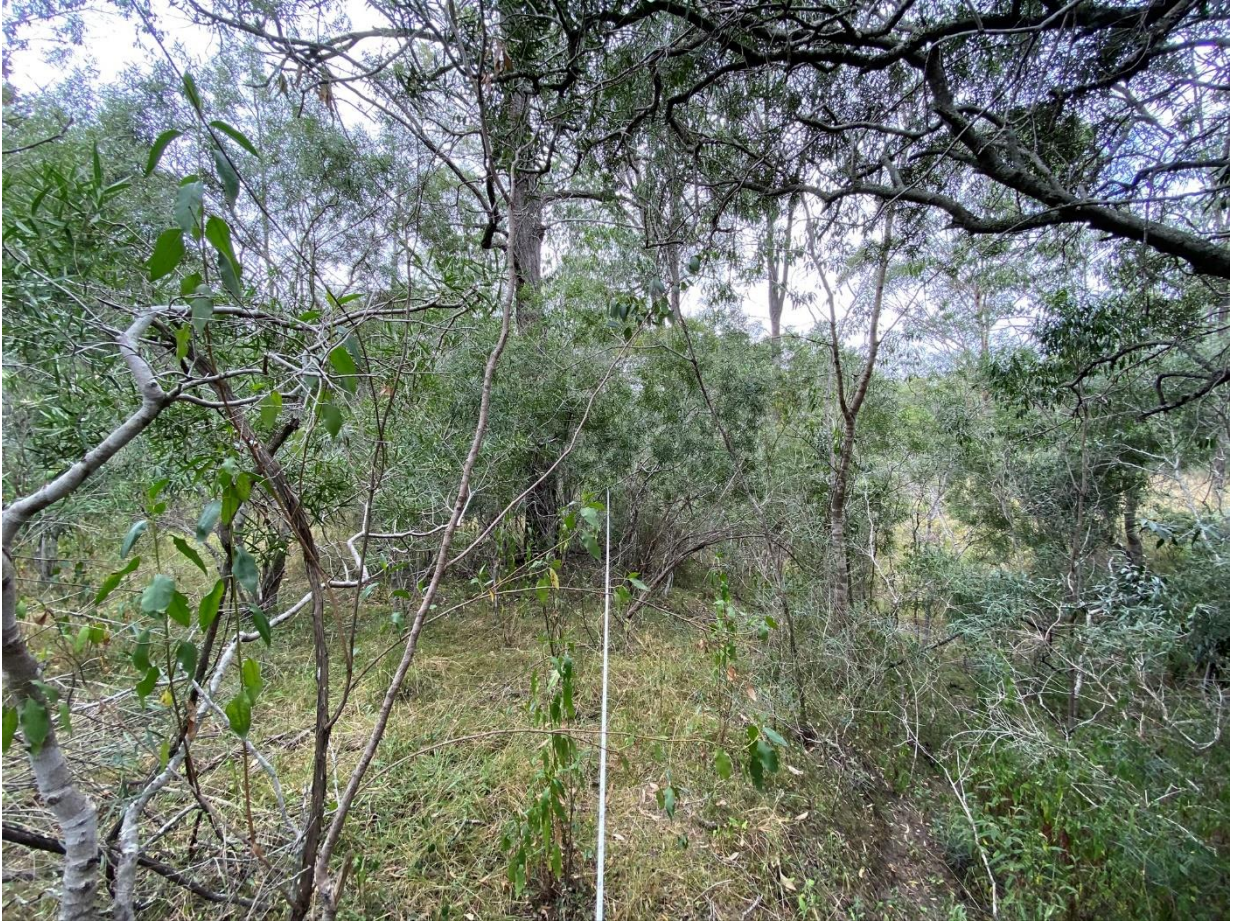
**Photograph 18: Brush Wilga/Native Olive Shrubland at V14-B2 in 2020**

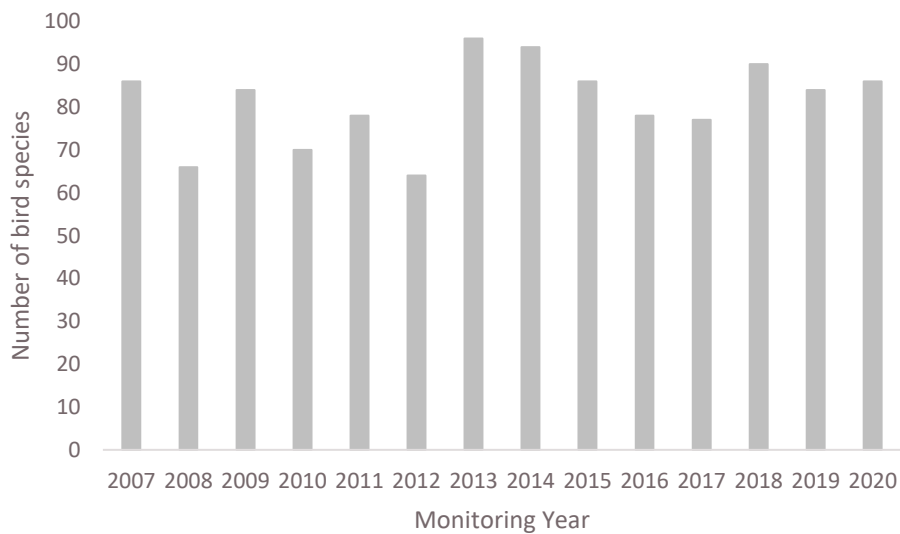
The 2020 monitoring recorded a total of 86 bird species from 26 monitoring sites during formal bird surveys of RWEAs. This number is higher than the median from all 26 sites in previous monitoring periods (2007-2019 - 81 species), and is within the range of previous years, which have varied from a low of 64 species in 2012 to a high of 96 species in 2013 (**Figure 11**).

**Figure 11: Number of bird species recorded at monitoring plots 2007 - 2019**

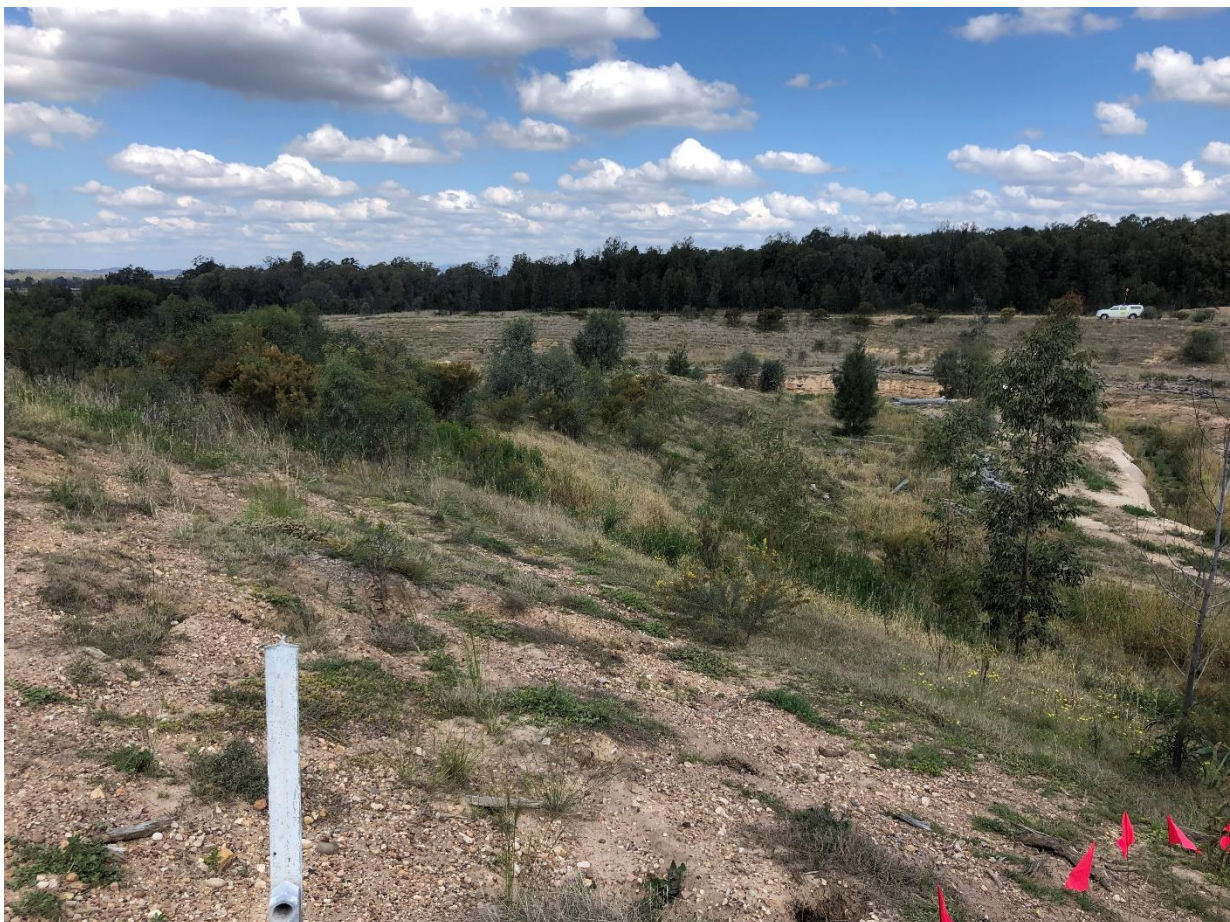
**Photograph 20: North Wambo Creek Diversion during 2020 at site 25R showing grasses with native shrubs and some bare soil**

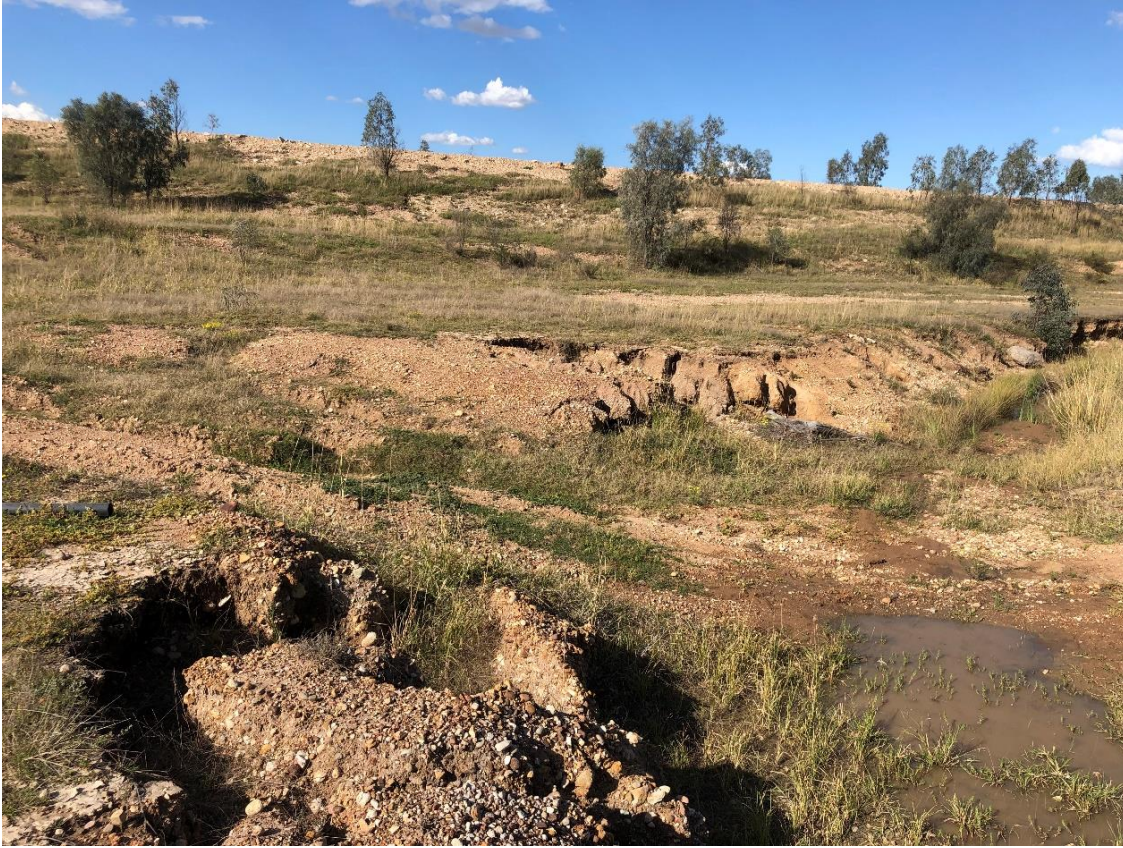
**Photograph 21: Gully erosion within the North Wambo Creek Diversion (near site 23R) in 2020**
