# **WAMBO COAL PTY LTD 2020 ANNUAL REVIEW**

1 January – 31 December 2020

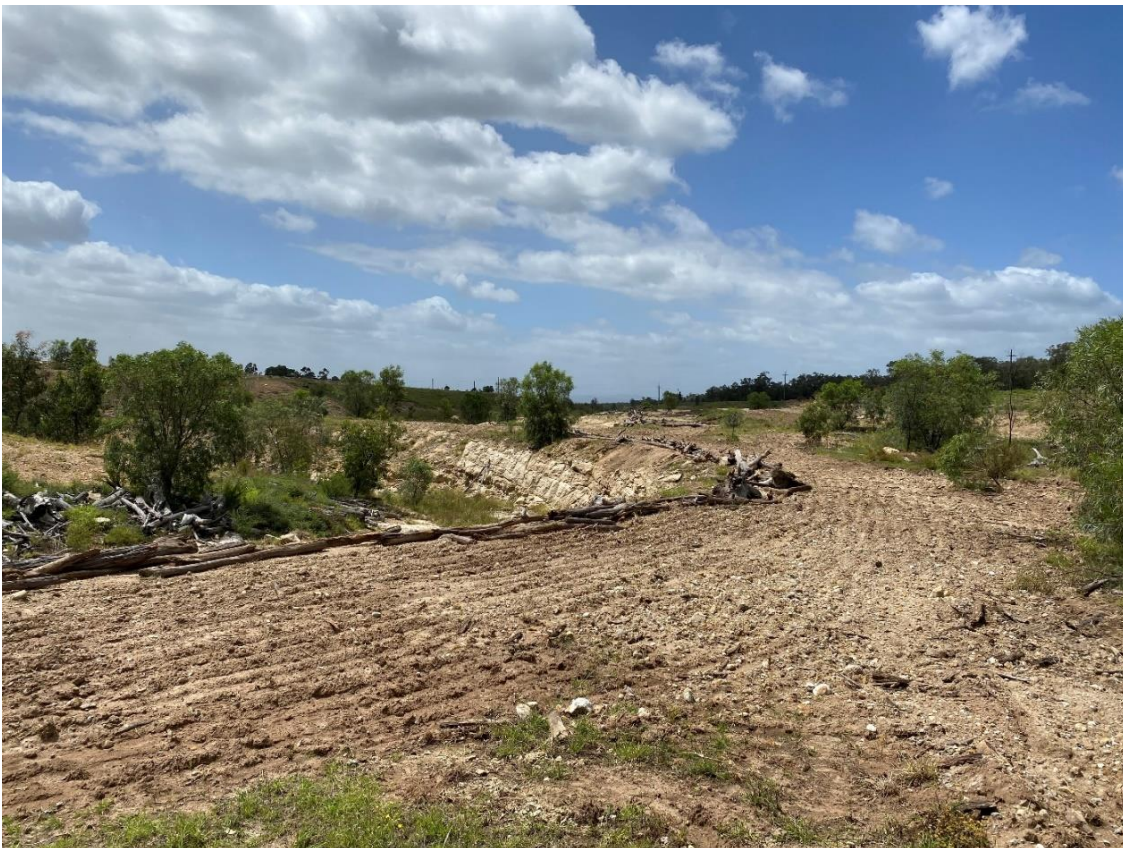
**Photograph 22: Example of active soil remediation work in the North Wambo Creek Diversion area in 2020**

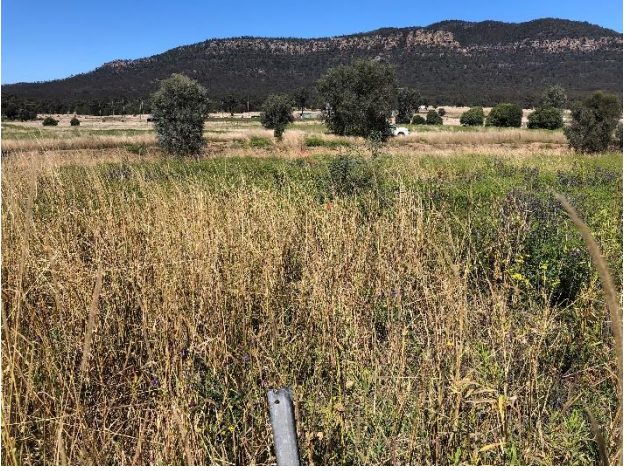
Transect	Notes	Photograph
17R	<p>This transect consists of relatively flat ground covered in pasture. Low grass (primarily <i>Cynodon dactylon</i>) and grass tussocks (primarily exotic <i>Chloris gayana</i>), together with high cover of annual ground covers make up 86% of the transect. An increase in annual ground cover was recorded following the wet year.</p>

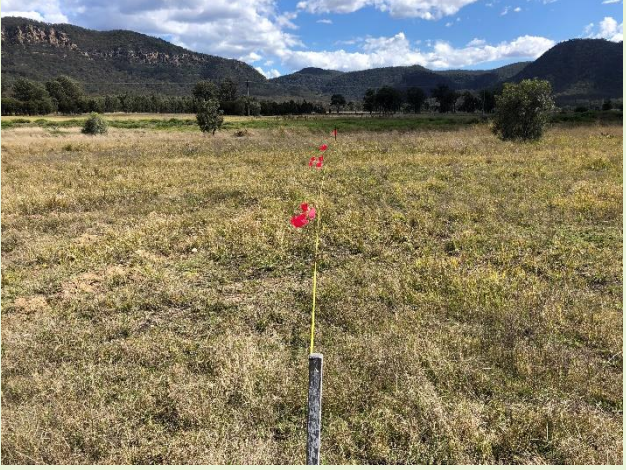
19R	<p>Transect relatively flat and comprised primarily of low grass (78%) and <i>Galenia</i> (4%), dispersed with patches of bare soil (18%). The appearance and scores are similar to the previous year.</p> <p>Young <i>Eucalyptus</i> and <i>Acacia</i> species are growing on creek banks downstream. Evidence of ripping activity from 2018 is visible near this transect, and the soil has been disturbed by vehicle tracks.</p>

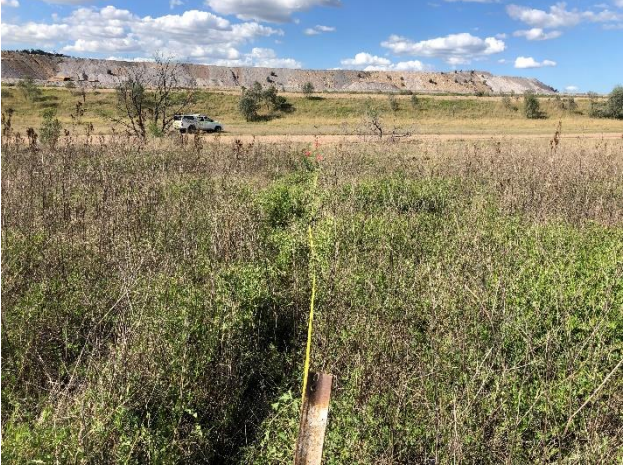
21R	<p>Transect relatively flat grassland dominated by annuals, low grass and <i>Galenia</i> (89%) with bare soil (11%). An increase in annual cover and decrease in bare ground was recorded from the previous year.</p>

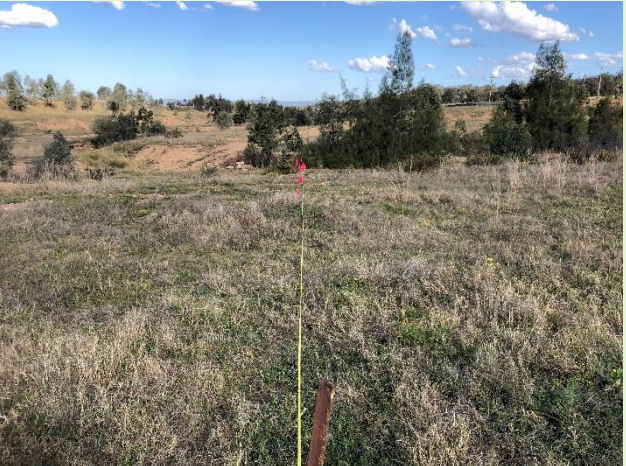
Transect	Notes	Photograph
23R	<p>Low grass occurs over 40% of the transect, similar to 2019. Large bare patches of stony soil occur towards the middle and end of transect where there is a slope. Bare soil patches cover 57% of the area. Some areas of active erosion including some 30cm deep rills occur in the surrounding area. The creek bank is in this area has been undercut and there is slumping on western bank. Regenerating <i>Casuarina cunninghamiana</i> (up to 8m) and some Eucalypts and <i>Acacia</i> sp. are present in and near the channel.</p>

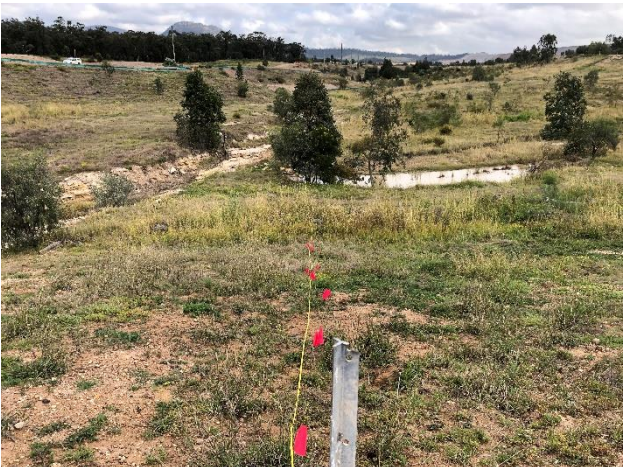
28R	<p>Transect primarily samples the relatively steep eastern creek bank. The majority of this transect was ripped to control <i>Galenia pubescens</i> and erosion prior to the 2017 monitoring.</p> <p>The dominant components were low grass 87 % and bare soil (13%), an increase in grass cover from the previous year.</p> <p>This transect was subject to soil remediation works by the Soil Conservation Service following the survey in 2020.</p>

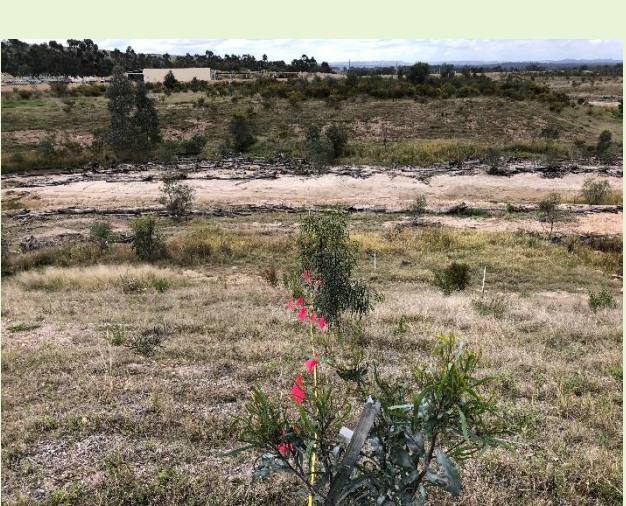
27R	<p>Transect samples the relatively steep western bank of the cutting. The majority of this transect was ripped to control <i>Galenia pubescens</i> and erosion prior to the 2017 monitoring. Low sparse grasses and logs dominate the flat area adjacent to the creek channel.</p> <p>The transect is dominated by low grass (47%) and tussocks (10%). Bare soil (40%) has increased from 2019, which corresponds to a loss of litter. Litter at this transect previously comprised small woodchips which have now decomposed and washed away. The low grass <i>Cynodon dactylon</i> is moderately established at the site.</p>

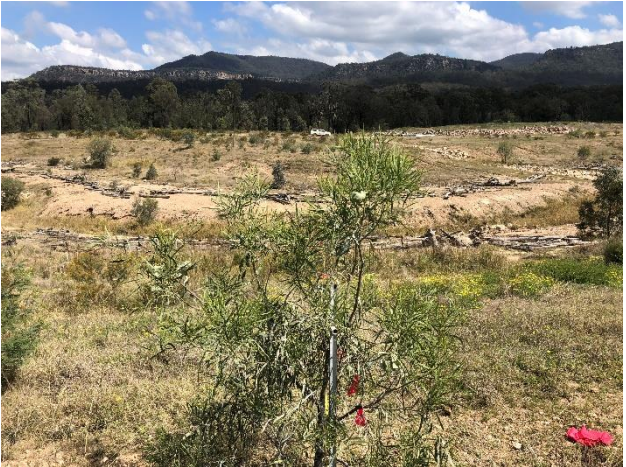
Transect	Notes	Photograph
26R	<p>Transect samples the relatively steep eastern bank to the edge of the creek channel. Low grass (56%) and tussocks (17%) dominated this transect in 2020. Bare soil areas (17%) and logs (8%) make up the remainder. The transect remained essentially unchanged from 2019. <i>Acacia</i> sp. shrubs are continuing to establish on some sections of the bank near this transect.</p>

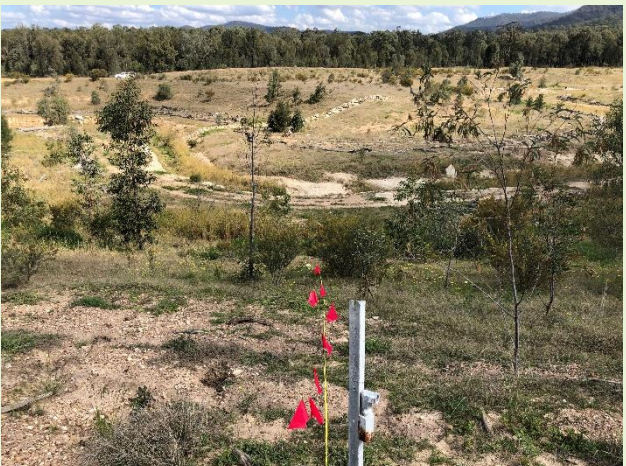
25R	<p>This slope is relatively steep with low grass dominating 74% of transect and having the highest contribution to soil stability.</p> <p>Bare soil is most prevalent at the top of transect where some minor erosion is occurring and makes up 17% of the transect.</p> <p>Large tussock grasses (<i>Chloris gayana</i>) and logs are present at the bottom of the transect near the creek channel. Overall scores were very similar to 2019.</p> <p><i>Acacia</i> sp. shrubs are continuing to develop on the bank near this transect.</p>

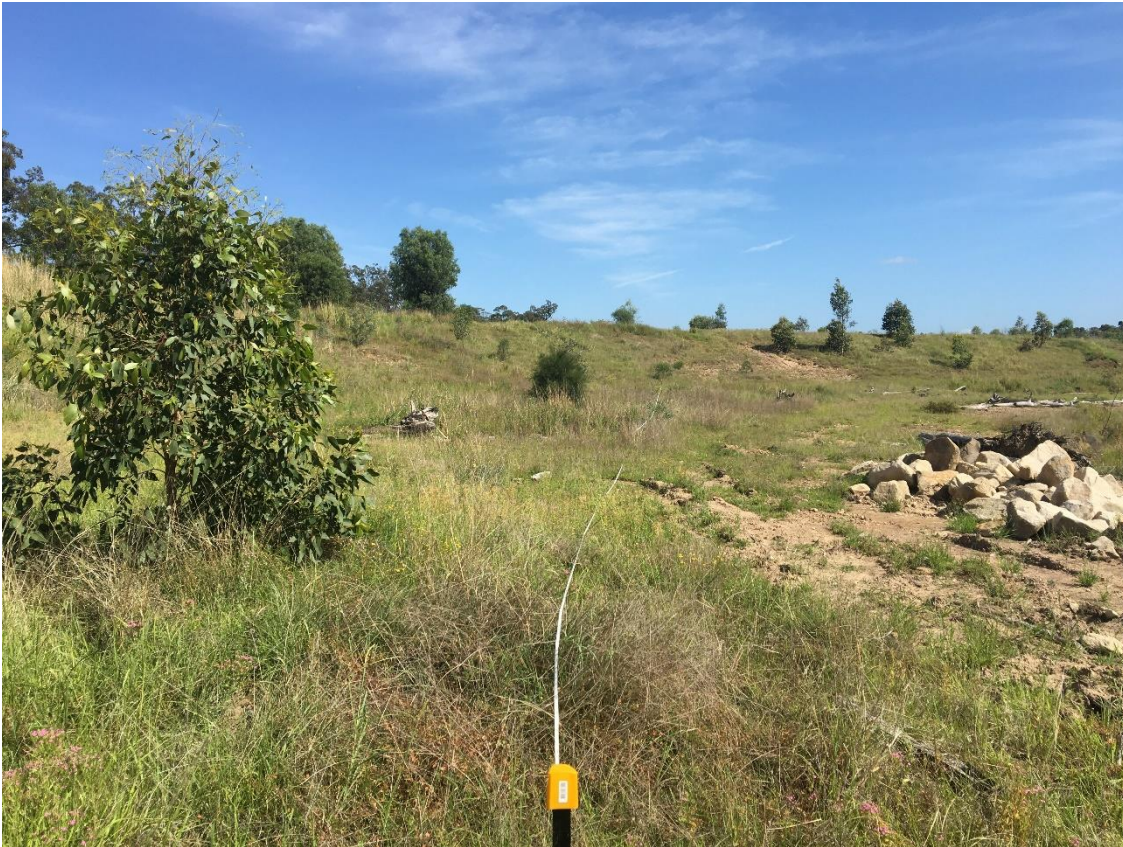
**Photograph 23: NWCD Biometric Plot 1 in 2020**

Two floristic monitoring sites were established within the NWCD area in 2020 (**Figure 2**; Photograph 23 and Photograph 24). Results of the floristic monitoring are presented in Table 17.

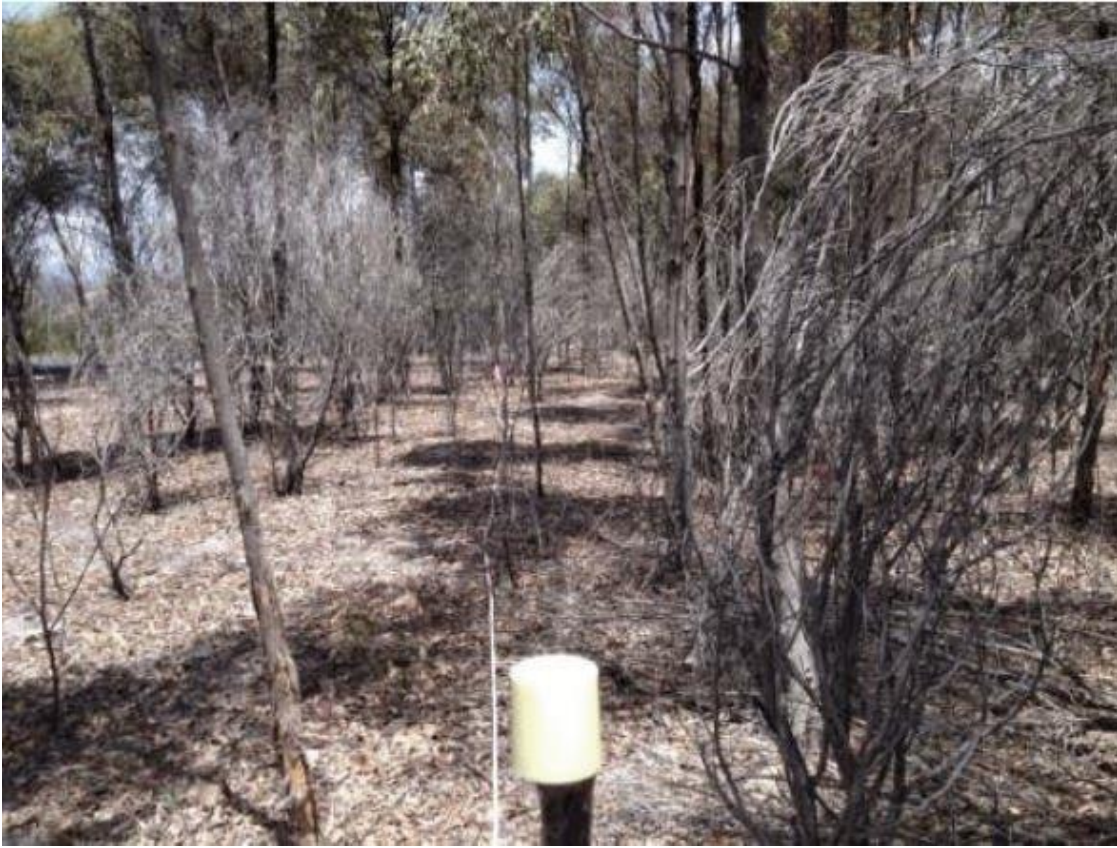
Photograph 25: Site 3R during 2014

Both photos taken at the sites and collected data, show that these sites have remained quite stable over the last six years notwithstanding the dieback of *Acacia saligna* and growth of trees (Photograph 25 and Photograph 26).

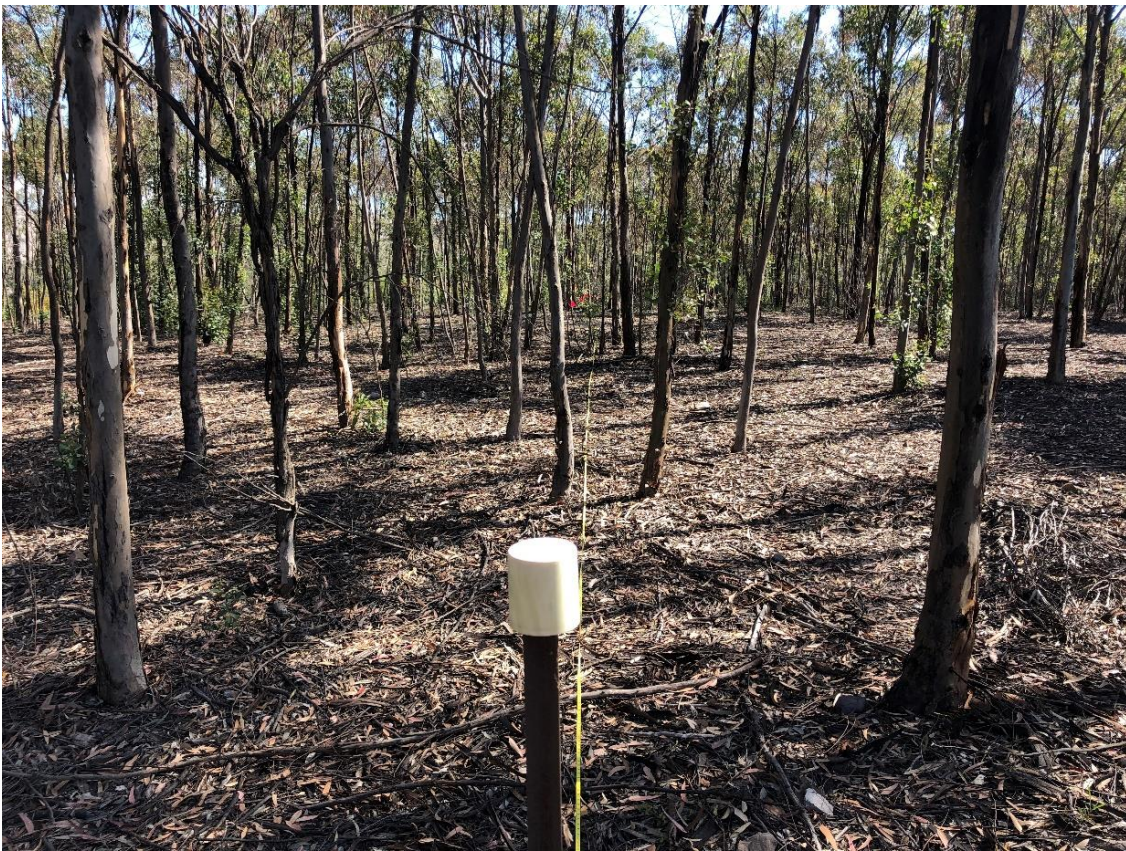
Photograph 26: Site 3R during 2020

Transect	Notes	Photograph (2020)
3R	<p>A relatively flat transect through a planting of <i>Eucalyptus cladocalyx</i>. Scattered and sparse <i>Corymbia maculata</i> are also present. Eight native groundcover species were recorded in the 20 x 20 m plot, although the cover of these species remains very sparse, such as &lt;5 individuals.</p> <p>Leaf litter is the major patch type making up 66% of the LFA transect with bare rocky soil areas covering 31%. The weed <i>Opuntia sp.</i> (Prickly pear) is scattered around the site and makes up 3%.</p>

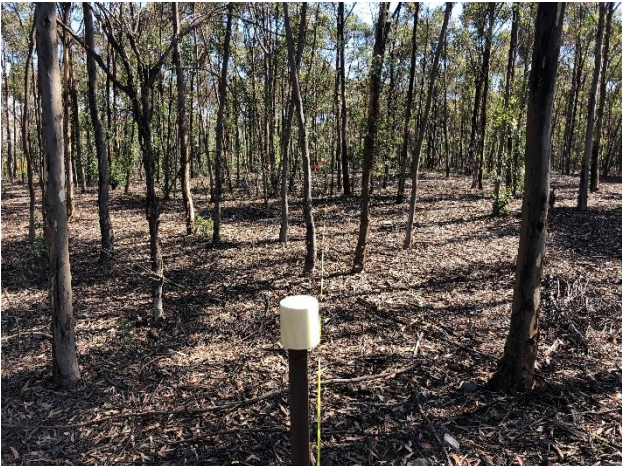
4R	<p>This transect travels along a small ridge and slopes slightly towards the end. The transect is surrounded by plantings of <i>Eucalyptus cladocalyx</i> and <i>Corymbia maculata</i>. Ground cover vegetation is very sparse to absent across the plot.</p> <p>Leaf litter is the major patch type on the LFA transect, covering 79% of the transect. Patches of bare soil make up 5%, with logs making up the remainder.</p>

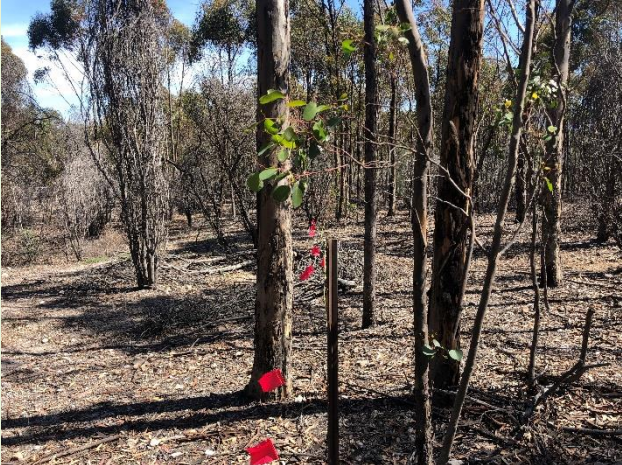
6R (new)	<p>This site is new in 2020, and is located 35m west of the previous site 6R. The site was moved as the previous site was cleared.</p> <p>This site has a canopy of <i>Eucalyptus cladocalyx</i>, <i>E. fibrosa</i> with a ground cover dominated by leaf litter (100%).</p> <p>Nine native ground cover species were recorded in the 20x20m plot and the weed <i>Galenia pubescens</i> also occurs in small patches.</p>

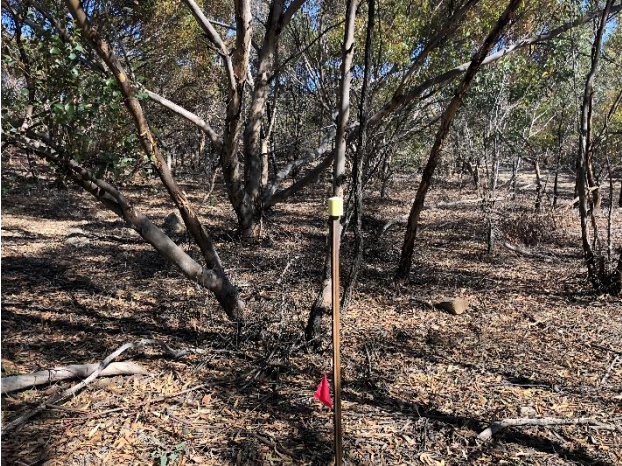
Transect	Notes	Photograph (2020)
8R	<p>This transect is located on a lightly sloping site with plantings of <i>Eucalyptus cladocalyx</i> and <i>Corymbia maculata</i>. Epicormic growth was observed in 2020.</p> <p>Fourteen native ground cover species were recorded in 2020, these are very sparse and generally present as &lt; 5 individuals within the 20x20m plot.</p> <p>Leaf litter covers 74% of the transect length, with the remainder 26% bare soil. The site has remained similar over time.</p>

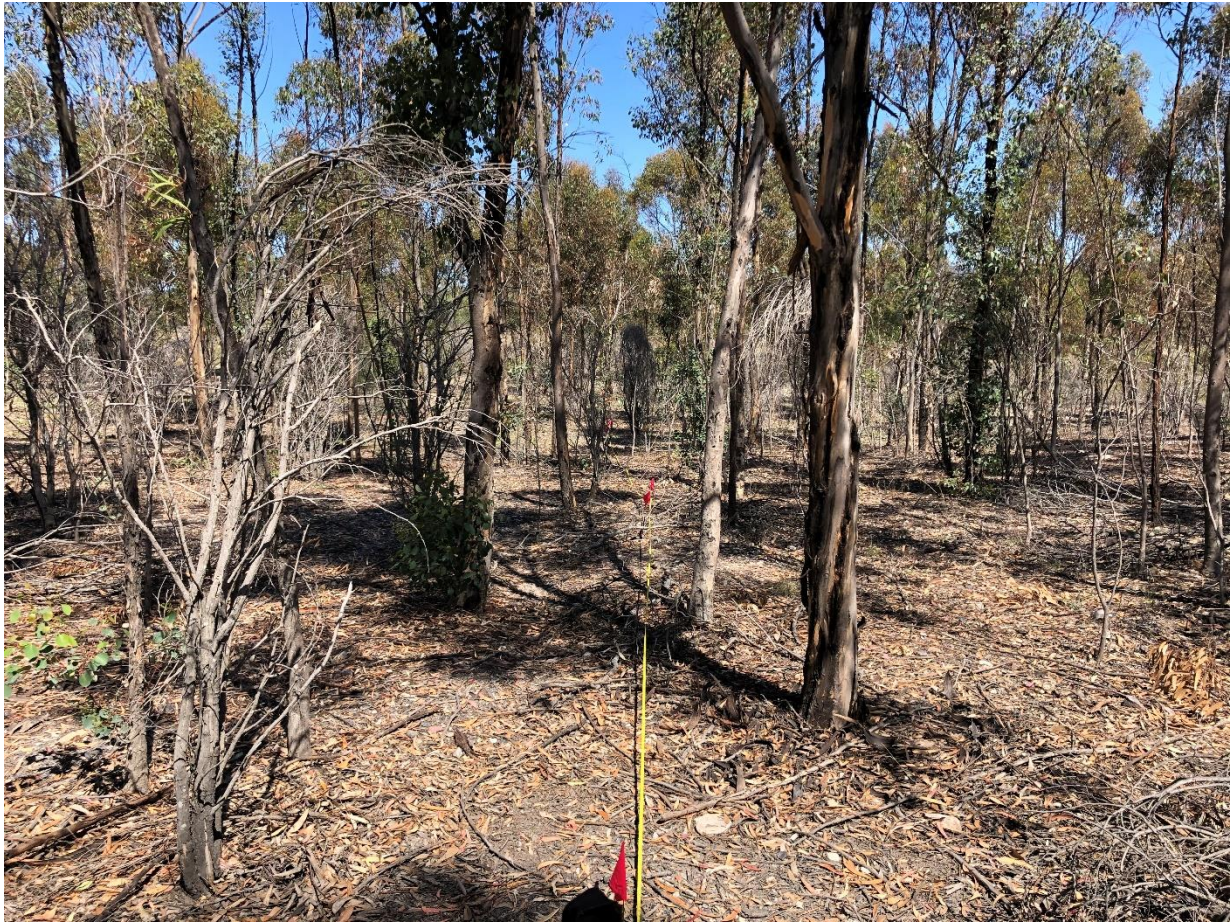
Vegetation in woodland rehabilitation areas consists primarily of *Eucalyptus cladocalyx* and occasionally *Corymbia maculata* (Photograph 27). *Acacia saligna* (Golden Wreath Wattle) was a dominant mid-storey species at site 4R and is also present at 8R, however, this species has mostly died-off within the woodland rehabilitation areas. *E. cladocalyx* is native to South Australia and *Acacia saligna* is native to the south of Western Australia, but both have been planted widely in eastern Australia.

Photograph 27: Woodland rehabilitation area dominated by *E. cladocalyx* at site 8R in 2020

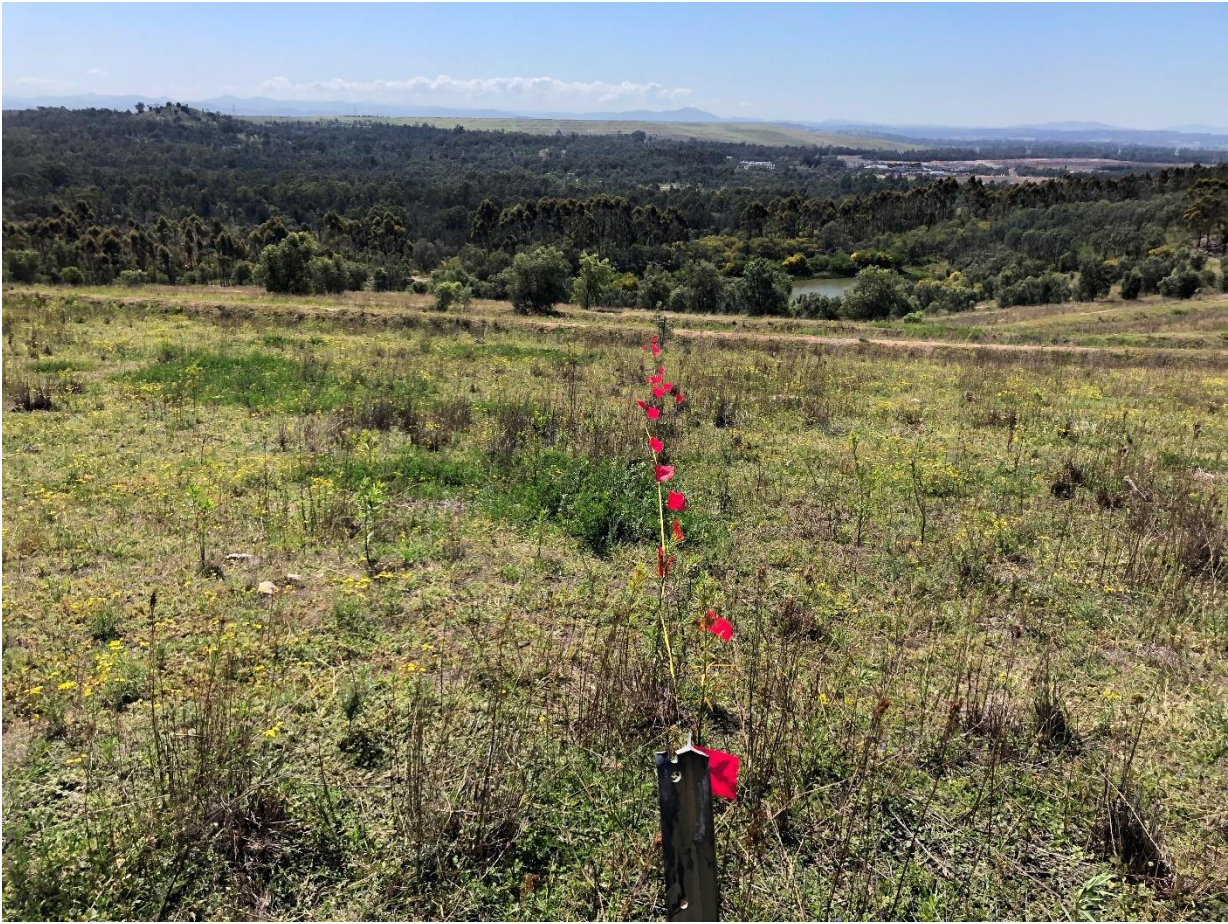
Pasture rehabilitation is currently meeting performance targets for all attributes with the exception of LOI. The LOI average score remains relatively high and close to the target, with resource accumulating patches covering an average of 87% of transect length with a target of 93% (**Table 21**). A description of each site is provided in Table 22, with a typical site shown in Photograph 28.

Photograph 28: Pasture rehabilitation area showing high grass cover at site 33R in 2020

Some large patches of bare soil which exceed the completion criteria were observed more broadly within pasture rehabilitation areas (e.g. near 33R). Actions to improve pasture rehabilitation areas could involve the slashing of large grass tussocks and subsequent mulching of bare areas to improve the soil profile and encourage establishment of vegetation in bare areas. Large areas of bare soil can be readily identified in pasture rehabilitation areas by reviewing recent, high-quality aerial imagery.

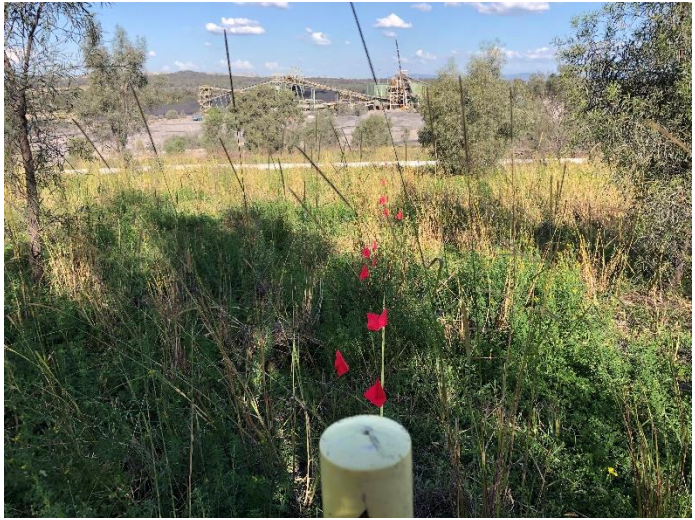
Transect	Notes	Photograph (2020)
1R	<p>Low grassy patches (74%) and tussocks of the exotic <i>Chloris gayana</i> (13%) dominate the transect and are the main stabilising features of this rehabilitation area near the coal preparation plant. These features also contribute toward infiltration and nutrient cycling.</p> <p>Bare soil has reduced to 10% in 2020, with a corresponding increase in grassy cover.</p>

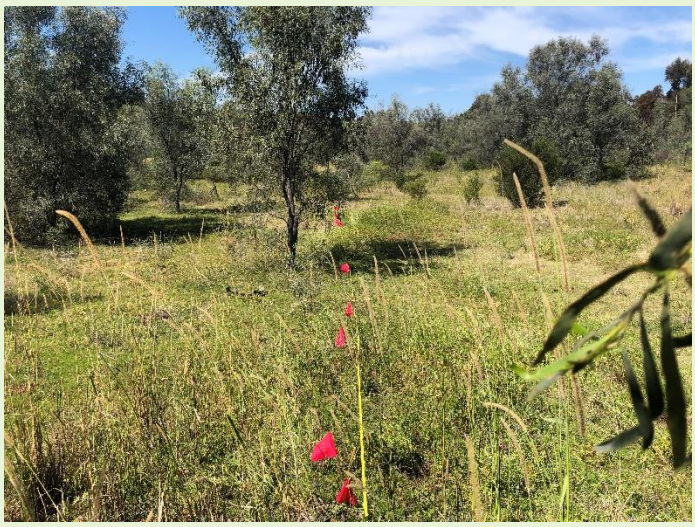
2R	<p>This transect runs down a very slight slope and was dominated by grassy patches (76%), bare soil (13%) and tussocks (10%).</p> <p>When compared to 2019 results, grass cover has increased, and bare soil has reduced. This site is meeting the target scores for stability, infiltration and nitrogen cycling, however the LOI target has not been met, although the LOI score has improved significantly since 2018 when it was 0.48, suggesting strong growth of grassy cover over bare soil in that time.</p>

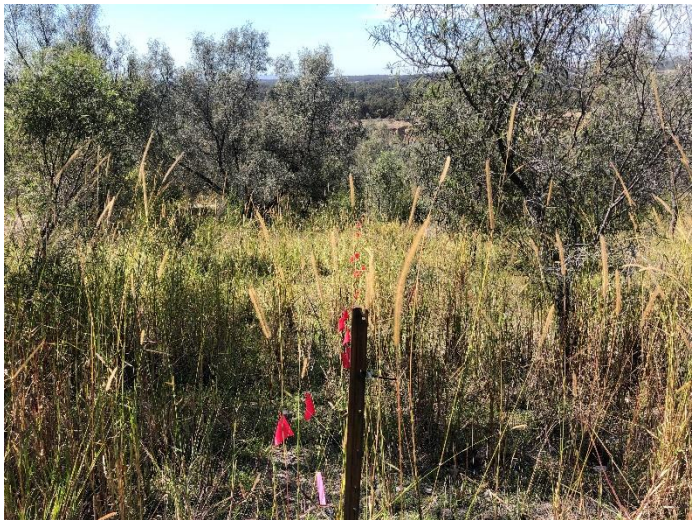
5R	<p>This site is dominated by grassy patches (48%), exotic tussock grasses (<i>Setaria</i> sp.) (19%) and bare soil (33%). Scattered large <i>A. salicina</i> are present surrounding the transect area.</p> <p>This site recorded an increase in grassy cover and bare soil, and a decrease in litter and tussock cover, resulting in an overall decrease to the LOI score from the previous year.</p> <p>This site is meeting the target scores for stability, infiltration and nitrogen cycling.</p>

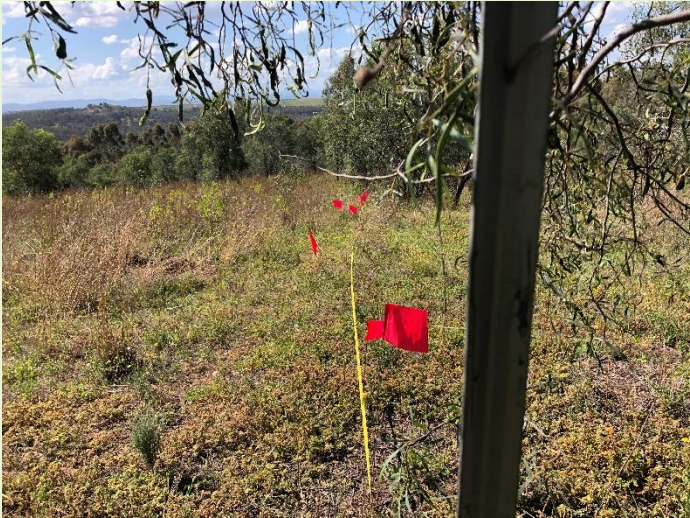
Transect	Notes	Photograph (2020)
7R	<p>Transect was dominated by short grass (43%) and the exotic <i>Galenia pubescens</i> (36%). Litter (14%), bare soil (4.5%).and exotic <i>Chloris gayana</i> tussocks (2%) contributed the remainder.</p> <p>Increases in Galenia and grass correspond to reductions in litter, suggesting ground cover vegetation has responded well to recent rainfall in areas with litter cover. The locally native <i>Acacia salicina</i> continues to colonise the rehabilitation in this area.</p> <p>This site is meeting all performance criteria including the LOI target, however the high cover of Galenia should be monitored.</p>

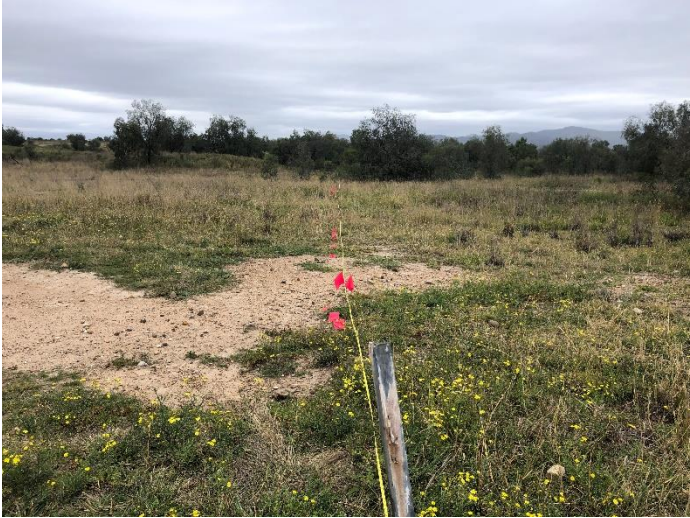
9R	<p>A large rocky soil scald dominates the start of this transect, however grassy patches and litter result scores for all indices except LOI above the performance criteria. Grassy patches (60%) and litter (18%) dominate the transect, the soil scald and other bare patches cover 18% of the transect. An increase in litter corresponds to a reduction in tussocks as many tussocks were dead.</p> <p>The LOI score continues to fall short of the did not meet the performance criteria target, indicating grassy cover is not expanding over bare soil.</p>

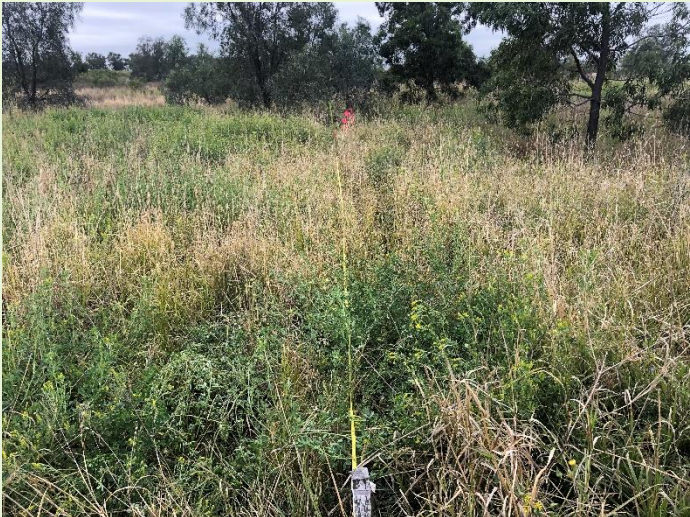
10R	<p>Dense tussocks of <i>Chloris gayana</i> (45%), leaf litter fallen from the dense tussocks and dry dead exotic perennial vegetation (29 %) and grassy patches (24%) made up the majority of this transect. Bare soil patches were minimal making up just 2% of the transect length. These results are similar to the previous year.</p> <p>This scores for this site meet all performance criteria. This site has the highest LOI score recorded in the 2019 surveys, indicating this transect has the least bare soil.</p>

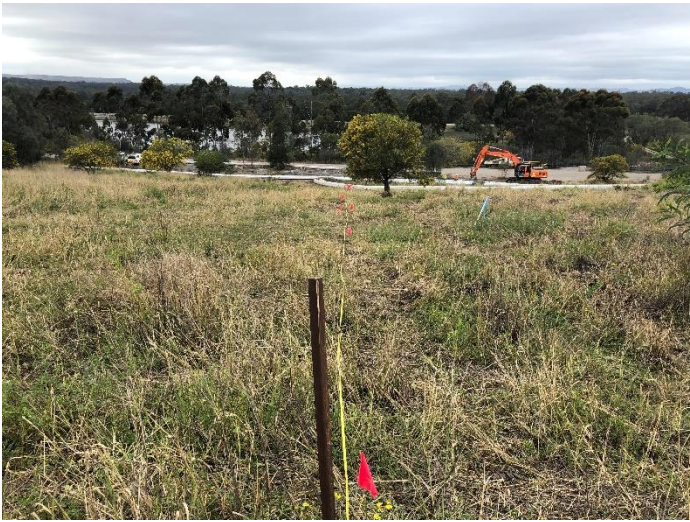
Transect	Notes	Photograph (2020)
16R	<p>Transect primarily composed of grassy patches (40%) and tussocks of <i>Chloris gayana</i> (30%) with litter (6%) and bare soil (23%).</p> <p>This site is exceeding all performance criteria except the LOI target. A increase in bare soil associated with excavator tracks from pipe installation for the Wambo United mine has contributed to the lower LOI score.</p>

Site 16R had an increased proportion of bare soil along the transect due to disturbance from an excavator constructing a pipeline for the adjacent Wambo United Mine project. Tussocks of *Chloris gayana* were previously more dominant at some sites, for example 33R and 34R, and have gradually died off and been replaced by low grass cover. Tussock grasses generally contribute strongly to overall scores, although they now contribute to litter and are likely to improve nutrients loads in the soil. Die off of tussock grasses may be temporary and a result of drought conditions in previous years.

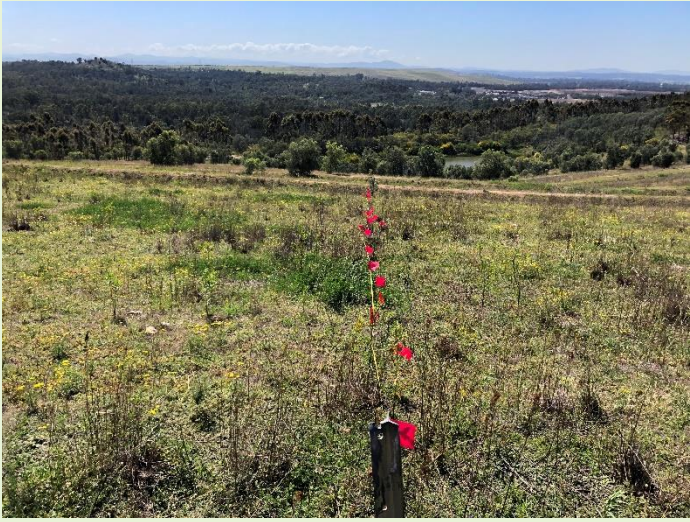
33R	<p>Transect primarily composed of low grass (62%), litter (18%), <i>Galenia</i> (13%) and tussocks (5%). Bare soil patches made up less than 2% of the transect.</p> <p>The progression of this site over the past three years has seen tussocks from 2018 break down into litter in 2019 and an increase in low grass in 2020.</p> <p>This site is meeting all performance criteria including the LOI target.</p>

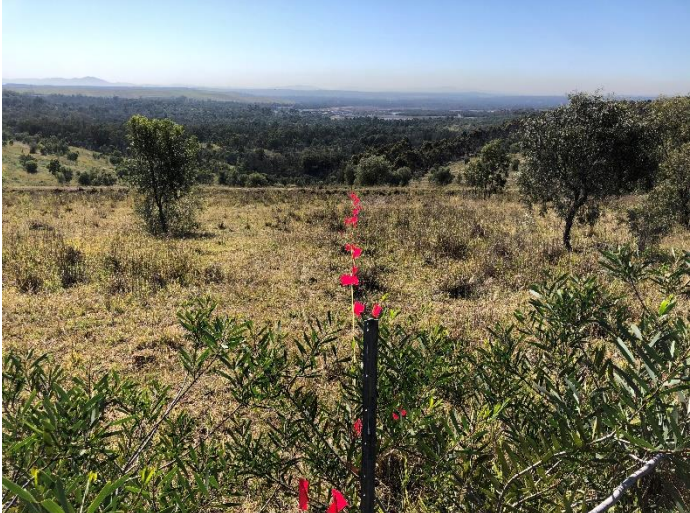
34R	<p>Transect is composed of low spreading grassy patches (69%), dense tussocks of <i>C. gayana</i> (27%) with fallen dead grass (leaf litter - 23%) and bare soil patches (12%).</p> <p>Grassy patches were the primary contributor to the site stability, nutrient and infiltration scores which exceed the targets. The LOI score has not been met for this transect due to the amount of bare soil (interpatch).</p>

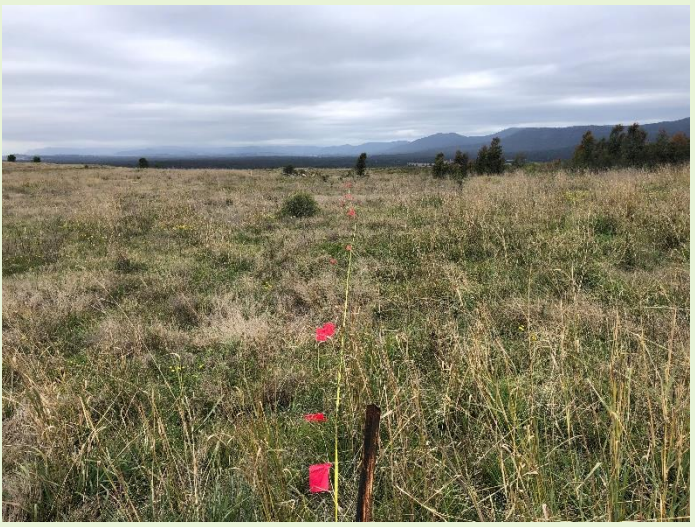
Transect	Notes	Photograph (2020)
35R	<p>Low grass (83.5%) dominated this newer area of rehabilitation, tussocks cover 7.5% with bare soil (9%) making up most the remaining transect.</p> <p>The LOI score has not been met for this transect due to the amount of bare soil (interpatch). Performance targets are met for the other indices.</p>

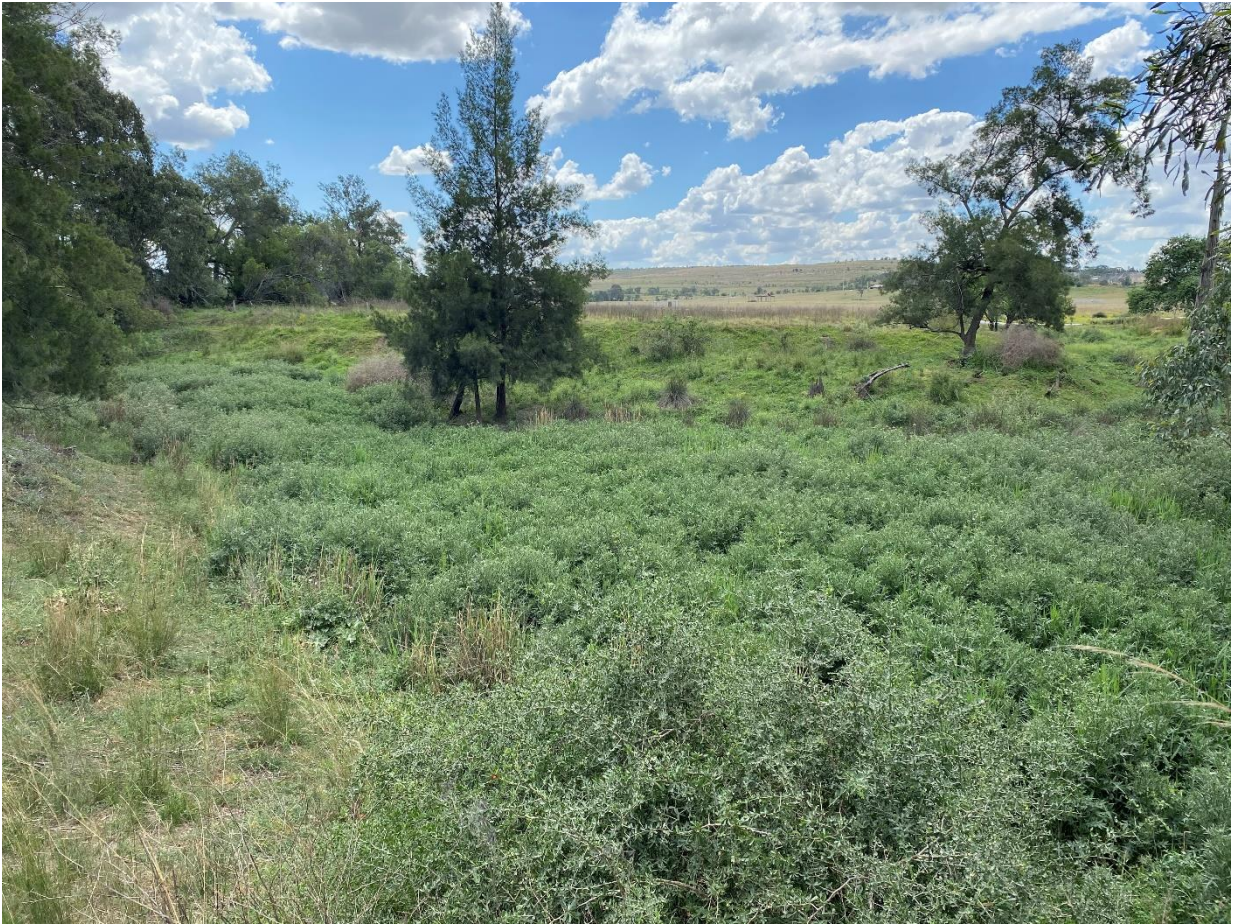
Evidence of significant recent stream flow was observed within the channel, with debris lodged in trees and shrubs along the banks. High cover of exotic annual ground cover weeds was observed in some areas (Photograph 29), with their growth a response to the higher rainfall in 2020.

**Photograph 29 :North Wambo Creek at transect 8A showing the creek channel dominated by annual thistles**

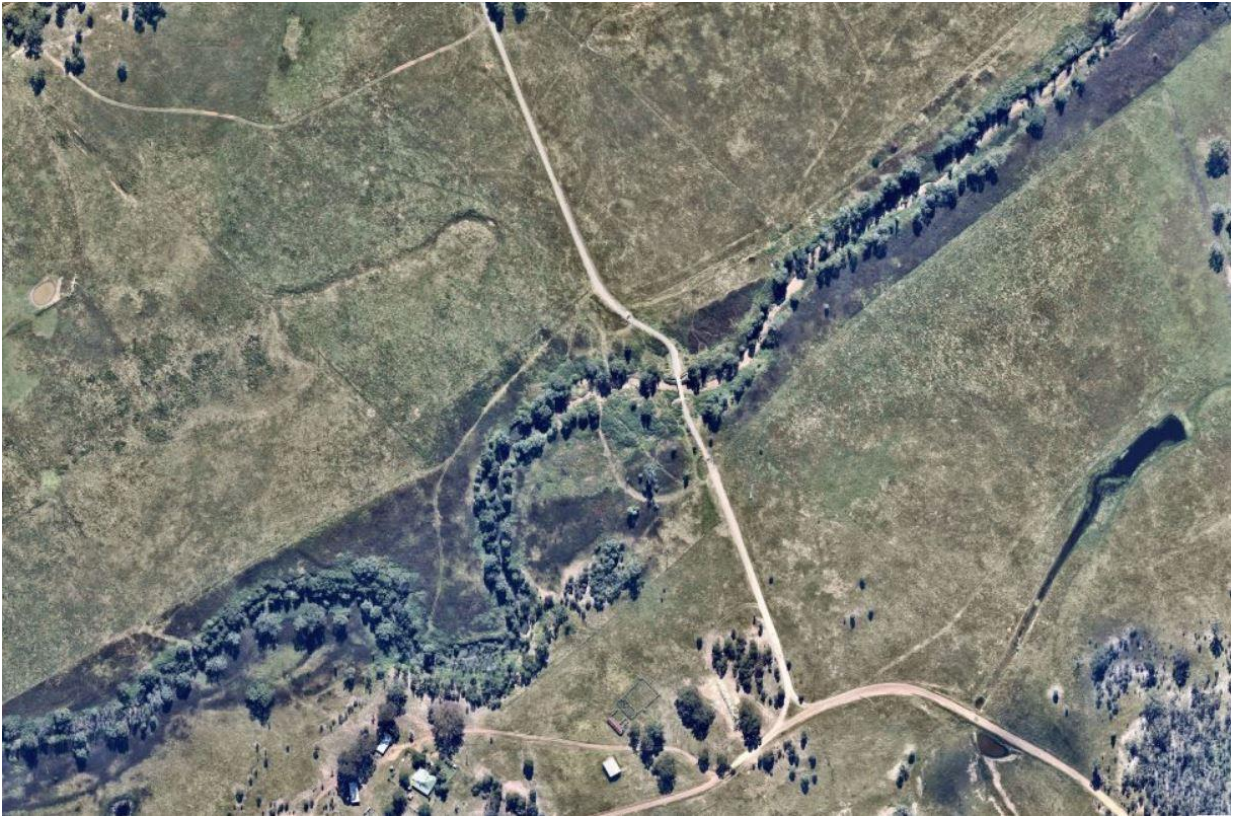
No evidence of recent cattle grazing was recorded in this area. Grazing pressure reduces the ground cover and destabilises the soils leaving these areas more prone to erosion. In previous years cattle grazing had impacted riparian condition scores along South Wambo Creek.

Photograph 30: Aerial image of South Wambo Creek from May 2020 (NearMap) showing riparian cover and cattle exclusion fencing

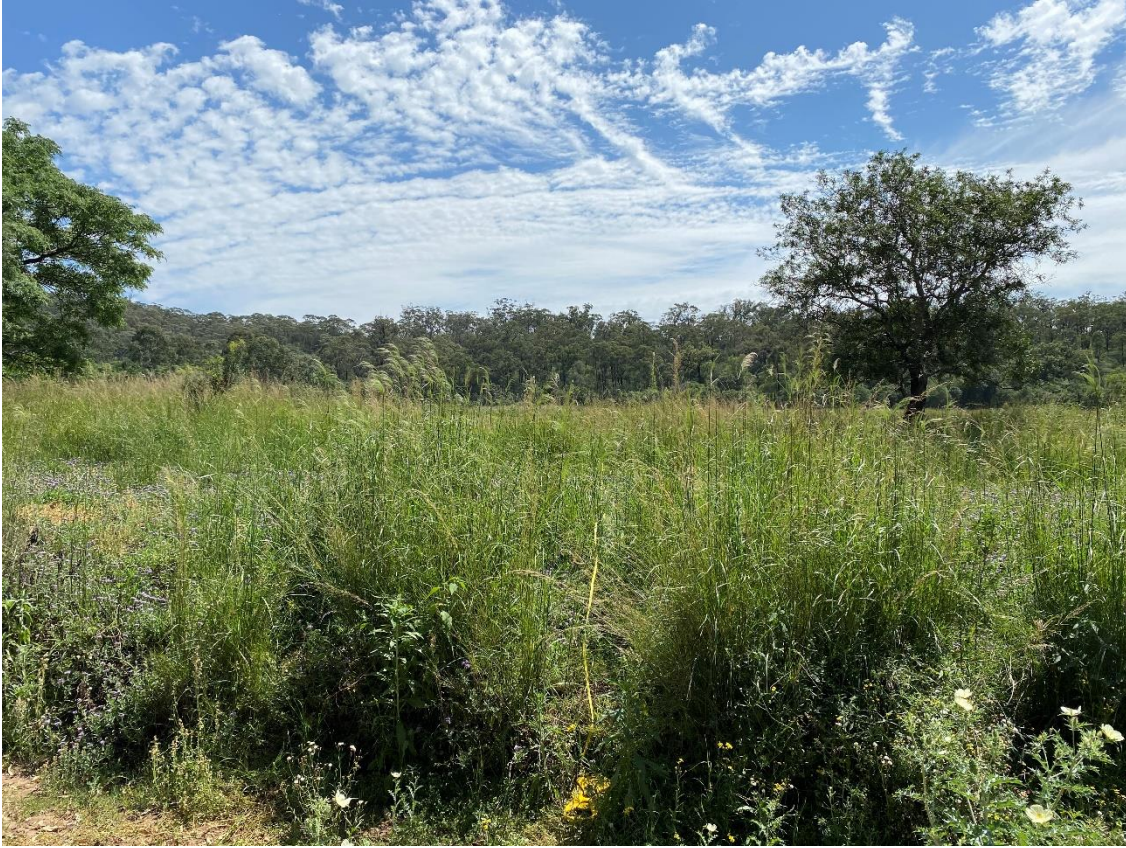
Overall increases in scores at all creeks were observed, particularly due to an increase in ground cover following drought in the previous two years. The change in ground cover from 2019 to 2020 can be seen in Photograph 32 and Photograph 33.

**Photograph 32: Transect 14 at stony Creek 2 in 2020 showing high ground cover following high recent rainfall**

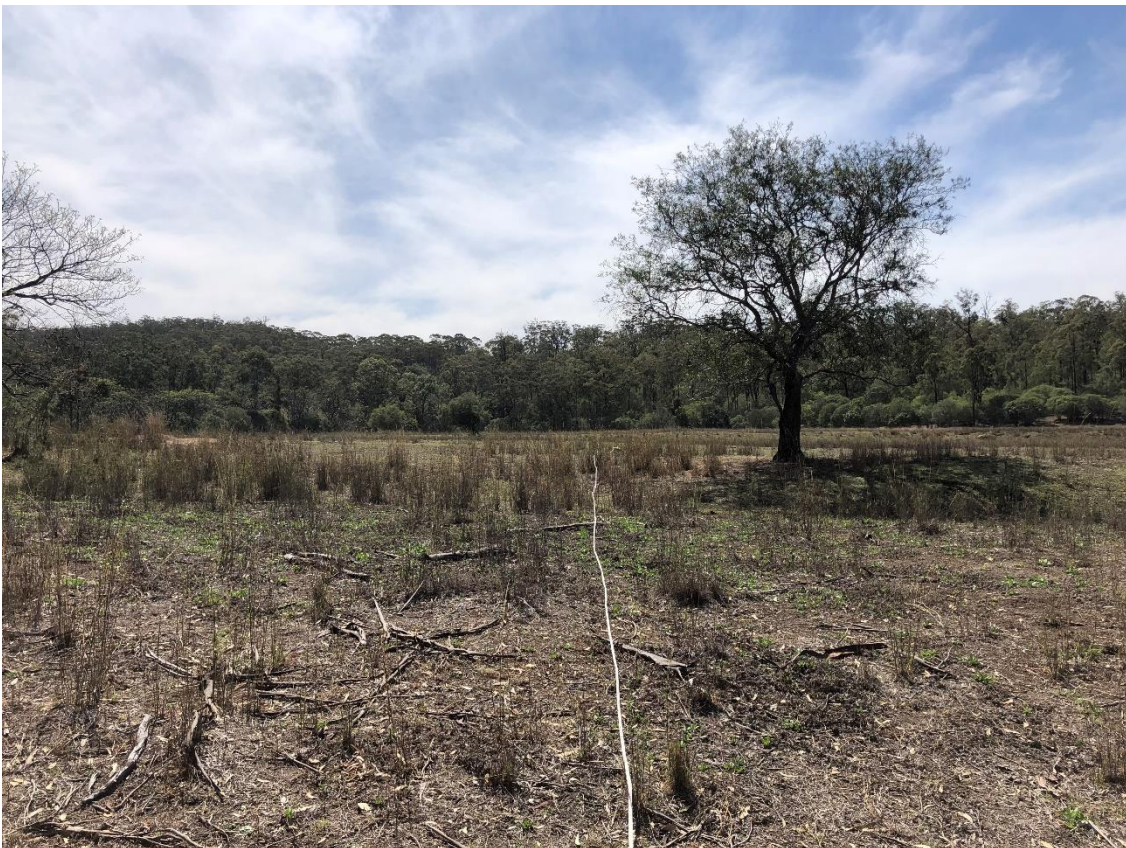
**Photograph 33: Transect 14 at stony Creek 2 in 2019 showing drought impacted ground cover**

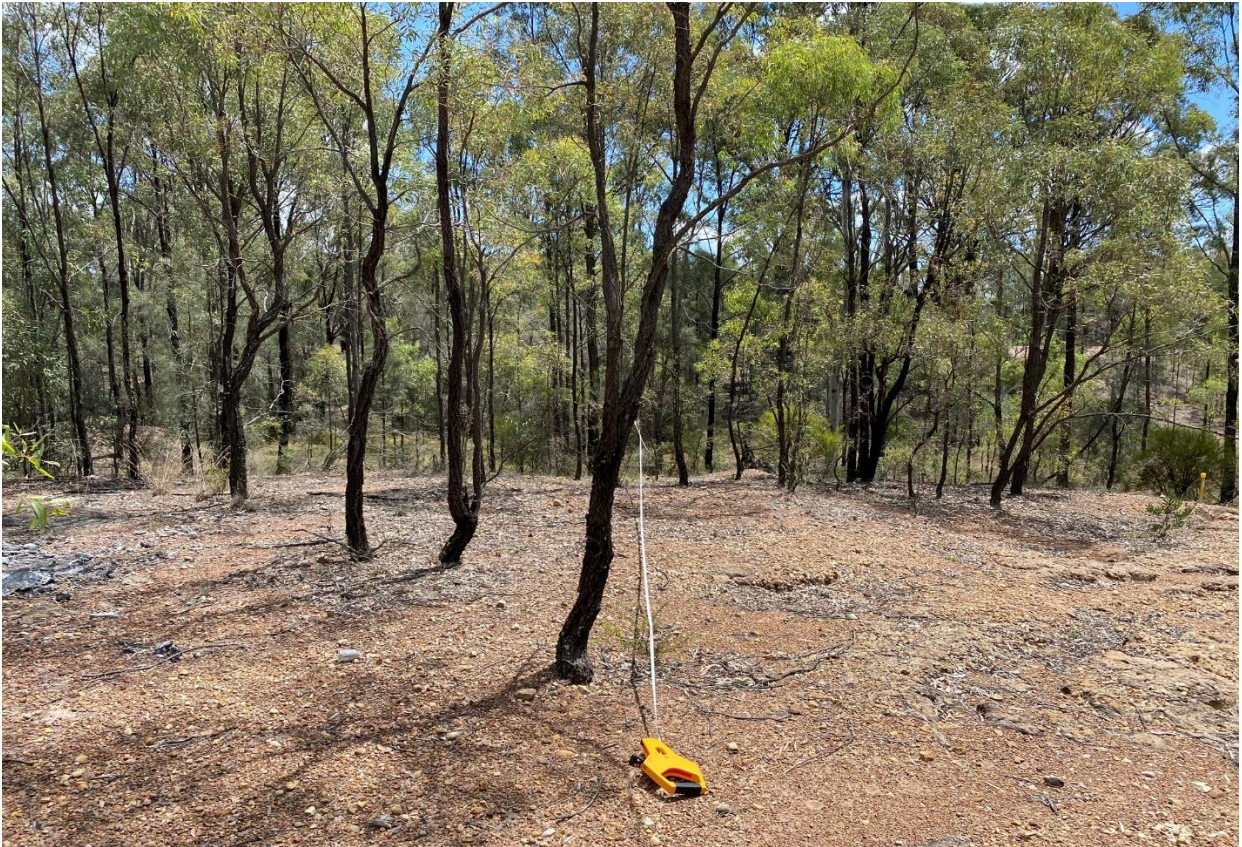
Of the four sites within the Slaty Box - Grey Gum shrubby woodland, two (V10-A1 and V10-A2) have been undermined and two (SBX1-SG-I and SBX3-SG-C) are acting as current reference sites. NOS was slightly below target at both impact sites and grass cover was high at V10-A1. NOS has fluctuated over time with most sites across the monitoring program scoring higher in 2020 than the previous year. Site V10-A2 scored lower for canopy cover, however review of plot photographs (Photograph 34) shows canopy in good condition, with all trees healthy and no observable impacts to the canopy from undermining. The two current reference sites within this community met the performance criteria for most attributes. At one site, SBX1-SG-I, NMS and NGCG were slightly below target although this is considered likely to representing natural variation within the community.

**Photograph 34: Site V10-A2 in 2020 with canopy in good condition**
