# **WAMBO COAL PTY LTD 2020 ANNUAL REVIEW**

1 January – 31 December 2020

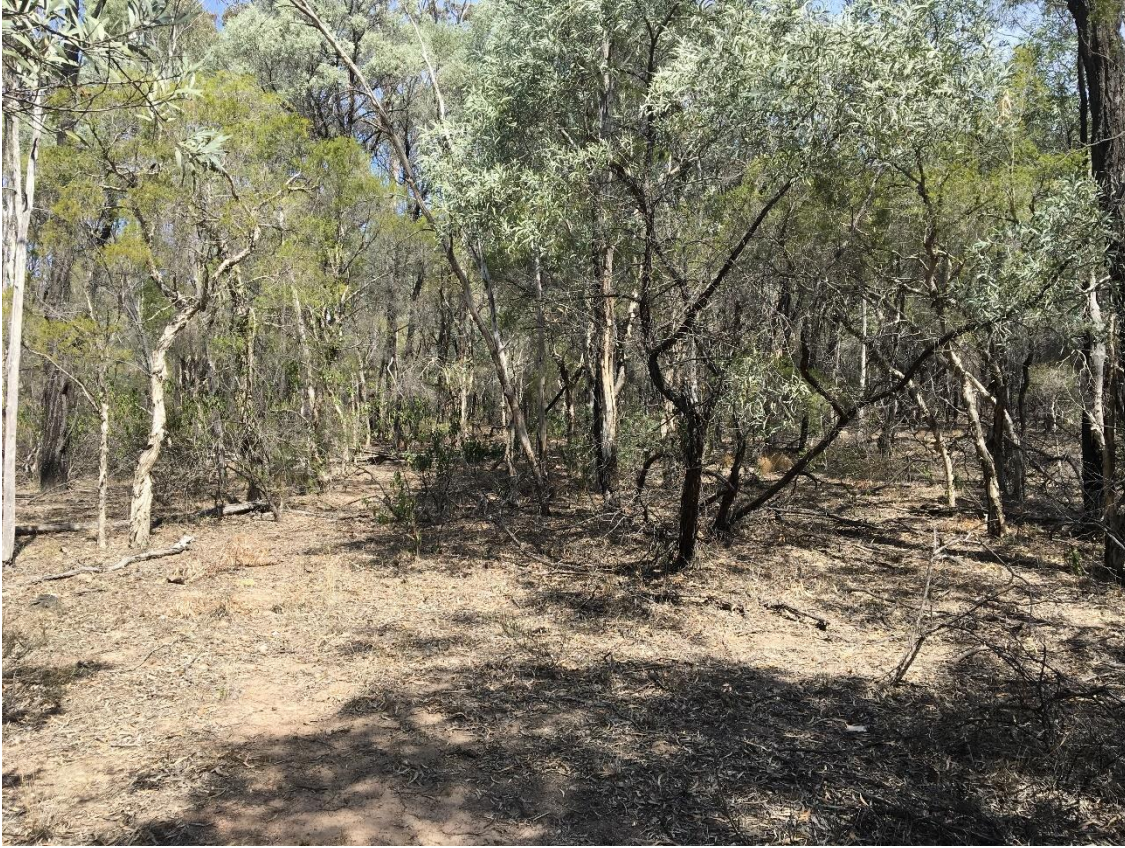
**Photograph 35: GDE Photo monitoring point M2 (facing south) in *Melaleuca decora* low forest in 2019**

Review of images from photo monitoring points show GDE vegetation in good condition in 2020. A noticeable increase in ground cover vegetation is visible in both *Melaleuca decora* low forest and River Oak riparian tall woodland GDE communities (Photograph 35 to Photograph 38).

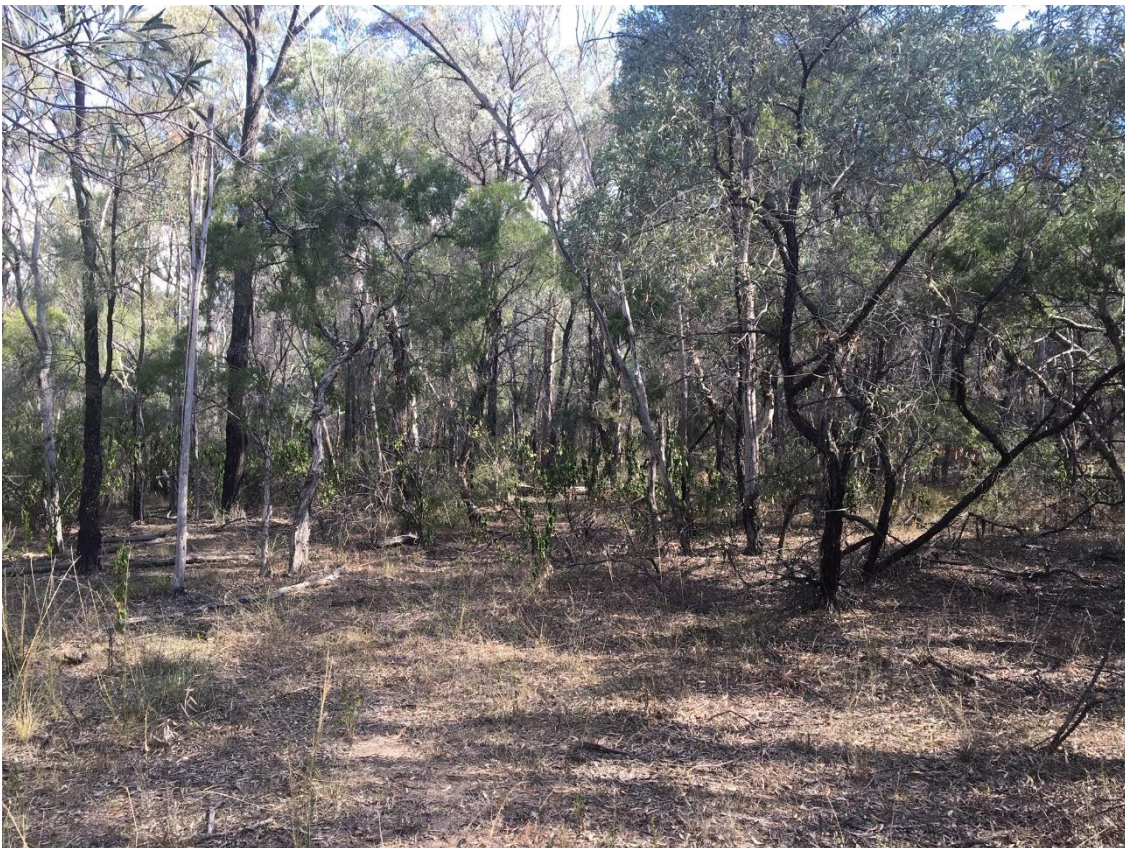
**Photograph 36: GDE Photo monitoring point M2 (facing south) in *Melaleuca decora* low forest in 2020**

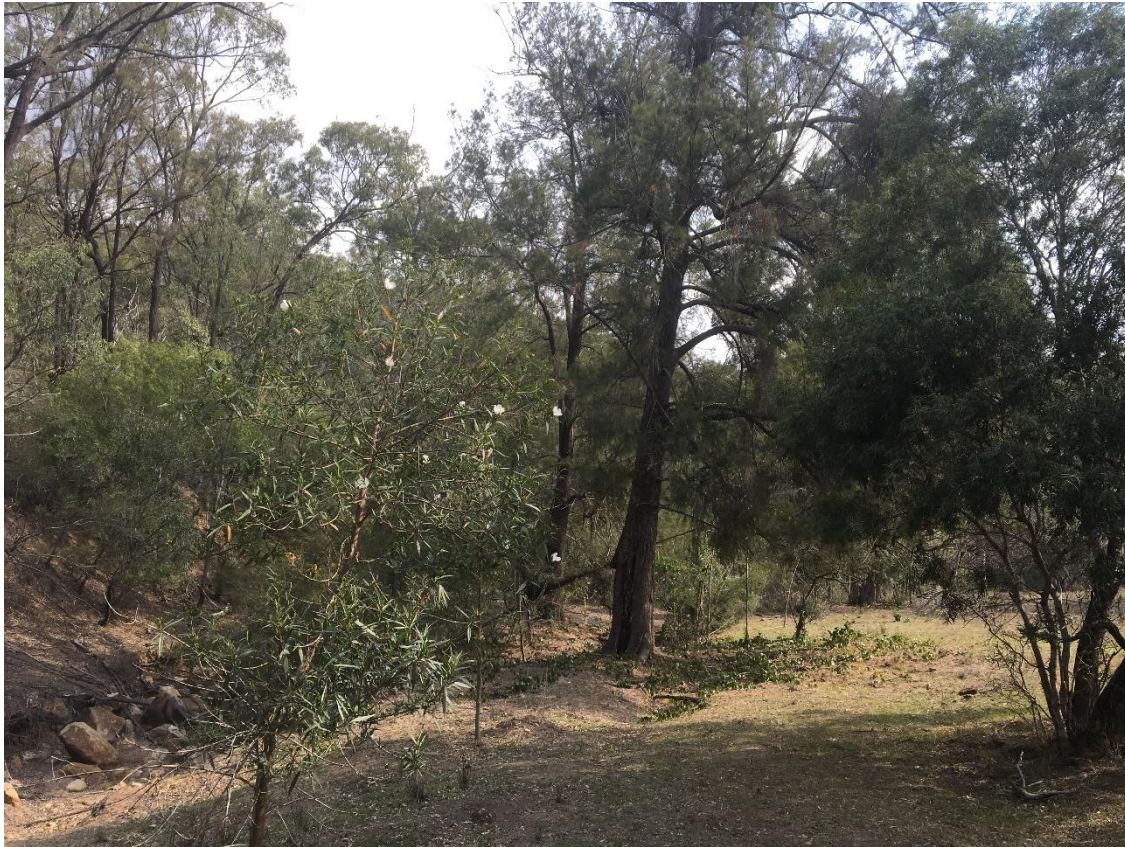
**Photograph 37: GDE Photo monitoring point M7 (facing south) in River Oak riparian tall woodland in 2019**

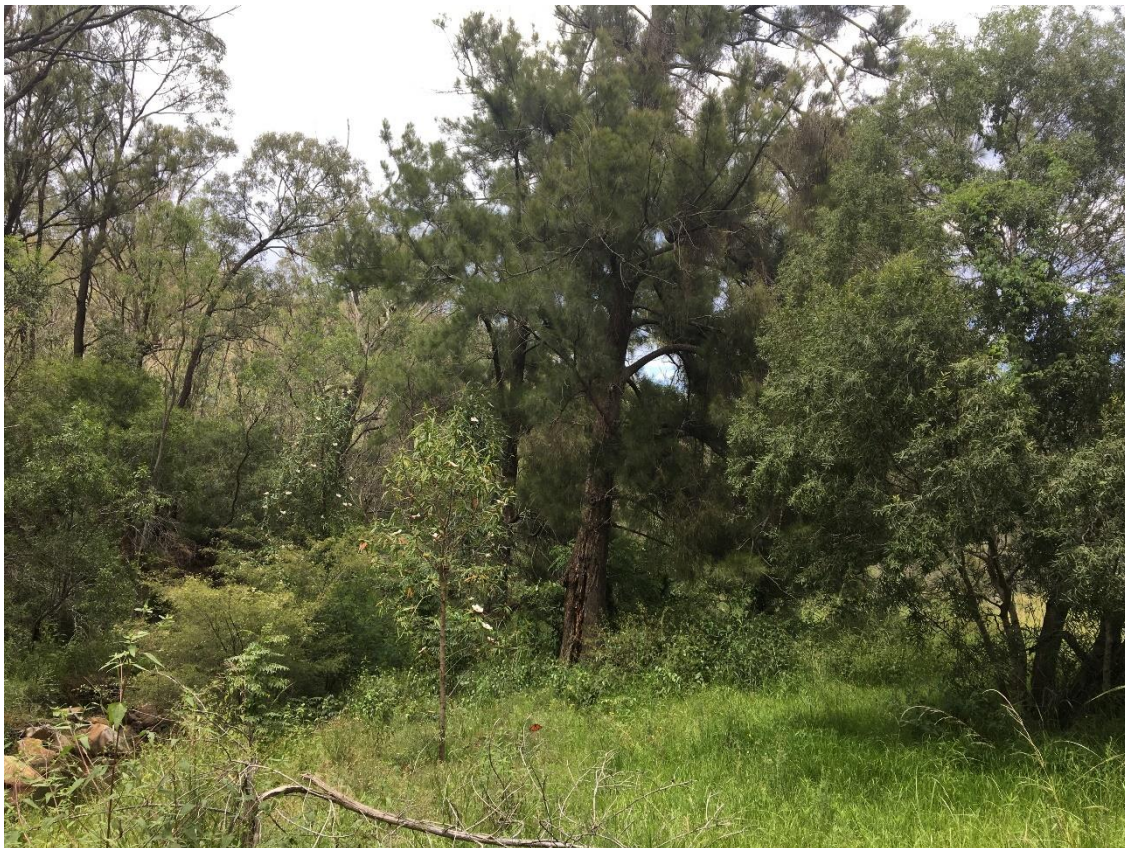
**Photograph 38: GDE Photo monitoring point M7 (facing south) in River Oak riparian tall woodland in 2020**

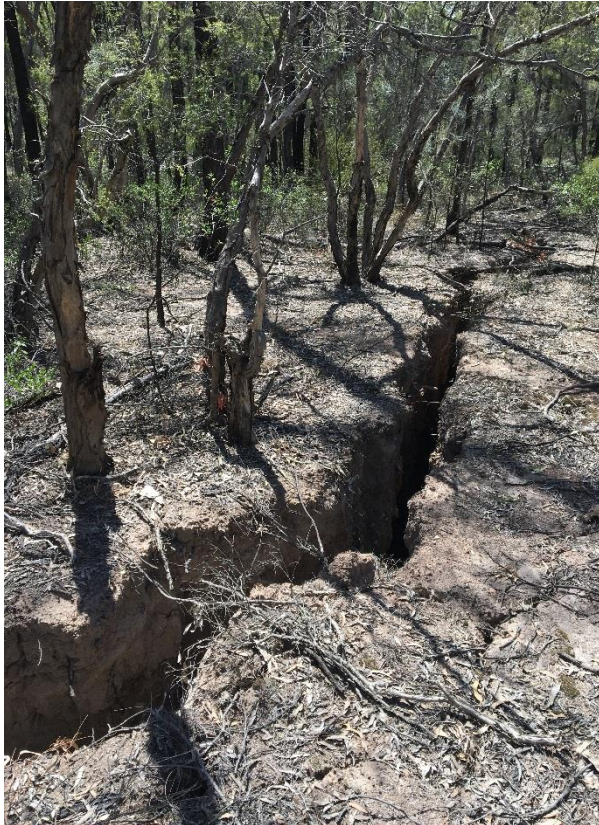
Subsidence cracking is present at four of the eight monitoring plots within this PCT. However, no significant vegetation damage has been observed. Very large cracks are present at site V11-B1 in RWEA C and this plot may not be safe to survey in the future. ELA recommends WCPL inspect this area and investigate remediation of large subsidence cracks. Potential for works to damage surrounding vegetation should also be taken into account when considering remediation.

**Photograph 39: Large subsidence cracks near flora monitoring site V11-B1 (in 2019)**

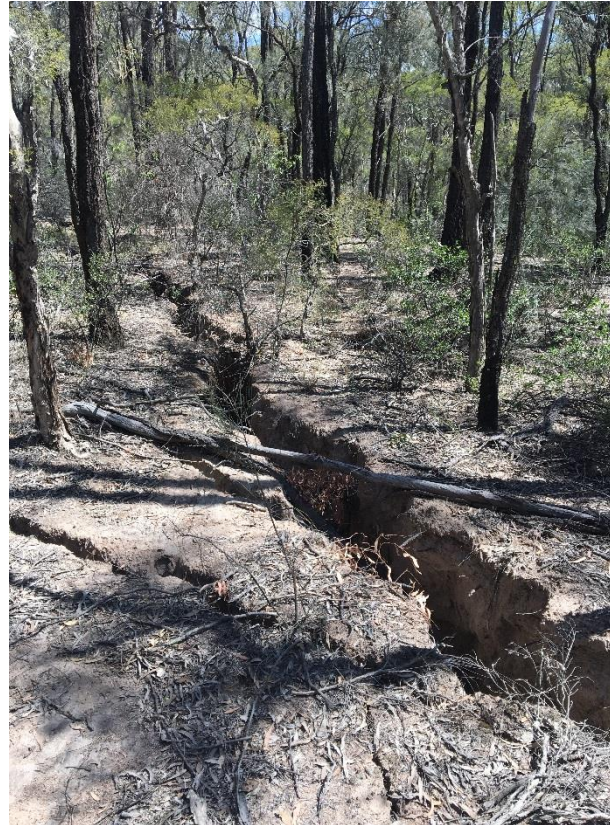
**Photograph 40: Large subsidence cracks near flora monitoring site V11-B1 (in 2019)**

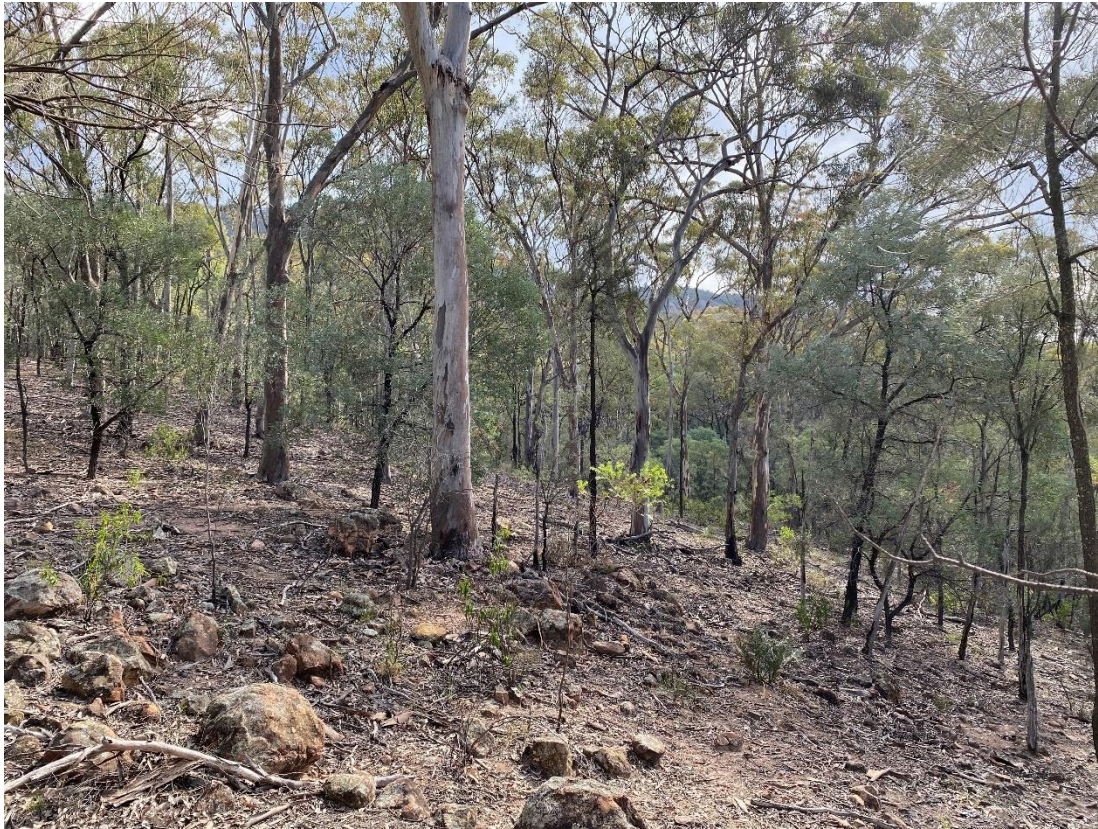
A low intensity fire was reported in RWEA D in 2019 near bird monitoring site BP25. The fire had burnt the understorey and parts of the mid-storey, with limited impact to the canopy. In 2020, this area was observed to be in good condition (Photograph 41).

Photograph 41: Recent low intensity fire has burnt within RWEA D near BP 25.

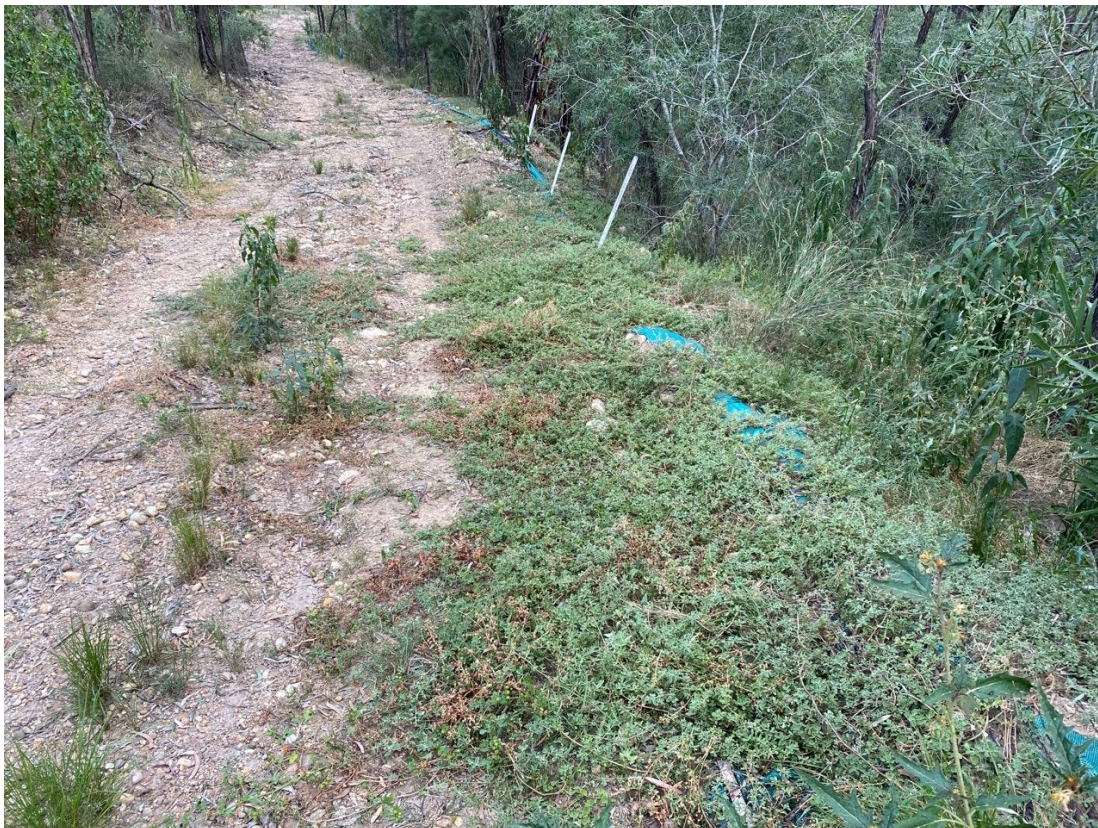
A new infestation of the weed *Galenia pubescens* was observed within high condition native vegetation in RWEA C. The weed appears to have been transported into the area during road maintenance works undertaken a few years ago (Photograph 42). This infestation should be treated as a high priority while it is localised, before it spreads. Further weed observations will be undertaken as part of the Annual Weed Treatment Plan update in early 2021.

Photograph 42: Infestation of *Galenia pubescens* in RWEA C, likely transported into area during road works

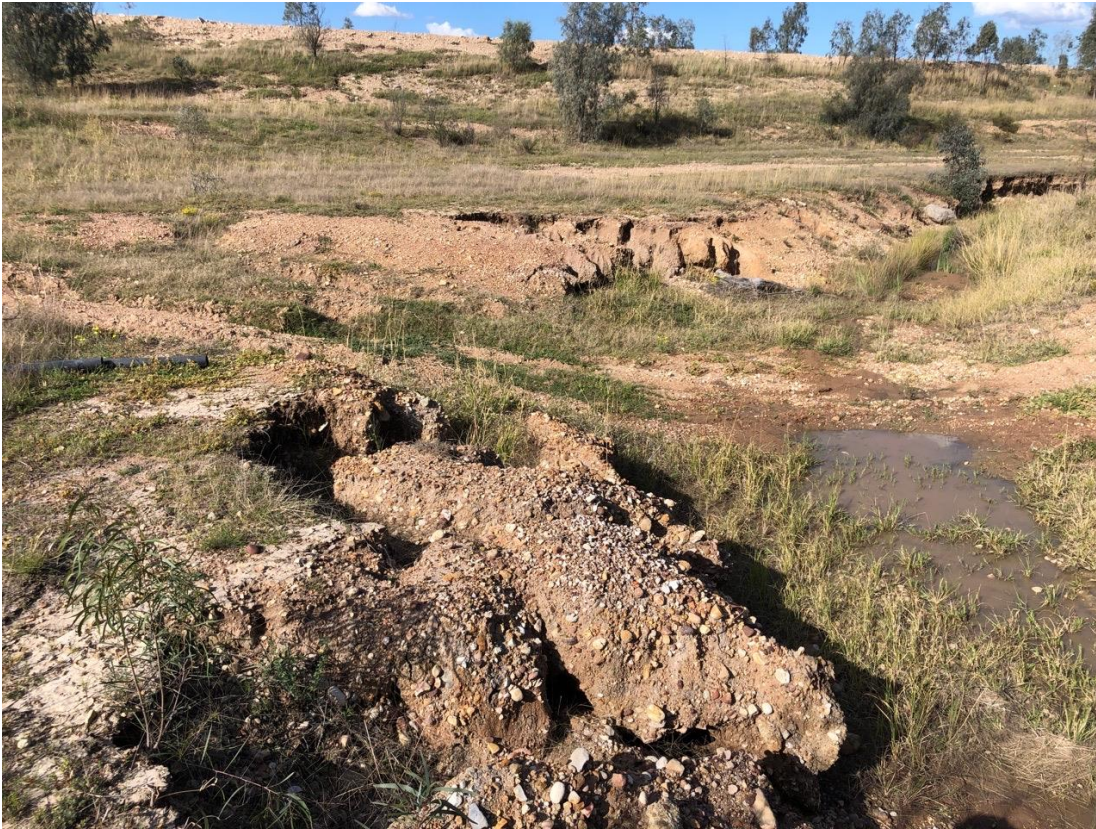
**Photograph 43: Erosion issues along the North Wambo Creek Diversion near site 23R**

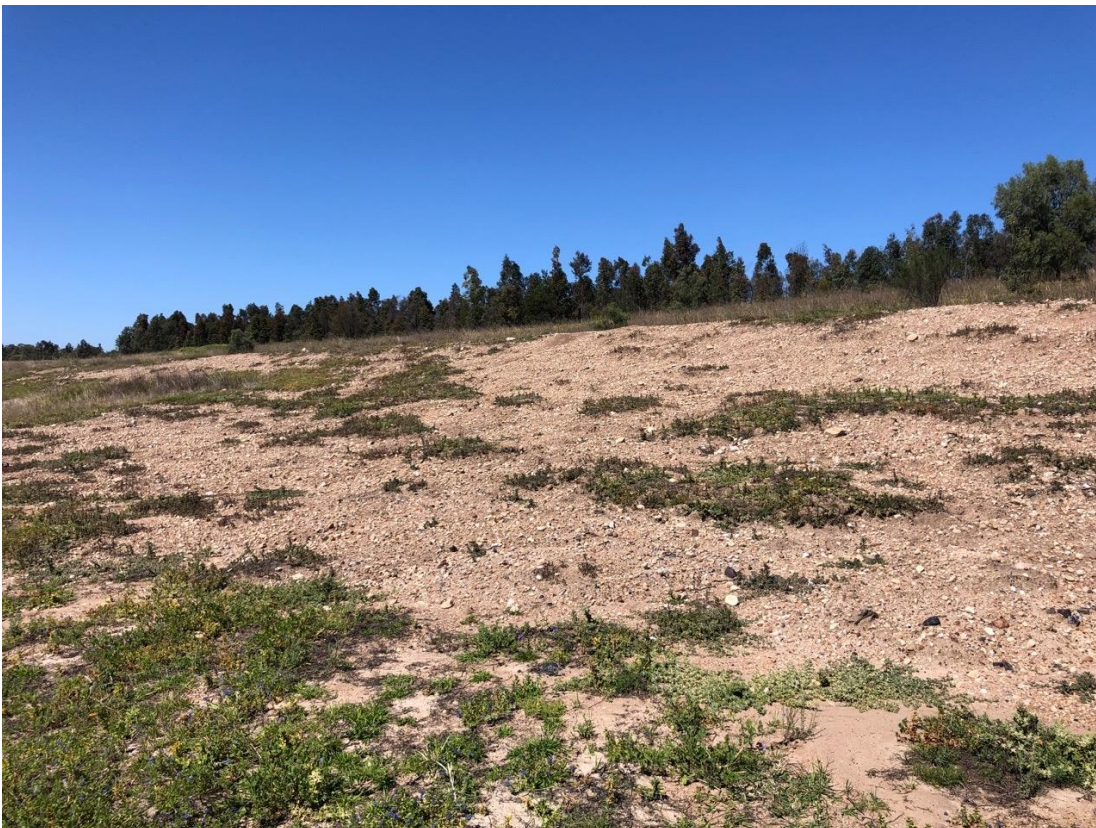
**Photograph 44: Large area of erosion/bare soil at failed pasture rehabilitation near site 33R (exceeding completion criteria)**
