**APPENDIX 4**  
**LAND MANAGEMENT**

**Project:** Peabody Wilpinjong West 5 rehabilitation trial  
**Project Manager:** Phil Milling

**Date:** 5.12.2022  
**Report by:** Pauline Sykes

**Notes:** Monitoring report – 29<sup>th</sup> November 2022

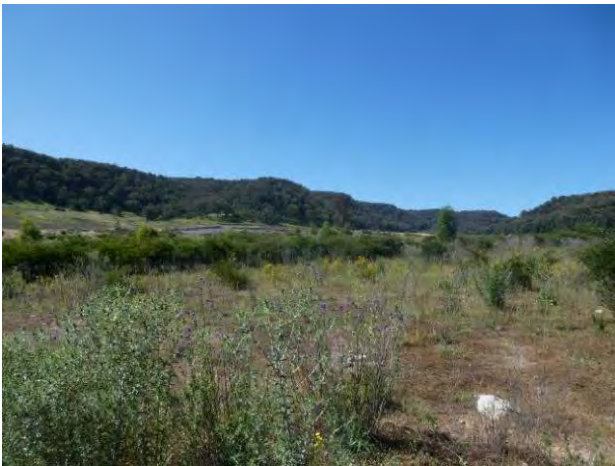
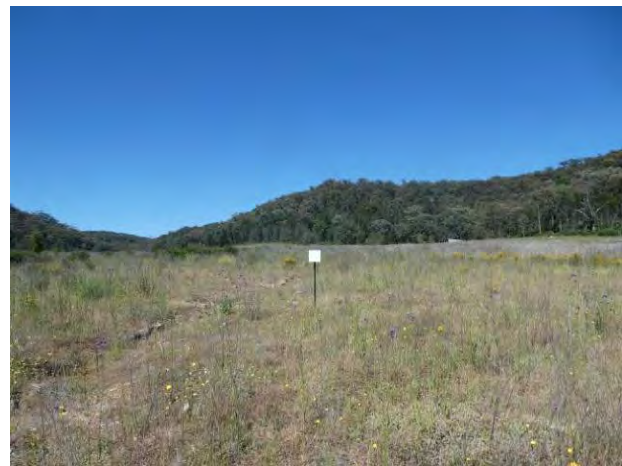
Minimal native species are noted in the monitoring area, the exception being grass species in minimal numbers. Native volunteer species are evident in the monitoring area. Outside of the monitoring areas, volunteer Acacia species are growing well and aiding in stabilising erosion points. Desired native species are growing in other areas within this plot, in some cases well established to over 1m in height, especially evident near the farm storage shed at the top of this plot.

Plot 1 has an erosion channel running through the monitoring transect. This seems to be stabilising itself through vegetative growth, largely Couch grass (*Cynodon dactylon*). Sharp sides and edges have rounded. Silt buildup was noted at points, illustrating the stabilising and self-repair of these erosion channels. Fauna utilising the site was evident through the recording of tracks and scat, as well as noting interactions with sighting posts being rubbed and unstable, and marker posts knocked out of the ground. Trampling and grazing was noted.

Exotic species are evident, with cover crop species of oats (*Avena sativa*) and clover species seen across the site. None of these are growing strongly or lushly. Annual weed species are evident, as are perennial species such as Purple Top (*Verbena bonariensis*) and more problematic species such as St John's Wort (*Hypericum perforatum*) and Blue Heliotrope (*Heliotropium amplexicaule*) are increasing in population. The last two are of concern and a management strategy should be put in place.

Photos above show Plot 1. Left, volunteer Acacia species can be seen as the darker green line of shrubs. These aid in helping to bind an erosion channel as well as providing desirable species diversity and coverage. Right, a healing erosion channel due to increasing ground cover from grass species can be seen to the left of the sighting post.

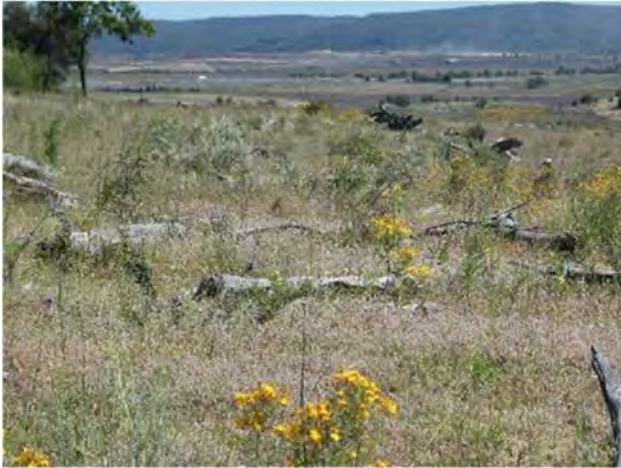
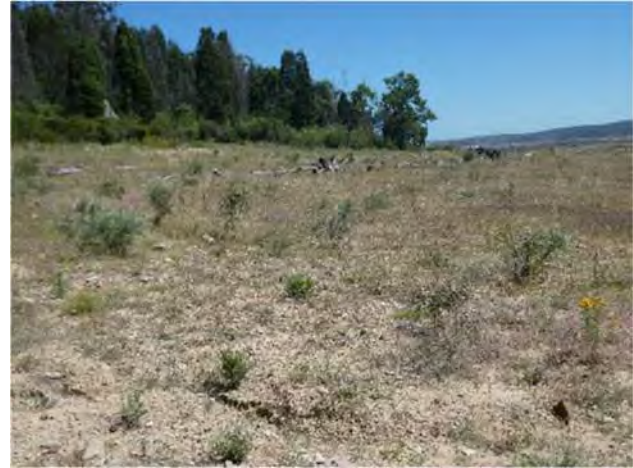
Native species seeded are increasingly evident across Plot 2. Several grass species and multiple shrubs are noted in the monitoring transect. Outside the monitoring area, increasing numbers of Eucalypts and other tree species are increasing, although are subject to continual herbivory. It was noted that a recent germination of new seedlings had occurred. This shows that coating the seed to be held safely in the landscape has been a viable strategy, with these

*Photos above illustrate Plot 2 and clearly show developing native trees and shrubs from the applied seed. Native grasses are extensive in this area too, however are less easily identified to species in these illustrative photographs, outside of grass growth being visible. Note the St John's Wort present.*

While grazing and past herbivory was evident, as were tracks and scats, the recent warm weather has allowed establishing native species to put on a rapid fresh flush of new growth. This is evidence of their ability to reshoot after browsing by herbivores (deer, wallaby) and show promise if this pressure can be managed.

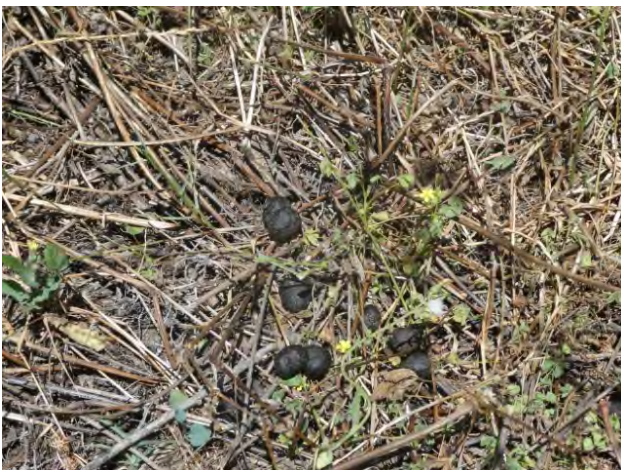
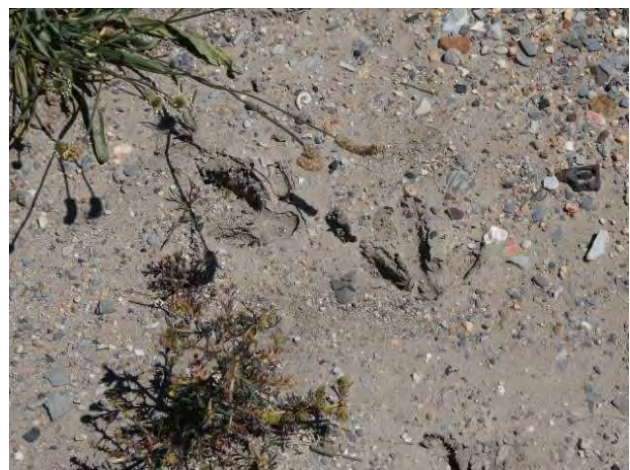
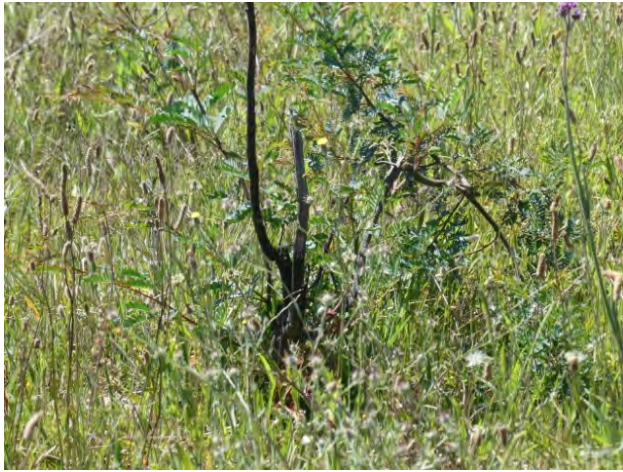
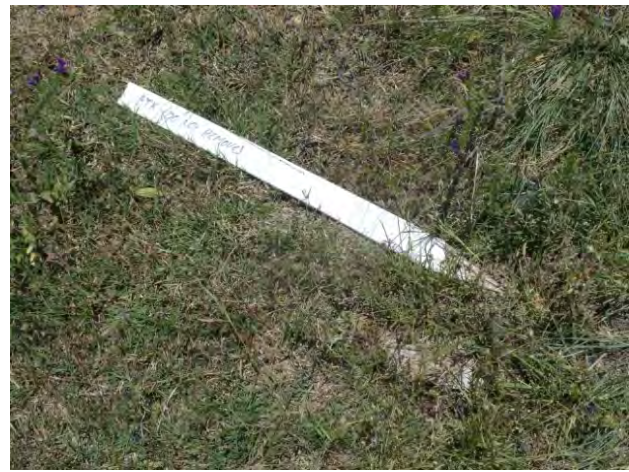
Again, weeds as discussed for Plot 1 were noted, especially the spreading of St John's Wort across the site and especially along the access track. Animals are known to utilise established tracks, so this could be spreading due to animal activity or from vehicle usage. A weed management strategy would best begin with a focus on these areas, along animal tracks and vehicle tracks and work out from there.

*Photos above and below (over page) show signs of animal usage across the whole site. Animal sign is noted on every monitoring visit. This is noted from recording of tracks, scat, stem damage, trunk rubbings on large woody debris (LWD), or interaction with marker posts.*

It is proposed to establish targeted fenced areas to determine the extent of damage on the growing trees by deer and other pest animals. Fenced areas must be deer and pig proof, so tall enough and strong enough to withstand animal interactions, and anchored well to eliminate pushing under the fencing. Small areas would be adequate for trialing the concept for larger installation. A larger compound could be trialed instead and would negate the need for two areas in each plot. Access for monitoring should be considered.

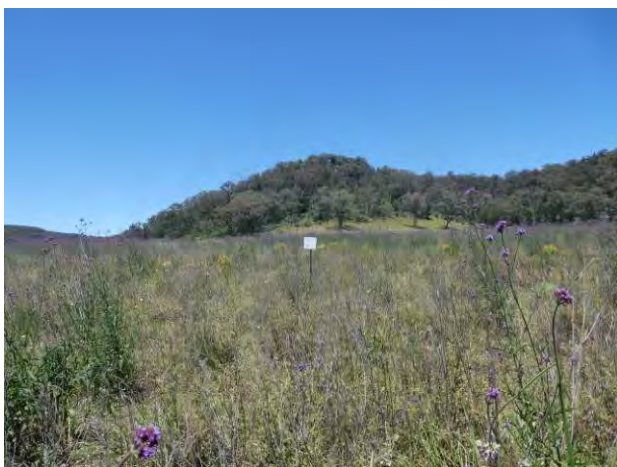
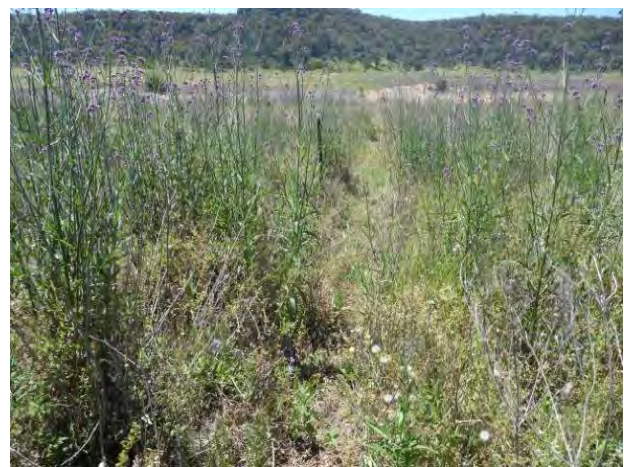
The monitoring area for these plots is one in which a difference in topsoil has allowed extreme competition from introduced species, both weeds and cover crop plants. Few if any native seeded species have been noted here previously. This competition has been thought to have shaded out the majority of potential native species seeded. The thick sheltering cover provided by the weed growth and weed seed load providing a food source here during the mouse plague could also potentially have led to predation of the desired seed. The prevalence of mice was noted during previous monitoring visits. This visit, however, saw the first seeded species noted in this area, being two grasses and three shrubs, albeit only one individual of each species. This indicates the potential that the applied seed is possibly still held in the landscape, although the presumption that it is fully available is not necessarily sensible, given the level of potential predation in this area from mice numbers noted during the mouse plague. Outside the area of “better” topsoil that allows this excessive weed species growth, native species are growing at similar stages to all other plots.

Weed species here are largely annual, with the perennial species less evident. Animal usage of this area is high, with many tracks and trampling evident, so seed carried in of St John’s Wort and Blue heliotrope is likely. As in Plot 3, the monitoring area of this plot is one with “better” topsoil and consequent strong competition from exotic annual weed species. Two native grass species were noted in the monitoring area. Other comments regarding native growth outside this section, native usage and weed species are all similar to that of Plot 3.

*Photos above show, left, Plot 3 with dense weed cover; and right, Plot 4 with a well-used animal track through the dense weed cover.*

The monitoring zone for these two plots, as discussed, has extensive overgrowth of annual weed species and little evidenced native species establishment. It is proposed to mark out the extent of this area, control the weed growth in here and then seed this area again with native species, trialing the use of a heavier than usual load of short-term pioneer *Acacia* species.

It is reasoned that utilising wattles in this manner will have the effect of a faster establishing species, rapid growth to 1-2m which will quickly shade the annual weeds. This will generate a boost in soil microbial activity and nutrition through the known action of *Acacia* species and their effect on the rhizosphere. Utilising their shorter lifespan (3-5 years for the bulk of the germinants), these will fall and add to the leaf litter and small woody debris layer more rapidly than longer term canopy species. The theory here is to replicate a natural regeneration process as seen after bushfire. In this scenario, the *Acacias* germinate rapidly, providing cover and added soil nitrogen to slower establishing species such as *Eucalypts*.

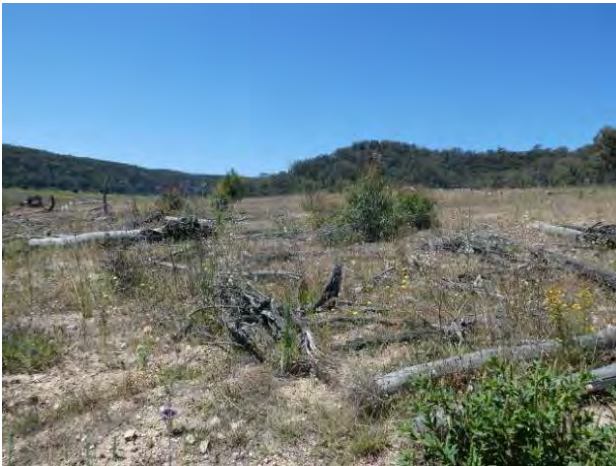
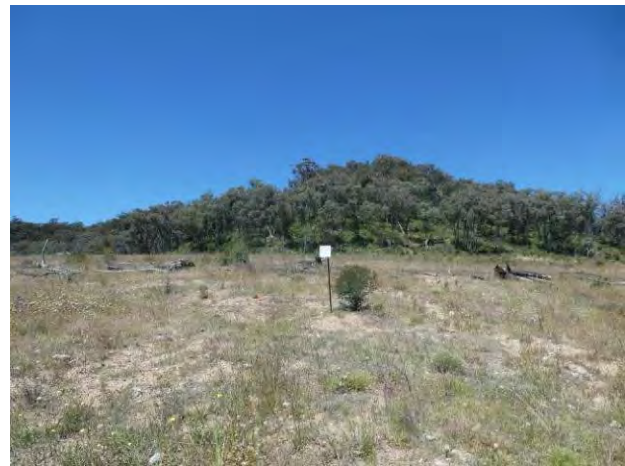
Plot 5 is one which has been noted as having a rocky harder topsoil and having struggled to gain good ground cover. Much of the increasing ground cover noted is couch grass (*Cynodon dactylon*), which is highly useful in binding the soil through its growth habit. Plot 5 has some large erosion channels running through it, and these are, in several cases, showing signs of stabilising through the action of sediment trapping and vegetative growth, not least of which is Couch. At the same time, native grass species are strongly present, and many have already seeded. Small shrub and forb species have grown, seeded, and cycled more than once already, and larger shrub species are emerging.

Native volunteer species have been evident in this plot from the beginning, including some forbs and many *Acacia* species. Notable also are the volunteer Eucalypts seeded naturally from the fresh woody debris placed on site. These are growing strongly and show less signs of damage, possibly due to some level of protection afforded by the logs placed as large woody debris (LWD), there being other easier accessed plants to thrash with antlers or otherwise interact with. The strong growth from these could also be due to the protection offered by the mulching effect of the LWD, as these particular areas had leaves and smaller twigs from the heads of the trees still intact, which then fell and added instant mulch, protecting from the elements and helping maintain moisture. Seed held in this material would also have been fresher than commercially provided seed would likely be and so more readily germinated.

*Photos above illustrate Plot 5 and the volunteer species noted within the swathe of LWD, visible in both photos, as well as, right, the Acacia linearifolia seeded from the adjacent National Park right next to the sighter post. Grass and forb species ground cover is establishing well and has great diversity in this plot.*

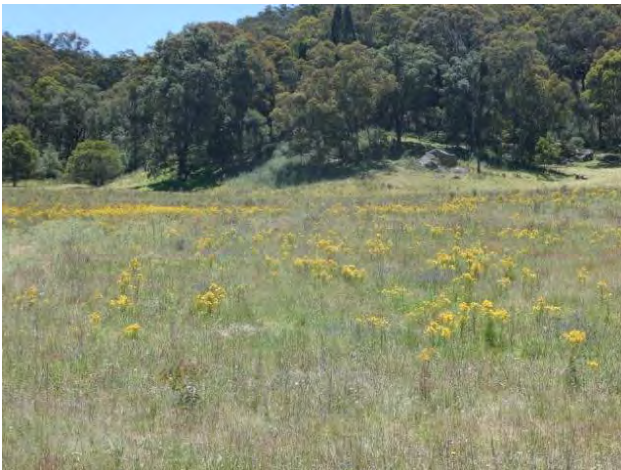
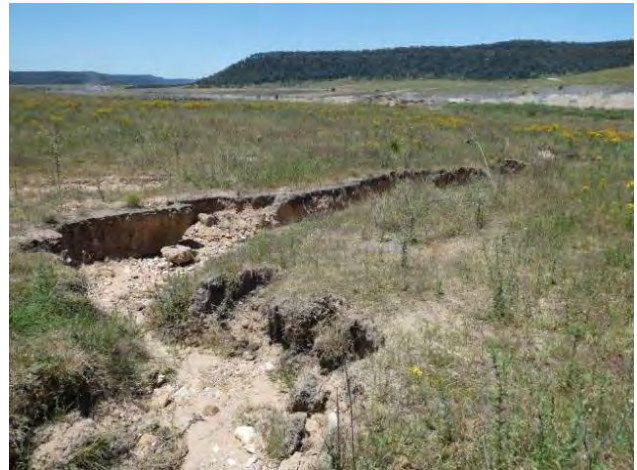
Plot 7 has excellent variety in all seeded species, particularly noting the Eucalypts. This plot is also very heavily grazed, with grass species regularly cropped short and trees and shrubs usually browsed heavily. This visit the tree species were in a growth stage, with less browsing evident and many evidencing new growth. This site is almost always one where kangaroo and wallabies are sighted, and this recent visit was no exception. It is hoped that the plants can get a spurt of growth and outgrow some of the browsing, although this will be monitored through the actions recommended below.

Plot 7 continues to experience heavy erosion, always in the same place.

*Photos above illustrate Plot 7. Left shows good ground cover overall. Knee-height trees are evident across much of this site, with new germinants noted on this visit as well. Right, note the erosion channel. This has been repaired multiple times; however the natural drainage line repeatedly causes the same channel to wash out after each major weather event. Limited natural repair is noted. The weed St John's Wort in full (yellow) flower can be noted extensively in both photographs.*

Most plots have at least some erosion channels noted, with some extensive. There are natural repair mechanisms developing in some of these. Plot 7 in particular, however, continues to be problematic. The major issue with this is that repair works, although undertaken repeatedly, simply replace the material in the same place with no change in management in place to eliminate these points repeatedly eroding.

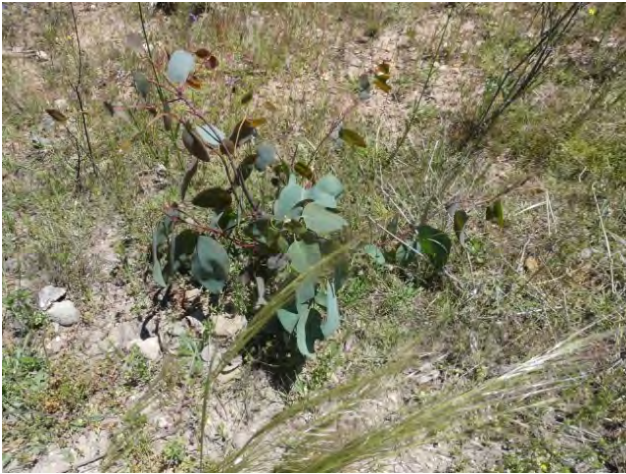
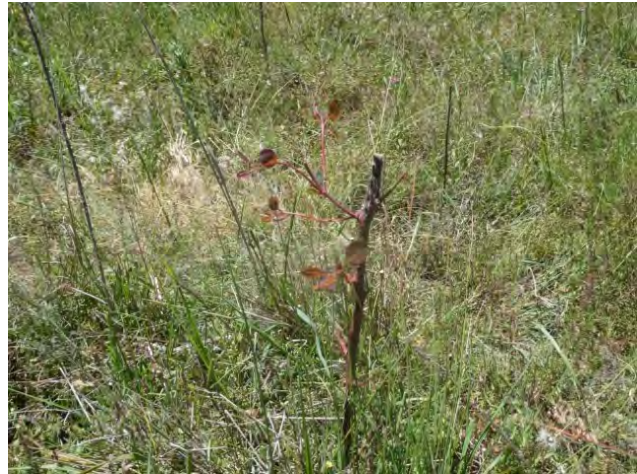
Photos above show two eucalypts in Plot 7. The one on the left has been damaged and is regrowing from the lignotuber already formed at its base. The one on the right has only recently been browsed back to its main stem and is showing emerging new growth.
