METROPOLITAN COAL LONGWALLS 301-303

WATER MANAGEMENT PLAN

Metropolitan Coal – Water Management Plan		
Revision No. WMP-R01-F		Page 1
Document ID: Water Management Plan

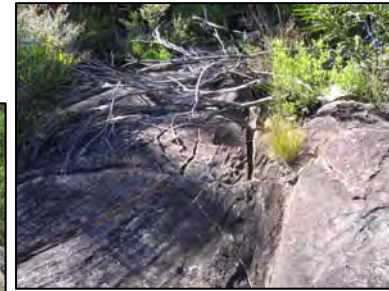
G1-5 Cracking in rockbar

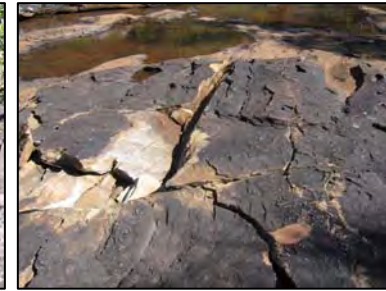
G1-6 Cracking in rockbar

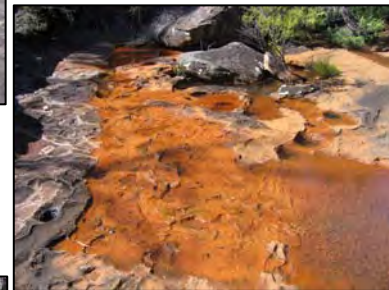
G1-10 Iron Staining

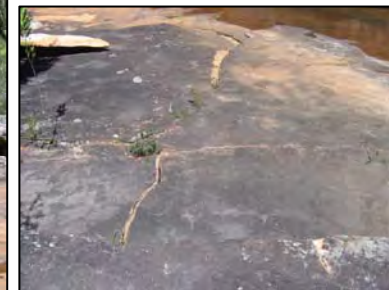
G1-14 Crack perpendicular to joint

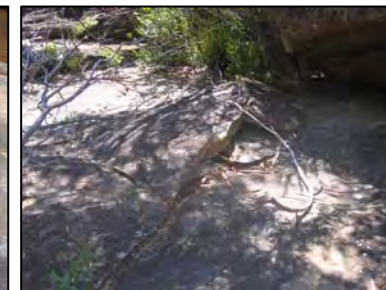
G1-15 Buckling

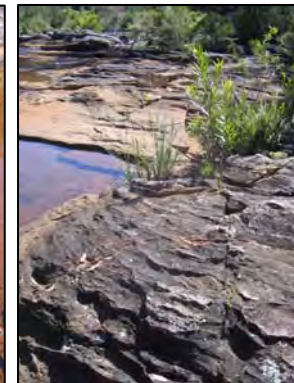
G1-4 Cracking in rockbar

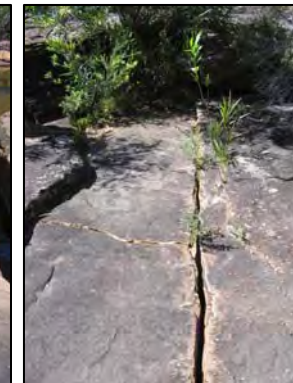
G1-13 Crack

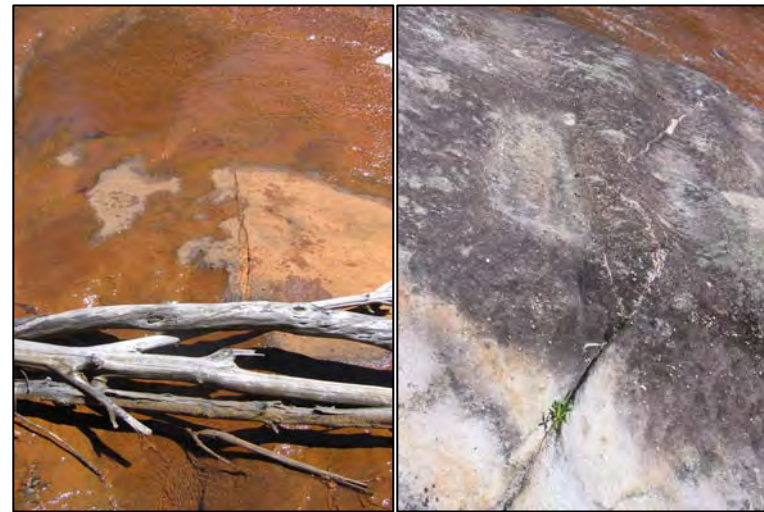
H-8 and H-9 Cracks in rockbar, 5mm wide, 5m apart.

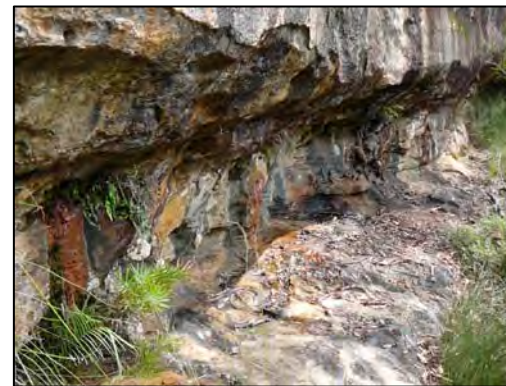
S-5 Iron staining at seepage

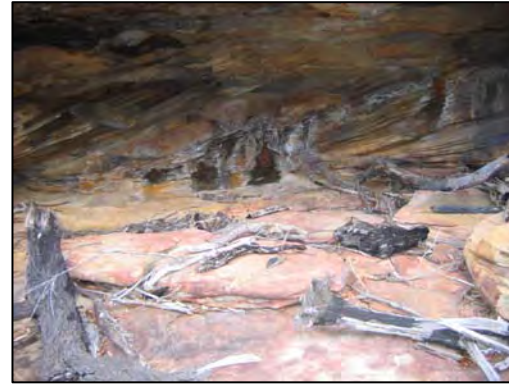
T-3 Iron stain at seepage, south east bank

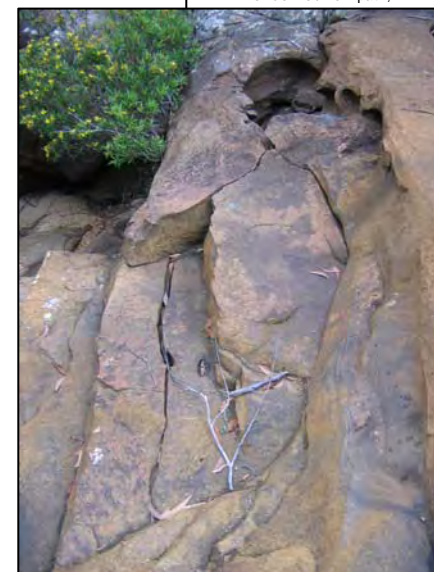
ETZ-10 Cracking at step down in sandstone

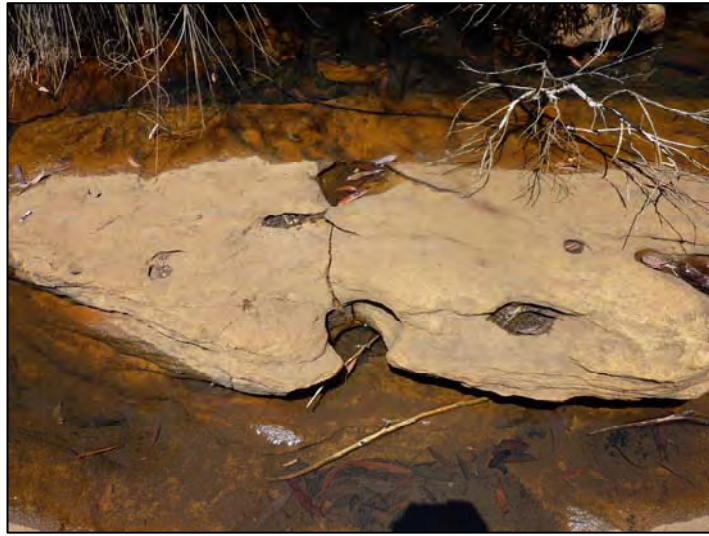
TA26-1 Cracking in rock

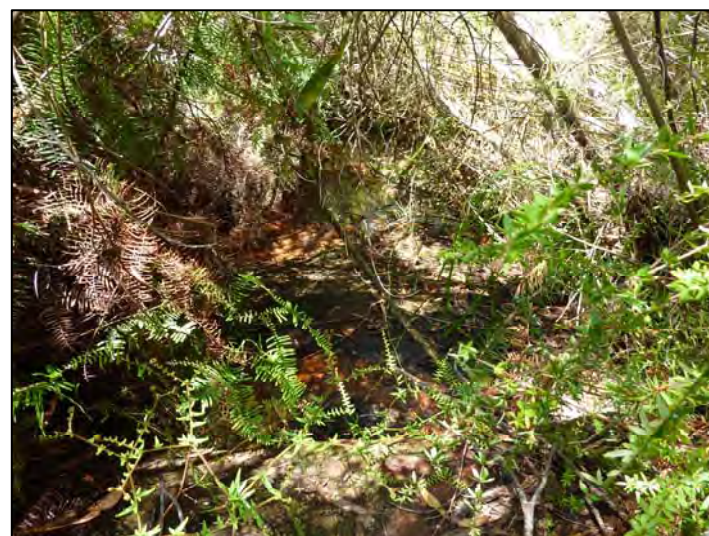
TB016-4 Ponding and iron staining looking Downstream
