**METROPOLITAN COAL**

**SIX MONTHLY REPORT**

**1 JANUARY TO 30 JUNE 2014**

Project No. MET-08-08/8.1  
Document No. 00629674

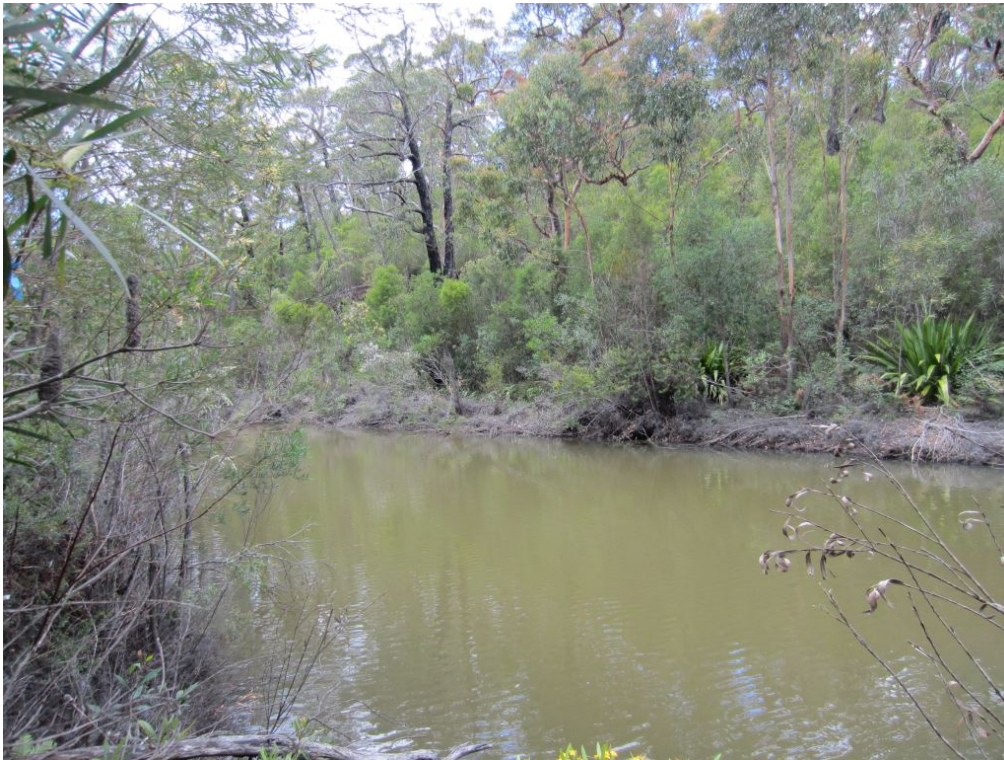
- Riparian areas that had not previously been inundated were observed to be inundated. This included areas at sites MRIP02 during autumn and spring 2013, and sites MRIP05 and MRIP09 in spring 2013.

**Plate 1 View downstream of Eastern Bank of Waratah Rivulet at Site MRIP02 (Photo Point 1), Spring 2013 (Photo taken at 46 m point along MRIP02 transect line)**

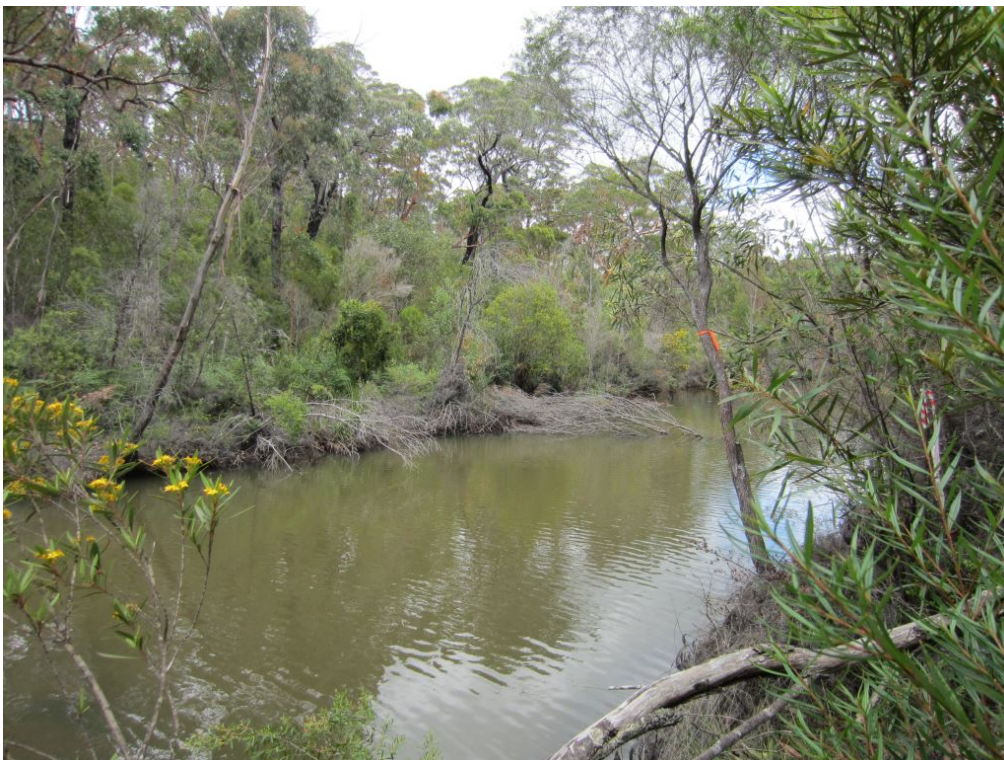
- Within site MRIP02 vegetation along the edge of the Waratah Rivulet was observed with extensive dieback and dead individuals were common (Plates 1 to 3). Dieback was observed along streamside vegetation on both the eastern and western bank, although the band of vegetation with dieback appeared to be more extensive on the eastern bank. Species impacted included groundcovers such as *Gleichenia microphylla*, *Sticherus flabellatus* var. *flabellatus*, *Bauera rubioides*, *Gahnia sieberiana* and the shrubs *Acacia obtusifolia*, *Tristania neriifolia*, *Lomatia myricoides*, *Prostanthera linearis*, *Persoonia pinifolia*, *Banksia ericifolia* subsp. *ericifolia* and *Grevillea diffusa* subsp. *diffusa*. Some of the dead vegetation continues to be inundated (since first observed autumn 2013).

Visual inspections of riparian vegetation identified vegetation dieback greater than 50 cm from the Waratah Rivulet at site MRIP02 (overlying Longwall 21) in the spring 2013 vegetation survey, and as a result the performance indicator has been exceeded. Photographs of the vegetation dieback are provided in Plates 1 to 3 in Section 3.2.1.3.

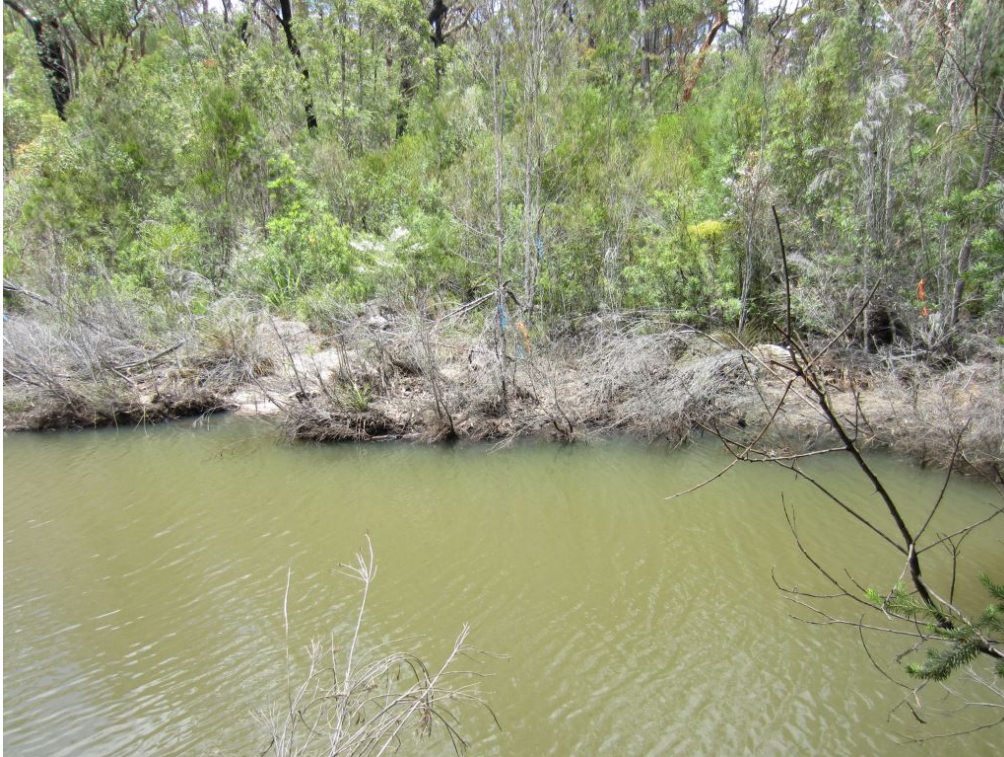
**Plate 2 View upstream of Eastern Bank of Waratah Rivulet at Site MRIP02 (Photo Point 1 view upstream), Spring 2013 (Photo taken at 46 m point along MRIP02 transect line)**
