**APPENDIX 3C – SURFACE WATER
MONITORING DATA**

Wilpinjong Coal Pty Ltd - 2016 Water Balance Model Update
Baseline OPSIM Model Setup - 31 Mar 2017

Wilpinjong & Cumbo Creek Stability Assessment, 2016

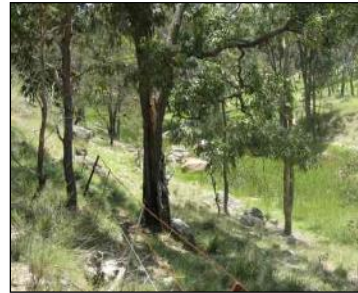
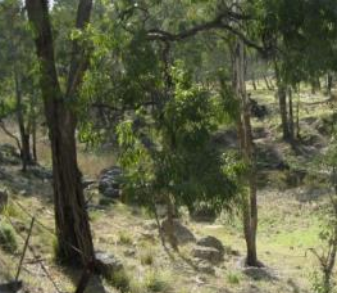
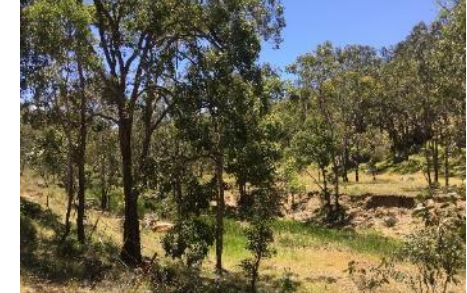
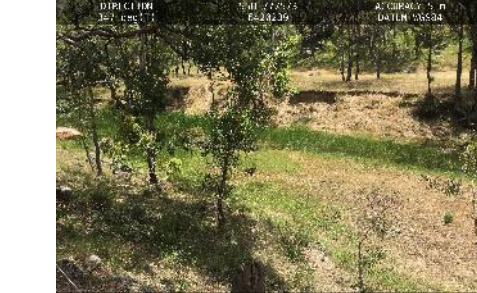
Site	Upstream December 2011	Upstream December 2014	Upstream December 2015	Upstream December 2016	Main Comparison
48

<ul style="list-style-type: none"> • Instream vegetation remains similar; • Site continues to stabilise; • Minimal riparian zone.
49

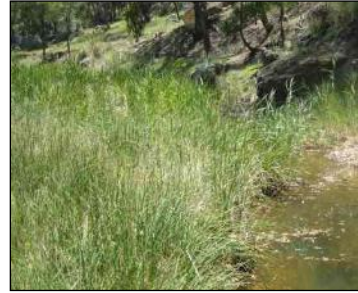
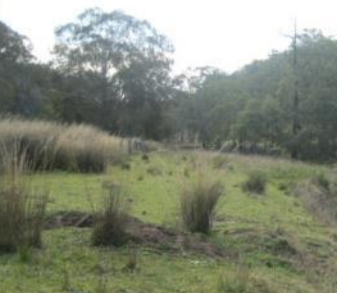
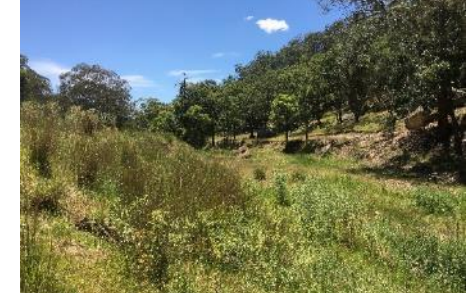
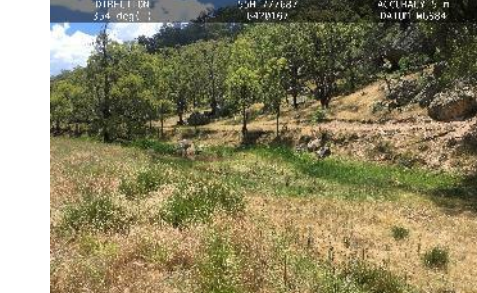
<ul style="list-style-type: none"> • Reduction in instream vegetation; • Instream vegetation remains similar; • Site continues to stabilise; • Minimal riparian zone.

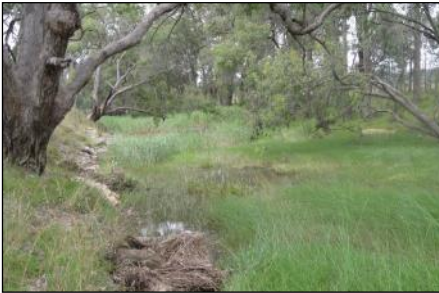
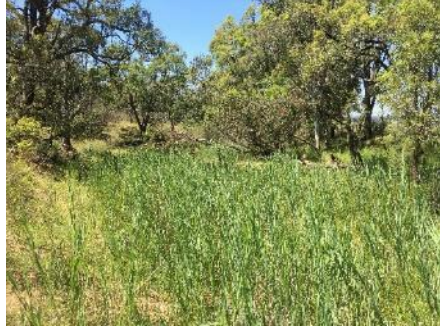
Site	Downstream December 2011	Downstream September 2014	Downstream December 2015	Downstream December 2016	Main Comparisons
6

<ul style="list-style-type: none"> • Increase shrub growth left bank. • A reduction in in stream flora growth; • Reduction in active channel width; • Increase in in stream debris; • Blackberry noted.
7

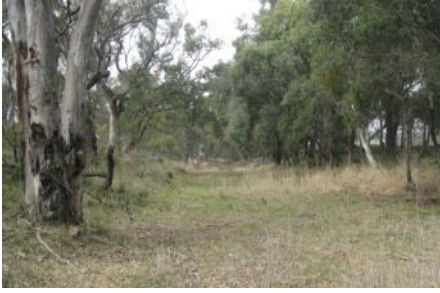
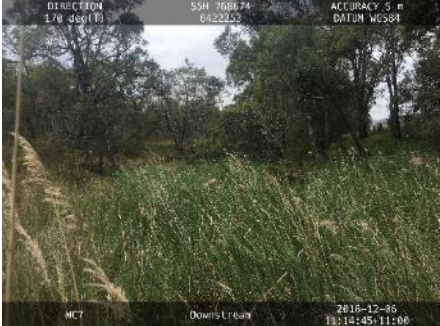
<ul style="list-style-type: none"> • Left bank stabilising; • Right bank stable; • Blackberry noted; • Fox noted; • Similar site to previous year.
8

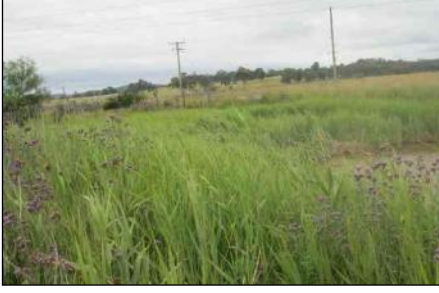
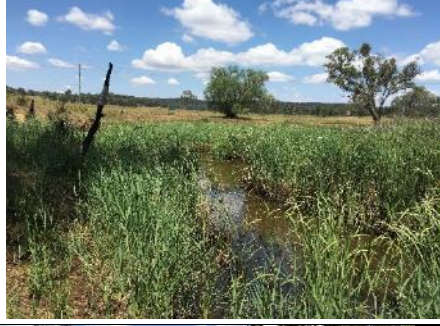
<ul style="list-style-type: none"> • Site moved due to access issues; • New site – sediment deposition but stable.
9

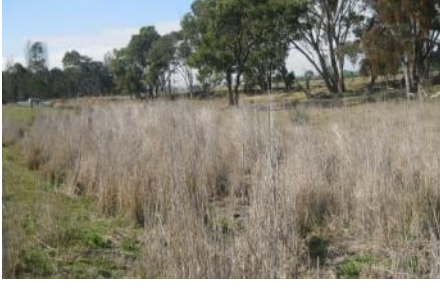
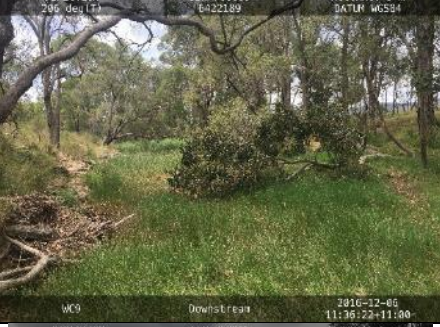
<ul style="list-style-type: none"> • Site moved due to access issues; • New site – sediment and debris deposition but stable.
10

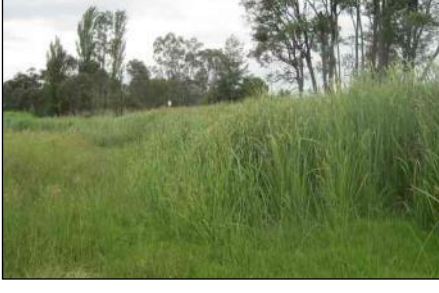
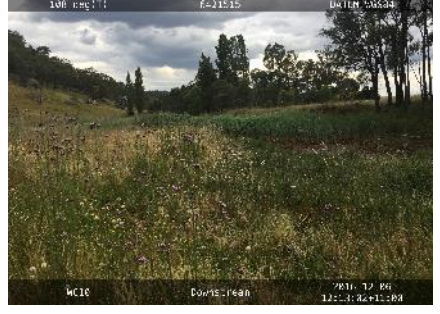
<ul style="list-style-type: none"> • Similar to previous year. • Blackberry noted.

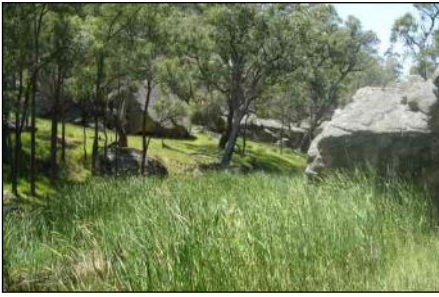
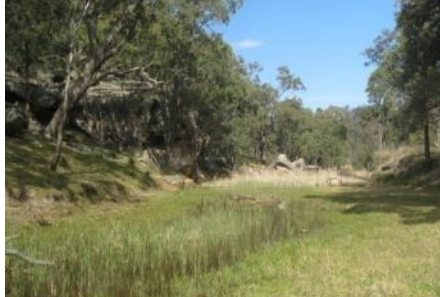
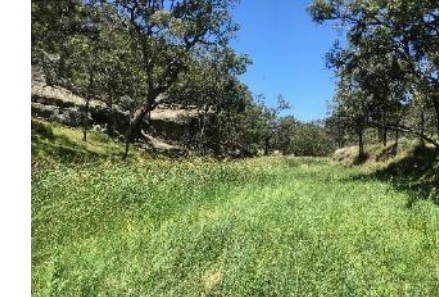
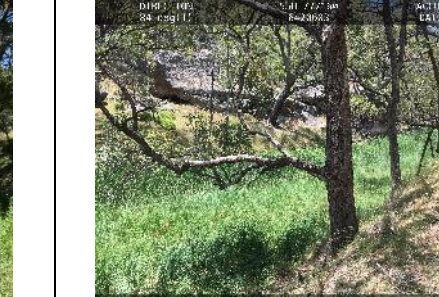
Site	Downstream December 2011	Downstream September 2014	Downstream December 2015	Downstream December 2016	Main Comparisons
46

<ul style="list-style-type: none"> • Creek bed is well vegetated with little to no exposure of the creek bed; • Both banks are well vegetated and stable; • Site continues to stabilise.
47

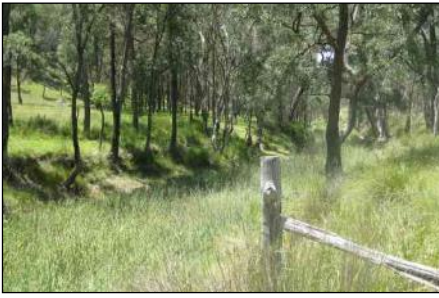
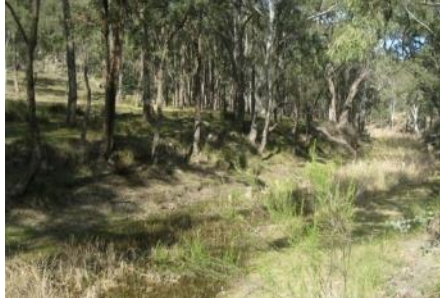
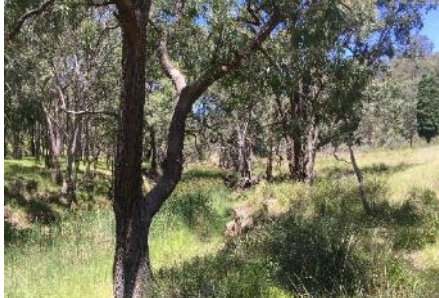
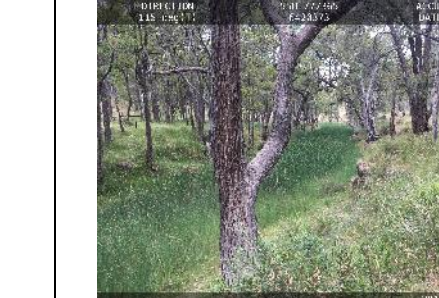
<ul style="list-style-type: none"> • Instream vegetation remains similar; • Site continues to stabilise; • Minimal riparian zone.
48

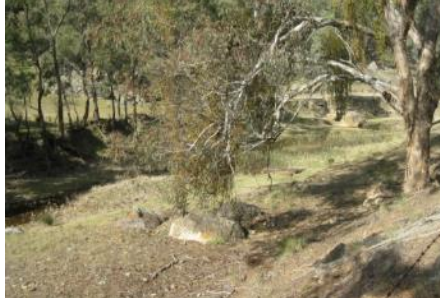
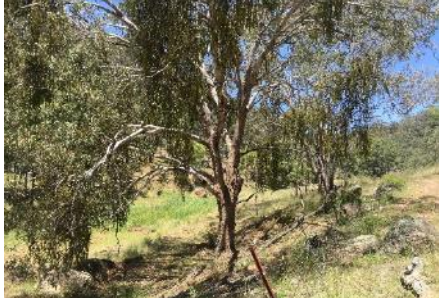
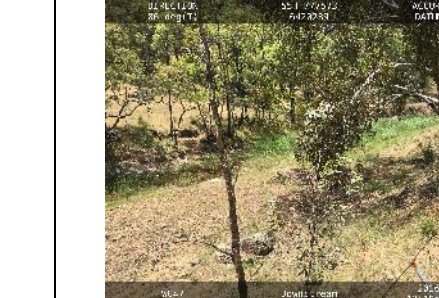
<ul style="list-style-type: none"> • Reduction in instream vegetation coverage; • Site continues to stabilise; • Minimal riparian zone.
49

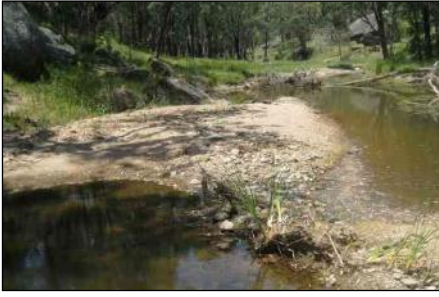
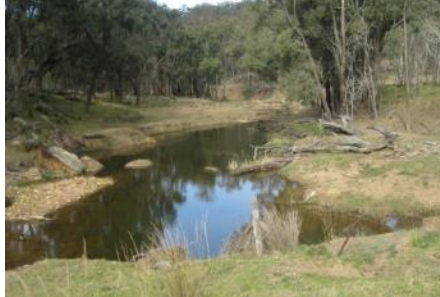
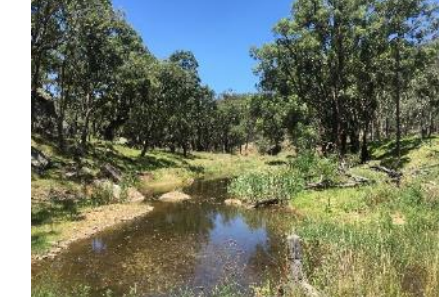
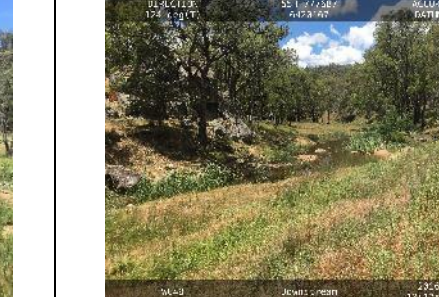
<ul style="list-style-type: none"> • Reduction in instream vegetation; • Instream vegetation remains similar; • Site continues to stabilise; • Minimal riparian zone.

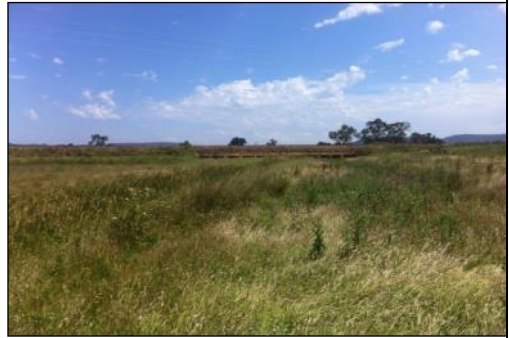
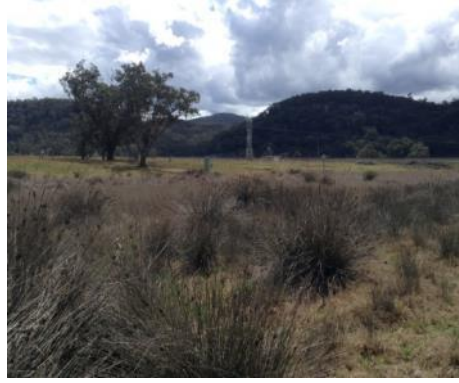
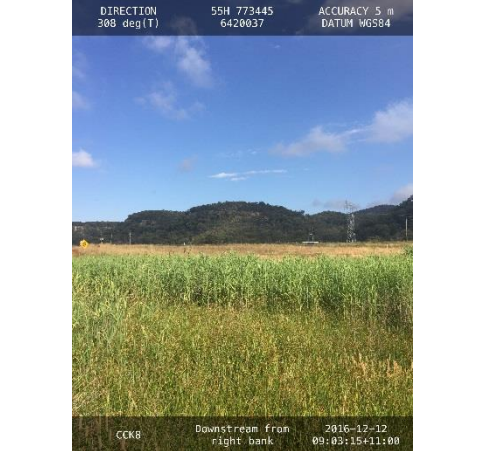
8

<p>DIRECTION 308 deg(T) 55H 773445 ACCURACY 5 m 6420037 6420037 DATUM WGS84</p> <p>CC8 Downstream from right bank 2016-12-12 09:03:15+11:00</p>	<ul style="list-style-type: none"> • Site remain well vegetated with groundcover and stable. • No riparian zone.
9

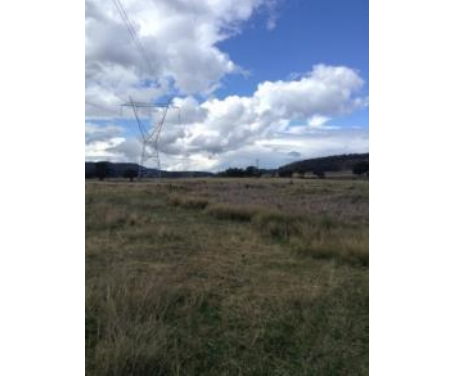
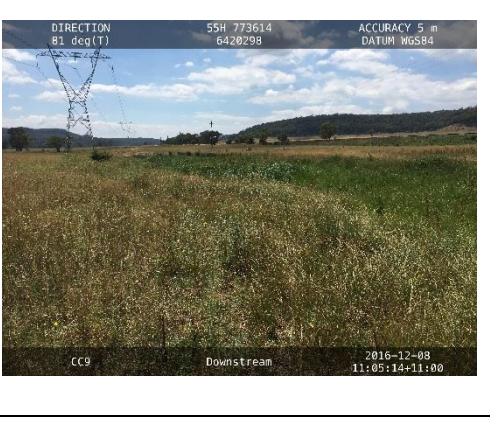
<p>DIRECTION 81 deg(T) 55H 773614 ACCURACY 5 m 6420298 6420298 DATUM WGS84</p> <p>CC9 Downstream 2016-12-08 11:02:14+11:00</p>	<ul style="list-style-type: none"> • Site remain well vegetated with groundcover and stable. • No riparian zone.
10	 	 	 	  <p>DIRECTION 91 deg(T) 55H 773691 ACCURACY 5 m 6420916 6420916 DATUM WGS84</p> <p>CC10 Downstream 2016-12-08 11:02:49+11:00</p>	<ul style="list-style-type: none"> • Pooling in local area. Reduction in groundcover, within the creek bed noted • Site remain well vegetated with groundcover and stable. • No riparian zone.
