**WILPINJONG COAL PTY LTD**

**Environment Protection Licence (EPL) 12425**

**LICENCE MONITORING DATA  
MONTHLY SUMMARY REPORT**

**1 September 2019 to 30 September 2019**

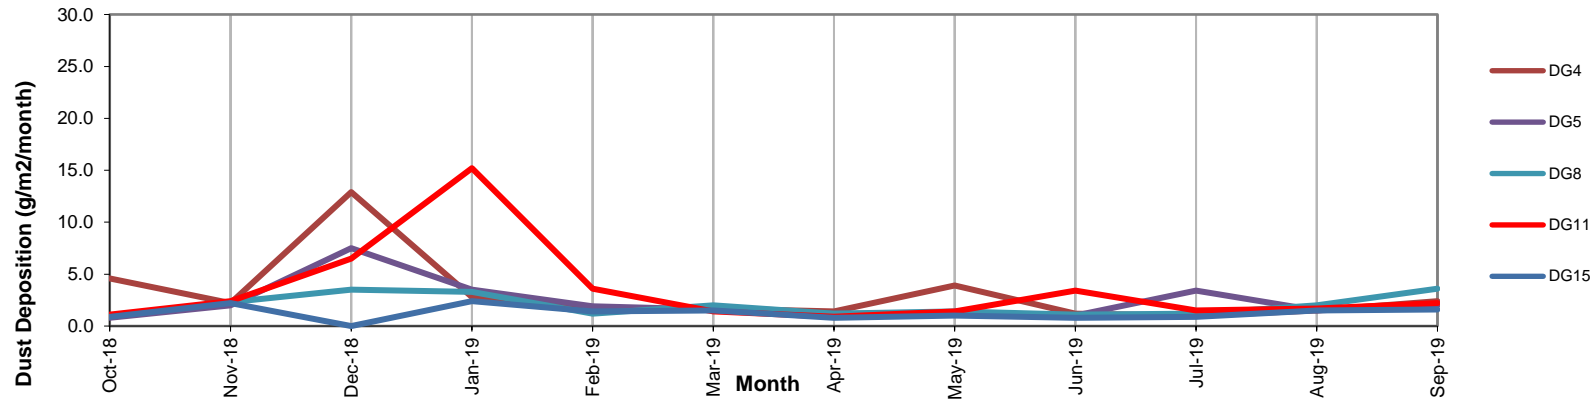
**Figure 1a. DG Results - 12 Month Trend**

1. Limit of 4 g/m2/month (annual average) applies to DG5 (Wollar Village) - refer Figure 1b.
2. The excessive dust level recorded at DG4 in December 2018 was due to a high concentration of organic matter.
3. Excessive dust levels recorded by DG5 in December 2018 and DG11 in January 2019 were caused by agricultural activities.

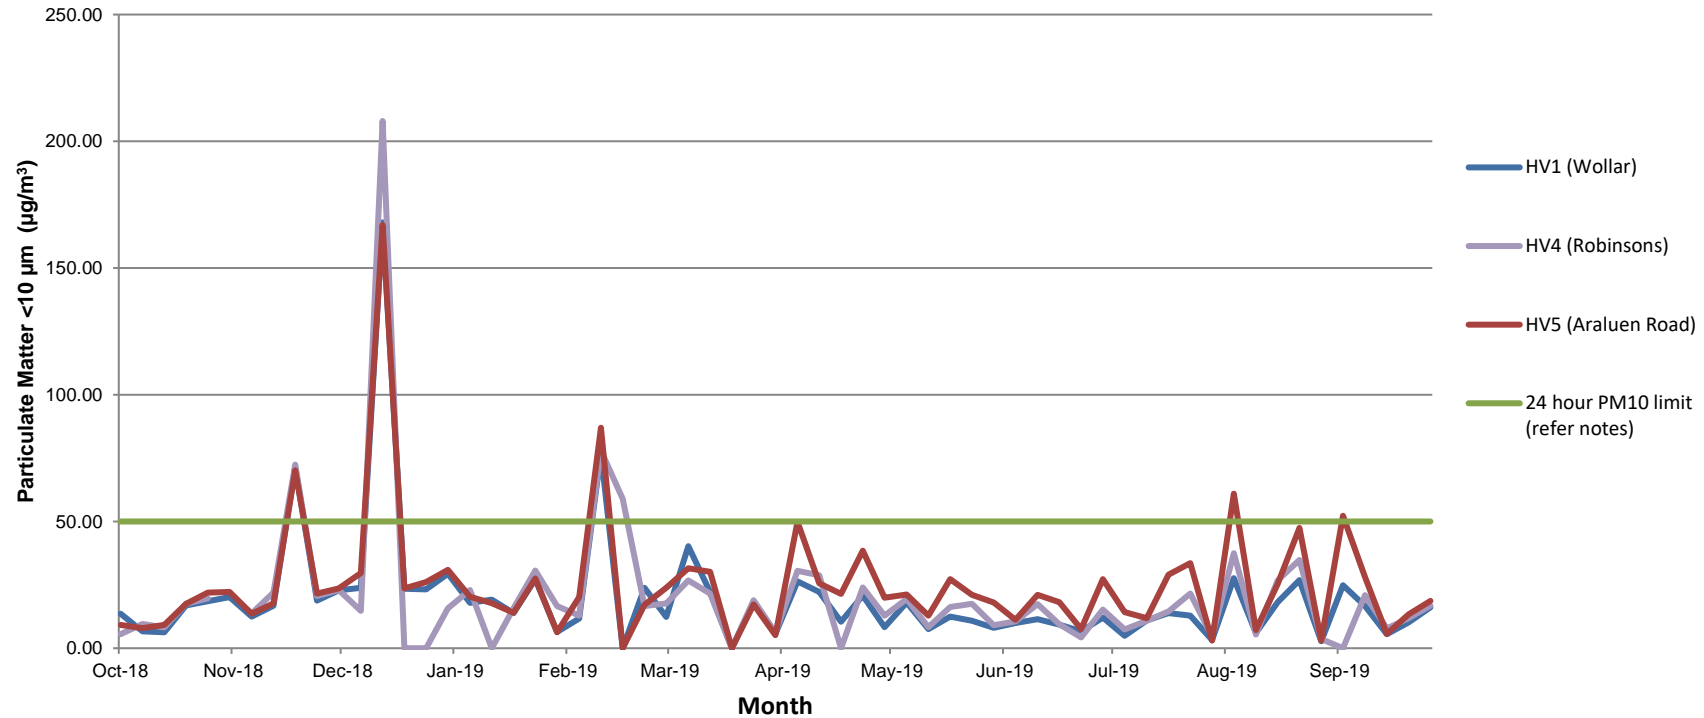
Figure 2. HV (PM10) Results - 12 Month Trend

1. Limit doesn't apply for extraordinary events such as bushfires, prescribed burning, or dust storms.
2. Power outages prevented dust samples being collected from **HV4**: 28 September 2018, 21 and 27 December 2018, 14 January 2019 and 20 April 2019, **HV1**: 19 February 2019 and 21 March 2019, **HV5**: 19 February and 21 March.
3. Recorded PM10 dust levels above 50 µg/m³ recorded in November and December 2018 and February 2019 were caused by regional dust events - refer EPA PM10 dust graph on page 6 of this report.
4. The PM10 dust level exceeding 50µg/m³ recorded at HV5 in August 2019 was due to a hazard reduction burn to the west of Wilpinjong Mine in the Goodman State Conservation Area. The exceedance at HV5 in September was caused by wheel-generated dust paired with an inversion down Araluen Road.

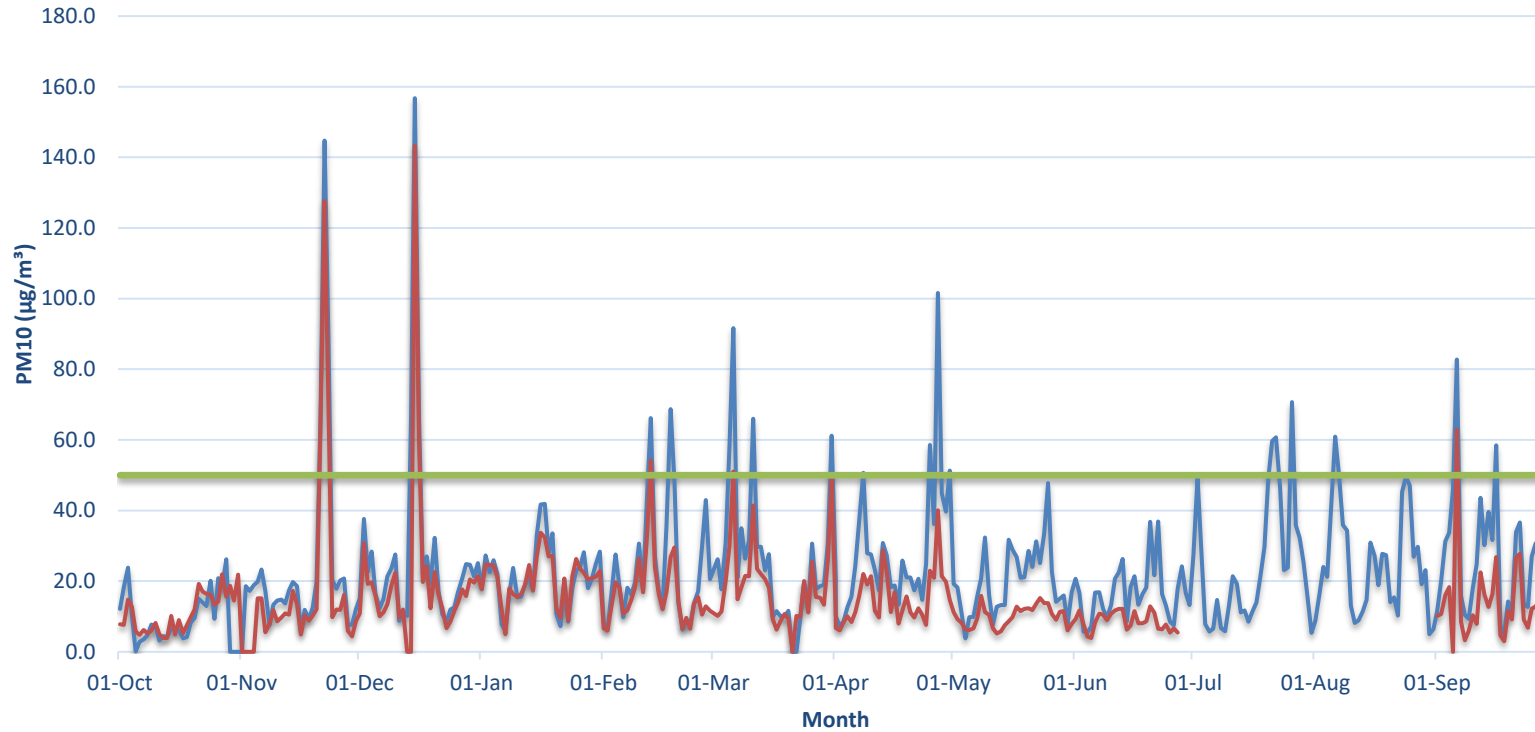
**Figure 3. TEOM (PM10) Results - 12 Month Trend**

1. Limit doesn't apply for extraordinary events such as bushfires, prescribed burning or dust storms
2. TEOM 4 (Araluen Rd) influenced by dust from Araluen Road generally during stable atmospheric conditions (i.e. temperature inversions)

3. Elevated PM10 dust levels recorded in November and December 2018 and February, March, April and September 2019 were due to regional dust events.
4. The elevated PM10 dust levels recorded at TEOM 4 on 6th August and 16th September 2019 were due to a temperature inversion trapping road dust and lack of rainfall. Additionally, a hazard reduction burn was taking place to the west of Wilpinjong Mine in the Goodman State Forests at the time of the September exceedance which also contributed to the high reading.

5. PM10 data recorded at TEOM 3 between 28 June and 31 August 2019 is invalid due to instrument fault causing inaccurate results. The data is unable to be corrected or adjusted due to the nature of the failure.

6. TEOM 3 offline from December 13 to 14 2018 due to instrument failure and repair

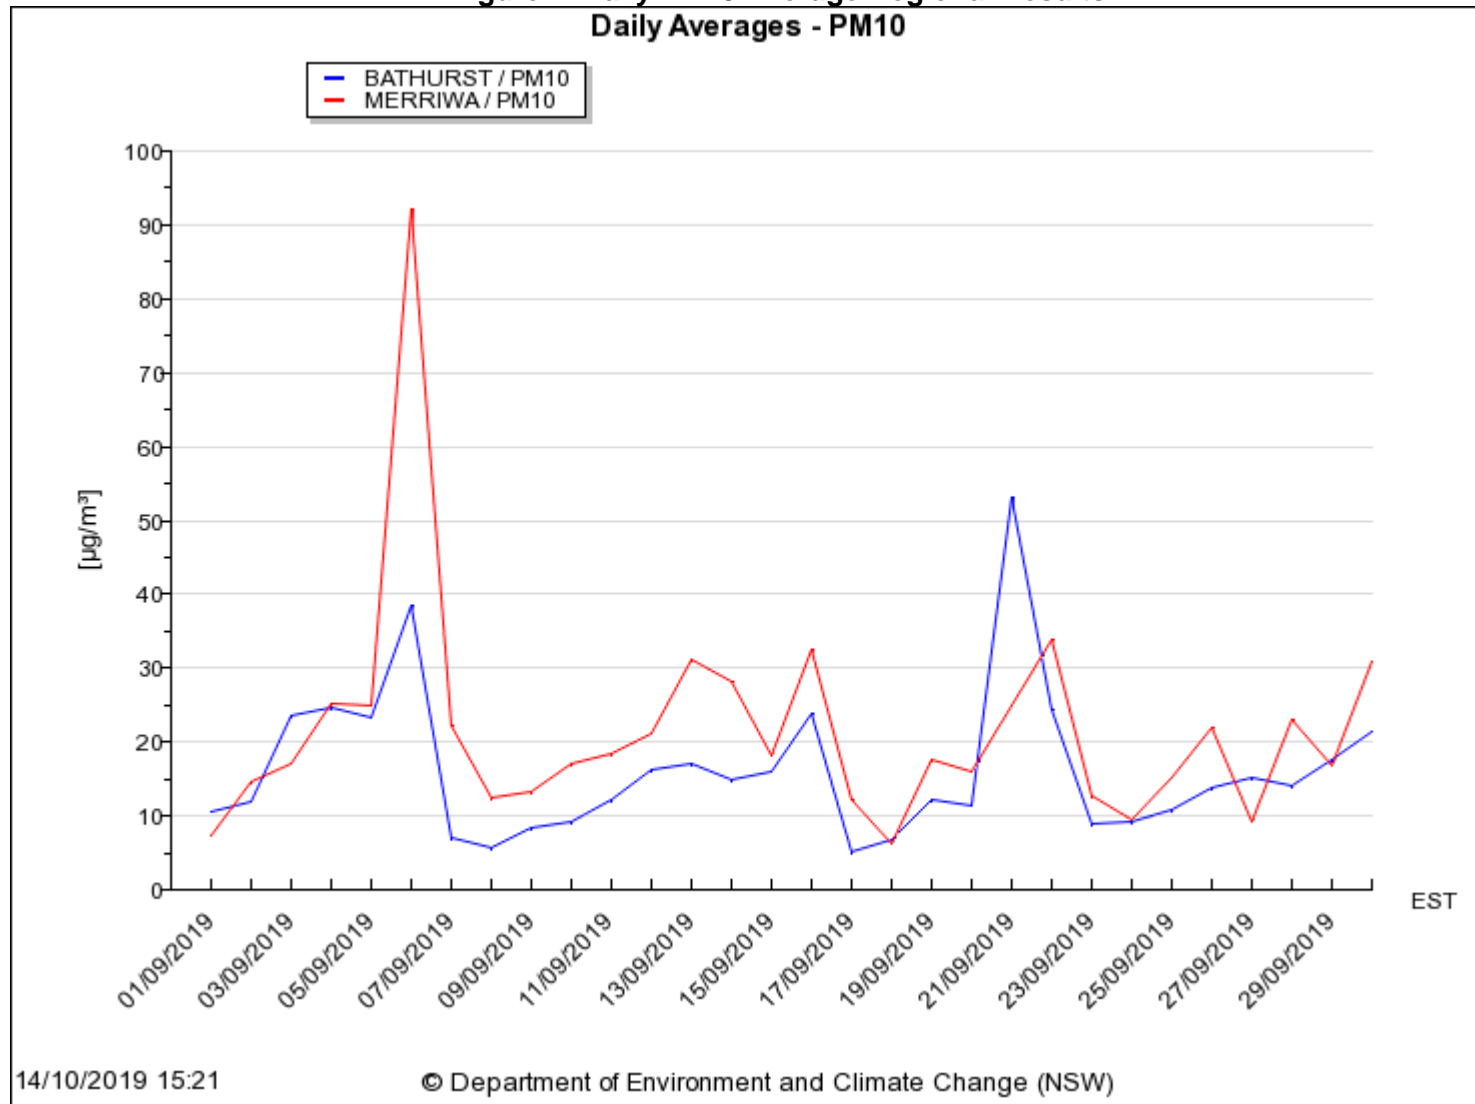
Figure 4. Daily PM10 Average Regional Results

For comparison with **Figures 2** and **3**, **Figure 4** displays the Regional 24Hr PM10 Average. PM10 dust levels for the month have been recorded in Bathurst and Merriwa by NSW EPA.

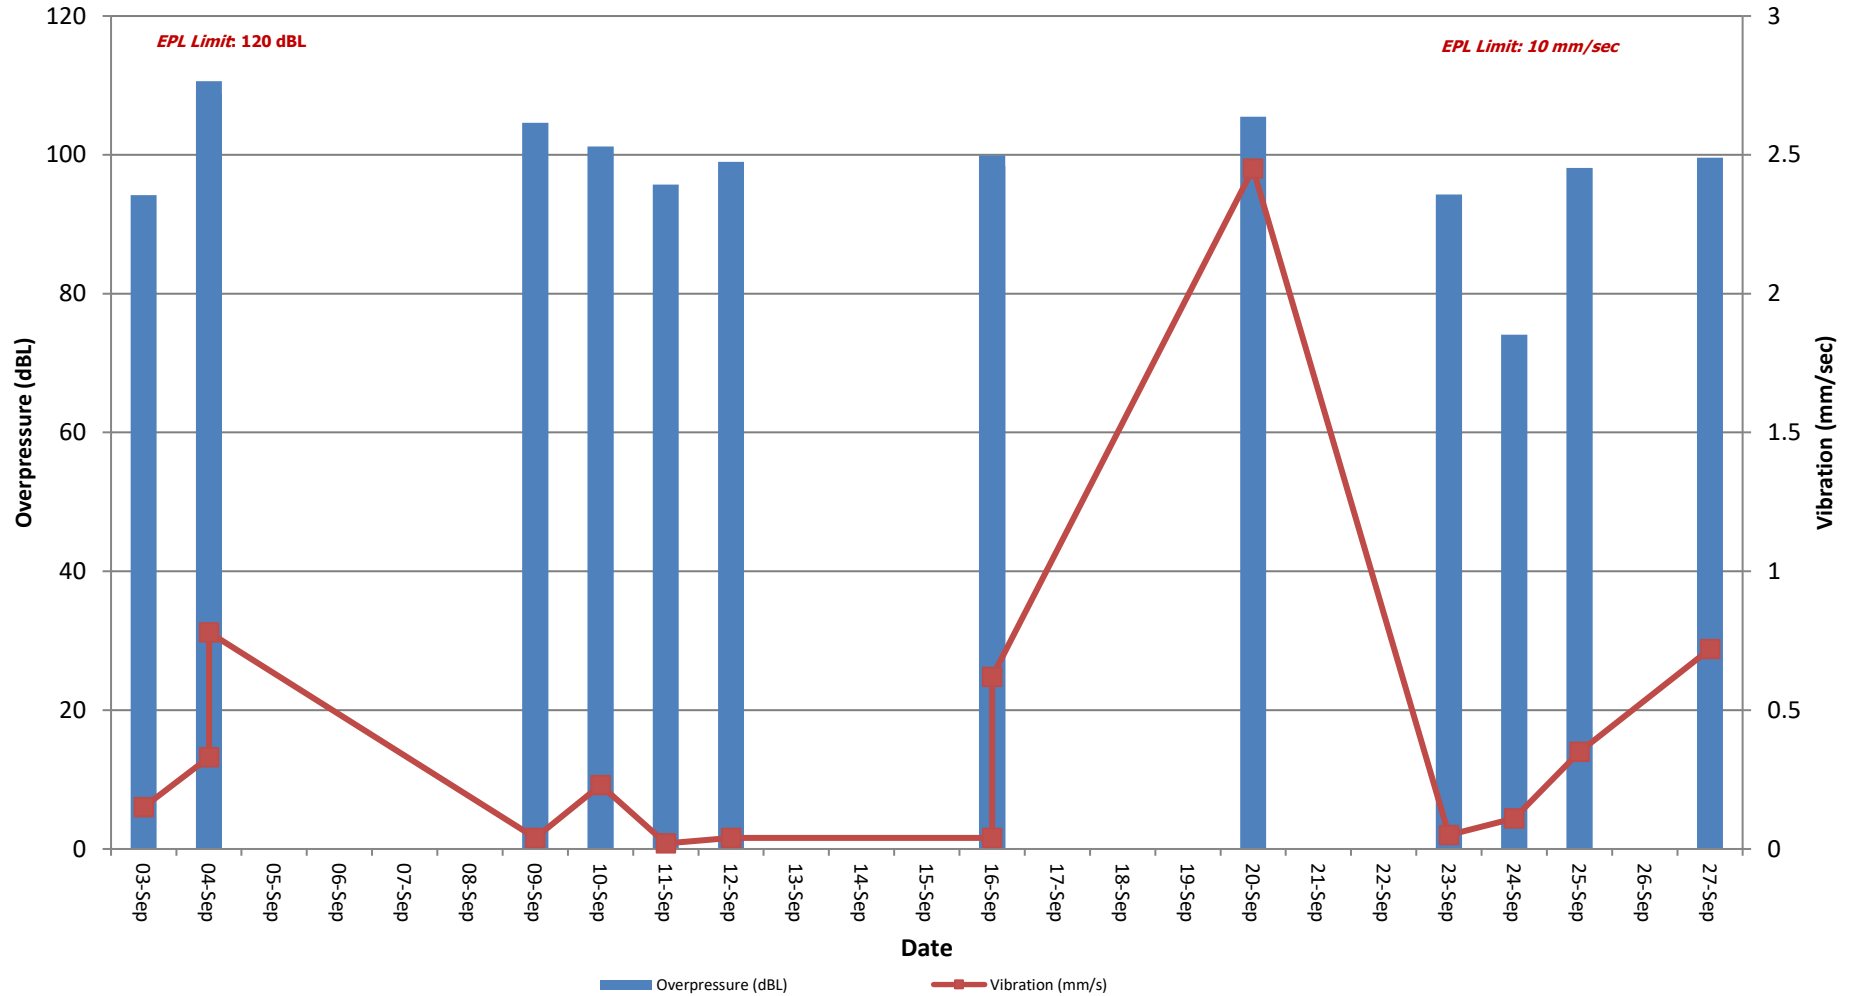
Figure 7. Overpressure (dBL) and Vibration (mm/sec) recorded during Month

Monitoring is carried out near sensitive locations during blasting activities to determine the vibration in the air (overpressure) and earth (ground vibration). A summary of the results of this monitoring, and the limits specified in the EPL, are shown in **Tables 3** and **4**. **Figure 7** shows the actual overpressure and vibration levels recorded during the month.

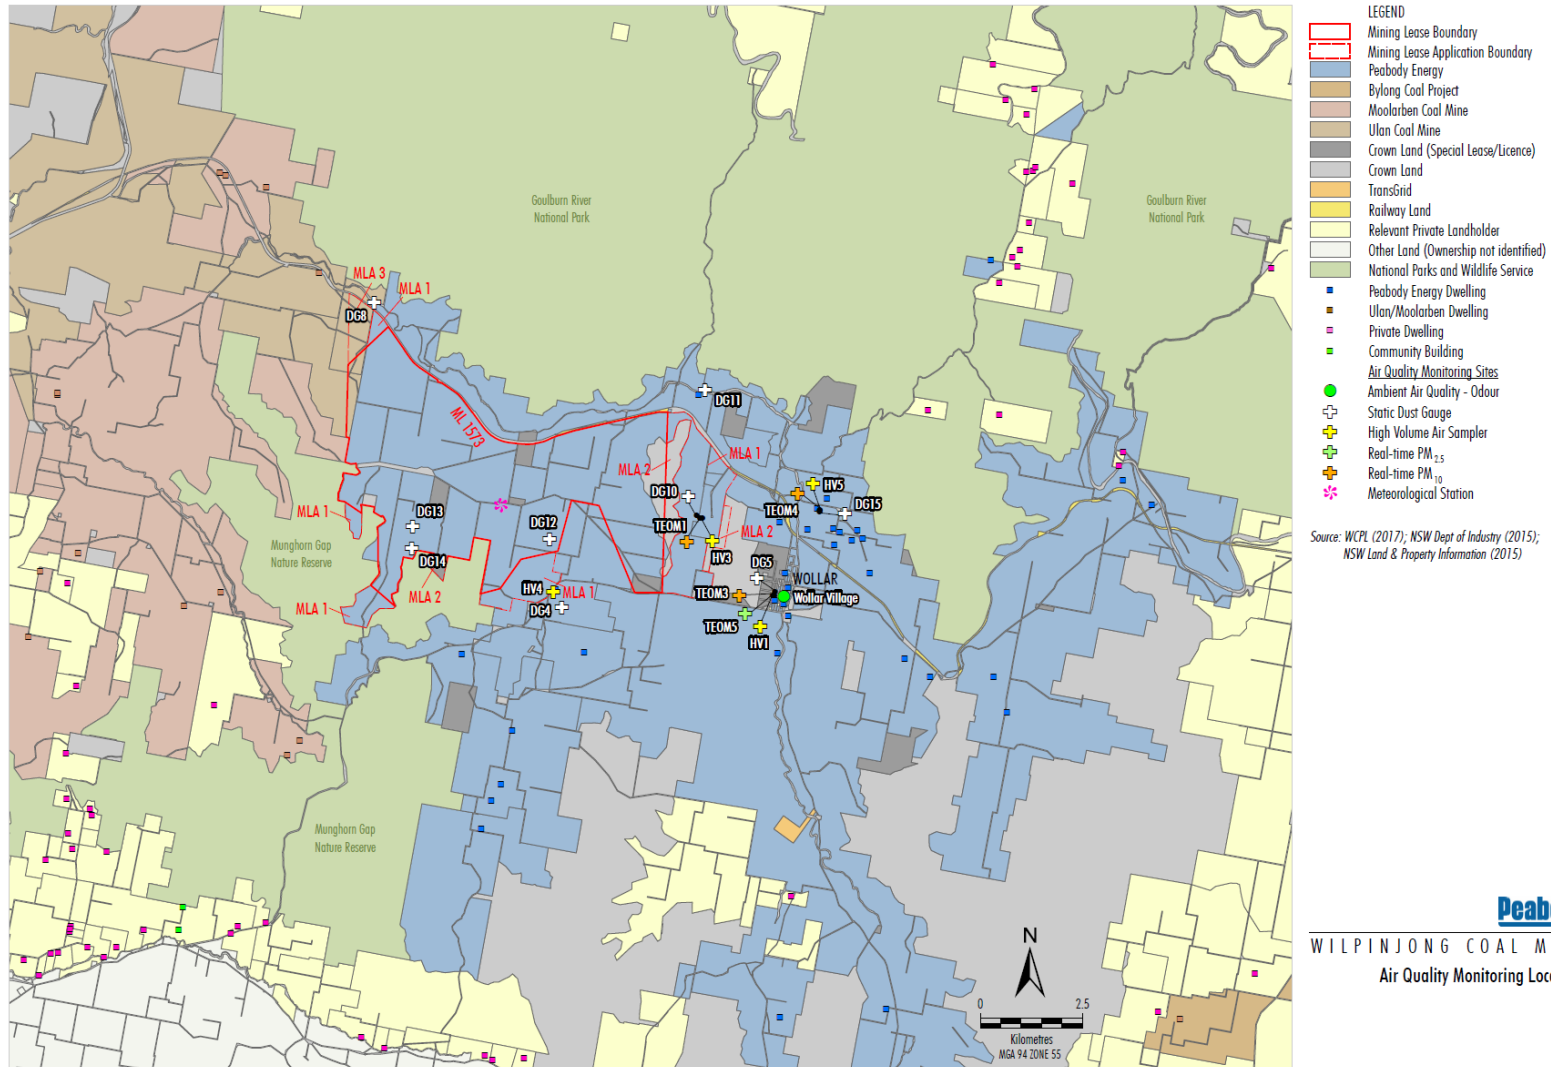
Figure 6 – Air (Dust) Monitoring Locations

The location of the above monitoring equipment in relation to Wilpinjong Coal Mine is shown in **Figures 6** and **8**.

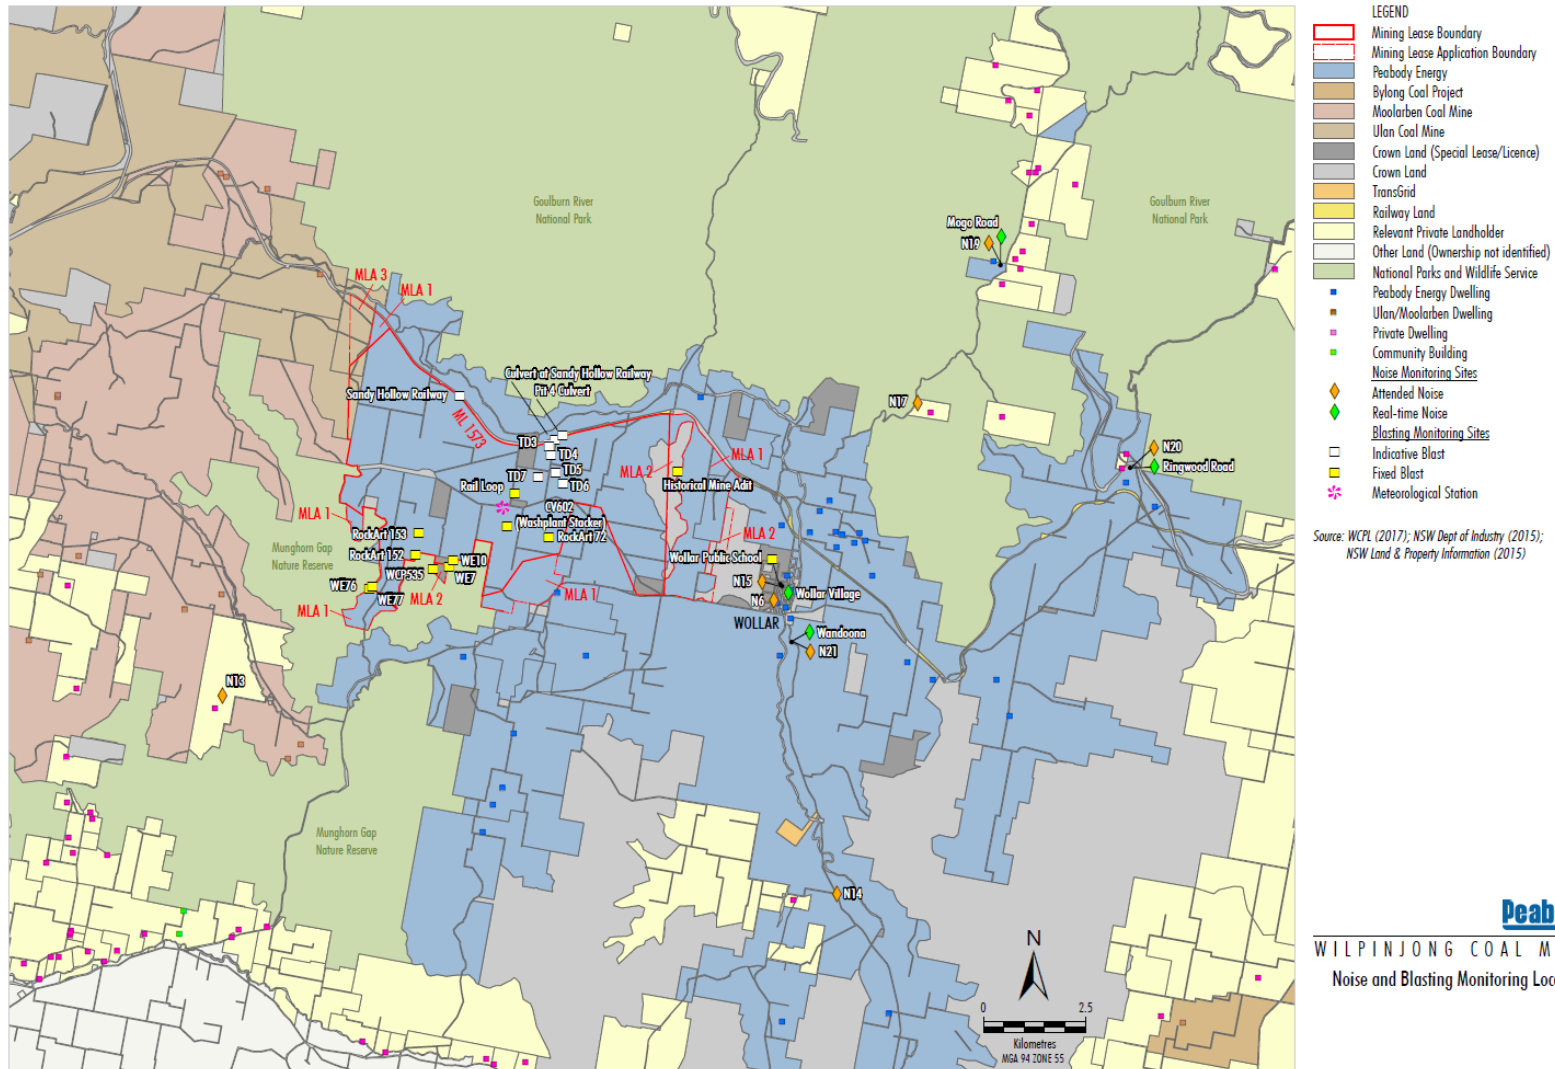
Figure 7 – Attended Noise Monitoring Locations

1. by an independent noise consultant;
2. during the night-time; and
3. at the sites shown in **Figure 7**.
