Wilpinjong Coal Mine Aboriginal Rock Art Monitoring and Assessment Program

Report on Nov 2020 site inspections WCP152 and WCP153

Wilpinjong, NSW

March 2021

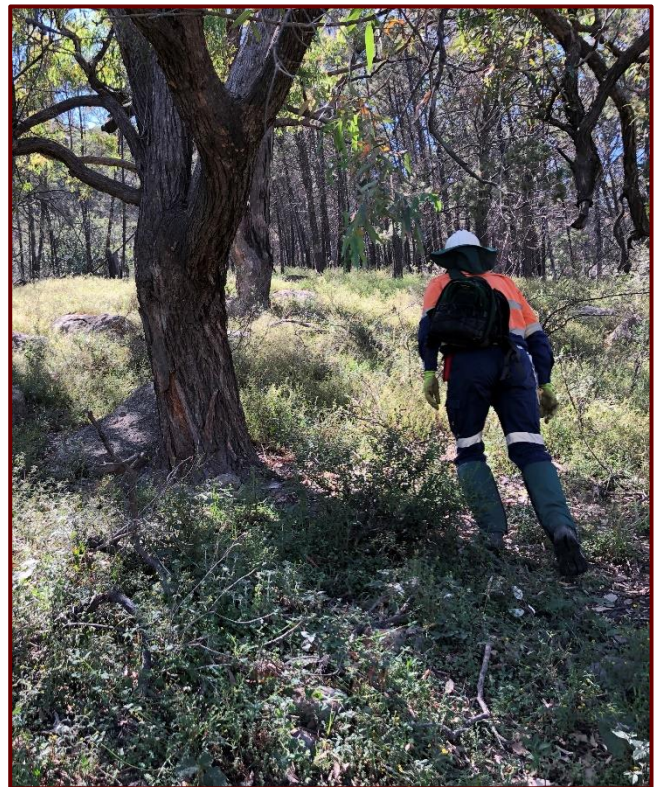
Figure 2 A welcome feature of the 2020 inspection was the return of green ground-storey vegetation in the forests surrounding the sites.

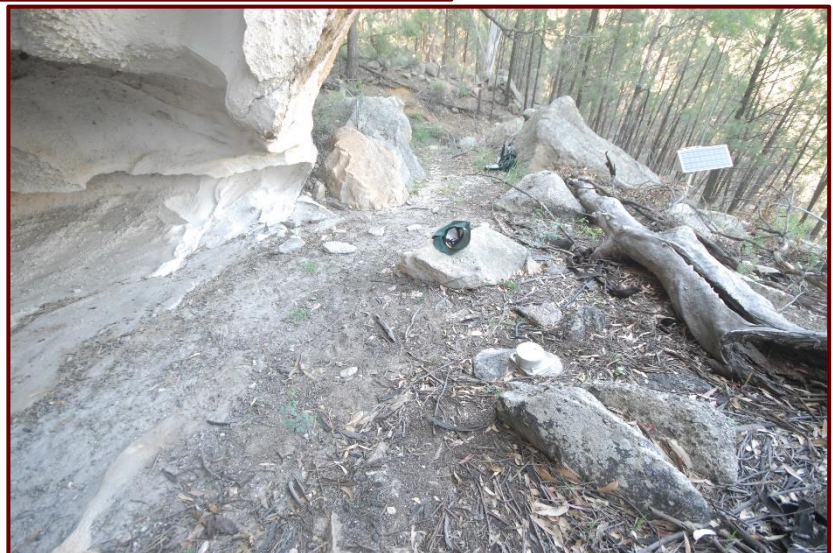
Figure 4 The former location of the WCP152 seismometer in 2014 (top left) (NOHC 2015: Fig 4.32), in 2017 (top right) (NOHC 2020: Fig 38) and during the present inspection (bottom, DSC_0315).

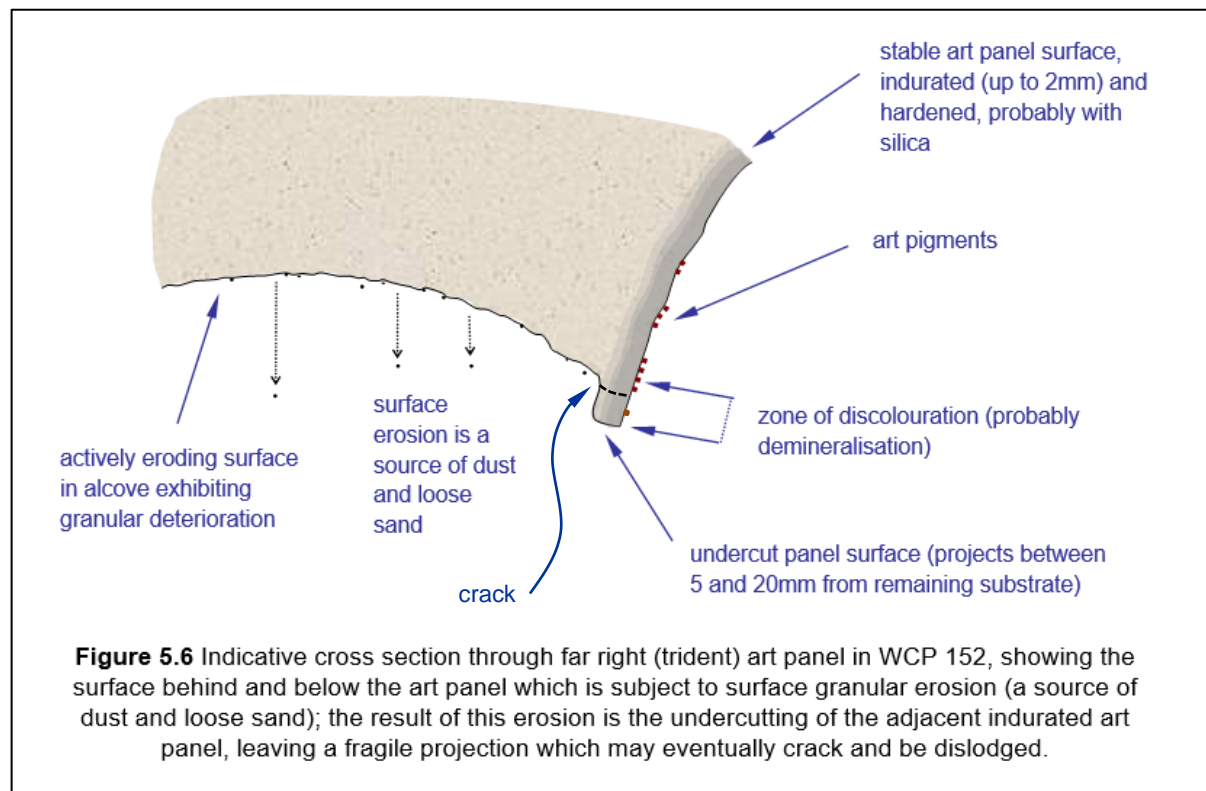
Given their actively eroding character, these surfaces are comparatively young and contain no art pigments. By contrast, the art pigments in this shelter are situated on much older surfaces which are case-hardened from mineralisation and are comparatively stable. Where the stable and actively eroding surfaces meet, there is a fragile undercut 'lip' where the erosion has eroded the underlying substrate behind the older case hardened surface (**Figure 6**). The entire lower edge of the remaining back-wall art panel has an edge of this type and is vulnerable to fracturing and dislodgement from impacts by animal and human visitors.

Figure 6 Diagram modified from (NOHC 2006:66, Fig.5.6) showing an indicative cross section through the lower portion of the WCP152 art panel.

The condition and nature of the hairline crack and remaining semi-dislodged panel-edge fragment should continue to be monitored. In the event that a portion of the art panel becomes dislodged, the piece(s) should be collected and an appropriate management action followed, (if and when determined through consultation as previously outlined).
