APPENDIX 5
BIODIVERSITY

Biodiversity Offset Strategy

WILPINJONG COAL MINE

Wilpinjong Coal Mine
2022 Channel Stability Monitoring

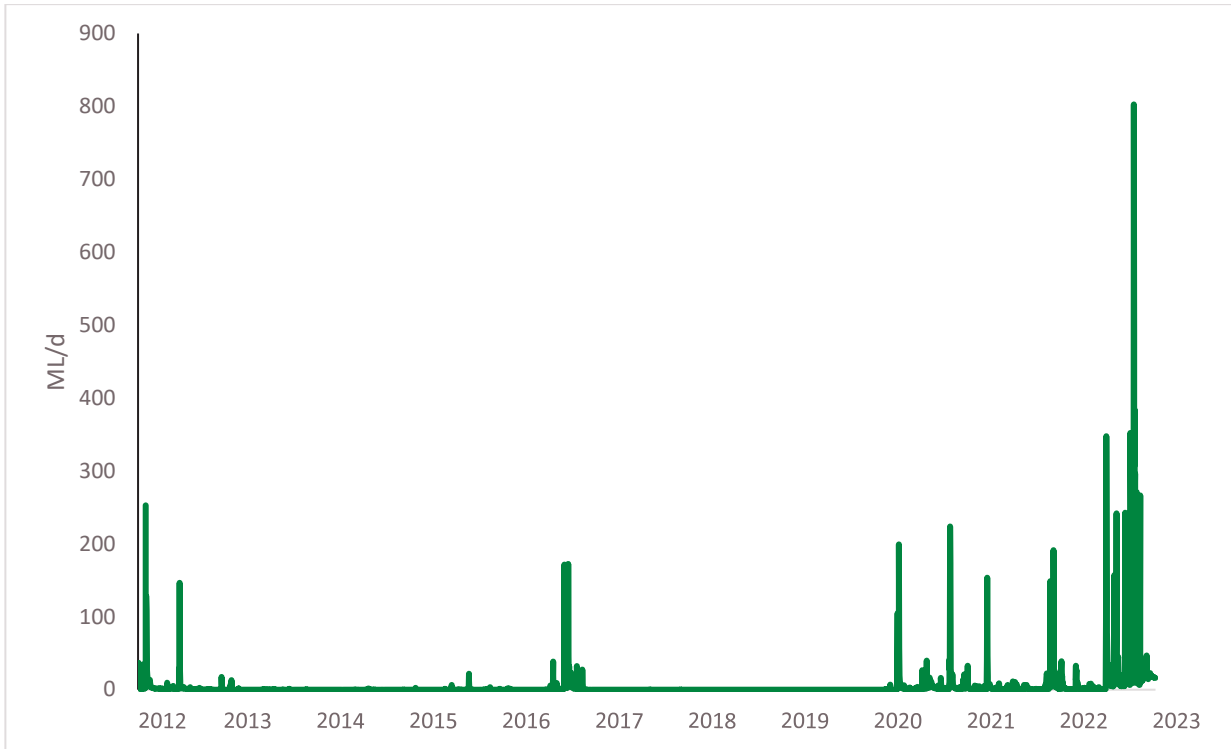
Figure 3: Wilpinjong Creek stream flow upstream of the WCPL mine discharge point EPL 24

During 2022 there were several rainfall events likely to have influenced erosion in the target creeks. Flow data indicates that water volume levels moving through the system in 2022 were higher compared to those recorded in 2021 (Figures 3 – 5). Lower than average rainfall and drought conditions were recorded between 2017 and 2019, followed by increases in 2020 and 2021, which were maintained into 2022.
