APPENDIX 4
BIODIVERSITY

Peabody
 WILPINJONG COAL MINE
 Project Area and
 Biodiversity Offset Strategy

Monitoring of Microbats at Slate Gully Adit (Pit 8), Wilpinjong Coal Mine, NSW for 2025

2025 Channel Stability Monitoring Report

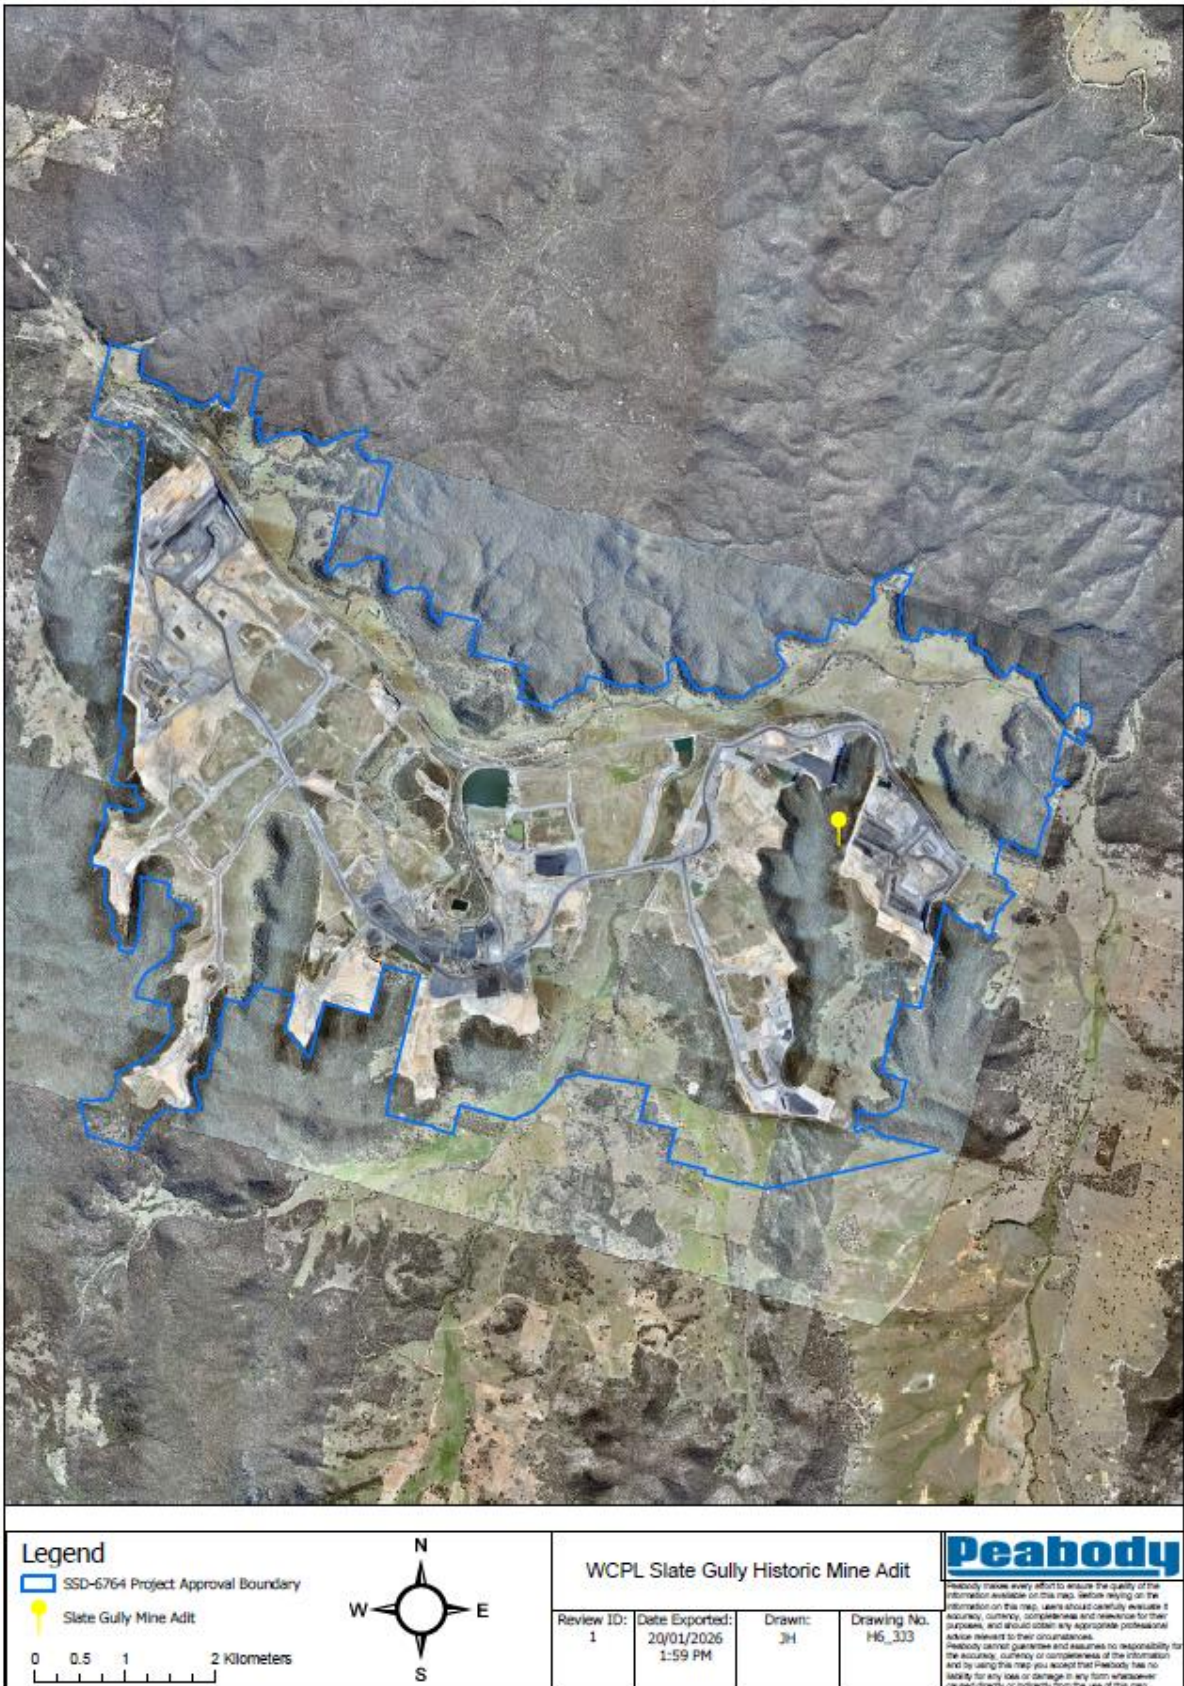
Figure 2-1: Location of Slate Gully Adit (WCPL 2026). Note topsoil stripping has passed adit, and the extraction pit is almost level with the adit (pit progression is southward).

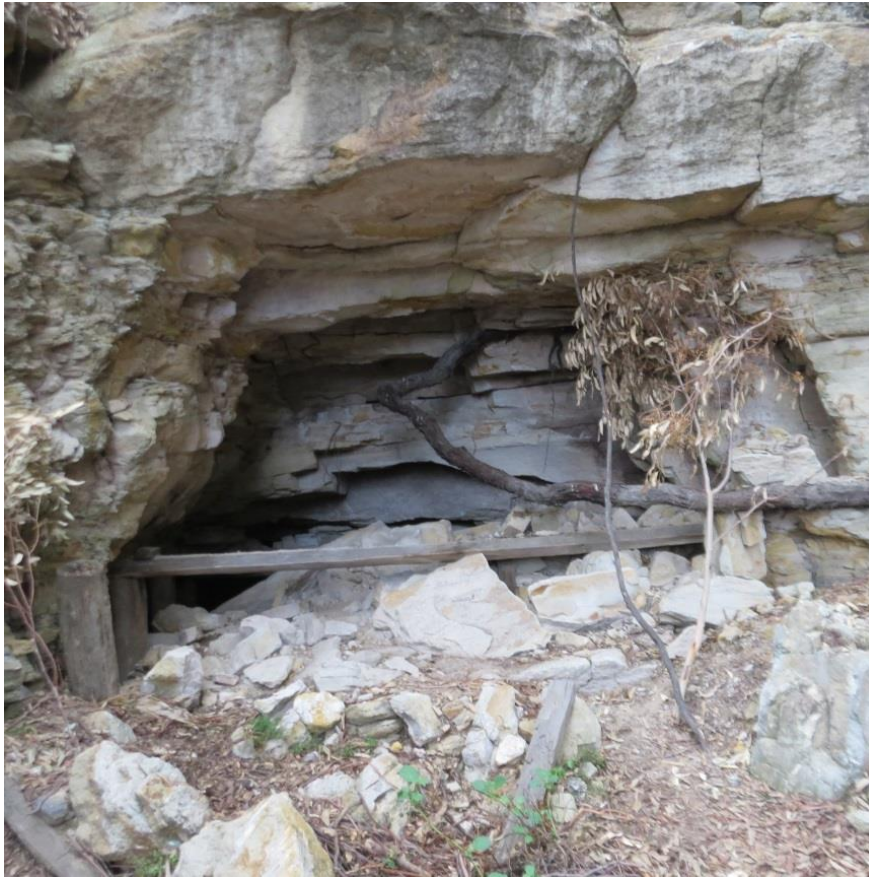
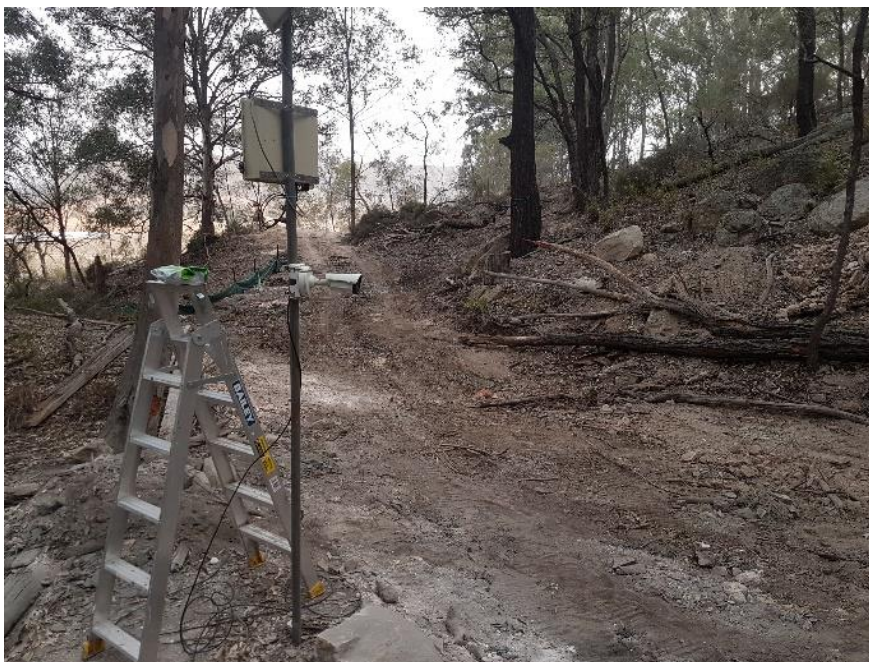
Plate 2-A: Slate Gully adit entrance prior to installation of steel pipe to maintain opening in the event of a collapse (mid 2019), also prior to installation of steel box tunnel (Apr 2023). Detector and solar panel setup 20m in front of adit.

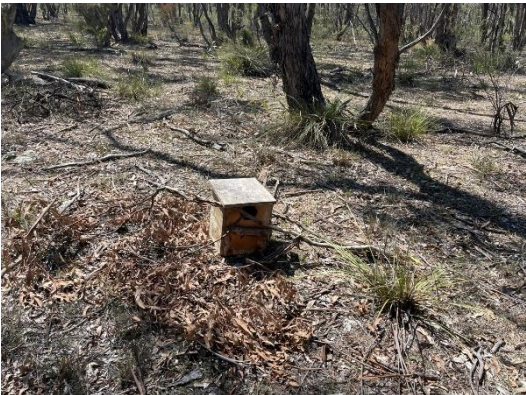
Nest box 65

Seven nest boxes were identified as needing repairs (Plate 1):

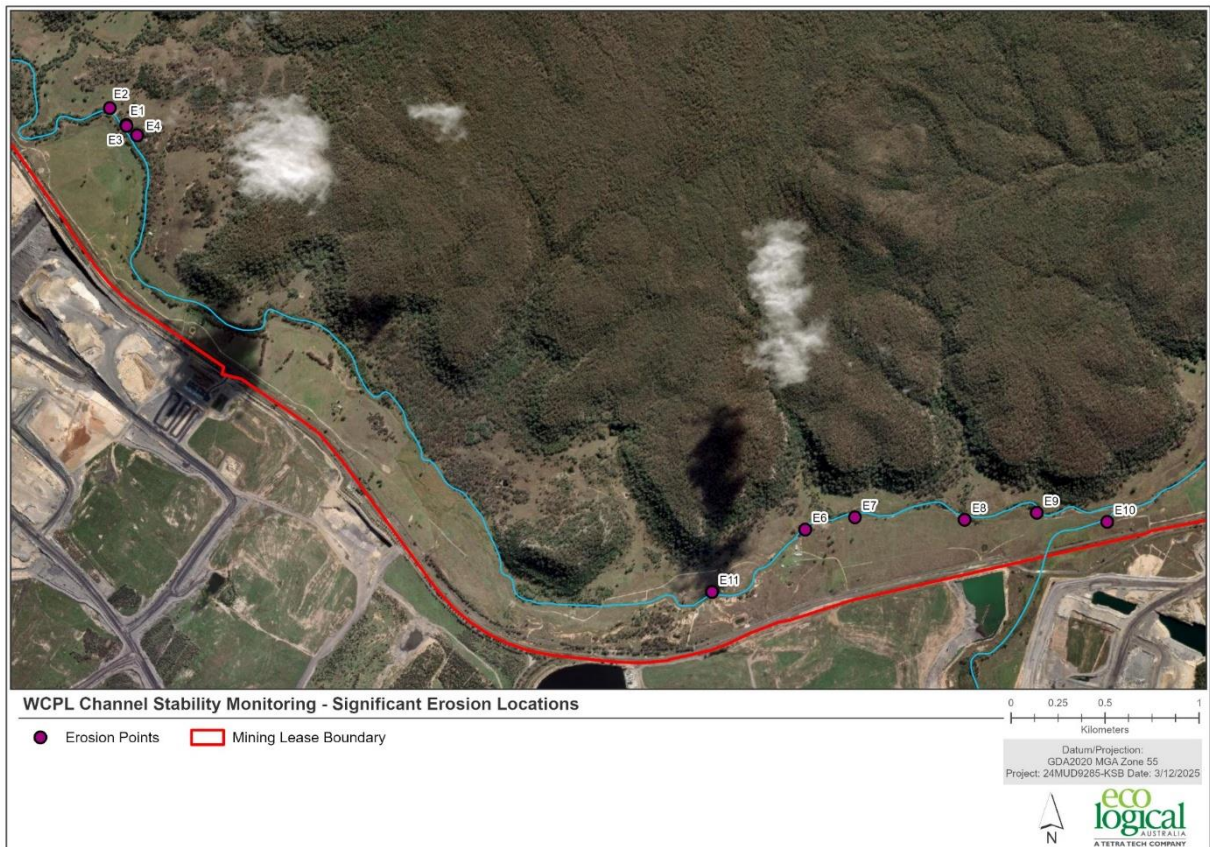
Figure 2-2: Significant erosion locations along Wilpinjong Creek

Figure 2-2:). These are in areas with moderate to severe erosion and are monitored to determine the presence and extent of on-going erosion. Management issues and threatened species were recorded opportunistically throughout the surveys, to highlight areas where management intervention is recommended.

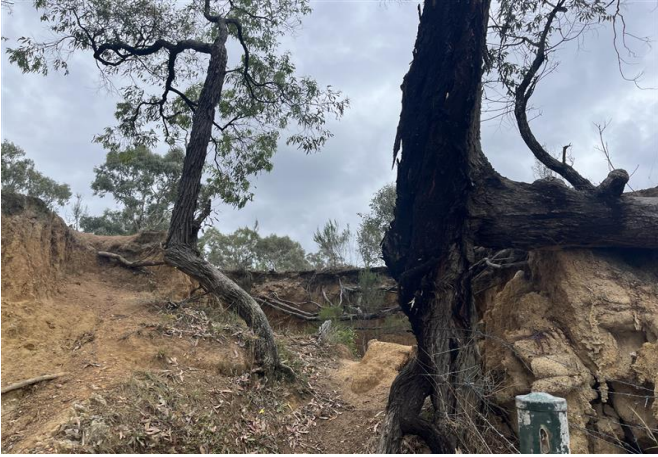
<p>Continuation of mass wasting, there appears to be some change to the left bank at the top with more erosion present.</p>
<p>E2 (768469, 6422527)</p>

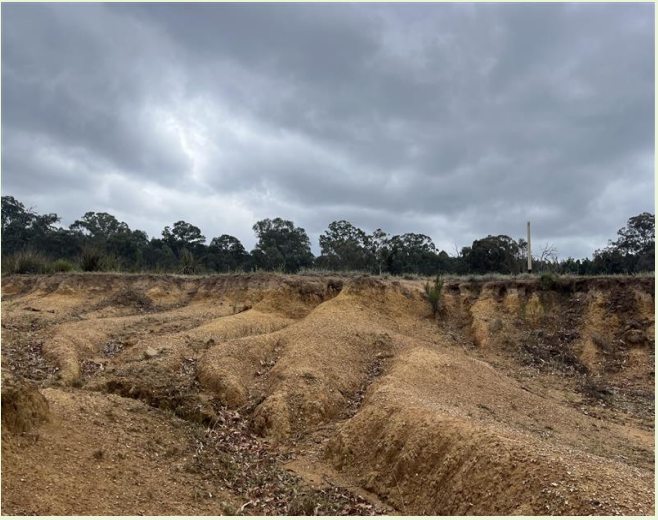
<p>Rills formed on exposed bare soil with mass wasting also evident. However, since 2024 data there doesn't appear to be any major erosion. Evidence of revegetation and mulching.</p>
<p>E3 (768558, 6422432)</p>

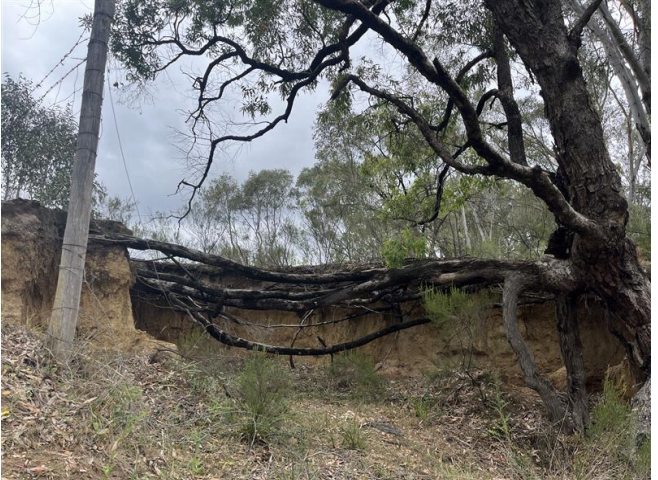
<p>Evidence of continued mass wasting at top of bank and around tree roots. Reshaping and contouring of bank to ease water flowing the erosion and revegetation. From the 2024 photo comparatively there appears to be far less veg ground cover.</p>

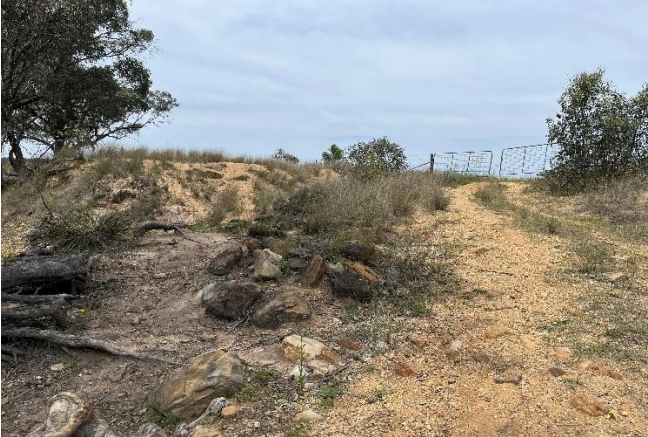
<p>Road continues to be stable with no further erosion evident. Continue to monitor rill.</p>
<p>E9 (773397, 6420376)</p>	 	<p>Erosion has continued to progress with evidence of undercutting and mass wasting. Tree roots on bank edge exposed. Reshaping and contouring of bank and revegetation.</p>
<p>E10 (773772, 6420328)</p>

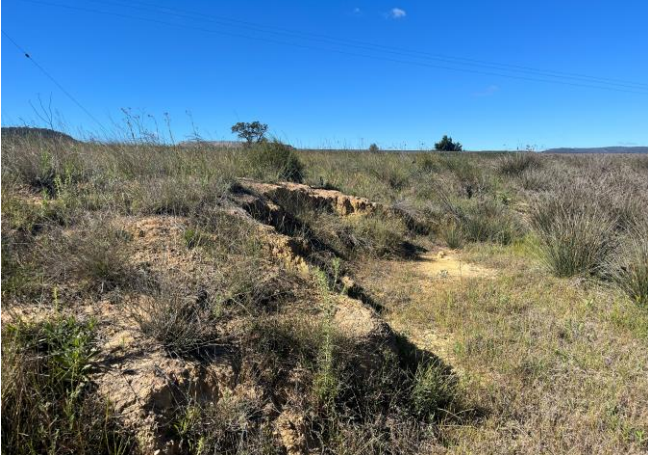
<p>Erosion has continued to remain stable over the past 2 years now. Not active at time of monitoring. Revegetation and mulching (Section 4.3)</p>
