# **2022 Annual Review**

**Wilpinjong Coal Mine**

**Table 1 Annual Review Title Block**

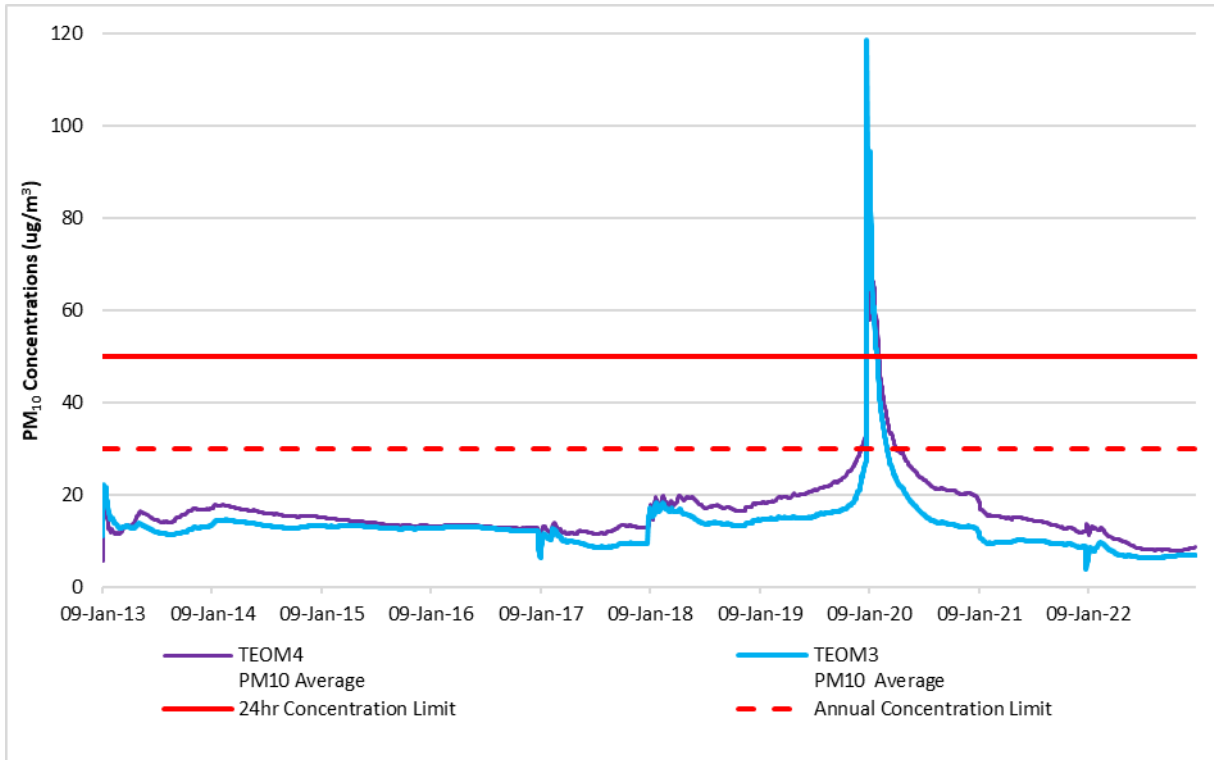
Graph 7 Compliance TEOM PM<sub>10</sub> (Rolling Averages) 2015-2022

**Notes:** The rolling annual average levels in generally show a trend of increasing levels, with the monitors all showing a sudden increase in levels at the end of 2019 associated with the 2019/2020 NSW bushfires and a sharp drop towards the end of 2020.

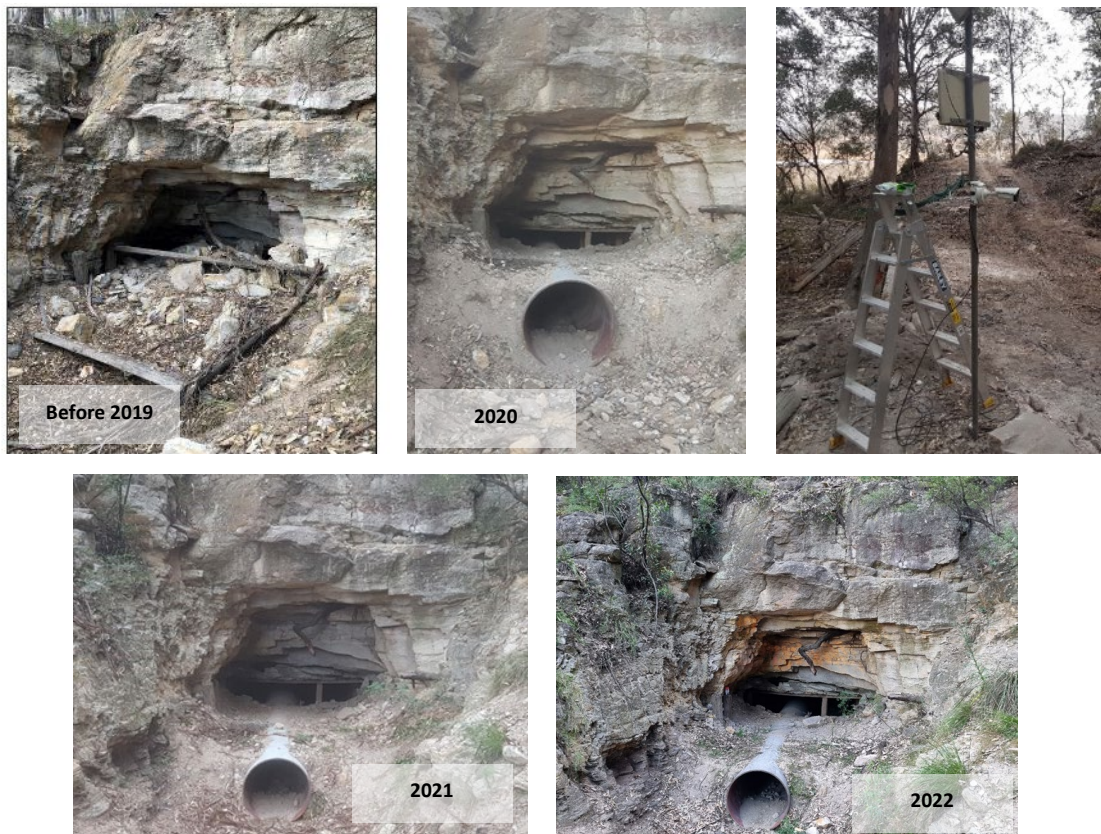
**Photo 1 Culvert Support & Bat Detector with Solar Panel setup 20m in front of Adit**

In accordance with the BMP, Eastern-Bentwing Bat Management Strategies were undertaken in 2019 with the installation of a section of 1000mm diameter steel pipe culvert inserted into the adit to ensure access/egress for microbat species. To mitigate the potential for future collapse, rock debris was removed from around the entrance. On further recommendations provided by WCPL’s microbat specialist, further rock material was removed in 2020 from around the top of the pipe to maintain access for microbats through the existing adit entry (**Photo 1**).

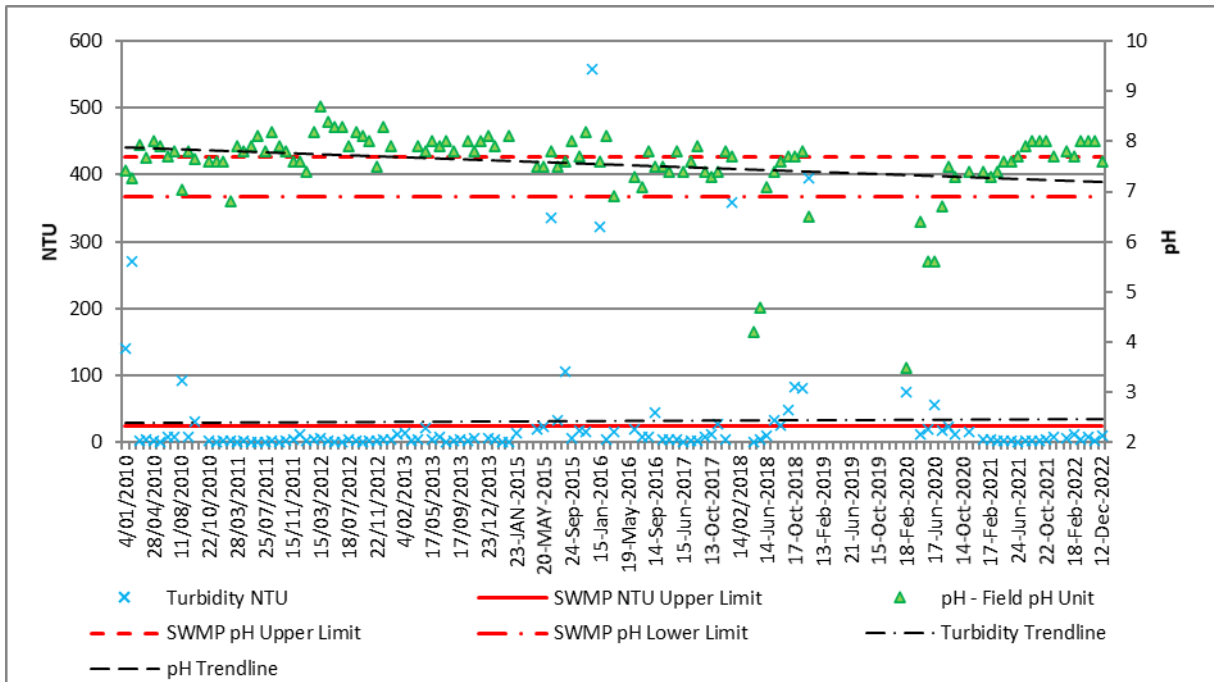
Graph 15 Long-term pH & NTU Water Quality Results at WIL\_D2

**Notes:** During 2022, pH observations at Wilpinjong Creek Downstream monitoring sites are above upper trigger values at WIL-D2 (3 consecutive observations from May-November 2022) and WIL-D (5 consecutive observations from April-August 2022). A similar trend was not observed at Wilpinjong Creek Upstream monitoring sites, therefore breaching the upper pH trigger level as defined in the SWMP (SLR 2023). During 2022, turbidity observations at Wilpinjong Creek Downstream monitoring sites are generally below the 80th percentile baseline (28 NTU) and trigger level (24 NTU) (SLR 2023).

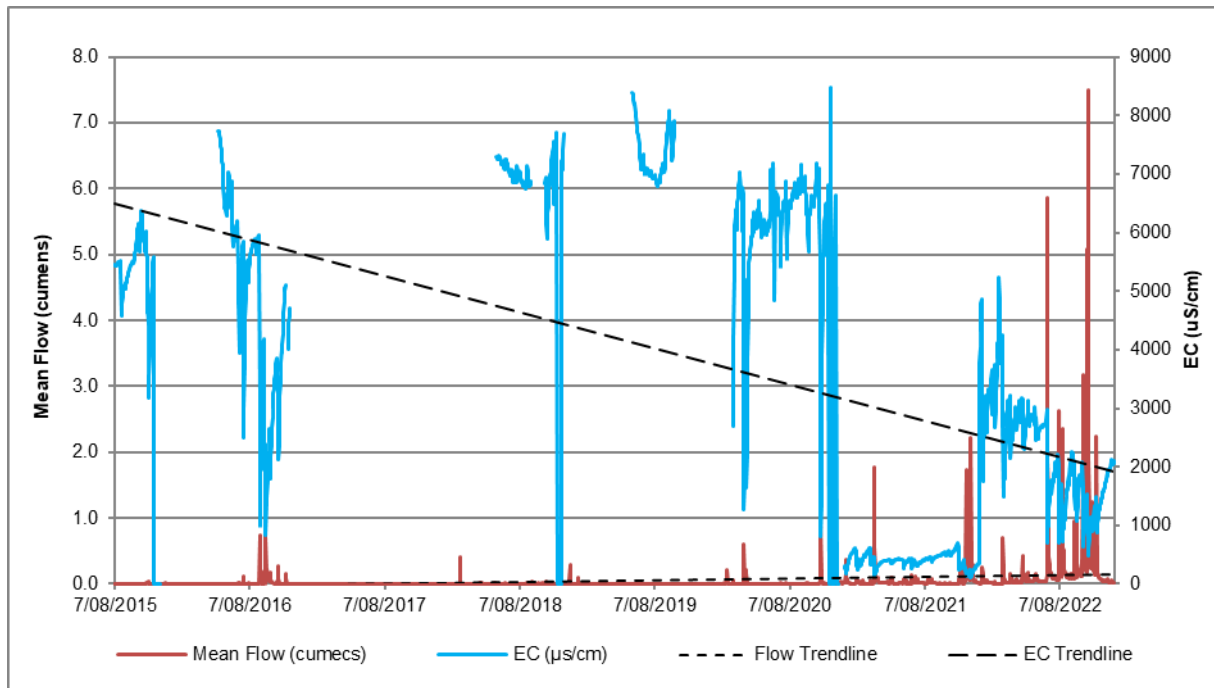
Graph 22 Gauging Station Cumbo Creek Long Term Trends

**Notes:** During 2022, flow at CCGSU fluctuates between 1 and 650 ML/day in response to rainfall events, with the highest flow events recorded in July (500 ML/day) and October (650 ML/day) 2022. CCGSU was observed to flow for the majority of the year with the exception of two brief periods in February and March. Flow at CCGSU is likely to have a persistent groundwater contribution that is sourced from weathered Permian coal measures. This results in observations of EC between 6,000 and 8,000  $\mu\text{S}/\text{cm}$ . Declines in EC are observed following peak rainfall events (SLR 2023).

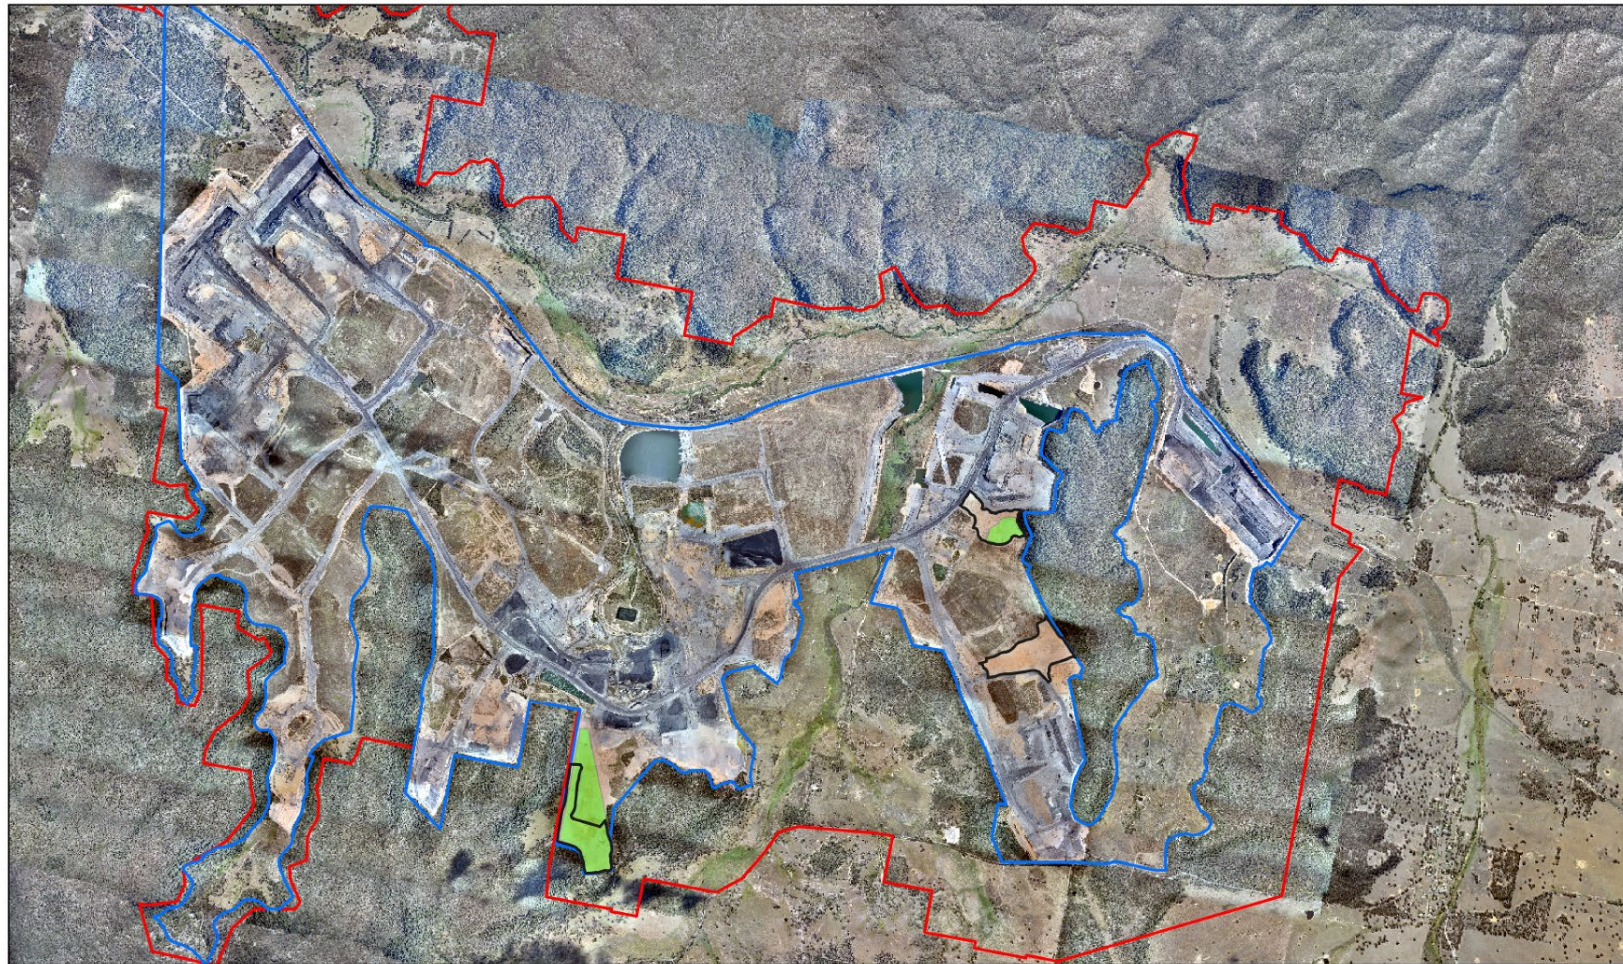
Figure 4 Rehabilitation Forecast Vs Actual 2022

- 2022 RMP Ecosystem & Land Use Establishment Areas - 34.9Ha
- 2022 Claimed Ecosystem & Land Use Establishment Areas - 47.1Ha
- SSD 6764 Disturbance Boundary
- SSD 6764 Approval Boundary

The predictive versus actual cumulative and rehabilitation progression for Year 1 (i.e. Plan 2A) as presented in the current ARRFP completed during the Reporting Period is provided in **Table 31** and **Figure 4**.

During 2022, a combination of approximately 42.8ha within the Mining Domain of overburden emplacement areas were completed in preparation for topsoil placement, ripping and seeding (**Figure 4**).

During 2022, a combination of approximately 47.1ha within the Mining Domain of overburden emplacement areas were topsoiled and ameliorated (**Figure 4**).

Areas rehabilitated in 2022 were directly seeded with specific native seed species aligning to particular BVTs (**Figure 4**). These BVT mixes did include a small ratio of cover crops (cereals) to provide quick germination, soil stability and structure. Of the 47.1ha rehabilitated in 2022, a total of 2 BVT's were established onsite with specific BVT seed mixes, these included;
