METROPOLITAN COAL LONGWALLS 305-307

BUILT FEATURES MANAGEMENT PLAN

GARRAWARRA CENTRE COMPLEX

ME-TSE-MNP-0086

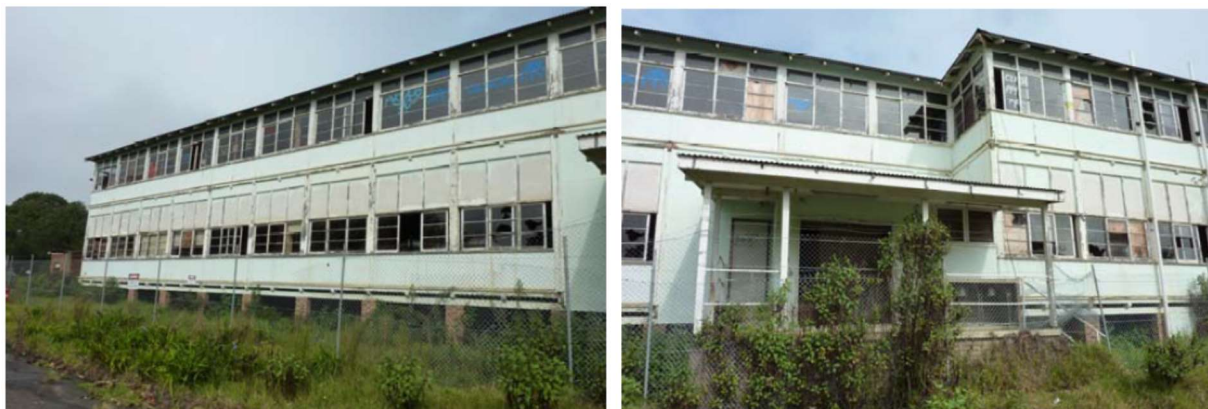
**Plates 1 & 2 – Abandoned Hospital Buildings [A01a] {Former Male Wards}
(Source: MSEC, 2016)**

No abandoned hospital buildings will be directly undermined by Longwalls 301-307. The abandoned hospital buildings are located more than 375 m away from the nearest longwall. No hospital buildings (including Former Male Wards [i.e. Wards 1 to 8 and Dining Room], Former Female Wards [i.e. Wards 1 to 9 and Library/Canteen], Laundry/Boilerhouse or Workshops nor the Gatehouse and Gate Piers are within the predicted 20 mm subsidence contour for Longwalls 301-303, Longwall 304 or Longwalls 305-307.

Photographs of the abandoned hospital building structures are shown on Plates 1 to 4.

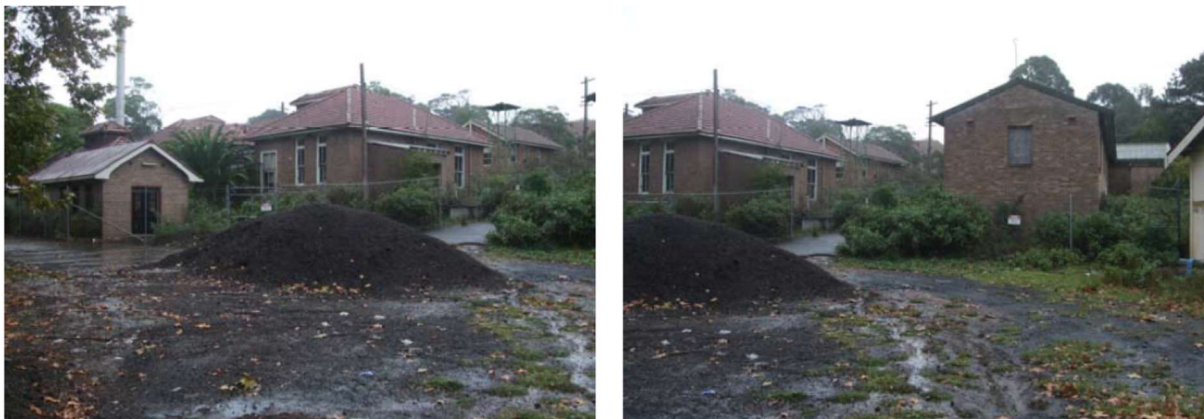
**Plates 3 & 4 – Abandoned Hospital Buildings [B03a] {Laundry / Boilerhouse}
(Source: MSEC, 2016)**

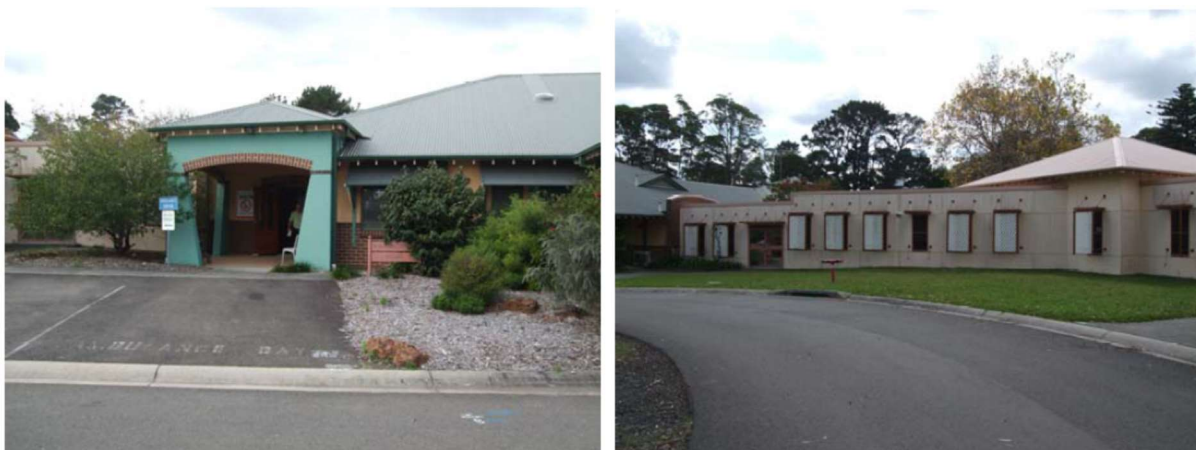
**Plates 5 & 6 – Aged Care Building Structures [B01a-B01d] {Administration}
(Source: MSEC, 2016)**

No aged care building structures will be directly undermined by Longwalls 301-307. The aged care buildings are located more than 250 m away from the nearest longwall. No aged care buildings (including the Nurses Quarters and Administration/Kitchen Group) are within the predicted 20 mm subsidence contour for Longwalls 301-303, Longwall 304 or Longwalls 305-307.

Photographs of the aged care building structures are shown on Plates 5 to 10.

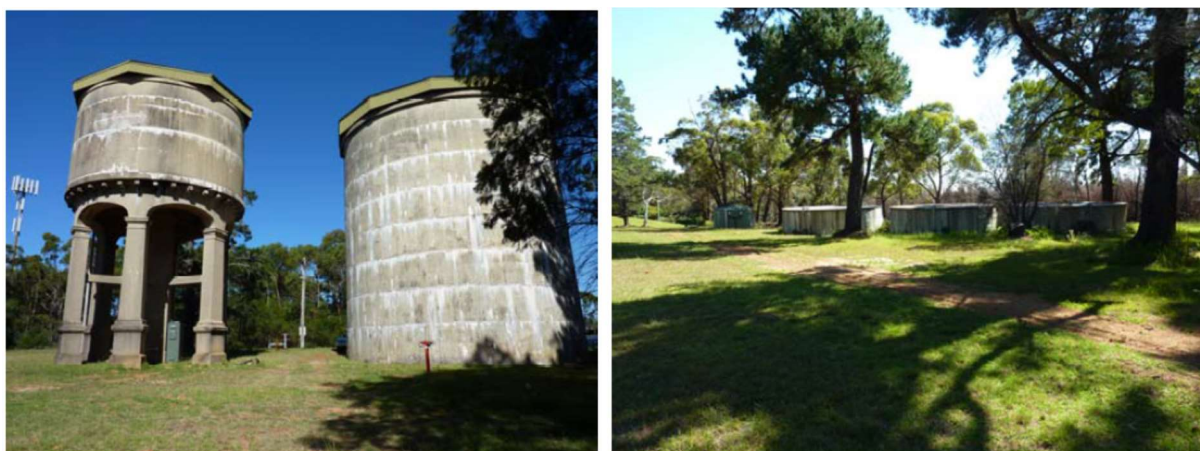
Plates 15 & 16 – Large Water Storage Tanks (Source: MSEC, 2016)

The two large water storage tanks (B14t01 and B14t02) and the below ground water storage tanks (B16t01-B16t03) are shown on Plates 15 and 16. It is noted that no water is currently stored in the elevated tank structure (Plate 15 - reservoir on the left).

Subsequent to the Longwalls 301-303 risk assessment, an agreement was reached between South Eastern Sydney Local Health District and Metropolitan Coal to remove derelict water tank B14t02 as part of risk mitigation process. The Memorandum of Understanding – signed 31 August 2017 details the structures to be removed subject to Wollongong City Council development approval. This derelict structure will be fenced during active subsidence effect periods or until removed.

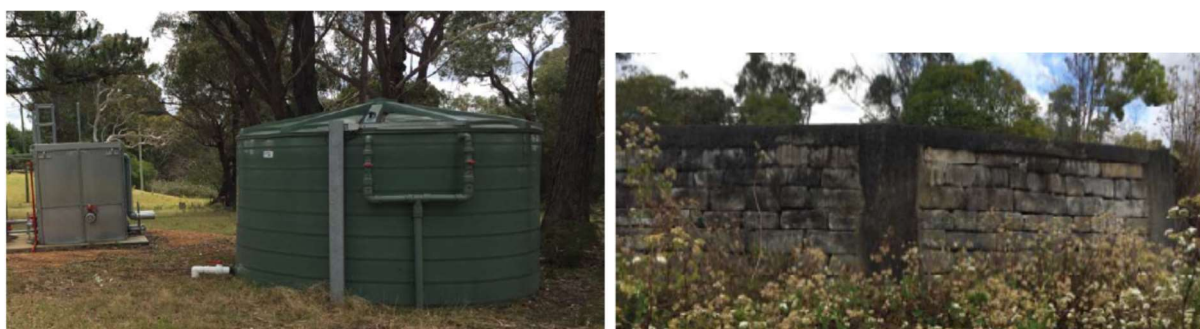
Plates 17 & 18 – Fire Water Tank and Steel Tank Adjacent Pump House, and Trickle Filter Tank (Source: MSEC, 2016)

The fire water tank and steel tank adjacent the pump house (B17t01 and B18t01), and the trickle filter tank (B15t01) are shown on Plates 17 and 18.

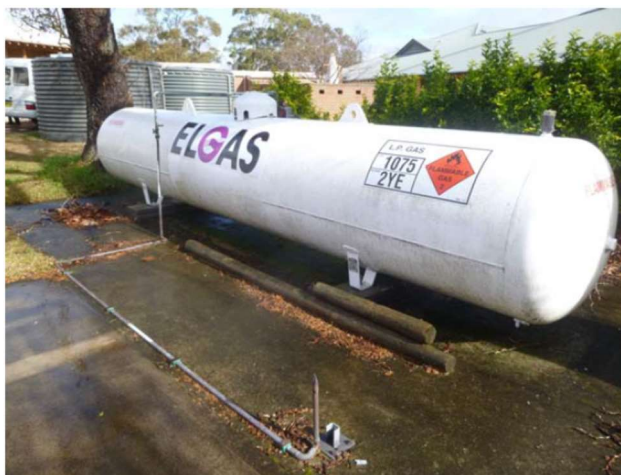
Plate 19 – Gas Storage Tank (Source: MSEC, 2016)

The gas storage tank will not be directly undermined by Longwalls 301-307. The gas storage tank is located more than 310 m away from the nearest longwall. The gas storage tank is not within the predicted 20 mm subsidence contour for Longwalls 301-303, Longwall 304 or Longwalls 305-307.

A baseline audit has been conducted to confirm the system of connection between gas storage tank and associated pipeline(s) at the Garrawarra Centre Complex is a flexible connection.

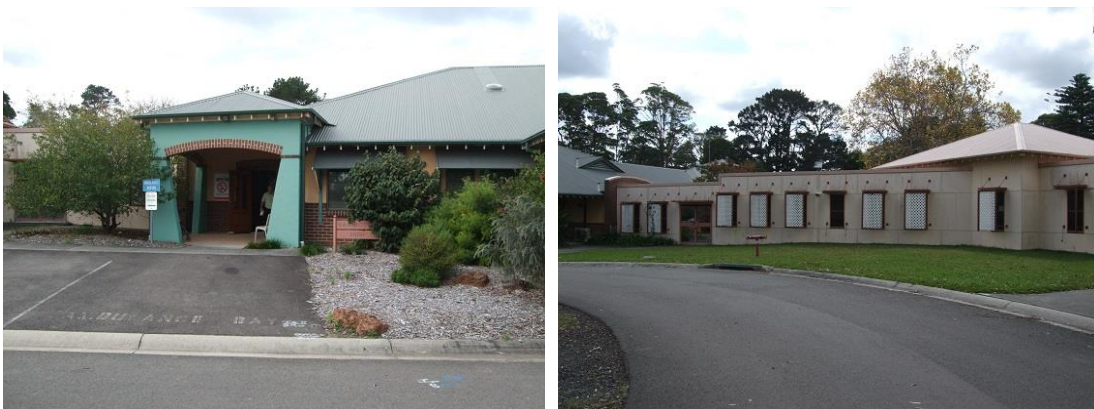
Structure Refs. B01a to B01d are located over 240 m to the north-east of Longwall 305. These buildings comprise single storey structures founded on a combination of ground slabs, strip footings and pad footings. The external walls are brick-veneer and the internal walls are of lightweight construction. The roofs are steel framed with metal sheeting. Photographs of these structures are provided in Figure 3.

Figure 3 Aged Care Building Structure Refs. B01a to B01d

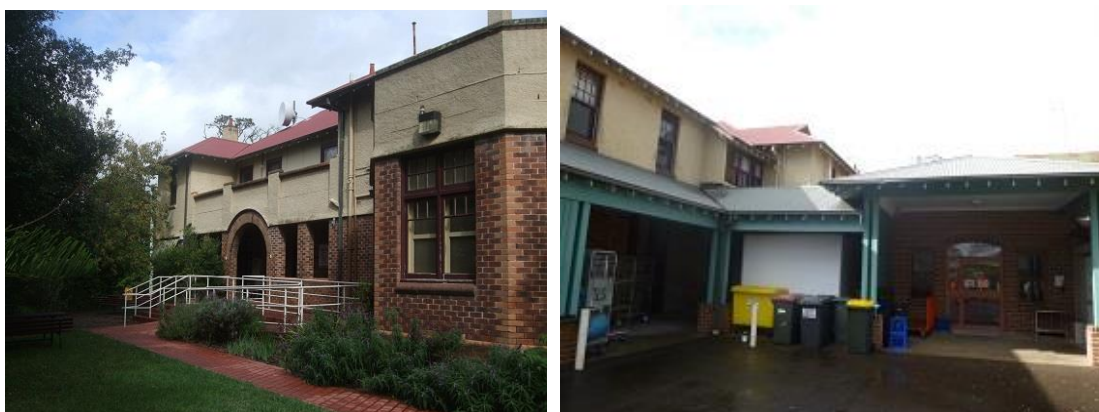
Structure Ref. B01e is located 350 m to the north-east of Longwall 305. This building is a double storey brick structure founded on a ground slab with a tiled roof. Photographs of this structure are provided in Figure 4.

Figure 4 Aged Care Building Structure Ref. B01e

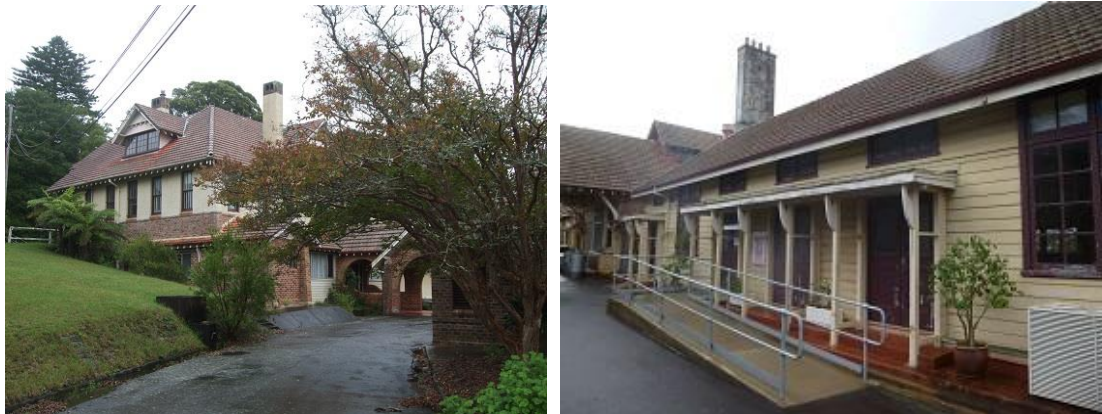
Structure Refs. B02a to B02h are located outside the Study Area. These buildings comprise one and two storey structures founded on strip footings and ground slabs. The perimeter walls are double brick, but in some cases the upper levels have timber framed walls. The suspended floors are timber framed and in some cases are supported on steel frames. The tiled roofs are supported by timber frames. Photographs of two of these structures are provided in Figure 5.

Figure 5 Aged Care Building Structure Refs. B02a and B02b

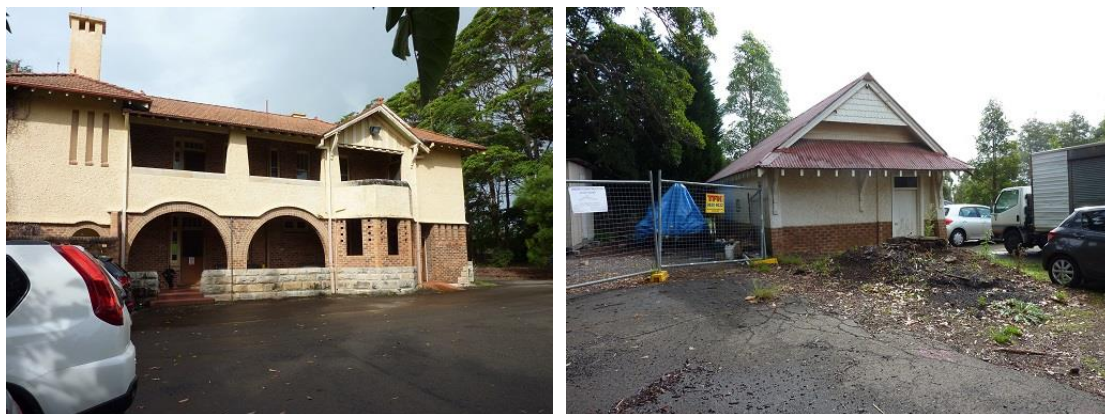
Structure Refs. A01m, A02a to A06a are located outside the Study Area. Structure Refs. A07a and A08a are partially located within the Study Area boundary, and Structure Ref. A09a is located within the Study Area. This building is a two storey double brick structure on strip footings with timber floor and a tiled roof. Photographs of this house and the associated structure A09b are provided in Figure 6.

Figure 6 House Structure Ref. A09a (left side) and A09b (right side)

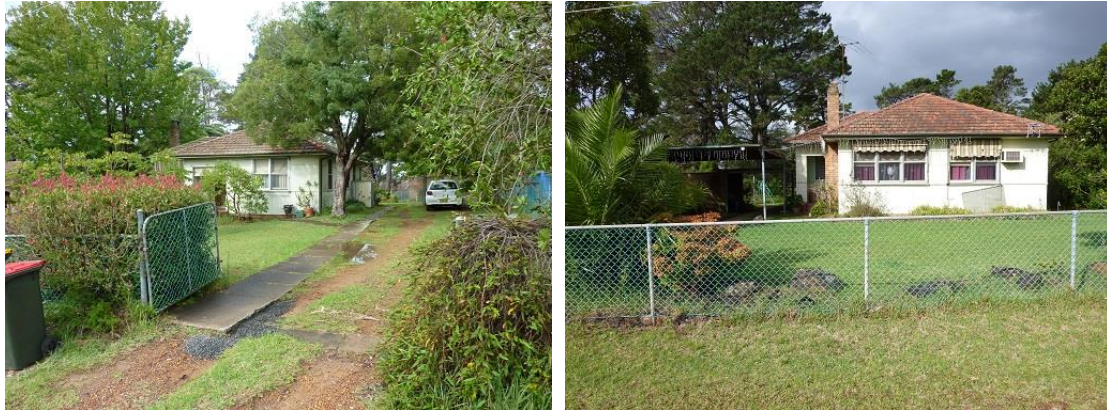
Structure Refs. B04a to B09a are located 360 m to 400 m to the east of Longwall 305. These houses are one storey structures founded on brick piers and low-level perimeter brick walls with timber floors, fibro walls and tiled roofs. Photographs of two of these houses are provided in Figure 7. The houses are currently vacant and have been fenced off in preparation for demolition.

Figure 7 Houses Structure Refs. B06a (left side) and B08a (right side)

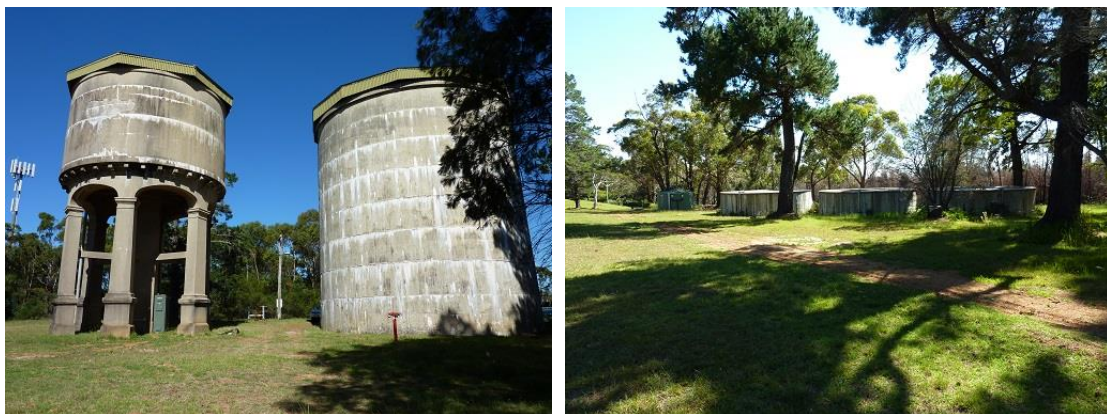
The other main structures on the complex include water storage tanks (Refs. B14t01, B14t02, B15t01 to B15t03, B17t01, and B18t01), above ground gas storage tank (Ref. B01t03), and trickle filter tank B16t01. Photographs of these features are provided in Figure 8 to Figure 11.

Figure 8 Water Storage Tanks Refs. B14t01 and B14t02 (left side) and Refs. B15t01 to B15t03 (right side)

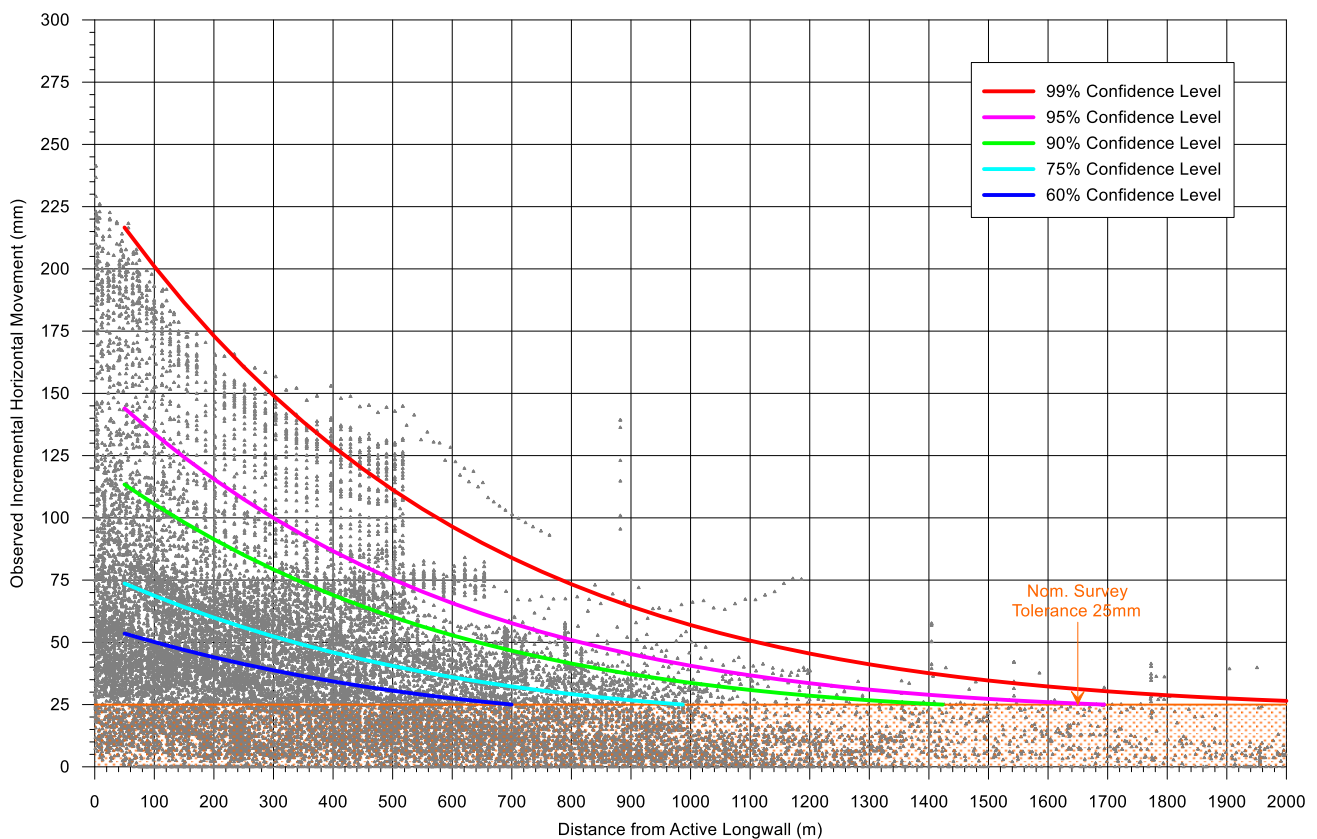
The observed incremental far-field horizontal movements, resulting from the extraction of longwalls in the Southern Coalfield, are provided in Figure 12. The data is based on survey marks located outside of the mining area (i.e. above solid coal).

Figure 12 Observed Incremental Far-field Horizontal Movements from the Southern Coalfield (Solid Coal)

The nearest building (B01a) is located 240 m from Longwall 305. The absolute incremental horizontal movements measured at distances greater than 240 m from mining are in the order of 110 mm based on the 95% confidence level. The observed far-field horizontal movements are expected to reduce with increasing distance from Longwall 305. The absolute incremental horizontal movements at the furthest structures (650 m) are in the order of 65 mm based on the 95% confidence level.
