METROPOLITAN COAL

LONGWALLS 301-303

BUILT FEATURES MANAGEMENT PLAN GARRAWARRA CENTRE COMPLEX

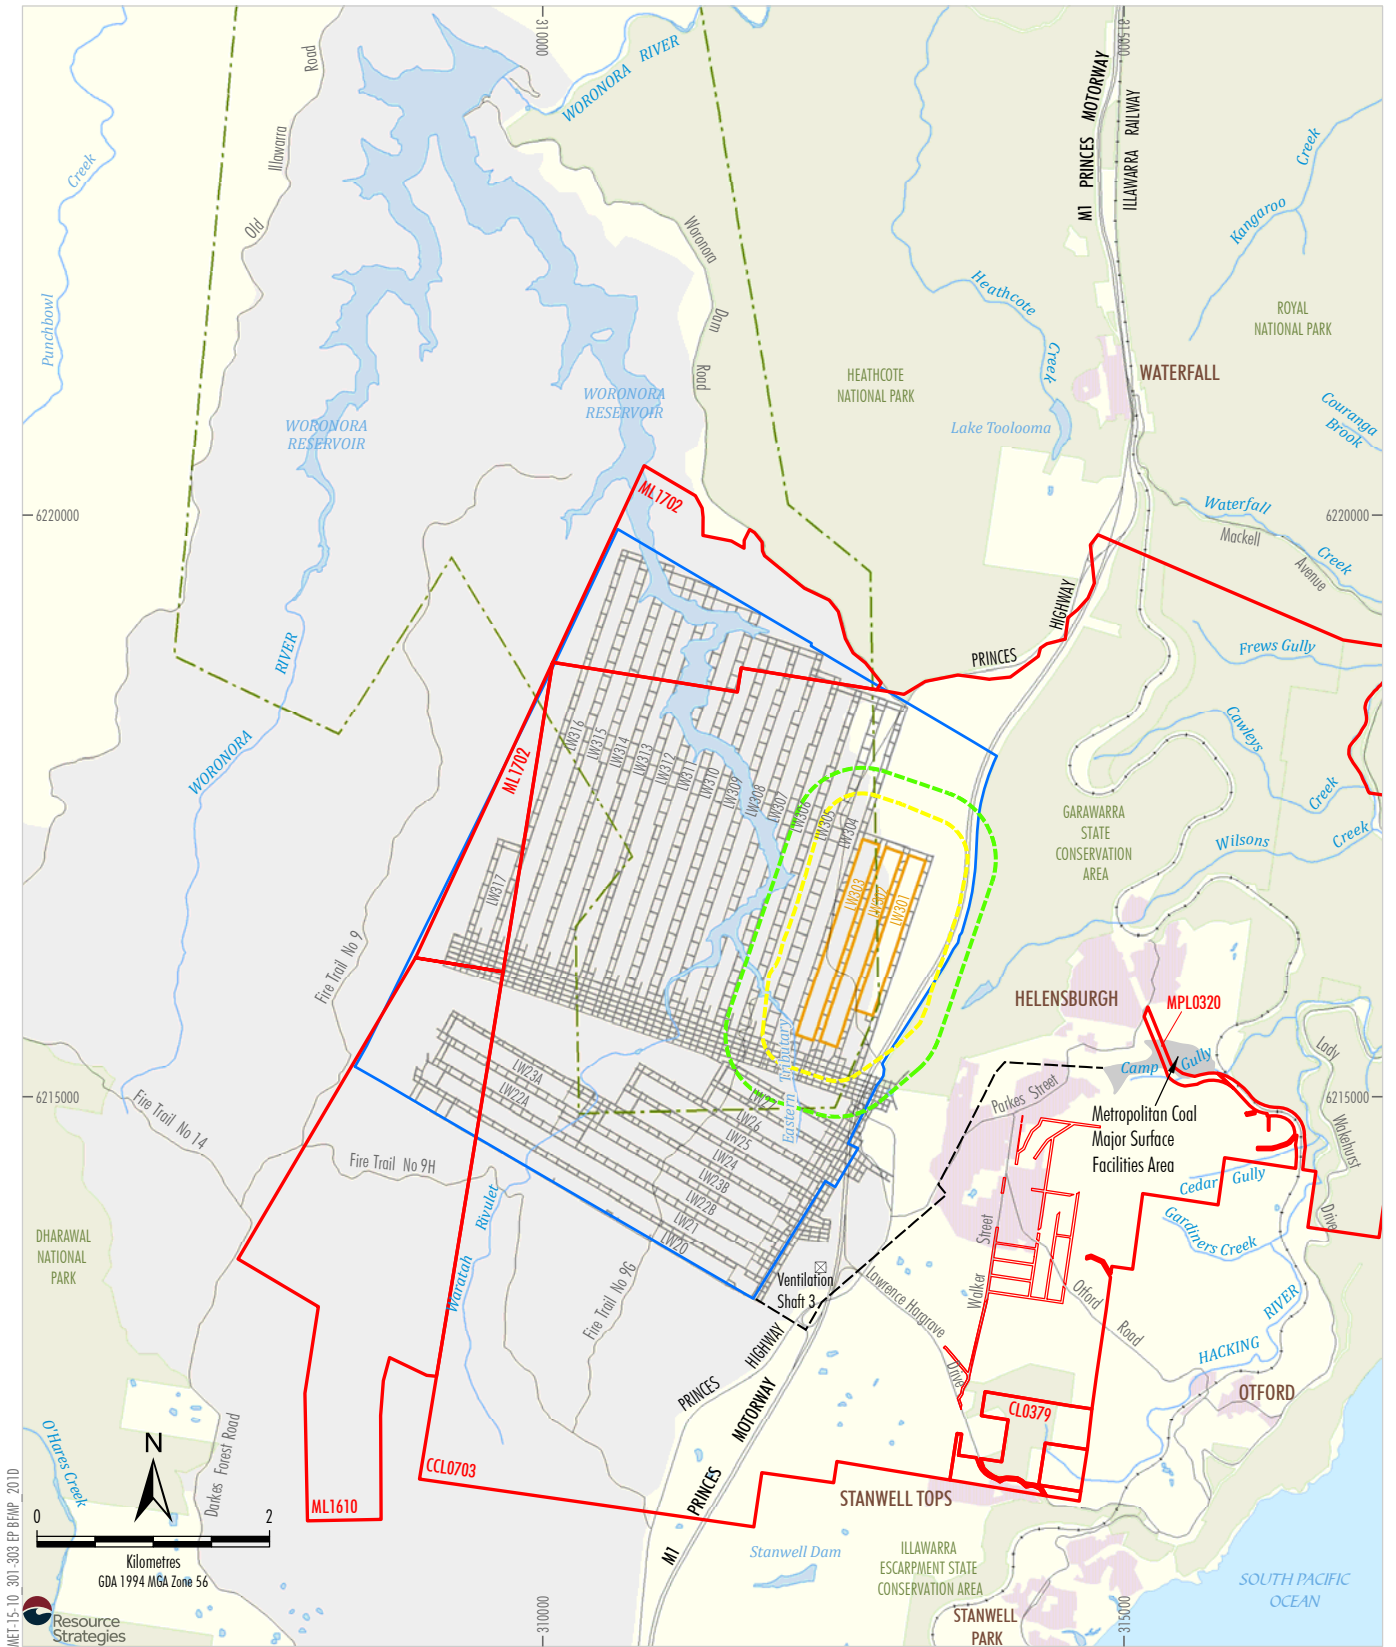
Figure 1

METROPOLITAN COAL
 Project Longwalls 20 - 27 and
 Longwalls 301 - 317 Layout

The Project comprises the continuation, upgrade and extension of underground coal mining operations and surface facilities at Metropolitan Coal. The underground mining longwall layout is shown on Figure 1. Following the completion of Longwall 27 in 2017, Longwalls 301, 302 and 303 (herein referred to as Longwalls 301-303) define the next mining sub-domain within the Project underground mining area (Figures 1 to 3).

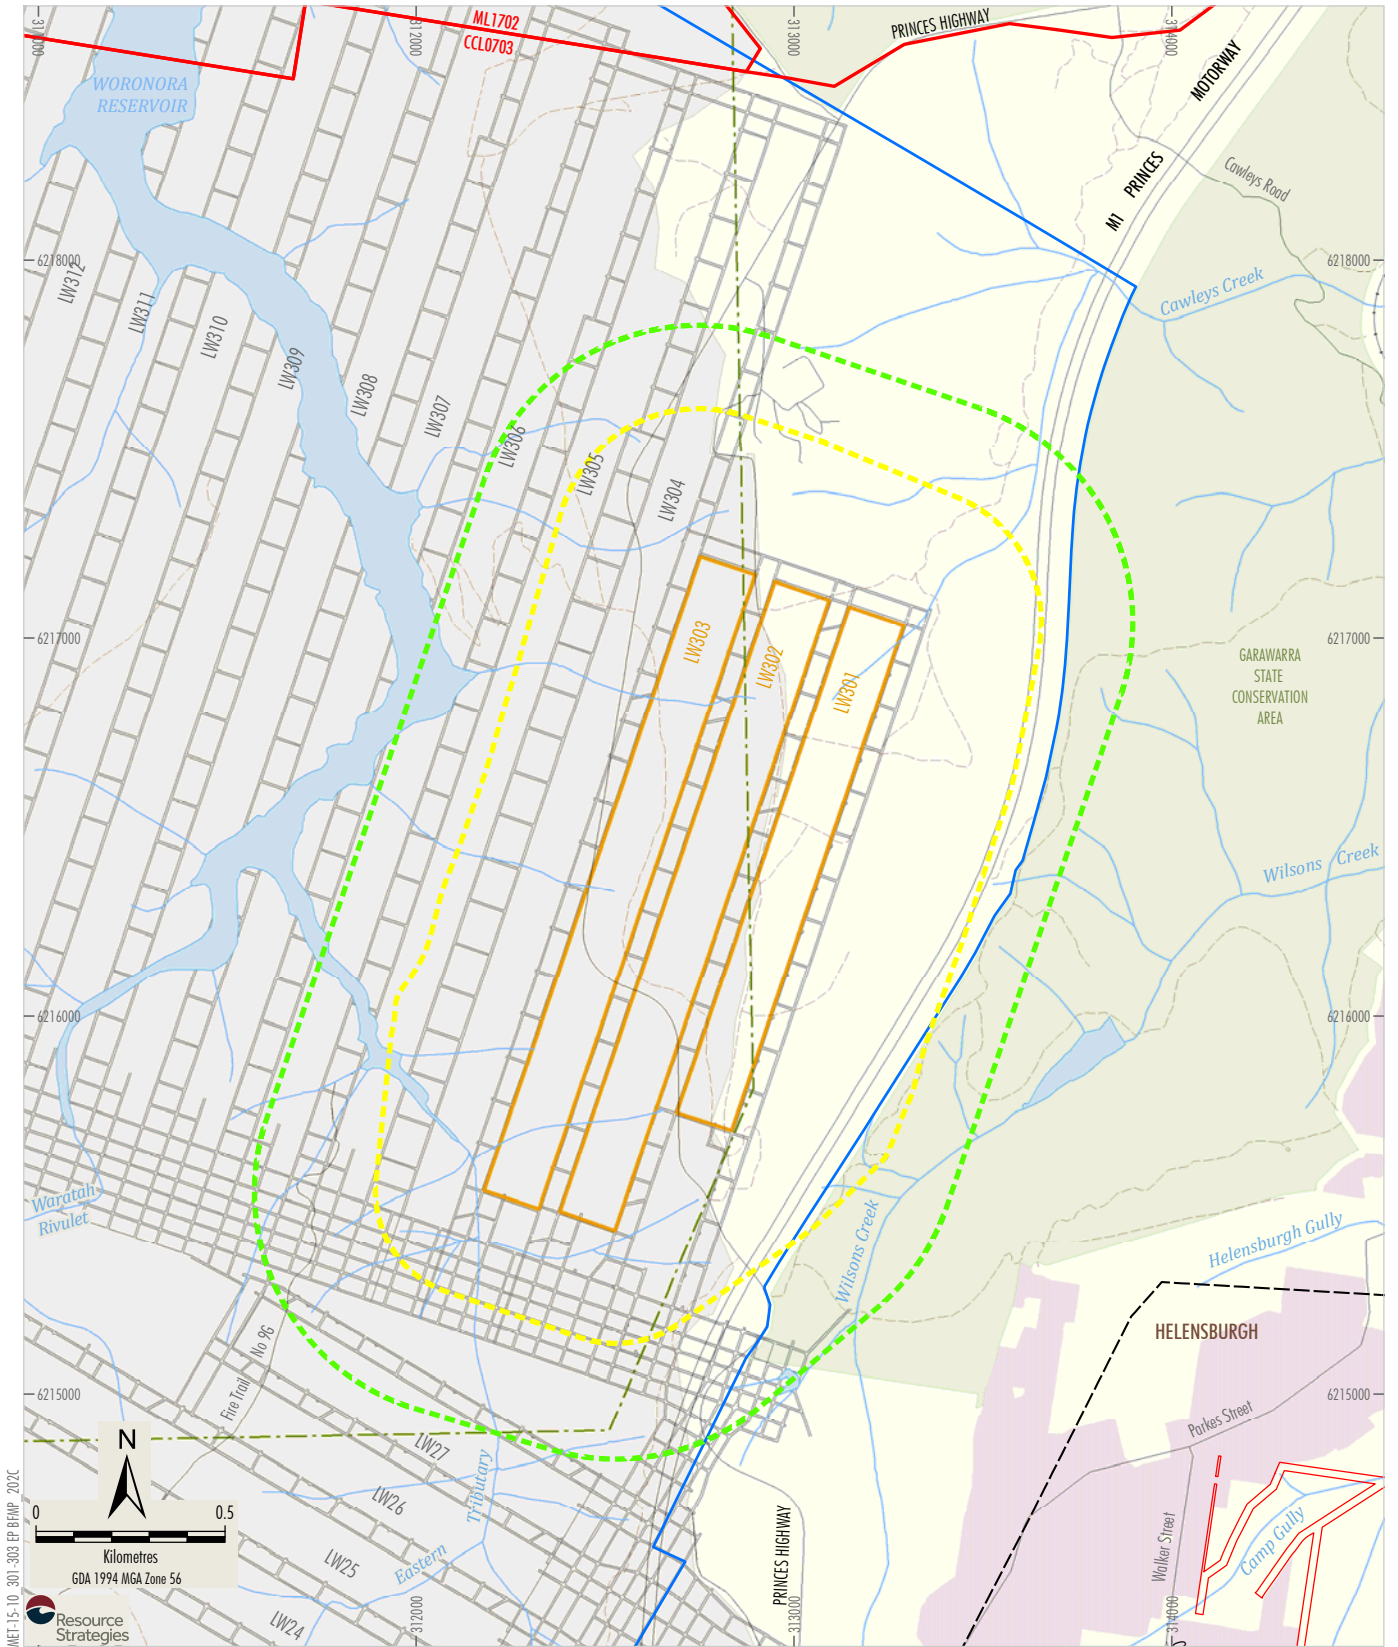
Figure 2

METROPOLITAN COAL
Longwalls 301 - 303 Layout

Longwalls 301-303 and the area of land within 600 metres (m) of Longwalls 301-303 secondary extraction are shown on Figures 2 and 3. Longwall extraction occurs from north to south. The longwall layout includes 163 m panel widths (void) with 45 m pillars (solid).

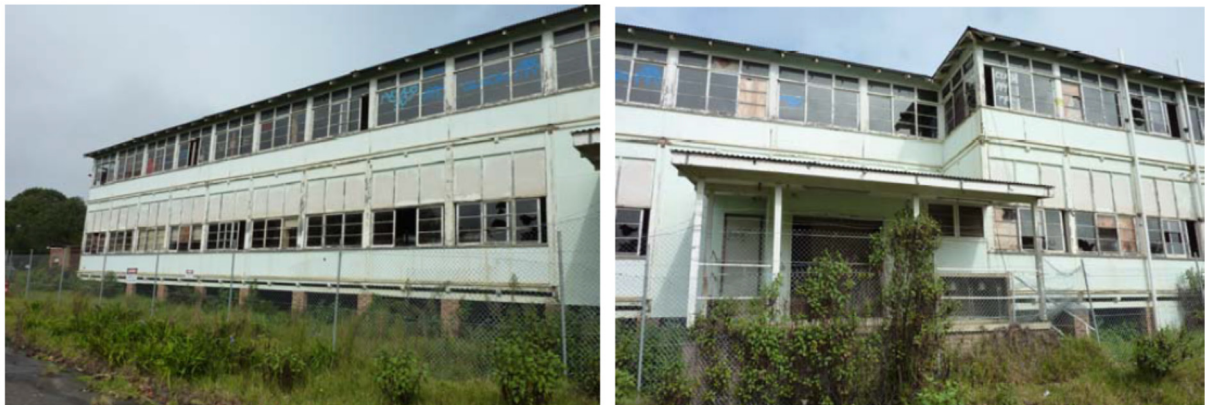
Plates 1 & 2 – Abandoned Hospital Buildings [A01a] {Former Male Wards} (Source: MSEC, 2016)

No abandoned hospital buildings will be directly undermined by Longwalls 301-303. The abandoned hospital buildings are located more than 375 m away from the nearest longwall. No hospital buildings (including Former Male Wards [i.e. Wards 1 to 8 and Dining Room], Former Female Wards [i.e. Wards 1 to 9 and Library/Canteen], Laundry/Boilerhouse or Workshops nor the Gatehouse and Gate Piers are within the predicted 20 mm subsidence contour for Longwalls 301-303.

Photographs of the abandoned hospital building structures are shown on Plates 1 to 4.

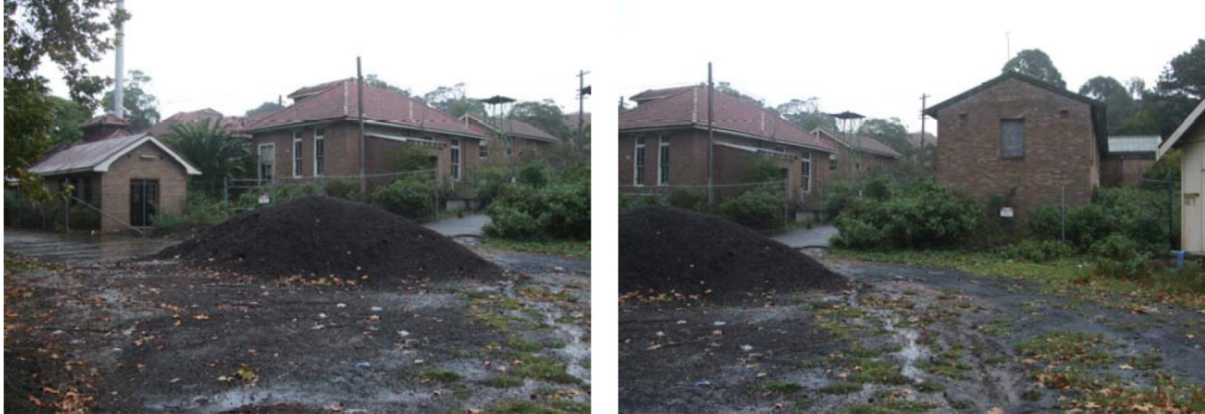
Plates 3 & 4 – Abandoned Hospital Buildings [B03a] {Laundry / Boilerhouse} (Source: MSEC, 2016)

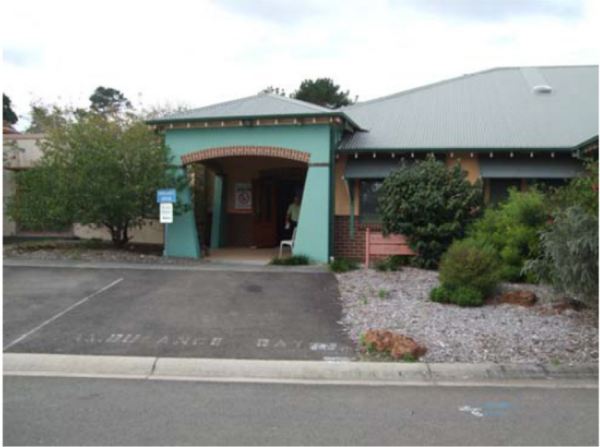
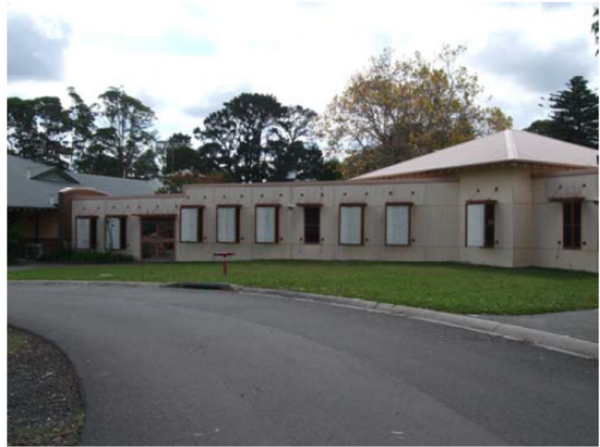
**Plates 5 & 6 – Aged Care Building Structures [B01a-B01d] {Administration}
(Source: MSEC, 2016)**

Photographs of the aged care building structures are shown on Plates 5 to 10.

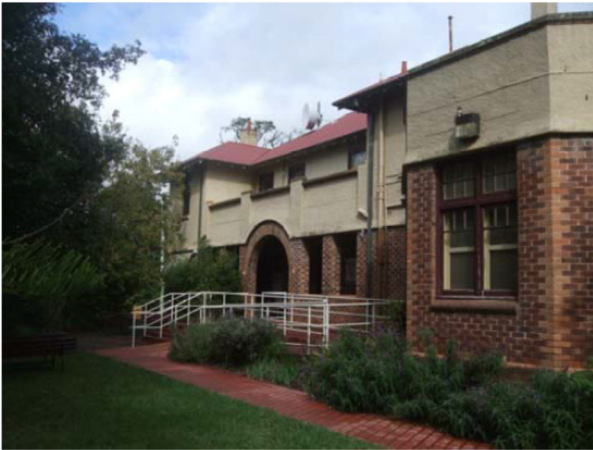
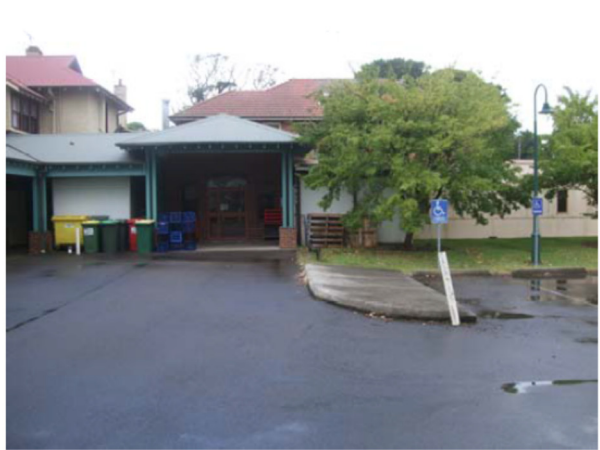
Plates 7 & 8 – Aged Care Building Structures [B01e] {Nurses Quarters} (Source: MSEC, 2016)

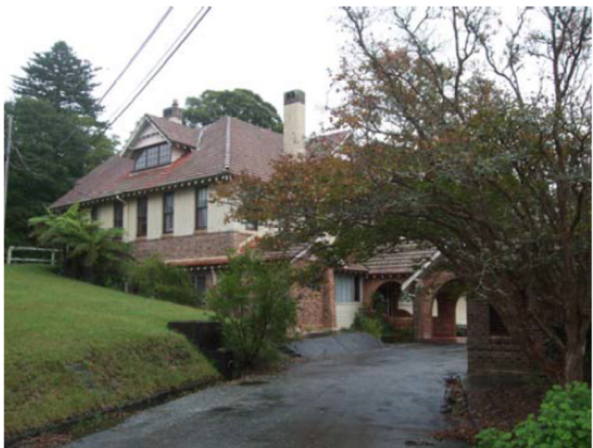
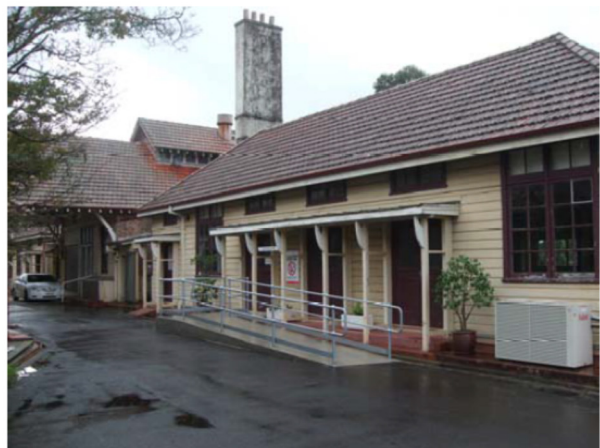
**Plates 9 & 10 – Aged Care Building Structures [B02a & B02b] {Administration/Kitchen Group}
(Source: MSEC, 2016)**

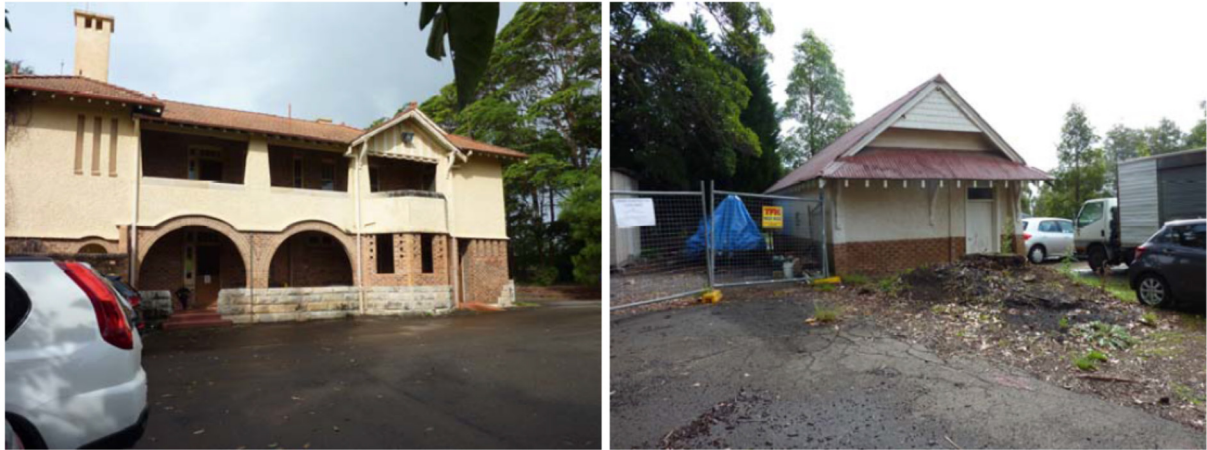
Plates 11 & 12 – Houses [A09a & A09b] {Palmer House and Adjacent Garage/Stable} (Source: MSEC, 2016)

Houses A01m and A02a-A08a are located outside the Study area (more than 600 m from the nearest longwalls). House A09a & A09b {Palmer House and adjacent garage/stable} is located outside the predicted 20 mm subsidence contour for Longwalls 301-303.

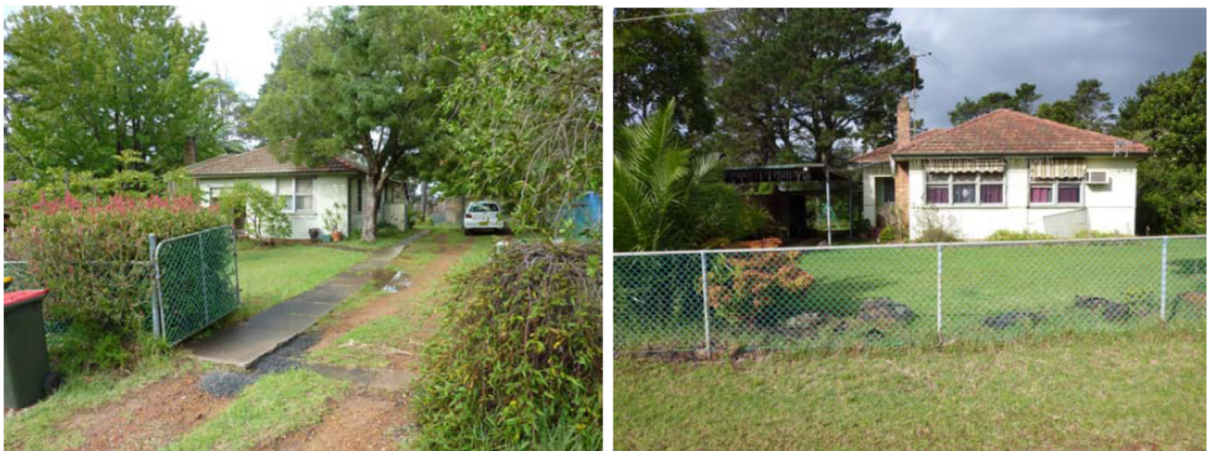
Plates 13 & 14 – Houses [B06a & B08a] {Staff Residences} (Source: MSEC, 2016)

Houses B04a-B09a are within the predicted 20 mm subsidence contour for Longwalls 301-303. Subsequent to the Risk Assessment an agreement has been reached between South Eastern Sydney Local Health District and Metropolitan Coal to remove cottages B04a-B09a as part of risk mitigation process. The Memorandum of Understanding – signed 31 August 2017 details the structures to be removed subject to Wollongong City Council development approval. These abandoned house structures will be fenced until development approval is granted.

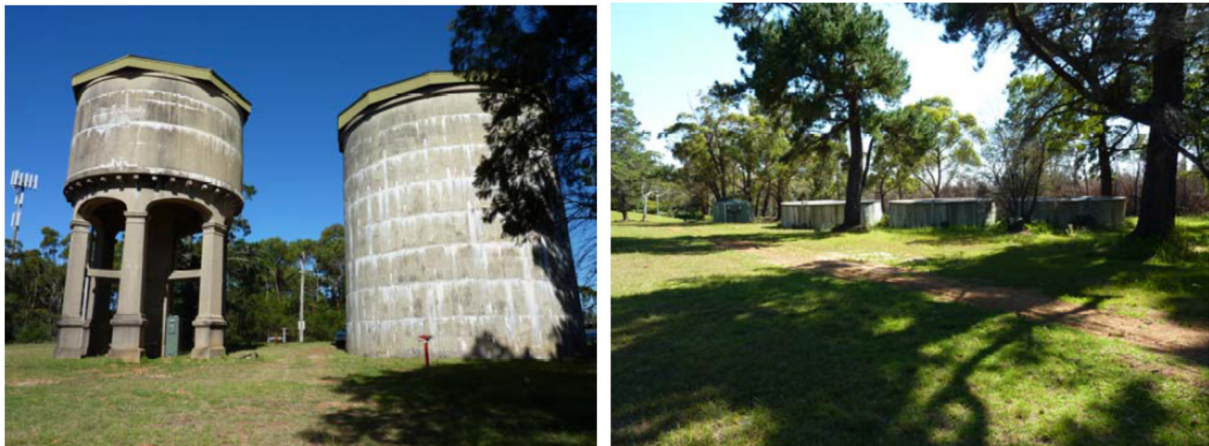
Plates 15 & 16 – Large Water Storage Tanks (Source: MSEC, 2016)

The two large water storage tanks (B14t01 and B14t02) and the below ground water storage tanks (B16t01-B16t03) are shown on Plates 15 and 16. It is noted that no water is currently stored in the elevated tank structure (Plate 15 - reservoir on the left).

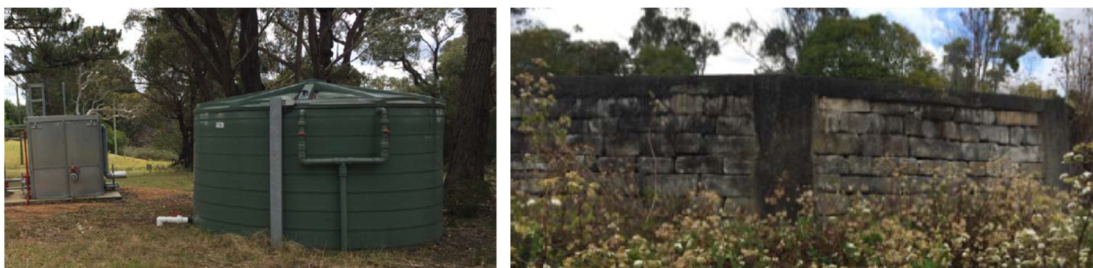
Plates 17 & 18 – Fire Water Tank and Steel Tank Adjacent Pump House, and Trickle Filter Tank (Source: MSEC, 2016)

The fire water tank and steel tank adjacent the pump house (B17t01 and B18t01), and the trickle filter tank (B15t01) are shown on Plates 17 and 18.

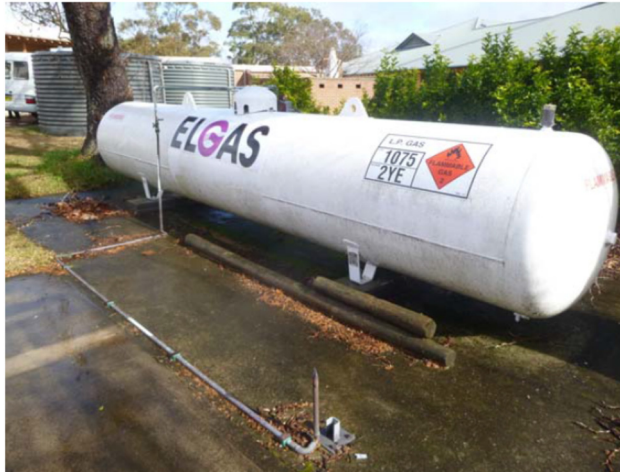
Plate 19 – Gas Storage Tank (Source: MSEC, 2016)

The gas storage tank will not be directly undermined by Longwalls 301-303. The gas storage tank is located more than 310 m away from the nearest longwall. The gas storage tank is not within the predicted 20 mm subsidence contour for Longwalls 301-303.

The gas storage tank is shown on Plate 19.

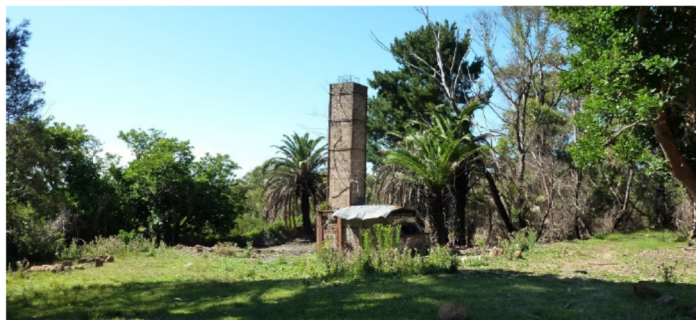
Plate 20 – Kiln (Source: JMA, 2016)

As described in Section 8, a barrier fence will be erected around the kiln to maintain an exclusion zone with a radius of 1.5 times the chimney height during active mining (i.e. which may result in impact on the kiln).

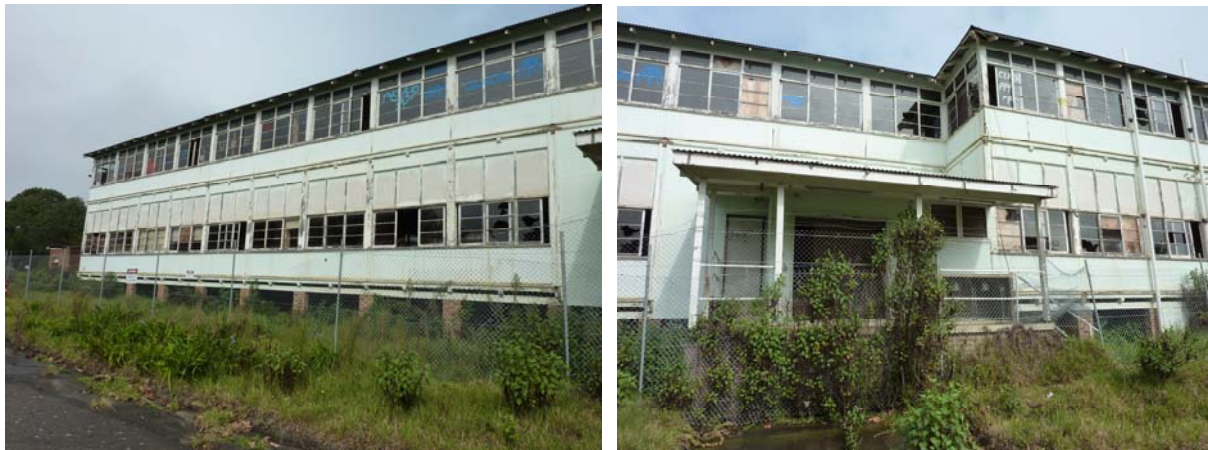
Figure 1 Hospital Building Structure (Ref. A01a)

The *hospital* building structures are Refs. A01a to A01k and B03a to B03l. These structures are located outside the extents of the longwalls at a minimum distance of 375 metres from Longwalls 301 to 303. The buildings are not currently in use and have been fenced off. Photographs of the main hospital building structures are provided in Figure 1 and Figure 2.

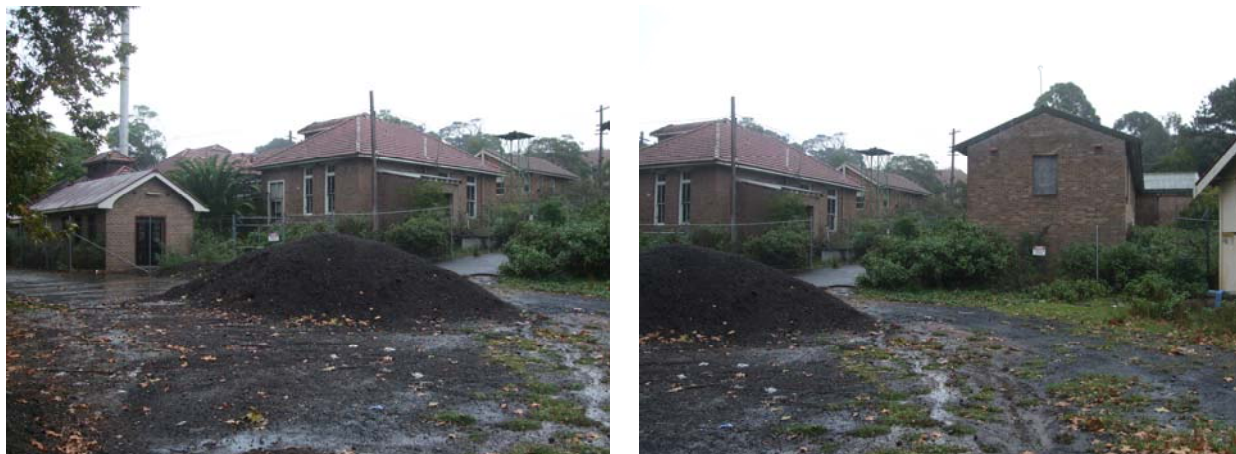
Figure 2 Hospital Building Structure (Ref. B03a)

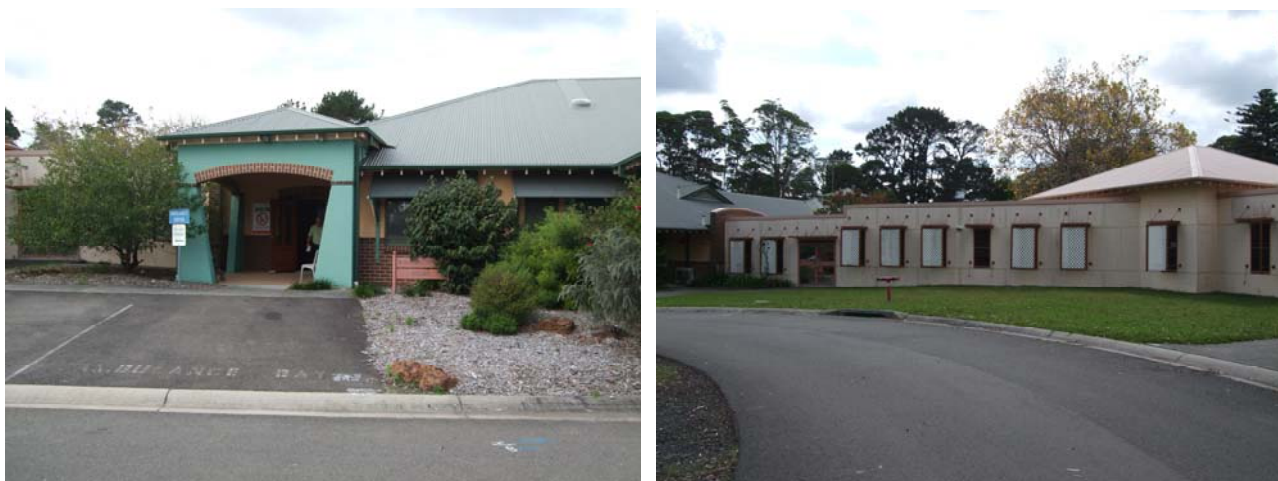
Structure Refs. B01a to B01d are the main patient wards currently in use and are located at a minimum distance of 210 metres from Longwall 303. These buildings comprise single storey structures founded on a combination of ground slabs, strip footings and pad footings. The external walls are brick-veneer and the internal walls are of lightweight construction. The roofs are steel framed with metal sheeting. Photographs of these structures are provided in Figure 3.

Figure 3 Aged Care Building Structure Refs. B01a to B01d

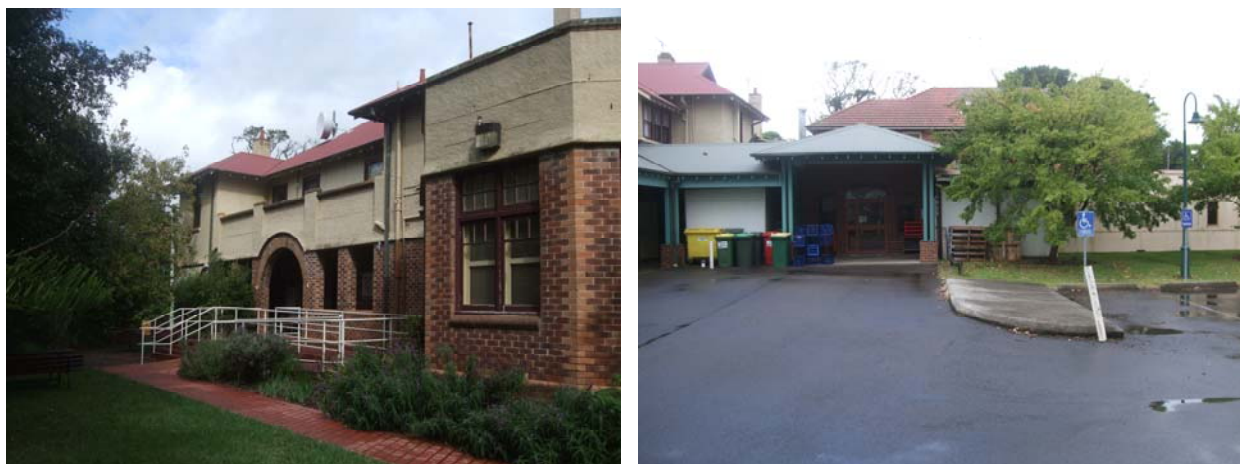
Structure Ref. B01e is located at a minimum distance of 315 metres from Longwall 303. This building is a double storey brick structure founded on a ground slab with a tiled roof. Photographs of this structure are provided in Figure 4.

Figure 4 Aged Care Building Structure Ref. B01e

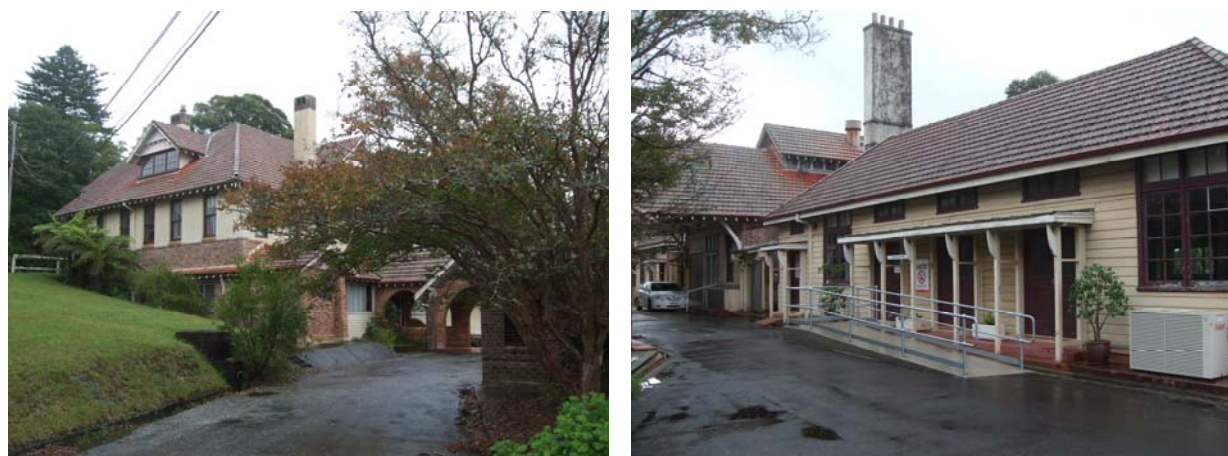
Structure Refs. B02a to B02h are located at a minimum distance of 290 metres from Longwall 302. These buildings comprise one and two storey structures founded on strip footings and ground slabs. The perimeter walls are double brick, but in some cases the upper levels have timber framed walls. The suspended floors are timber framed and in some cases are supported on steel frames. The tiled roofs are supported by timber frames. Photographs of two of these structures are provided in Figure 5.

Figure 5 Aged Care Building Structure Refs. B02a and B02b

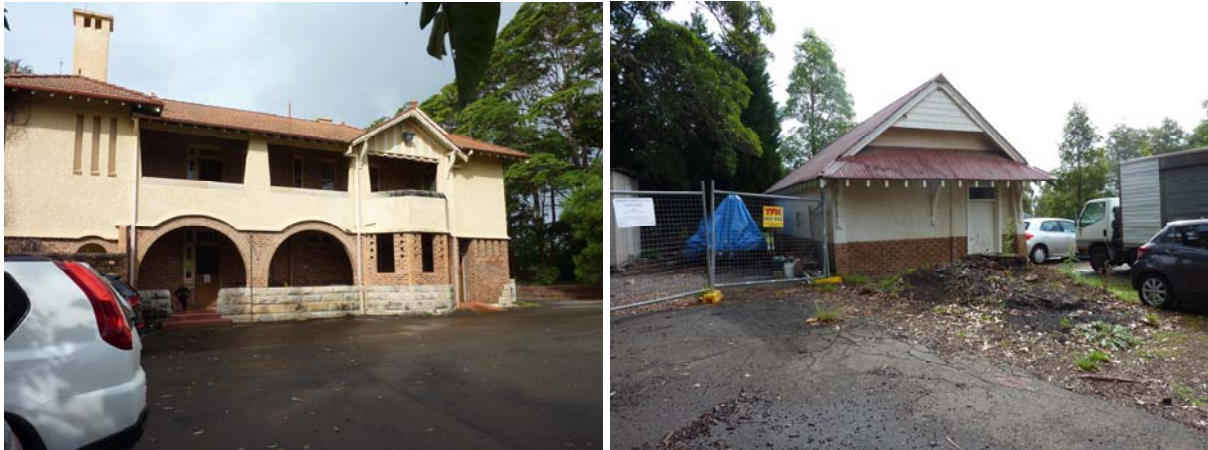
Structure Refs. A01m, A02a to A09a are located at a minimum distance of 350 metres from Longwall 303. Structure Ref. A09a is the nearest structure to Longwall 303. This building is a two storey double brick structure on strip footings with timber floor and a tiled roof. Photographs of this house and the associated structure are provided in Figure 6.

Figure 6 House Structure Ref. A09a (left side) and A09b (right side)

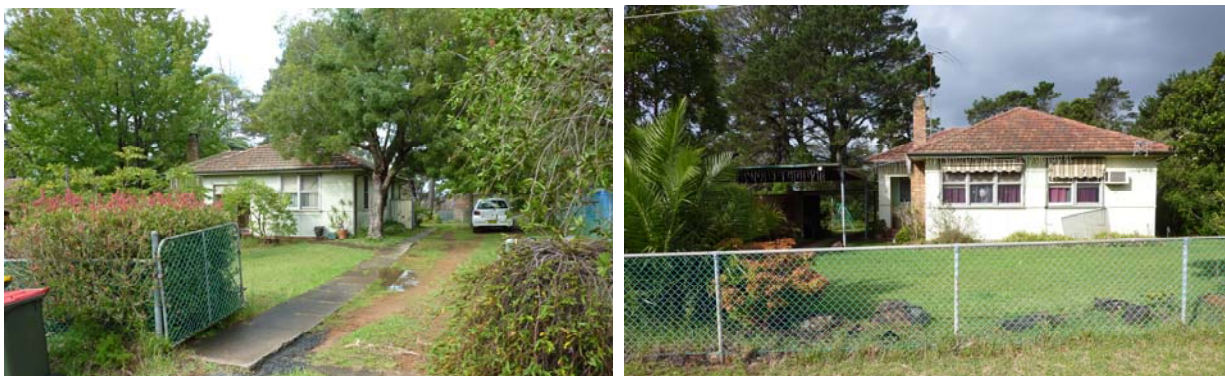
Structure Refs. B04a to B09a are located at a minimum distance of 60 metres to a maximum distance of 185 metres from Longwall 303. These houses are one storey structures founded on brick piers and low level perimeter brickwalls with timber floors, fibro walls and tiled roofs. Photographs of two of these houses are provided in Figure 7.

Figure 7 Houses Structure Refs. B06a (left side) and B08a (right side)

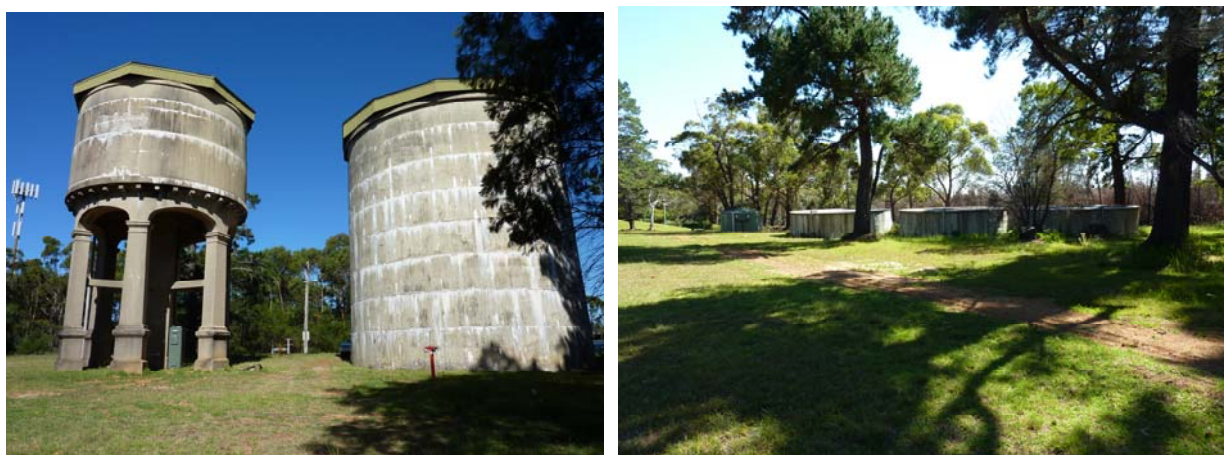
Figure 8 Water Storage Tanks Refs. B14t01 and B14t02 (left side) and Refs. B16t01 to B16t03 (right side)

The other main structures on the complex include water storage tanks (Refs. B14t01, B14t02, B16t01 to B16t03, B17t01, and B18t01), above ground gas storage tank (Ref. B01t03), trickle filter tank B15t01, and telecommunications towers and compounds (Refs. B06b and B10a to B12a). Photographs of these features are provided in Figure 8 to Figure 12.

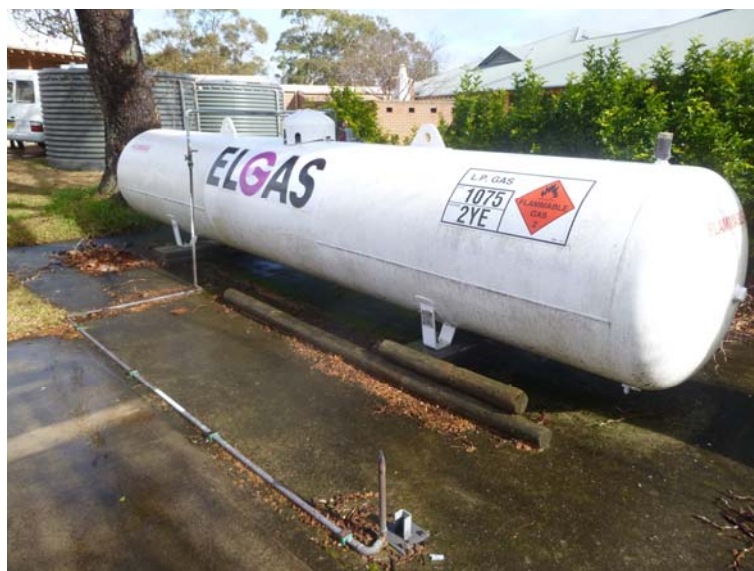
Figure 10 Gas Storage Tanks Refs. B01t03 and B01t04

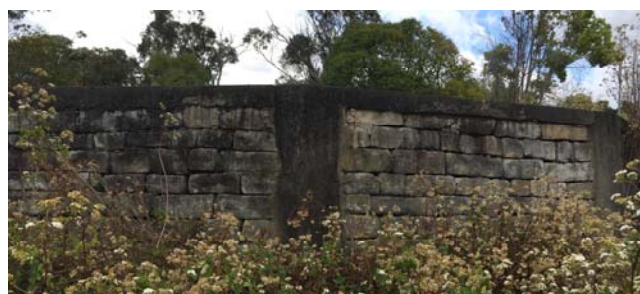
Figure 11 Trickle Filter Tank B15t01

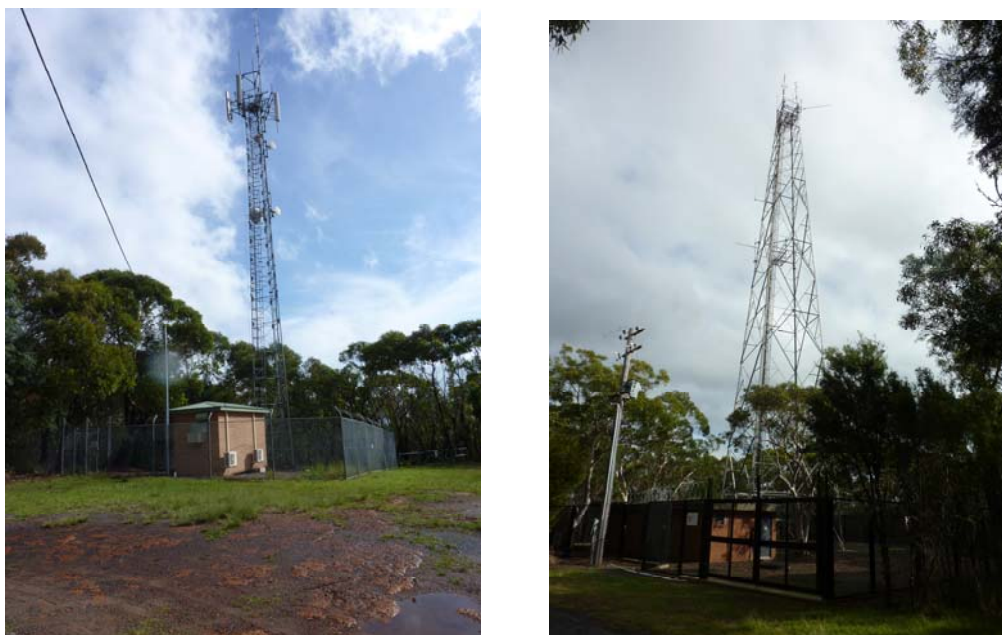
Figure 12 Telecommunications Towers and Compounds Refs. B10a (left side) and B12a (right side)
