METROPOLITAN COAL

LONGWALLS 301-303

BUILT FEATURES MANAGEMENT PLAN GARRAWARRA CENTRE COMPLEX

November 2016

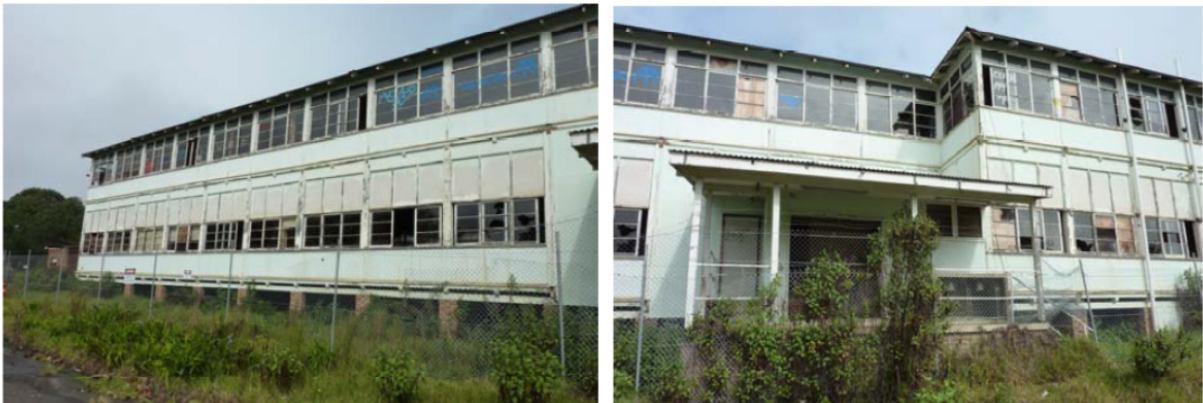
Plates 1 & 2 – Abandoned Hospital Buildings [A01a] {Former Male Wards} (Source: MSEC, 2016)

No abandoned hospital buildings will be directly undermined by Longwalls 301-303. The abandoned hospital buildings are located more than 375 m away from the nearest longwall. No hospital buildings (including Former Male Wards [i.e. Wards 1 to 8 and Dining Room], Former Female Wards [i.e. Wards 1 to 9 and Library/Canteen], Laundry/Boilerhouse or Workshops nor the Gatehouse and Gate Piers are within the predicted 20 mm subsidence contour for Longwalls 301-303.

Photographs of the abandoned hospital building structures are shown on Plates 1 to 4.

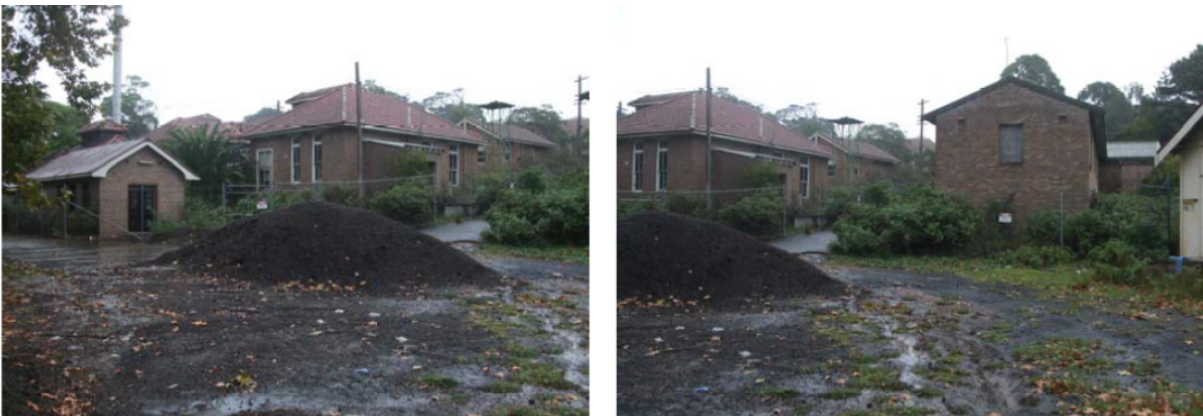
Plates 3 & 4 – Abandoned Hospital Buildings [B03a] {Laundry / Boilerhouse} (Source: MSEC, 2016)

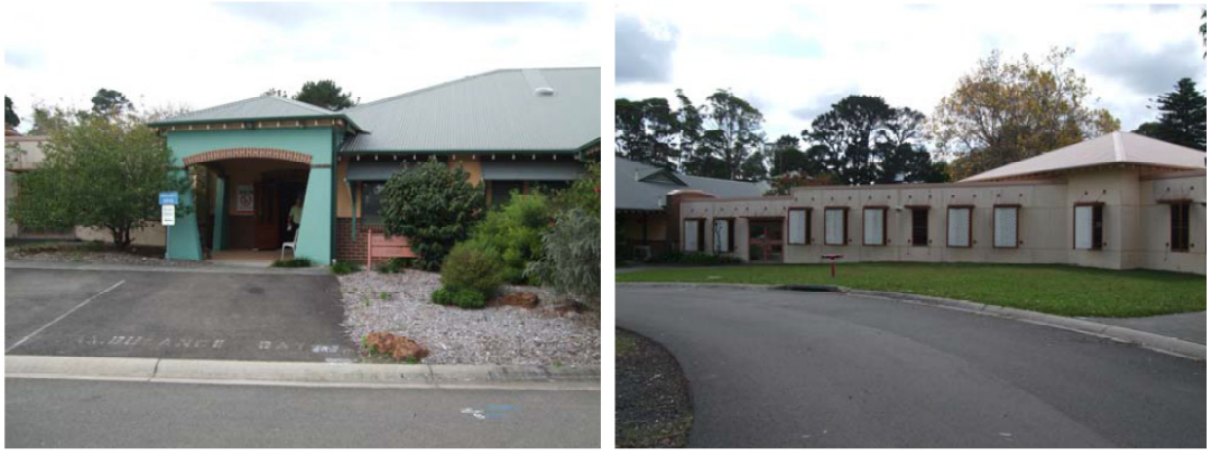
**Plates 5 & 6 – Aged Care Building Structures [B01a-B01d] {Administration}
(Source: MSEC, 2016)**

No aged care building structures will be directly undermined by Longwalls 301-303. The aged care buildings are located more than 210 m away from the nearest longwall. With the exception of building structure B01d (administration), no aged care buildings (including the Nurses Quarters and Administration/Kitchen Group) are within the predicted 20 mm subsidence contour for Longwalls 301-303.

Photographs of the aged care building structures are shown on Plates 5 to 10.

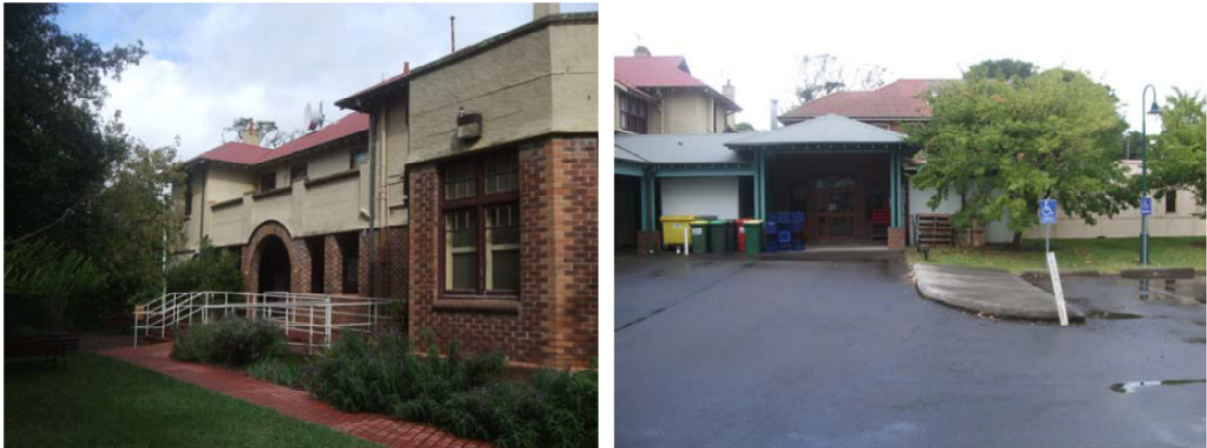
Plates 7 & 8 – Aged Care Building Structures [B01e] {Nurses Quarters} (Source: MSEC, 2016)

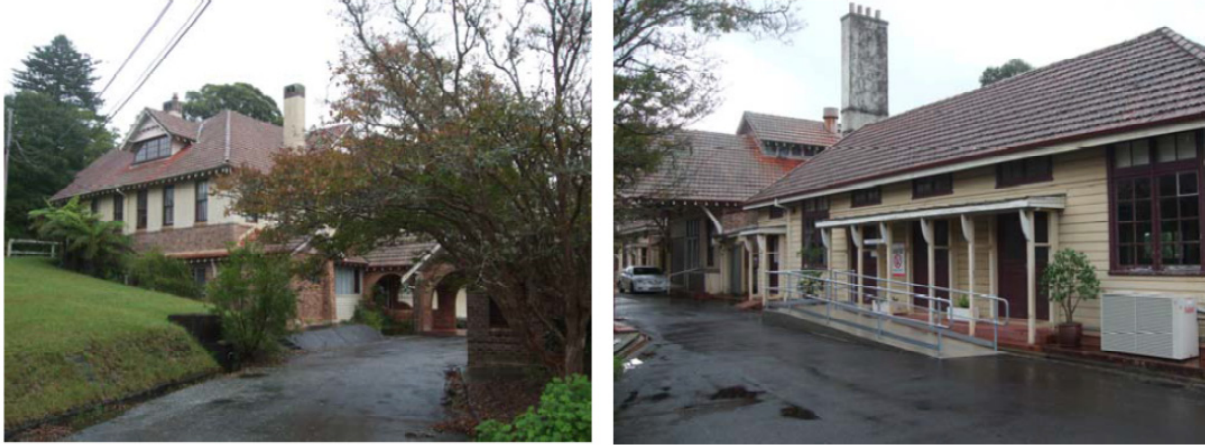
Plates 9 & 10 – Aged Care Building Structures [B02a & B02b] {Administration/Kitchen Group}
(Source: MSEC, 2016)

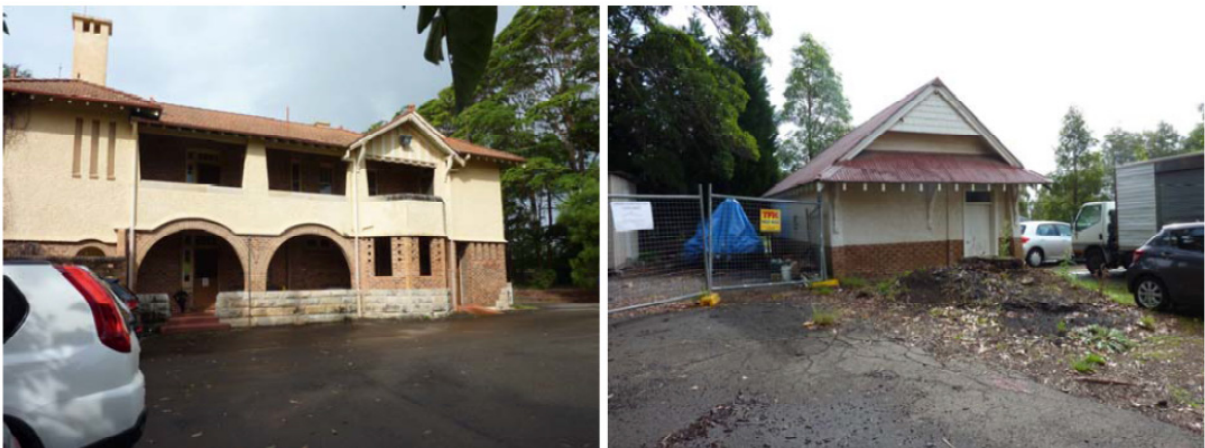
Plates 11 & 12 – Houses [A09a & A09b] {Palmer House and Adjacent Garage/Stable}
(Source: MSEC, 2016)

Photographs of the houses are shown on Plates 11 to 14.

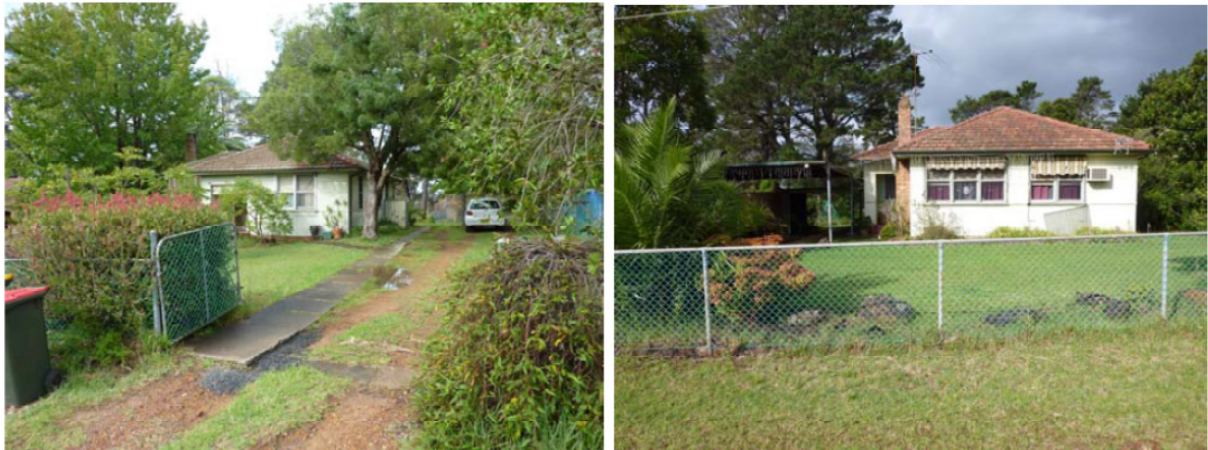
Plates 13 & 14 – Houses [B06a & B08a] {Staff Residences} (Source: MSEC, 2016)

Houses B04a-B09a {Staff Residences} are within the predicted 20 mm subsidence contour for Longwalls 301-303. The nearest house (B09a) is located more than 60 m away from the Longwall 303.

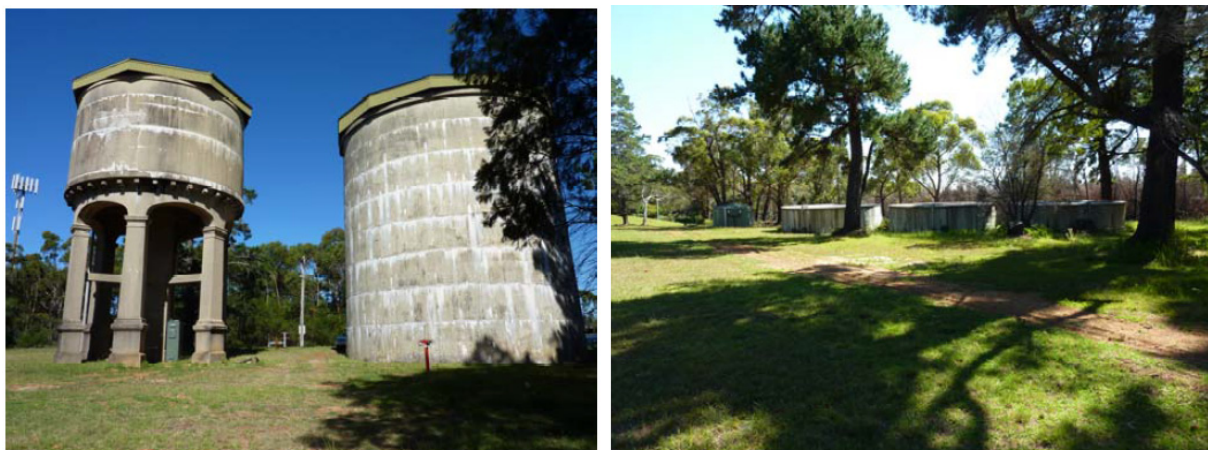
The two large water storage tanks (B14t01 and B14t02) and the below ground water storage tanks (B16t01-B16t03) are shown on Plates 15 and 16. It is noted that no water is currently stored in the elevated tank structure (Plate 15 - reservoir on the left).

Plates 15 & 16 – Large Water Storage Tanks (Source: MSEC, 2016)

No water storage tanks will be directly undermined by Longwalls 301-303. The water storage tanks are within the predicted 20 mm subsidence contour for Longwalls 301-303.

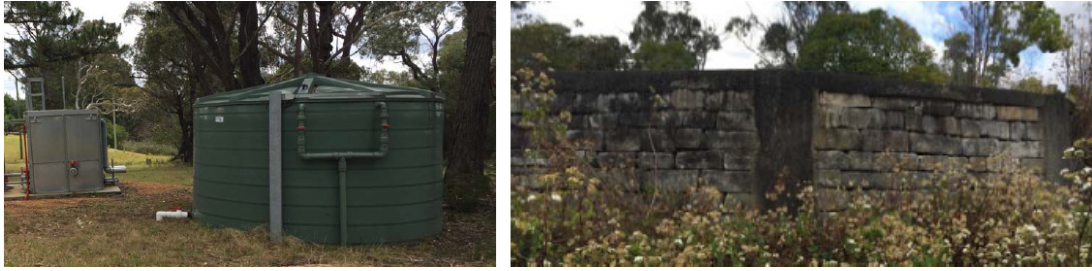
The fire water tank and steel tank adjacent the pump house (B17t01 and B18t01), and the trickle filter tank (B15t01) are shown on Plates 17 and 18.

Plates 17 & 18 – Fire Water Tank and Steel Tank Adjacent Pump House, and Trickle Filter Tank (Source: MSEC, 2016)

A baseline audit will be conducted to assess the integrity of the water storage tanks at the Garrawarra Centre Complex. Subject to the outcomes of the baseline audit, Metropolitan Coal will determine the type of temporary fencing and signage required around the two large water storage tanks at the Garrawarra Centre Complex and timing for installation (i.e. during active mining which may result in impact on the tanks).

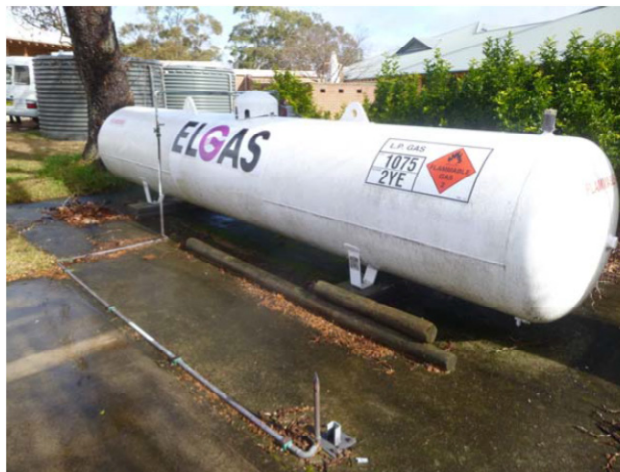
The gas storage tank is shown on Plate 19.

Plate 19 – Gas Storage Tank (Source: MSEC, 2016)

The gas storage tank will not be directly undermined by Longwalls 301-303. The gas storage tank is located more than 310 m away from the nearest longwall. The gas storage tank is not within the predicted 20 mm subsidence contour for Longwalls 301-303.

A baseline audit will be conducted to confirm the system of connection between gas storage tank and associated pipeline(s) at the Garrawarra Centre Complex. Subject to the outcomes of the baseline audit, Metropolitan Coal will consider the need for providing a flexible connection between the gas storage tank and the pipelines(s) at the Garrawarra Centre Complex.

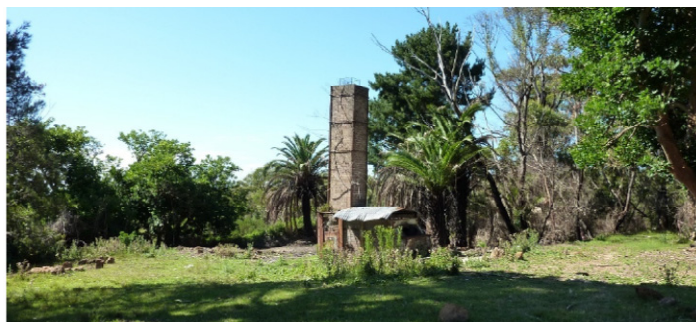
The kiln is shown on Plate 20.

Plate 20 – Kiln (Source: JMA, 2016)

The location of the kiln (F01b) at the Garrawarra Centre Complex is shown on Figure 6. While the kiln will not be directly undermined by Longwalls 301-303, it will experience tilt and strains as it is located within the predicted 20 mm subsidence contour for Longwalls 301-303.

As described in Section 8, a barrier fence will be erected around the kiln to maintain an exclusion zone with a radius of 1.5 times the chimney height during active mining (i.e. which may result in impact on the kiln).

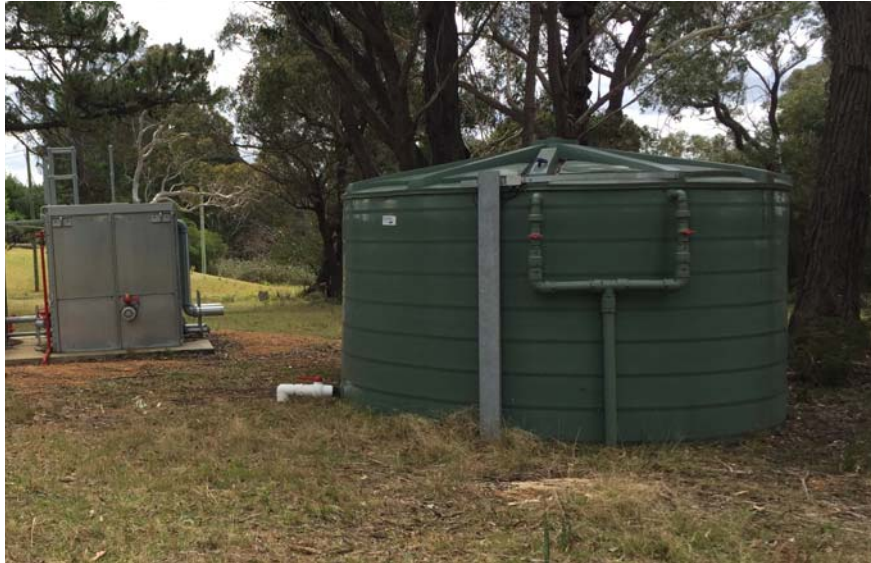
Figure 9 Water Storage Tanks Refs. B17t01 (poly tank) and B18t01 (steel tank)

The other main structures on the complex include water storage tanks (Refs. B14t01, B14t02, B16t01 to B16t03, B17t01, and B18t01), above ground gas storage tank (Ref. B01t03), trickle filter tank B15t01, and telecommunications towers and compounds (Refs. B06b and B10a to B12a). Photographs of these features are provided in Figure 8 to Figure 12.

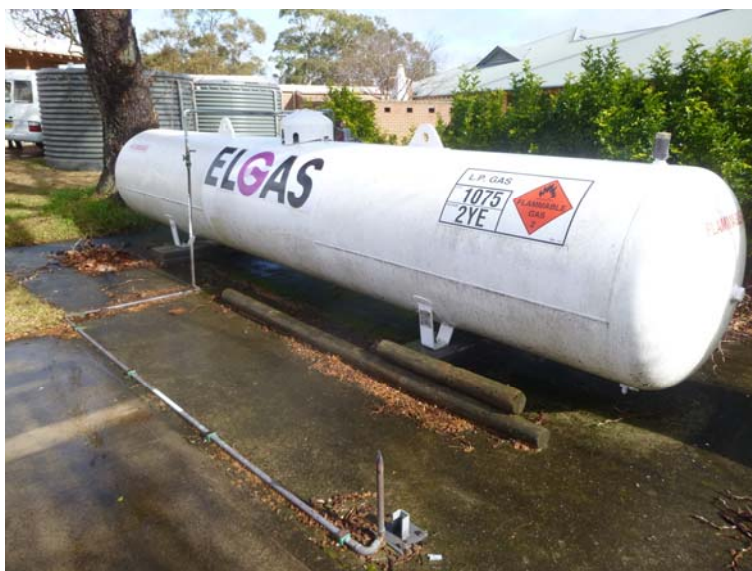
Figure 10 Gas Storage Tanks Refs. B01t03 and B01t04
