# 2016 Annual Review

Wilpinjong Coal Mine

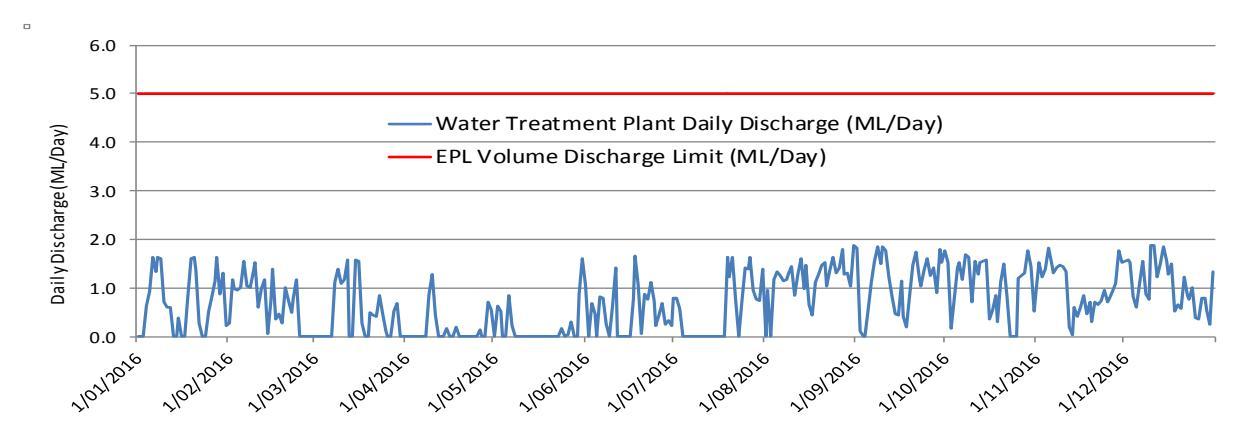
## Graph 13 Treated Water Discharged During 2016

**Graph 13** presents the daily discharge (in ML/day) from the WTF during the 2016 review period. The total water discharged over the 2016 review period was 262.8ML. WCPL did not exceed the daily volume criteria of 5ML/day. **Graph 14** presents the EC results of the treated water discharged from the WTF during the 2016 review period. WCPL did not exceed the maximum criteria of 500µS/cm for EC. **Graph 15** presents the pH, TSS and O&G results of the treated water discharged from the WTF during the 2016 review period. WCPL did not exceed the pH maximum or minimum criteria (i.e. 6.5 - 8.5pH). WCPL achieved the water quality criteria for TSS and O&G (i.e. 50mg/L and 10mg/L respectively).

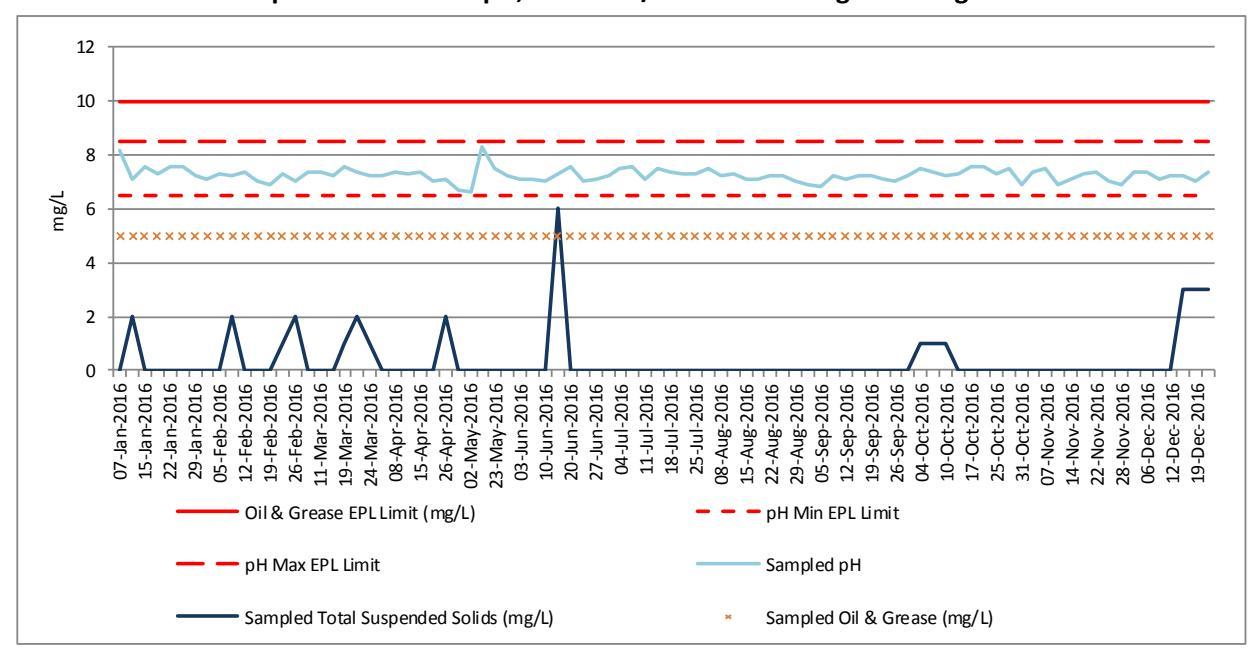
Graph 15 Results for pH, TSS & Oil/Grease Discharged During 2016

- Electrical conductivity (EC) not to exceed 500 μS/cm (continuous monitoring);
- Oil and grease (O&G) not to exceed 10mg/L (grab sample weekly during any discharge);
- pH range of 6.5 to 8.5 (continuous monitoring); and
- Total suspended solids (TSS) not to exceed 50mg/L (grab sample weekly during any discharge).

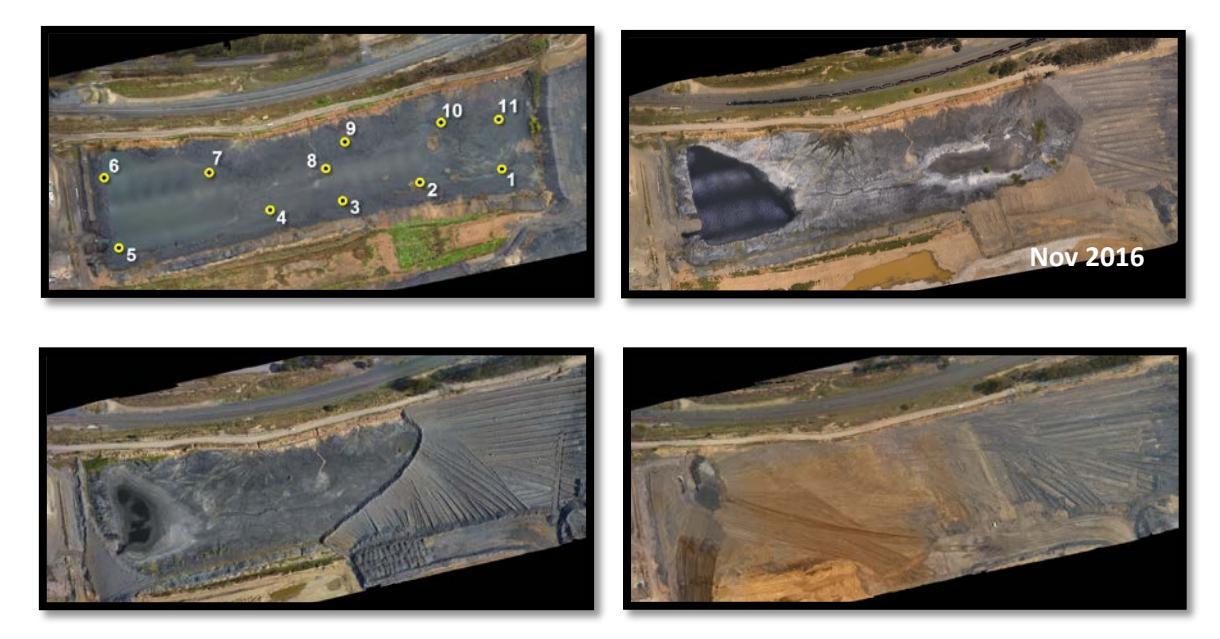
#### Figure 3 Tailings Dam 3 Capping Campaign

Capping of Tailings Dam 3 commenced in 2016 and was completed in February 2017 as shown in Figure 3. The capping Landform development will continue during 2017 with the aim of rehabilitation completed by the end of the year. Landform development was completed on TD4 with rehabilitation activities completed in 2016.

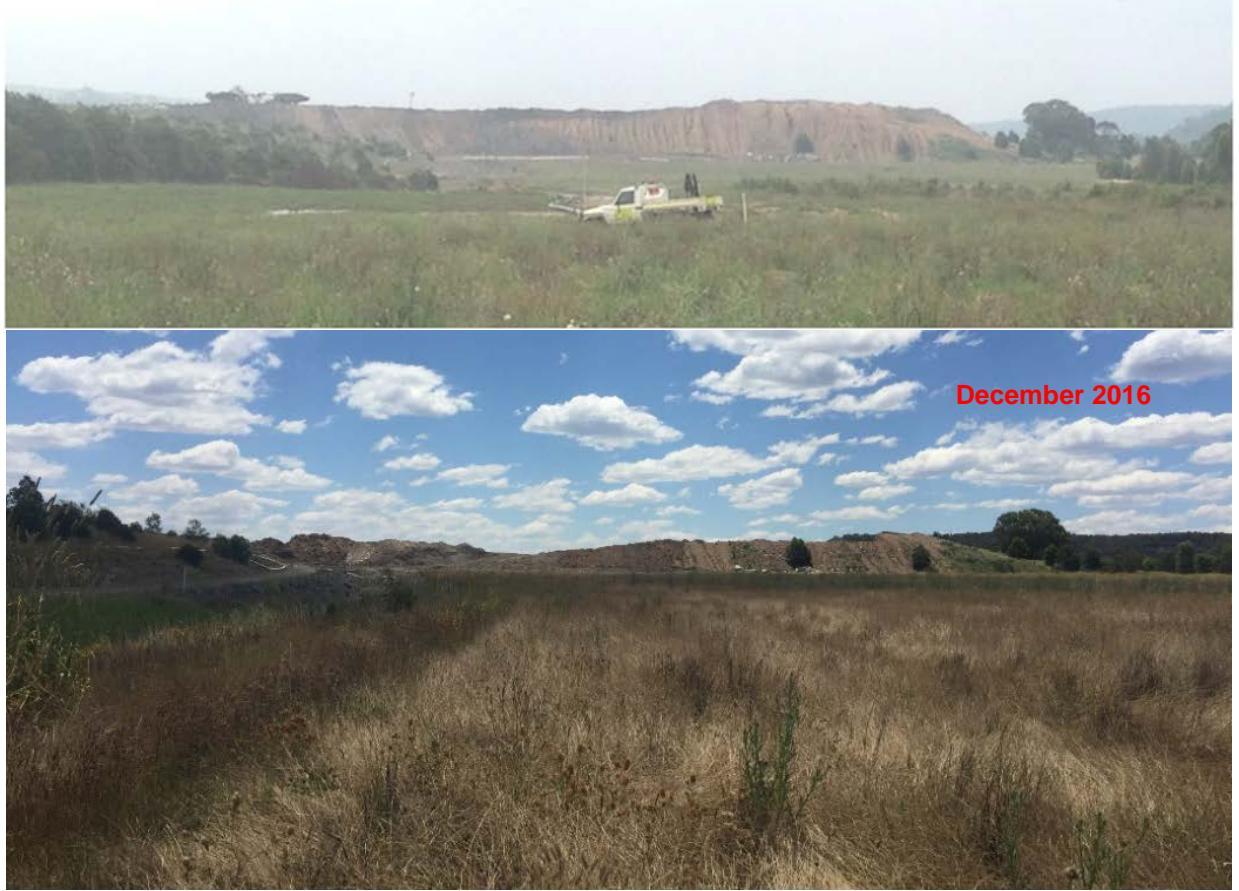
Figure 4 Progressive Removal of Keylah Dump

Keylah Dump removal continued during 2016 with approximately 130,000m<sup>3</sup> of material left for removal (**Figure 4**). The removal of the dump was undertaken in accordance with the *Keylah Dump Management Plan*. As identified, hot material was placed in identified voids in Pit P5 and Pit P1 in layers of approximately 2.5m (average) thickness.

Keylah Dump removal is scheduled to continue during 2017.

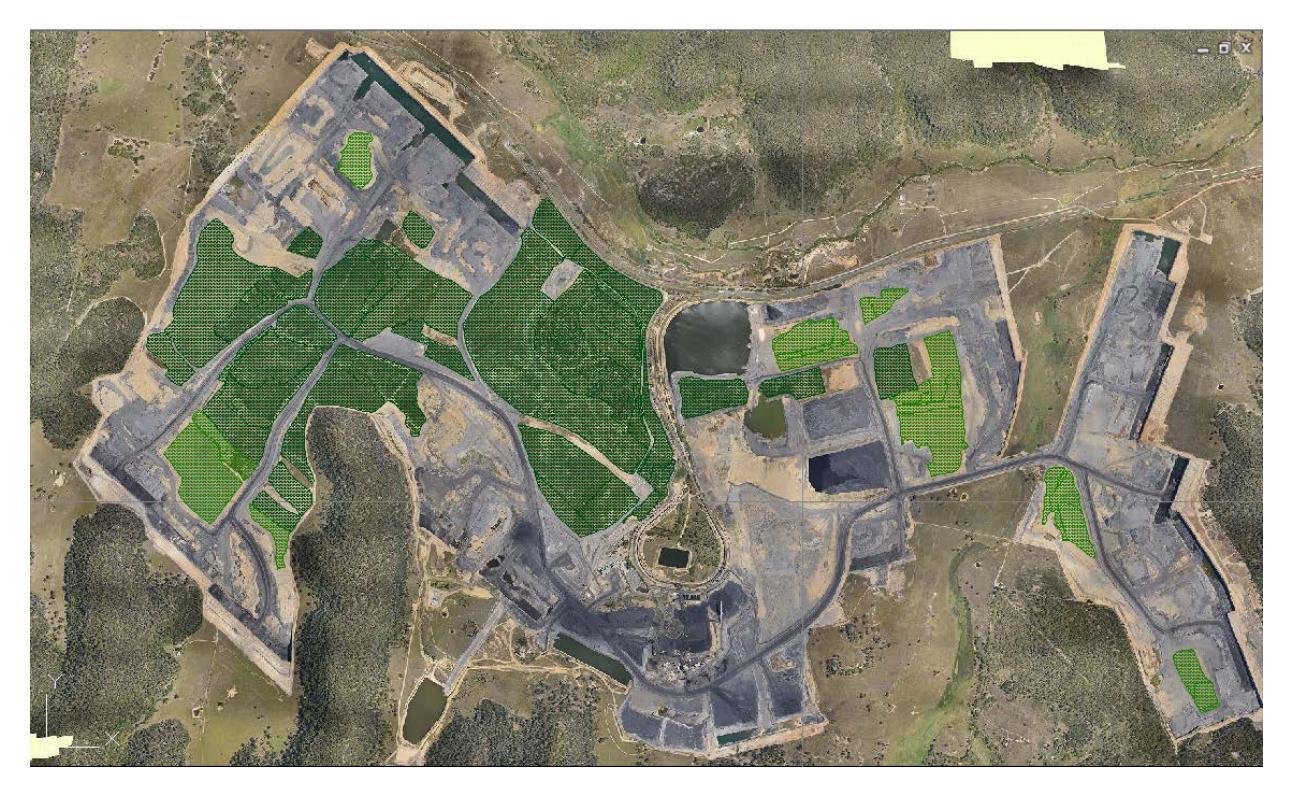
Figure 5 2016 Seeded Areas (light green areas)

During 2016, all rehabilitation areas have been placed under a green manure crop. The green crops include various combination of legumes (cow peas, clover), sorghum, millet, sudan grass, oats. Combinations and rates are shown in **Table 31** of different species and rates. Details are provided below in the "rehabilitation trials" section.

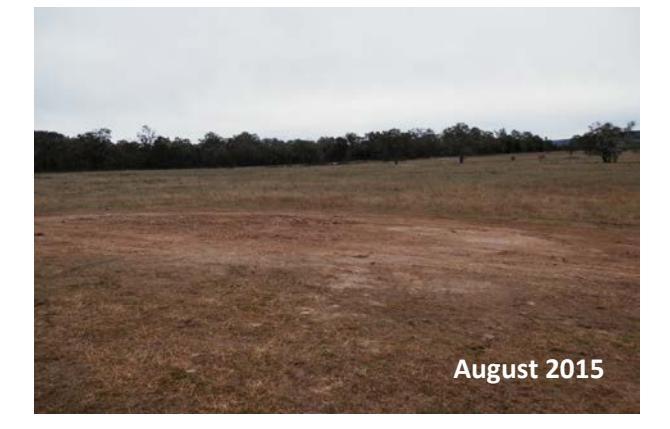
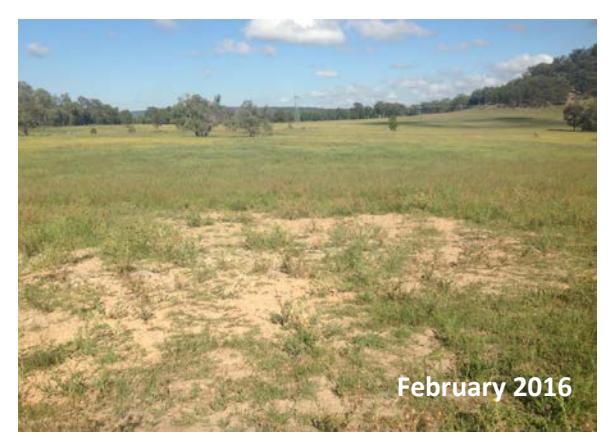
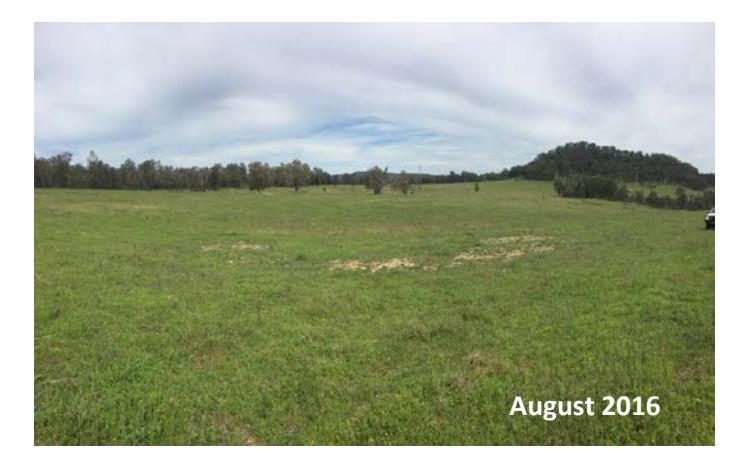
#### Figure 6 Drill Site PW1162A Rehabilitation Progress

- Return of vegetation;
- Any evidence of weed or pest invasion; and
- Active erosion issues or slumping.

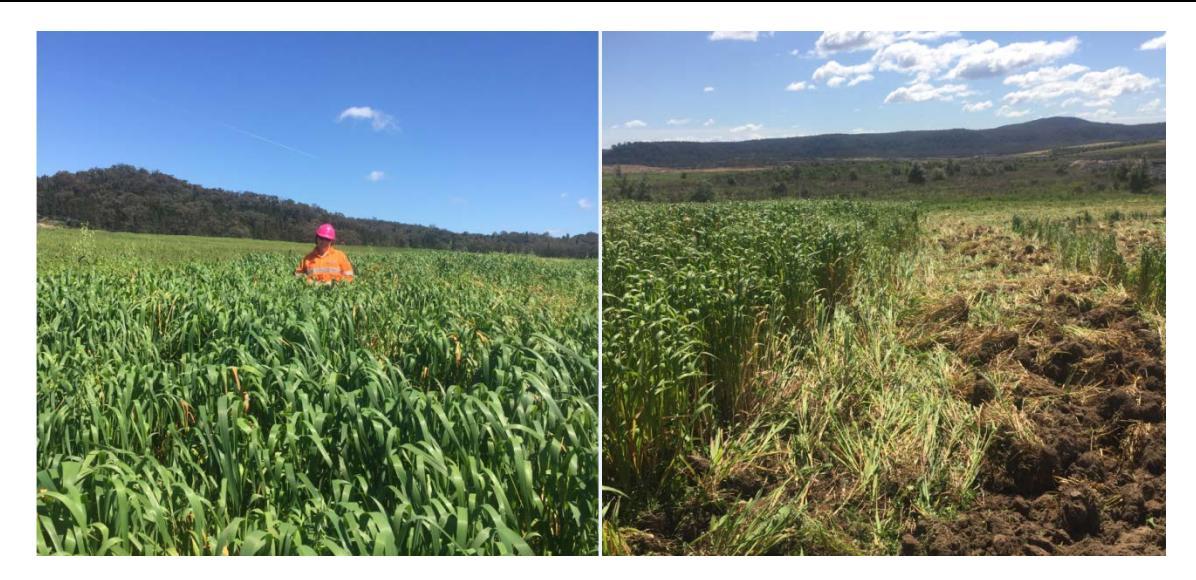
**Photo 2 Turned Oats**

Below are photos of oats and clover green manure crops in Pit 5 (**Photo 1**) showing the growth of the crops. **Photo 2** shows oats cover crop just turned over by a disc plough with **Photo 3** illustrating the result after drying. After this process, the ground will be work one last time in preparation for the final seed application relevant to the proposed post mine land use. Soil conditions will continually be monitored to gauge the effects of the green manure crops.

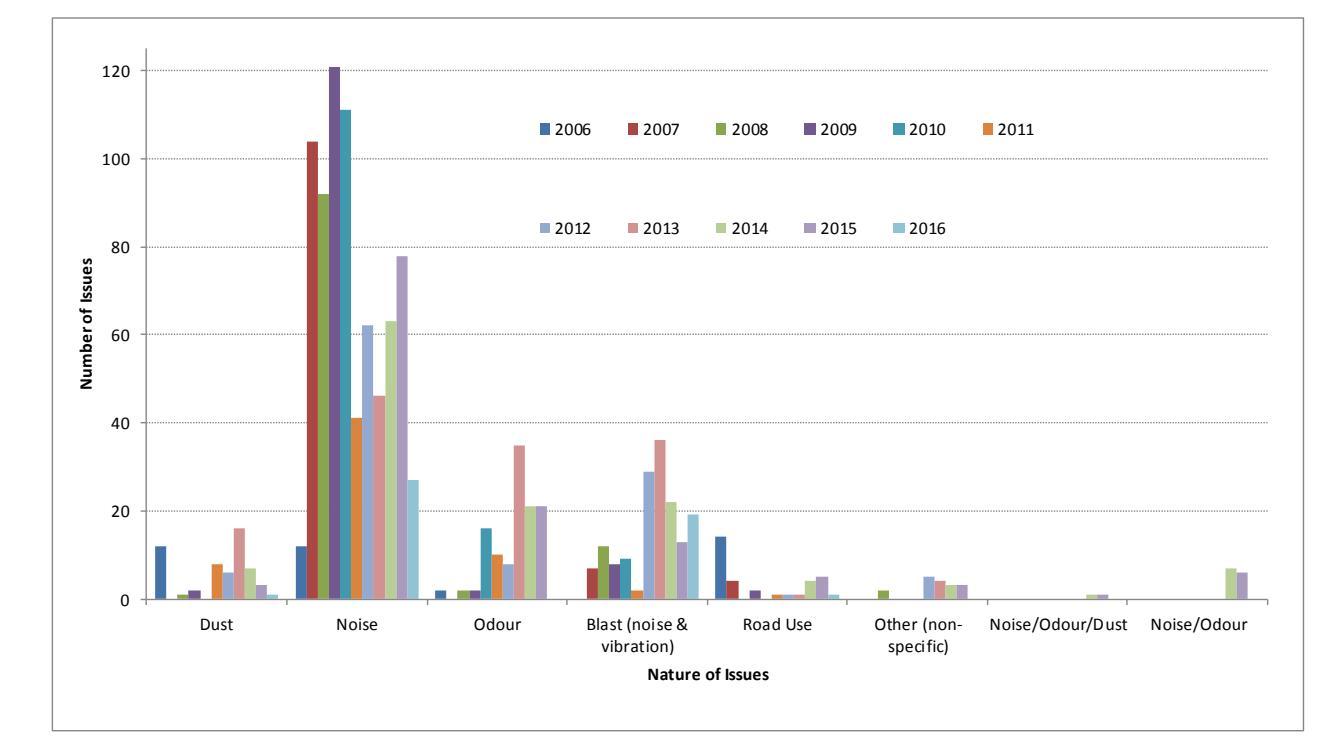
#### Graph 16 Summary of Community Complaints and Issues Raised by Complainants 2006 – 2016

During the 2016 review period, 48 environmental-related complaints were received by WCPL (**Appendix 6**) as opposed to 130 complaints in 2015. **Graph 16** presents a comparison of the environmental complaints received by WCPL over the period 2006 to 2016.

WCPL received fewer noise related complaints during the 2016 review period than in 2015. There were no odour complaints, however blast related complaints did slightly increase when compared to 2015.
