# WILPINJONG COAL PTY LTD Environment Protection Licence (EPL) 12425

# LICENCE MONITORING DATA MONTHLY SUMMARY REPORT

1 August 2020 to 31 August 2020

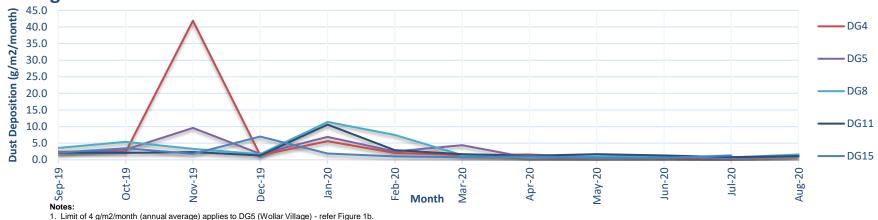
Figure 1a. DG Results - 12 Month Trend

- 2. The excessive dust result recorded at DG4 in November 2019 was due to high concentrations of organic matter. DG8's excessive dust level recorded in October 2019 was also due to a high concentration of organic matter.
- 3. During November 2019, DG5 accumulated a high concentration of ash due to bushfires in the area. During January 2020, all dust gauges recorded an ash content higher than 80% due to the regional bushfires.
- 4. In March 2020, DG5 contained high concentrations of both ash and organic matter. The excessive result can be linked to lawn mowing occurring near the dust gauge during the month.

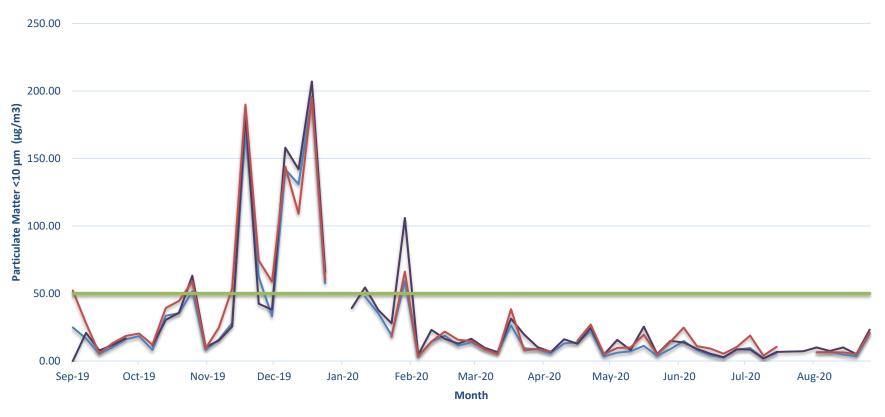
Figure 2. HV (PM10) Results - 12 Month Trend

- 1. Limit doesn't apply for extraordinary events such as bushfires, prescribed burning, or dust storms.
- 2. Recorded PM10 dust levels above 50 µg/m³ recorded in October and November 2019 and January and February 2020 were caused by regional dust events refer EPA PM10 dust graph on page 6 of this report.
- 3. Due to operator error, all results recorded on the 9th January 2020 were invalid.
- 4. Power outages prevented samples from being collected at HV1 and HV5 during July 2020.

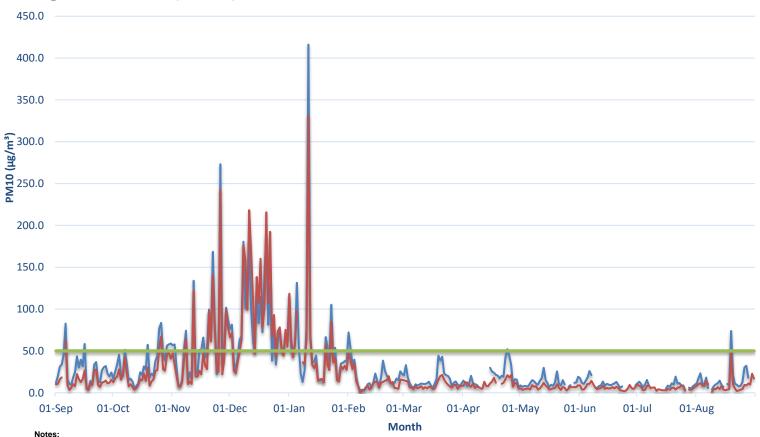
Figure 3. TEOM (PM10) Results - 12 Month Trend

- 1. Limit dosen't apply for extraordinary events such as bushfires, prescribed burning or dust storms
- 2. TEOM 4 (Araluen Rd) influenced by dust from Araluen Road generally during stable atmospheric conditions (i.e. temperature inversions)
- 3. Elevated PM10 dust levels recorded in September, October, November and December 2019 and January 2020 due to regional dust events and/or bushfire smoke.
- 4. The elevated PM10 dust levels recorded at TEOM 4 in April 2020 was due to a temperature inversion trapping road dust and lack of rainfall.
- 5. Power outages during April, June and July 2020 resulted in periods of no data at TEOM 4. TEOM 3 underwent scheduled maintenance between April 19 and 20 2020.
- 6. The elevated dust levels recorded on 19 August 2020 align with the regional dust event recorded by the Department of Planning, Industry and Environment,

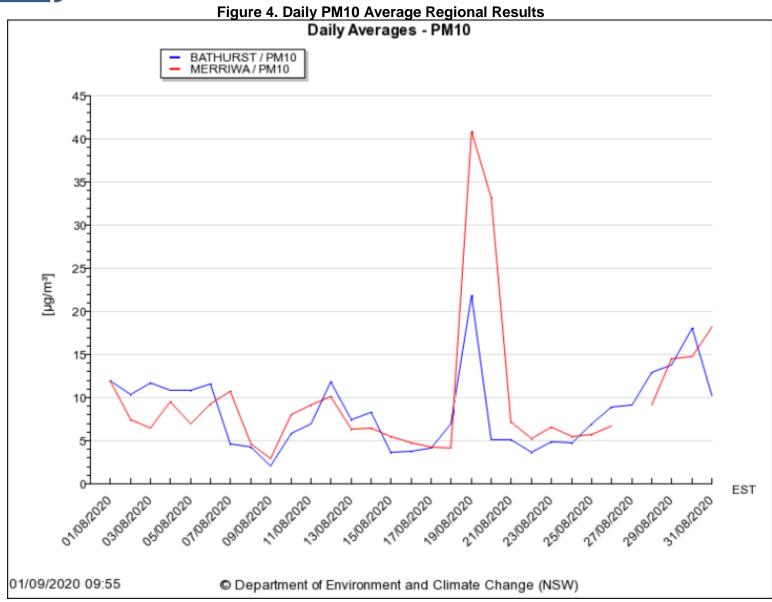
For comparison with **Figures 2** and **3**, **Figure 4** displays the Regional 24Hr PM10 Average. PM10 dust levels for the month have been recorded in Bathurst and Merriwa by NSW EPA.

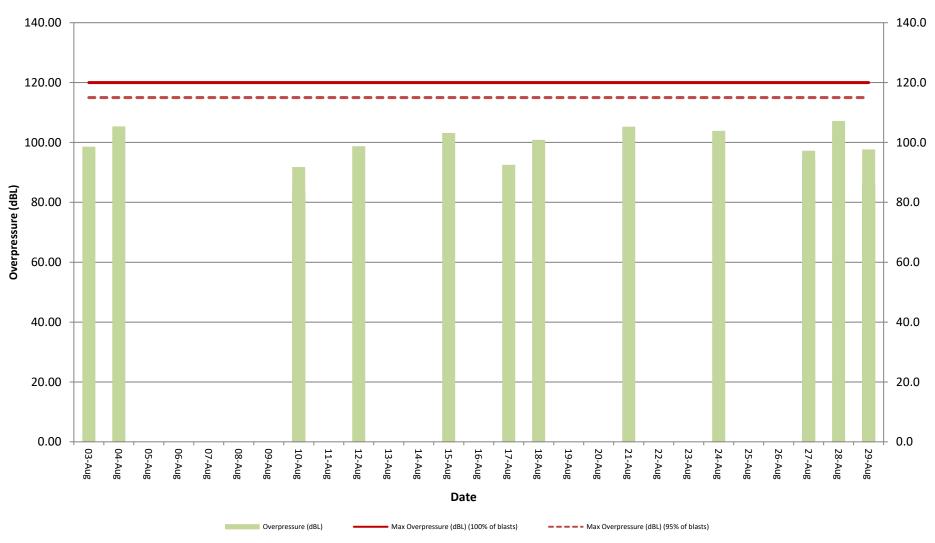
Figure 7. Overpressure (dBL) recorded during Month

Location	Month Number of Blasts		Minimum overpressure (dB(L))	Maximum overpressure (dB(L))	Mean overpressure (dB(L))	EPL overpressure Limits (dB(L))	Exceedance (yes/no)	
Approx. 50m west of the Wollar Public School	August	15	83.5	107.0	97.61	115dB (95% blasts) 120 dB (100% blasts)	no

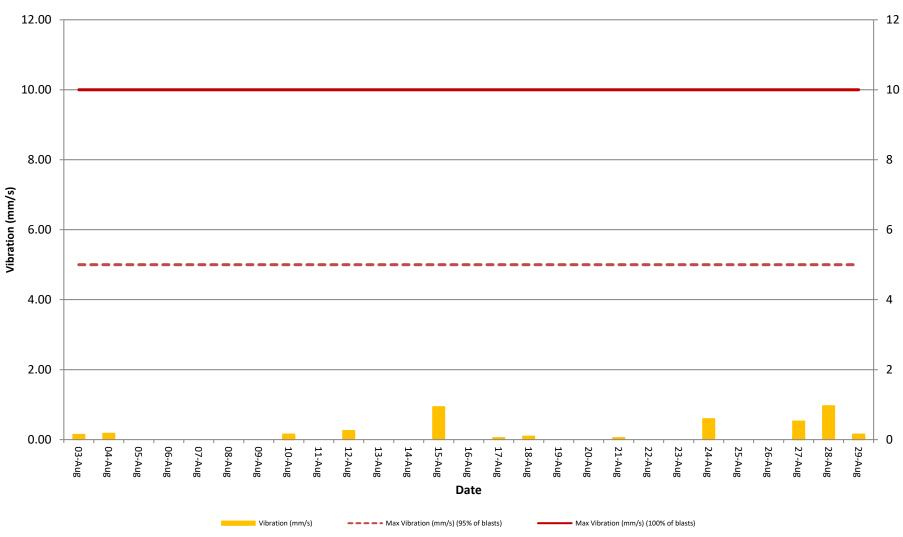
Figure 8. Vibration (mm/s) recorded during Month

Location	Month Number of Blasts		Minimum vibration (mm/sec)	Maximum vibration (mm/sec)	Mean vibration (mm/sec)	EPL vibration Limits (mm/sec)	Exceedance (yes/no)	
Approx. 50m west of the Wollar Public School	August	15	0.06	0.97	0.30	5 mm/s (95% blasts) 10 mm/s (100% blasts)	no

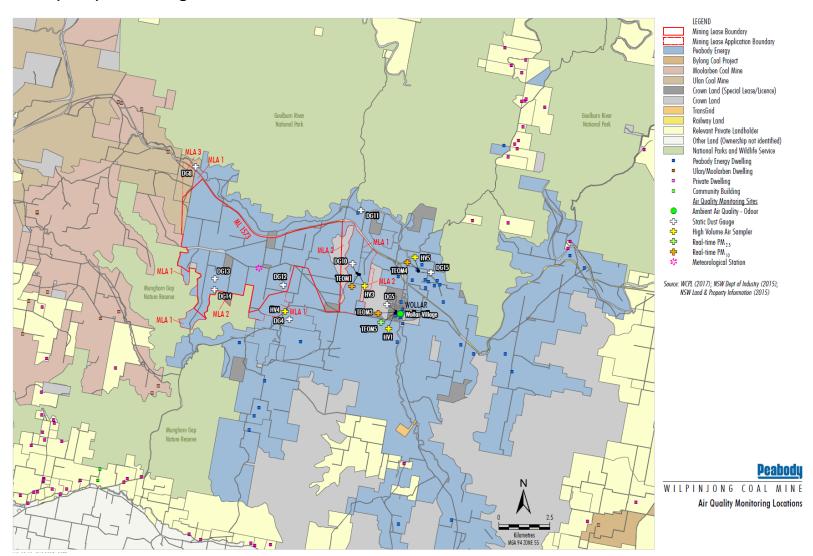
Figure 6 – Air (Dust) Monitoring Locations

The location of the above monitoring equipment in relation to Wilpinjong Coal Mine is shown in Figures 6 and 8.

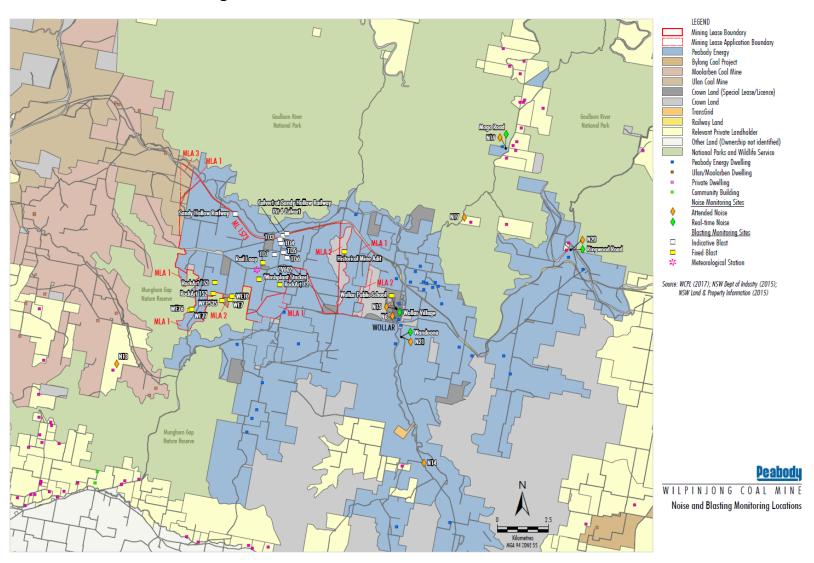
Figure 7 – Attended Noise Monitoring Locations

- 1. by an independent noise consultant;
- 2. during the night-time; and
- 3. at the sites shown in **Figure 7**.
