WILPINJONG COAL PTY LTD Environment Protection Licence (EPL) 12425

LICENCE MONITORING DATA MONTHLY SUMMARY REPORT

1 April 2021 to 30 April 2021

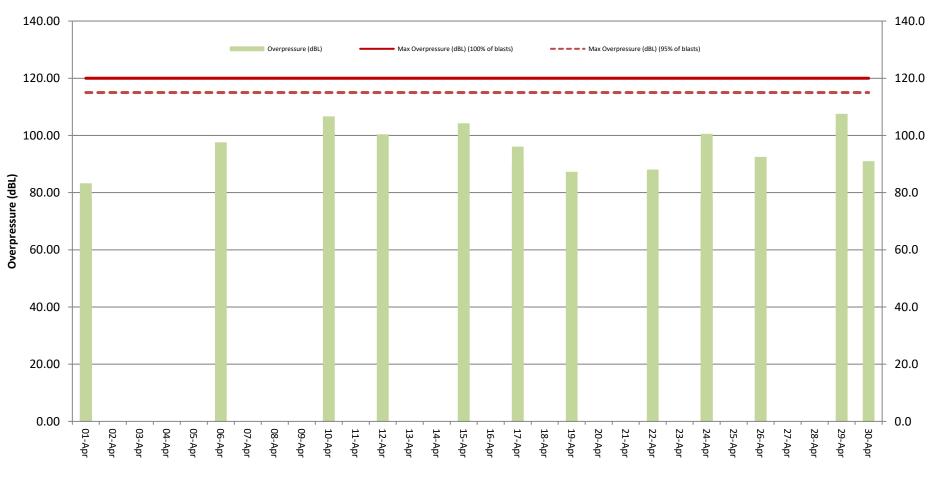
Figure 7. Overpressure (dBL) recorded during Month

Location	Month	Month Number of Blasts		Minimum Maximum overpressure (dB(L)) (dB(L))		EPL overpressure Limits (dB(L))	Exceedance (yes/no)	
Approx. 50m west of the Wollar Public School	April	15	77.6	107.4	93.2	115dB (95% blasts) 120dB (100% blasts)	no
