**WILPINJONG COAL PTY LTD**

**Environment Protection Licence (EPL) 12425**

**LICENCE MONITORING DATA  
MONTHLY SUMMARY REPORT**

**1 August 2021 to 31 August 2021**

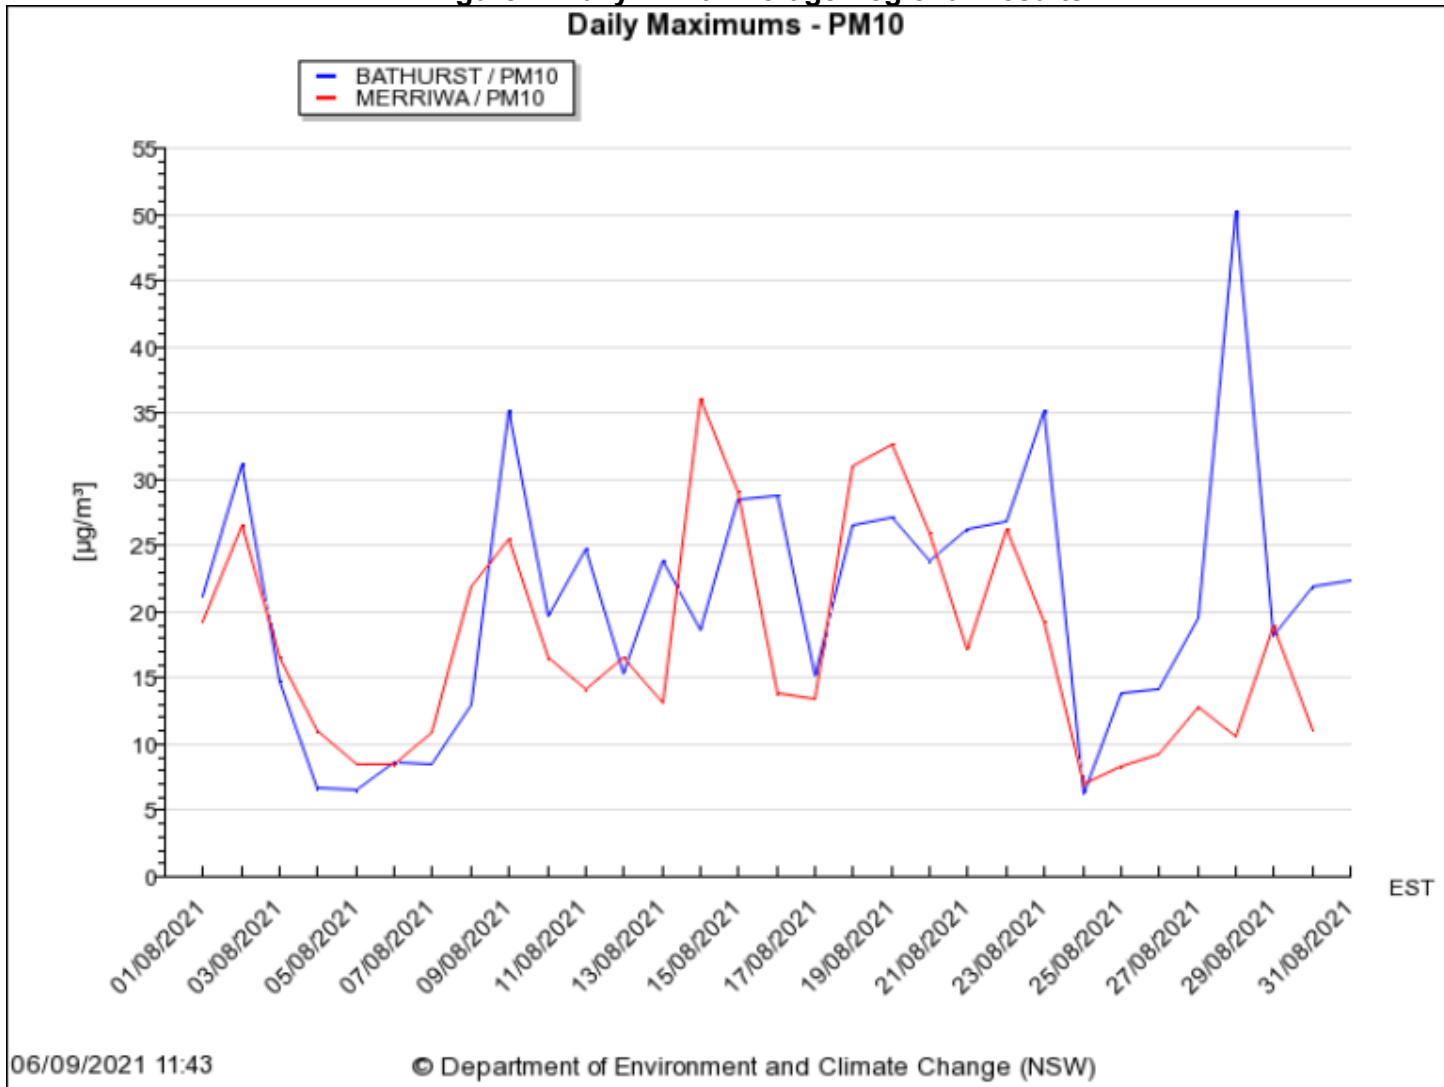
Figure 4. Daily PM10 Average Regional Results

For comparison with **Figures 2** and **3**, **Figure 4** displays the Regional 24Hr PM10 Average. PM10 dust levels for the month have been recorded in Bathurst and Merriwa by NSW EPA.
