SOUTH BATES EXTENSION UNDERGROUND MINE

EXTRACTION PLAN LONGWALLS 24 TO 26

APPENDIX H
SUBSIDENCE MONITORING PROGRAM

SUBSIDENCE MONITORING PROGRAM LONGWALLS 24 - 26

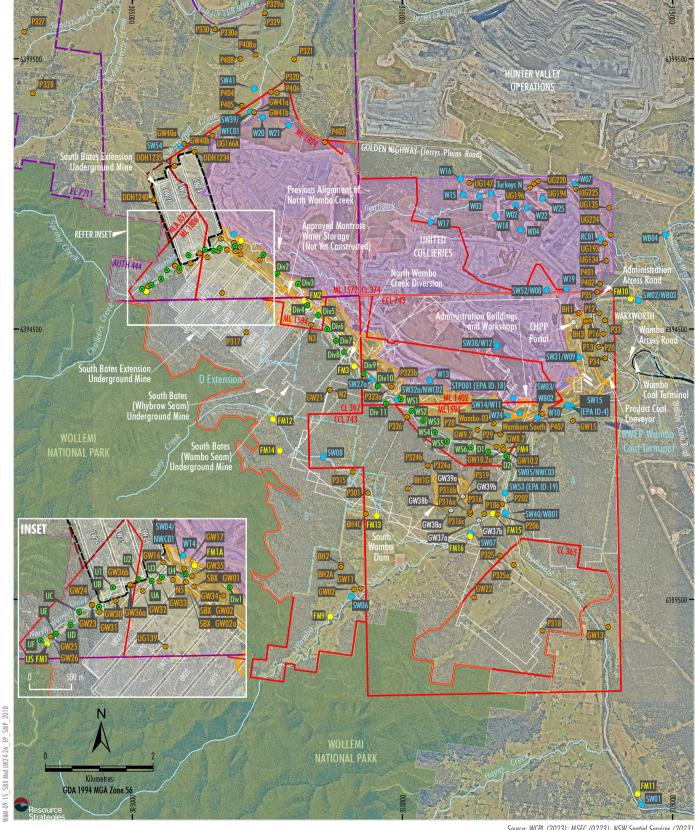
Location of Surface Water and Groundwater Monitoring Sites

Figure 1 presents the location of surface water and groundwater monitoring sites.

The various monitoring programs presented in each of the management plans under the Extraction Plan are summarised in **Table 2** and the location of environmental monitoring sites included in WCPL's various environmental monitoring programs are presented in **Figures 1** and **2**.

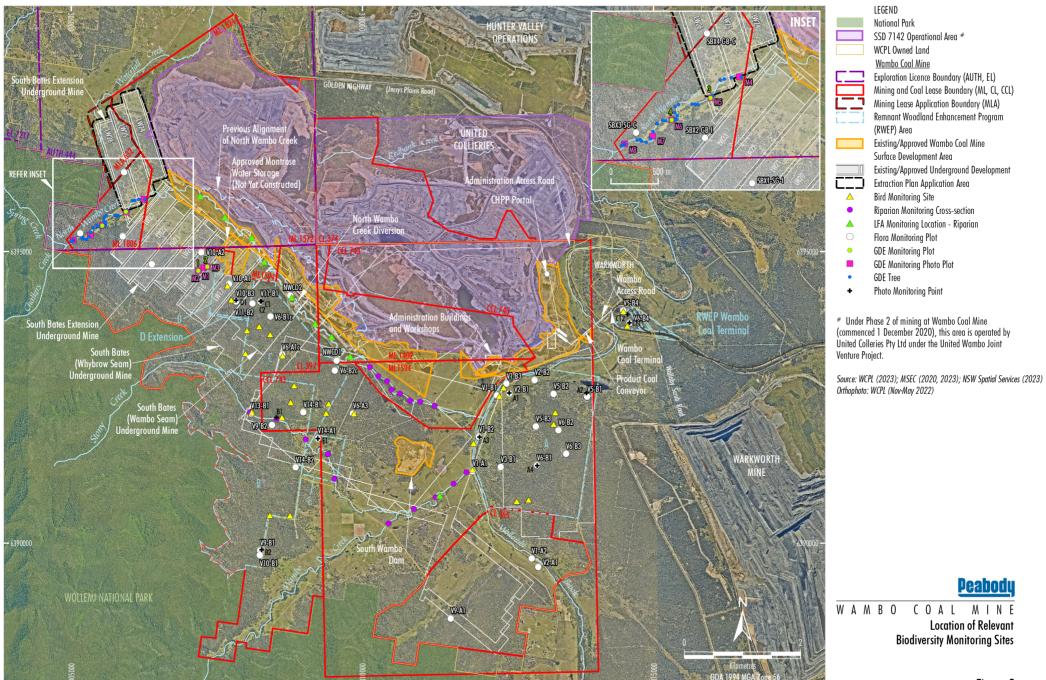
Figure 2 presents the location of biodiversity monitoring sites. As described in **Table 2**, visual observation of the Wollemi National Park escarpment will be undertaken as part of the subsidence monitoring program.
