SOUTH BATES EXTENSION UNDERGROUND MINE

**EXTRACTION PLAN
LONGWALLS 24 TO 26**

**REPORT 3
SURFACE WATER ASSESSMENT REVIEW**

Longwalls 24-26 – Extraction Plan -Surface
Water

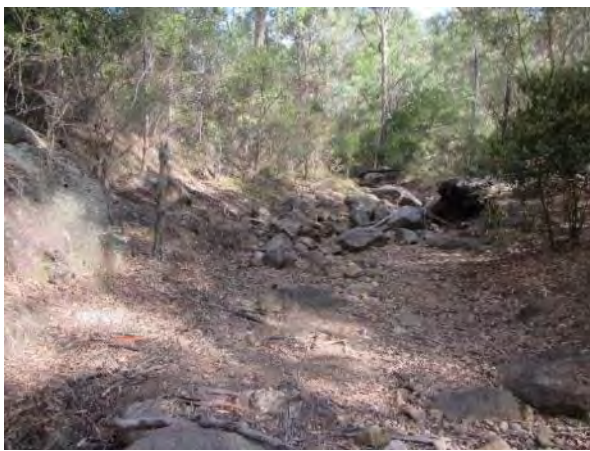
Typical Spring Creek reach (2018 baseline)

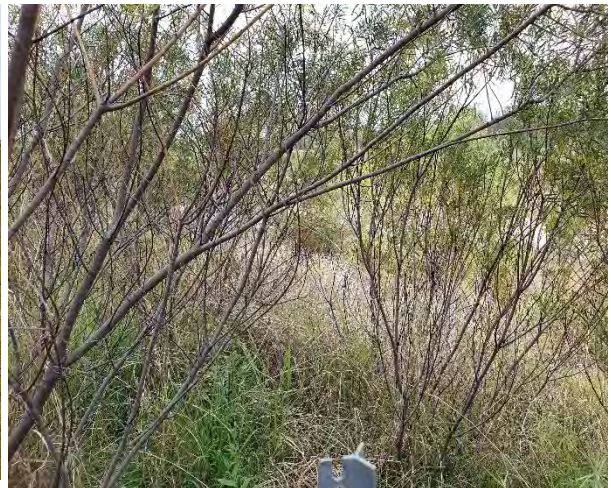
Downstream view at Div9 highlighting positive condition trajectory of revegetation efforts

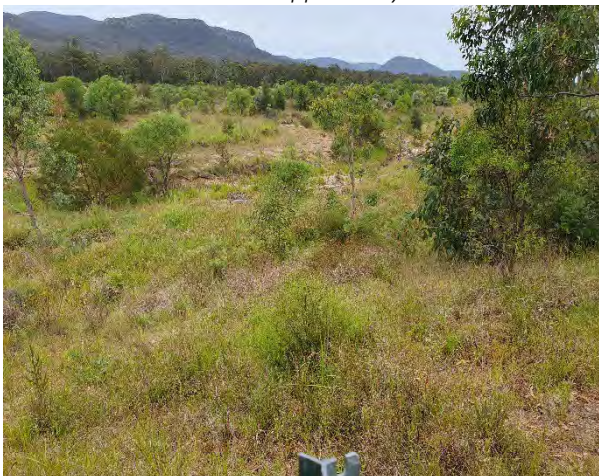
Upstream view at Div11 highlighting positive condition trajectory for revegetation efforts

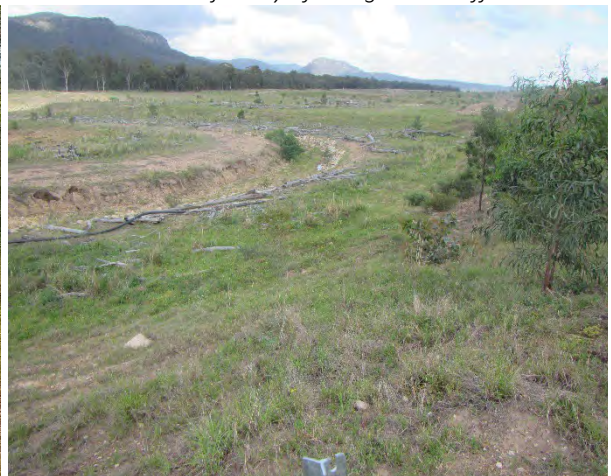
Figure 2-2. North Wambo Creek Diversion Stage 2 and Stage 3

Upstream view at Div11 in 2017 for comparison

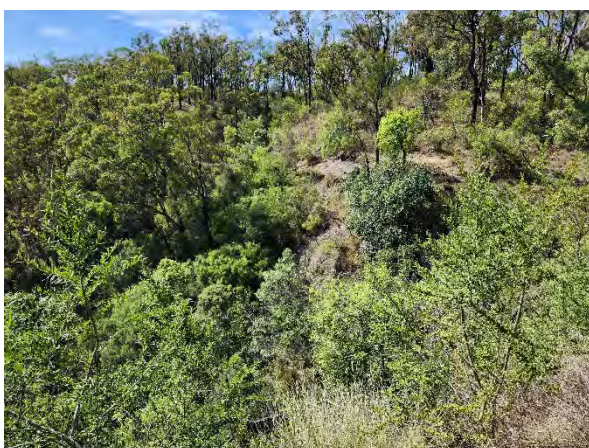
View across the broad scarp from which Waterfall Creek derives its name. The scarp sits on the LW26 western pillar and is likely to crack when subsidence occurs

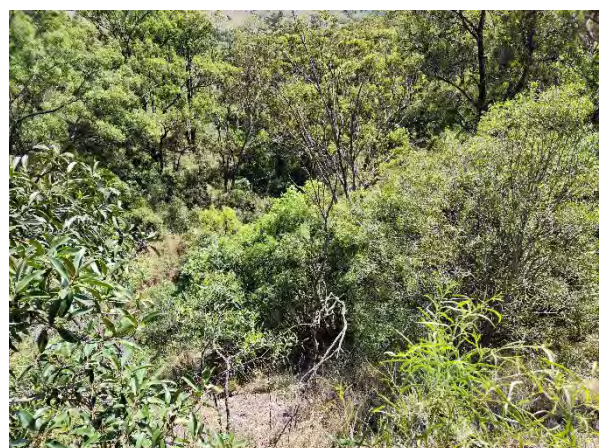
View from scarp looking downstream in Waterfall Creek where LW26 will subside

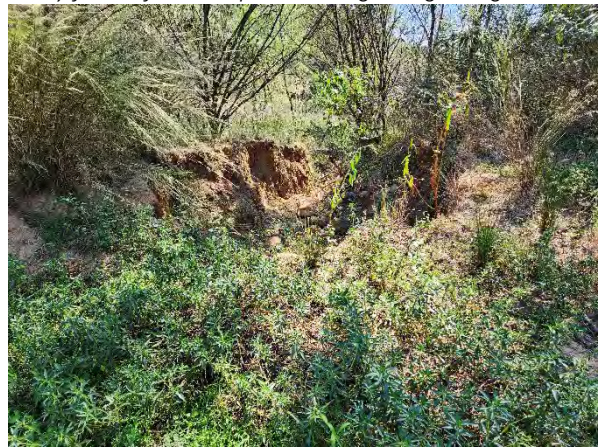
The embankment of the farm dam has already breached and may be subject to rapid failure in future flows.

A farm dam downstream of LW24 has breached in recent high flow events and is likely to fail without intervention. This will have no consequence for subsidence related processes as a bedrock cascade is present shortly upstream at the margin of the mine plan.

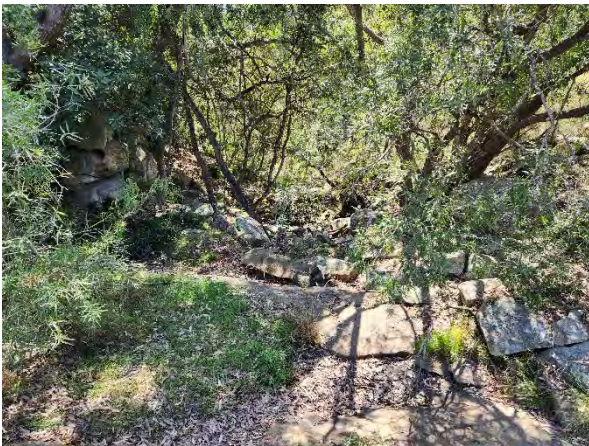
Bedrock cascade on tributary above farm dam where it crosses out of LW24 would limit any potential adjustment should the dam embankment erode further

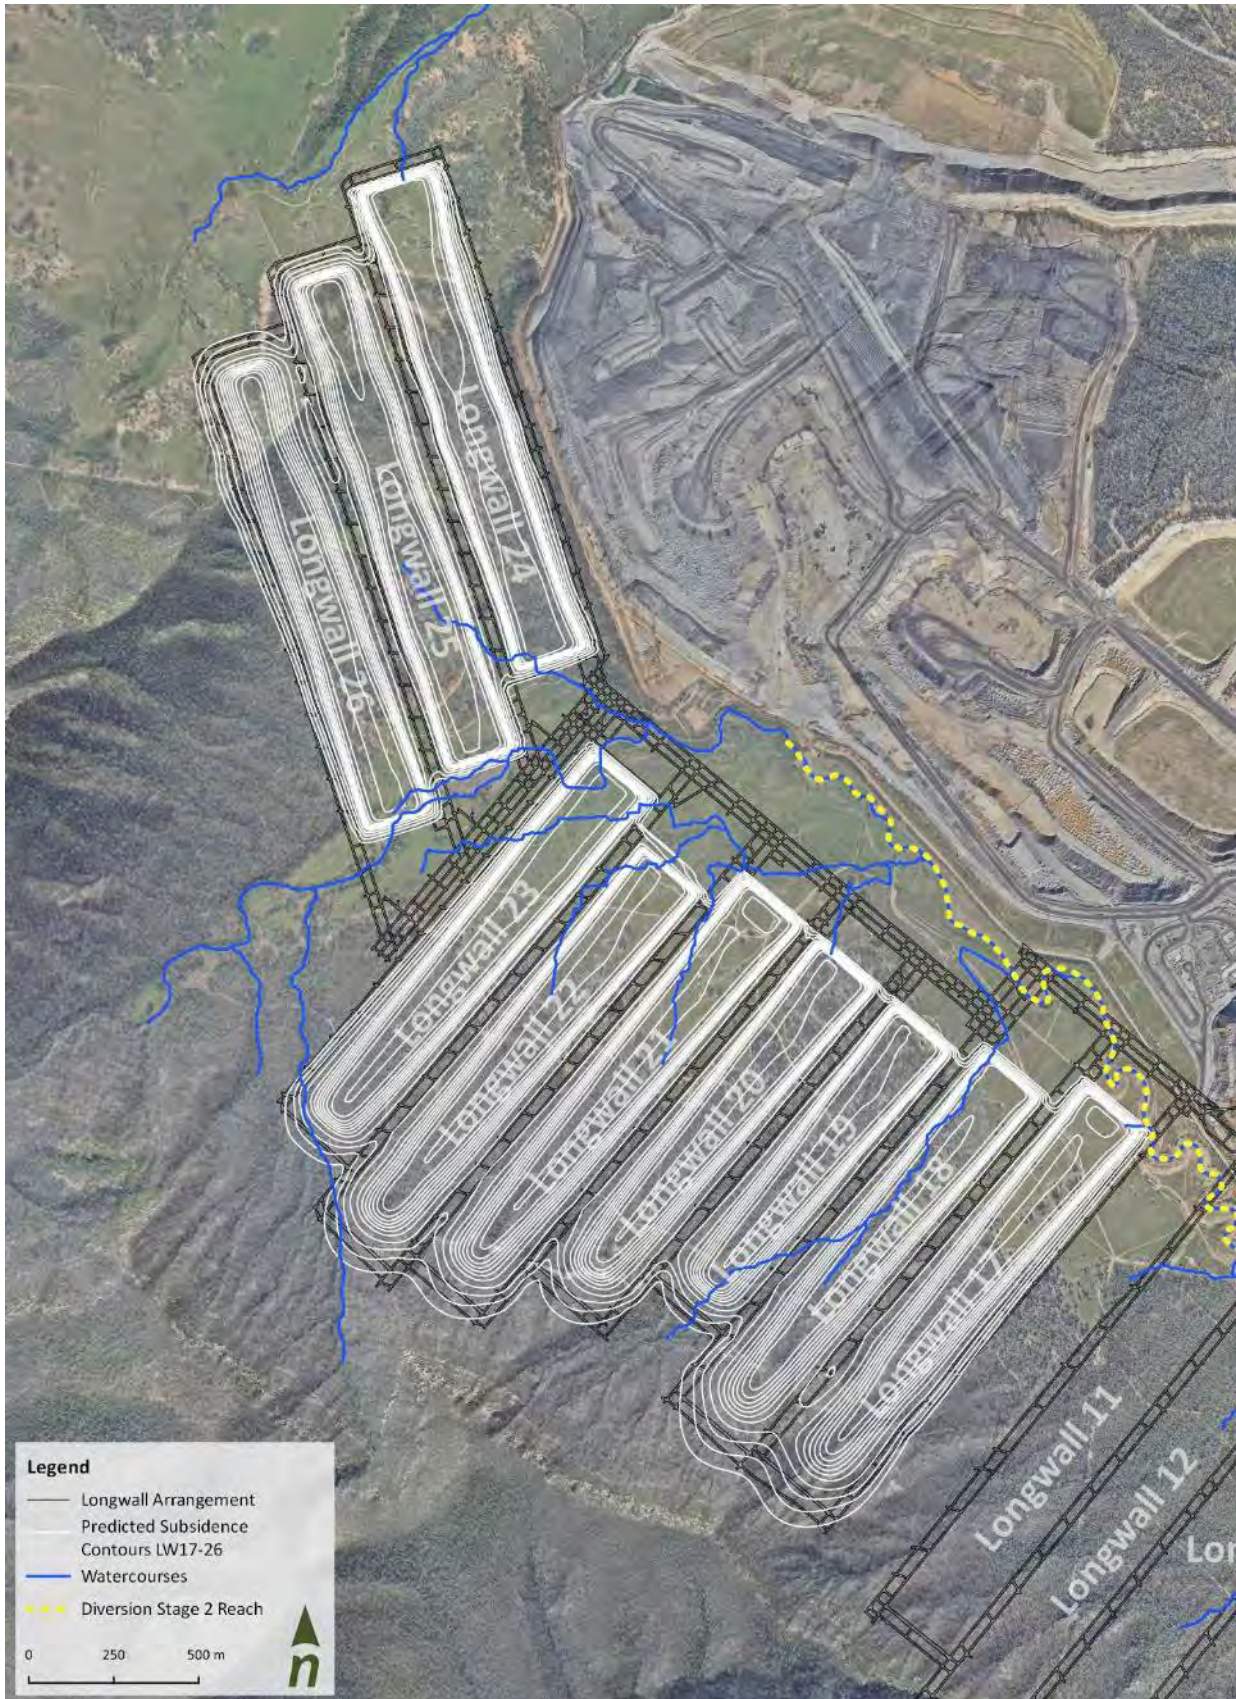
Figure 3-1. Predicted post subsidence surface contours – LW21 to LW26

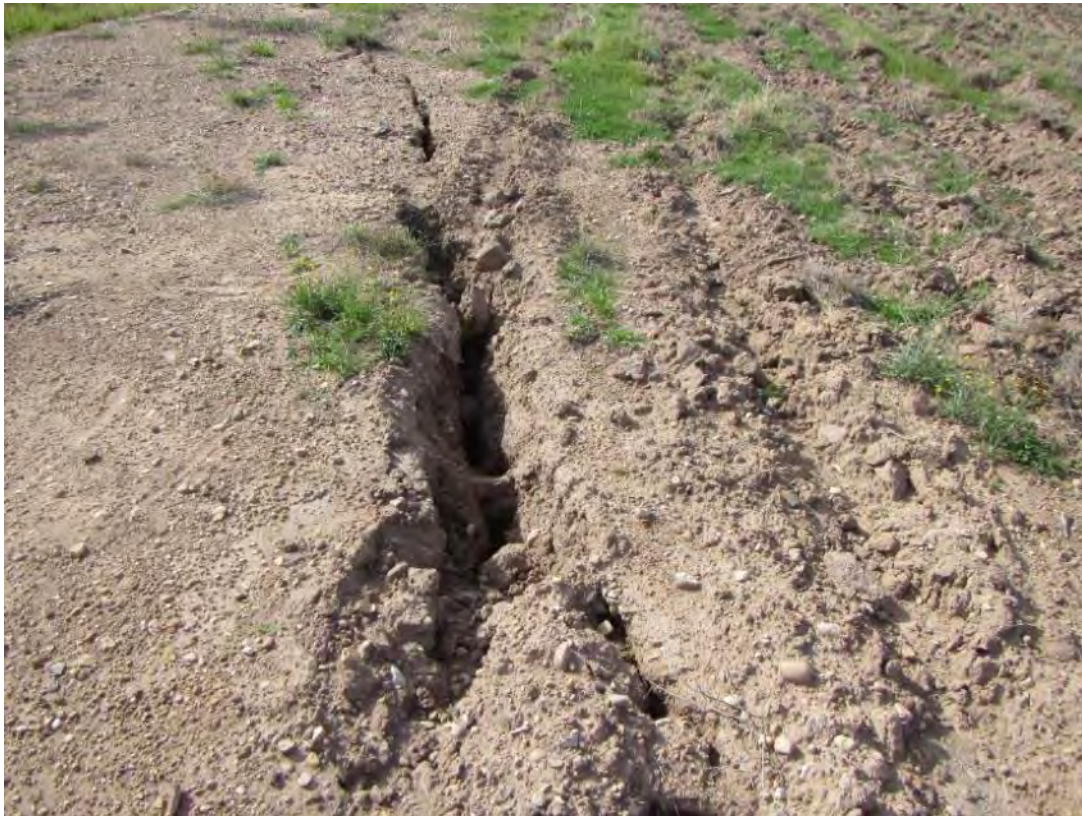
Figure 3-4. *Cracking at surface over LW13/14*

Cracking has been observed above LW11/16, LW12/15, LW13/14 (Figure 3-4) and LW17 at the surface. As part of their subsidence assessment, MSEC have mapped the surface cracking across Wambo Mine for LW11-LW20 (Figure 3-5 and Figure 3-6). Where these cracks occur in colluvial and alluvial sediments, surficial and sub surface erosion response can be expected. The sediments across this terrain can be dispersive, which makes them prone to changes in rates of erosion with changes in landscape dynamics. No additional cracking was observed in the 2022-23 inspections however the increased ground cover made these features harder to identify.

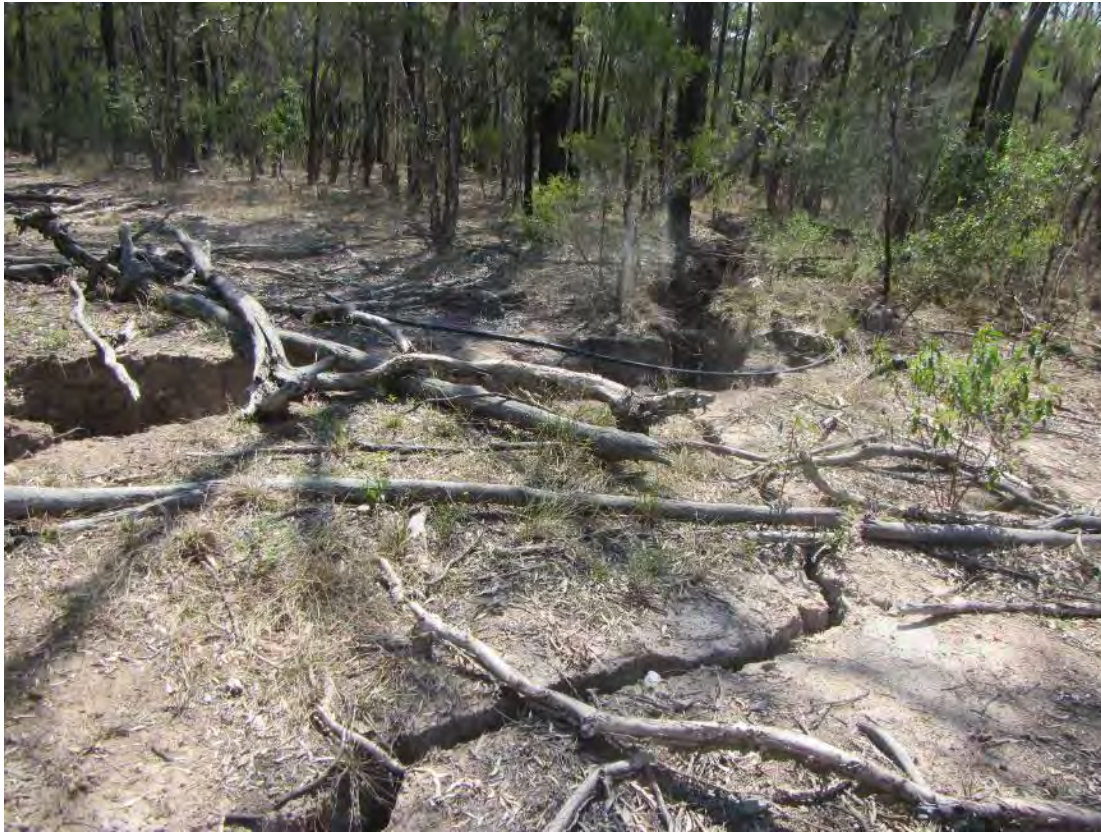
Figure 3-7. Large crack development example over LW11-16 in woodland east of NWCD

The areas of greatest risk will be where cracks open in erodible sediments with an orientation down slope or where flow entry may be concentrated, or ponding occurs. These may be prone to enlargement should the volume of the crack be sufficient that local inputs of sediment don't infill it nor do the clays swell sufficiently to seal it. In these instances, some rill/gully erosion may develop. This had not been observed to the end of 2019 due to dry conditions. Further inspection post the wet conditions of 2020-22 should be undertaken when safe to do so as cracks such as those shown in Figure 3-7 have the potential to undergo substantial enlargement due to runoff.

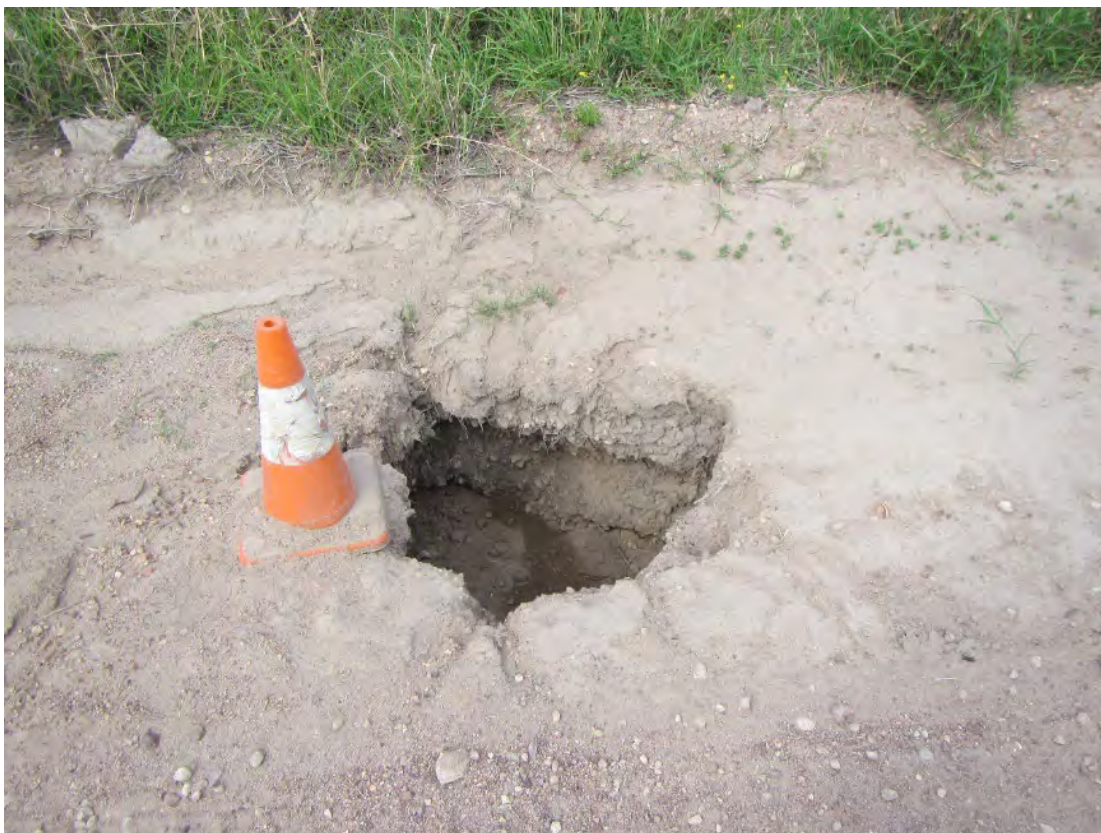
Figure 3-8. Tunnelling over LW12/15 on track adjacent NWCD associated with subsidence crack

Where local ponding occurs in the same location as cracking, dispersive sediments are likely to flow down cracks with water, enlarging the crack at surface, which may develop into considerable tunnel erosion. An example of tunnel erosion can be seen below in Figure 3-8.

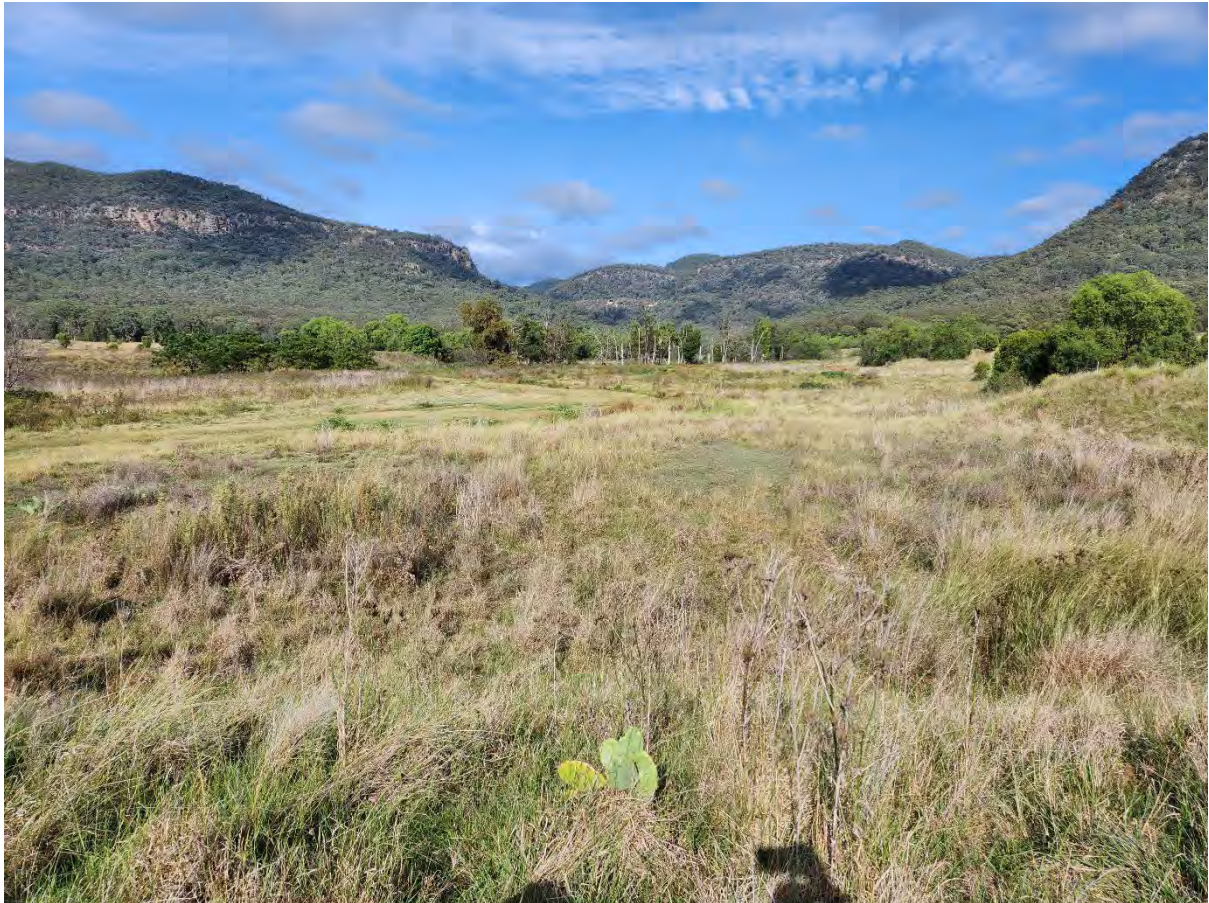
Figure 3-17. *NWC low flow channel is likely to migrate to the north (right) to the base of hillslope/terrace in LW25*

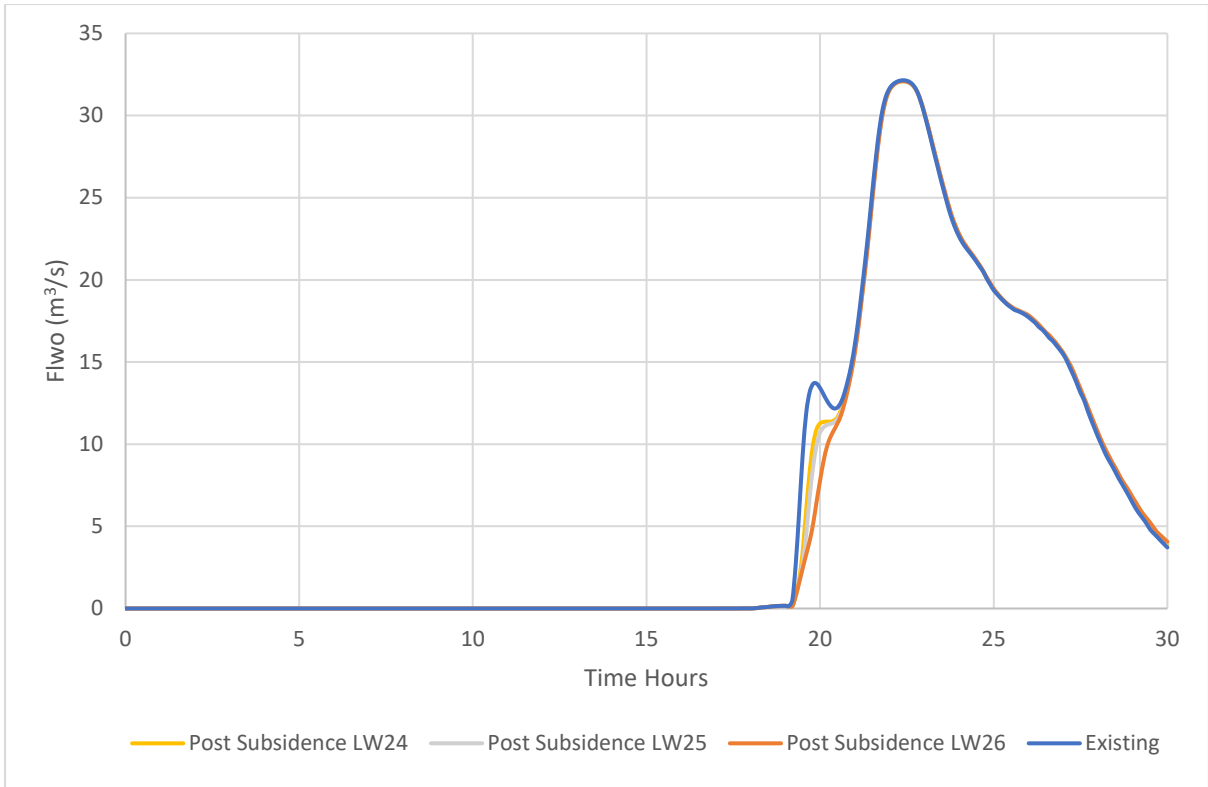
Figure 3-24. North Wambo Creek Hydrograph at FM2 – Pre and post Subsidence (0.5EY Event)

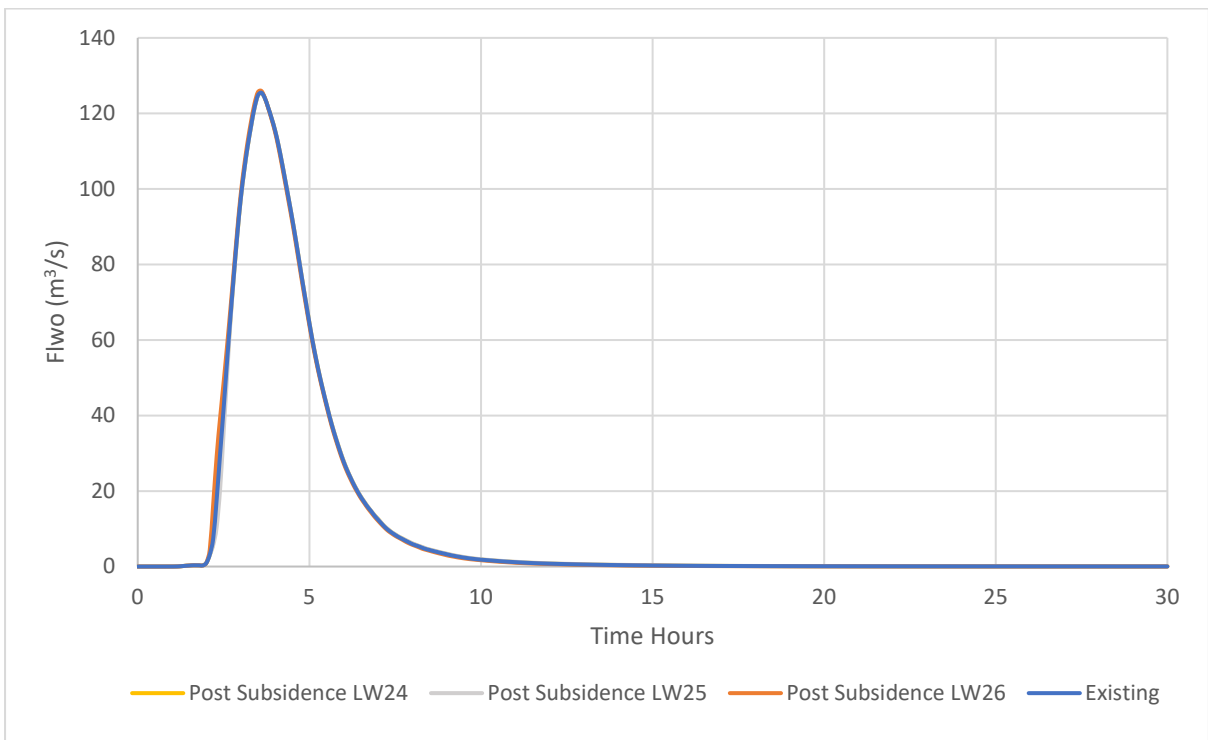
Figure 3-25. North Wambo Creek Hydrograph at FM2 – Pre and post Subsidence (2% AEP Event)

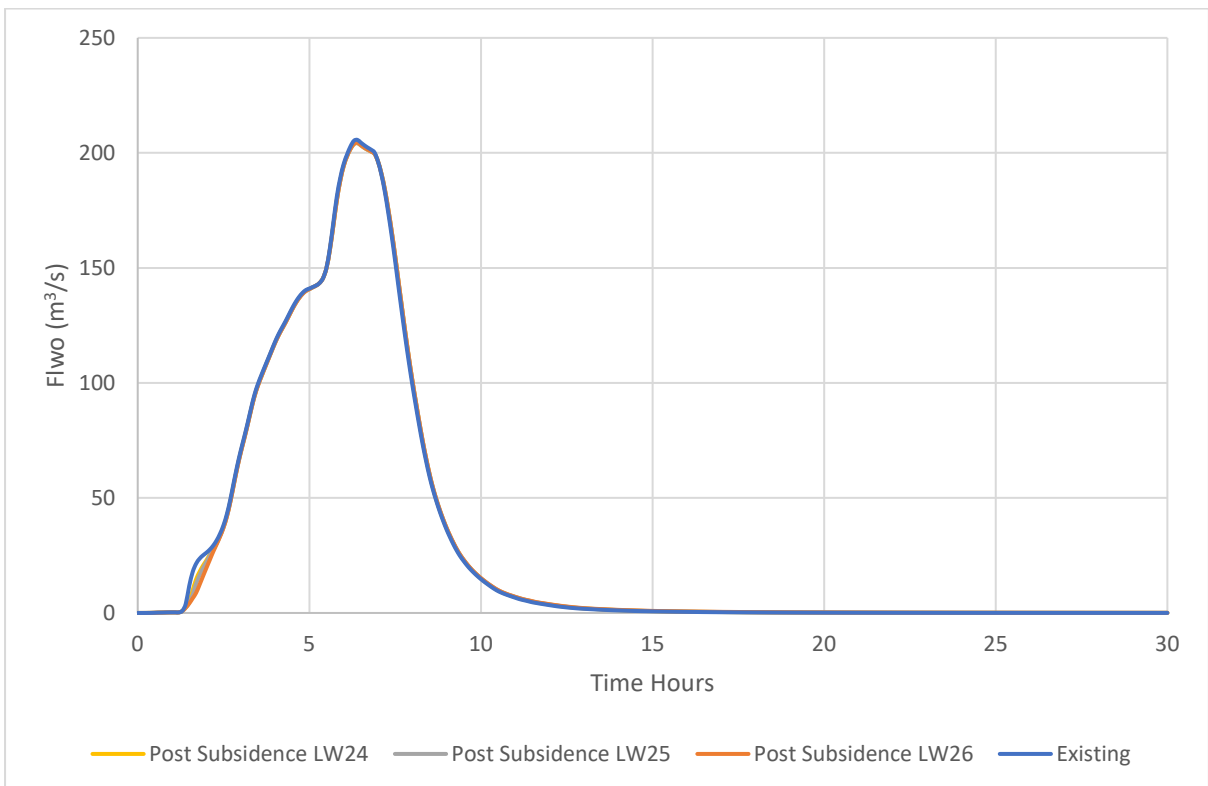
Figure 3-27. North Wambo Creek Hydrograph at FM2 – Pre and post Subsidence (0.1% AEP Event)

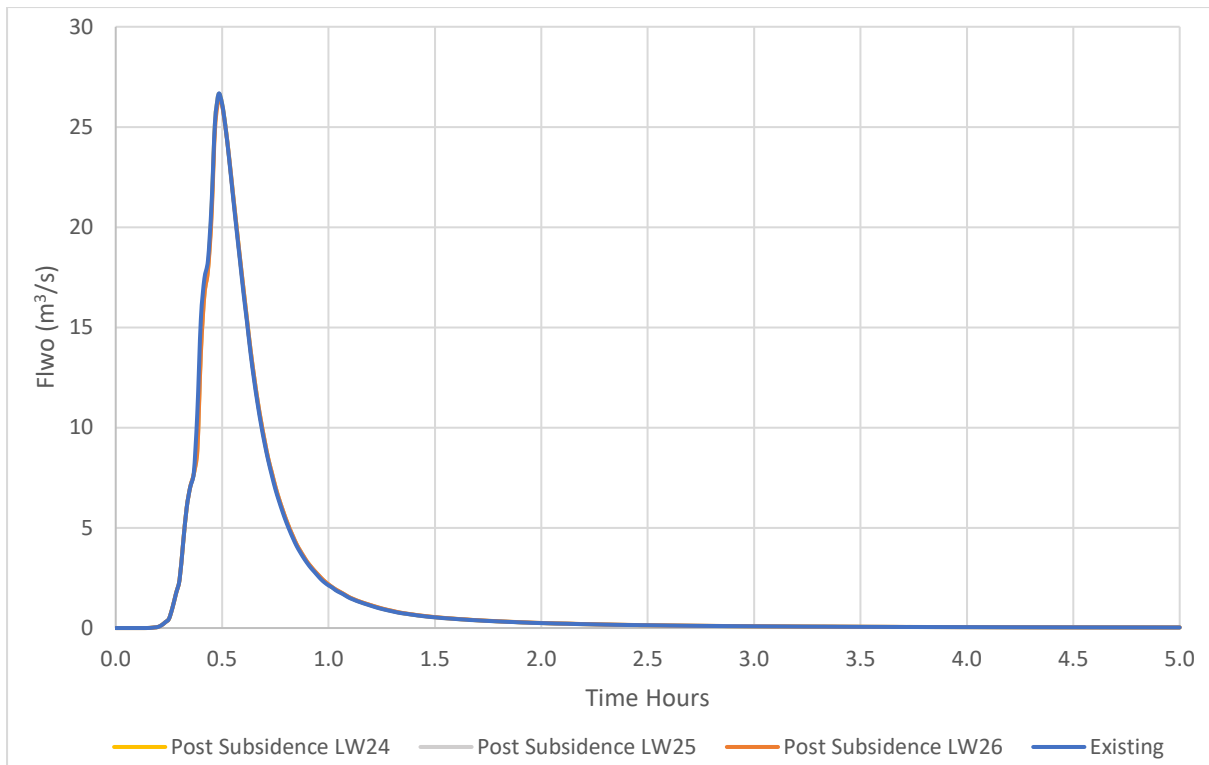
Figure 3-28. Waterfall Creek Hydrograph at downstream of model extent – Pre and post Subsidence (2% AEP Event)

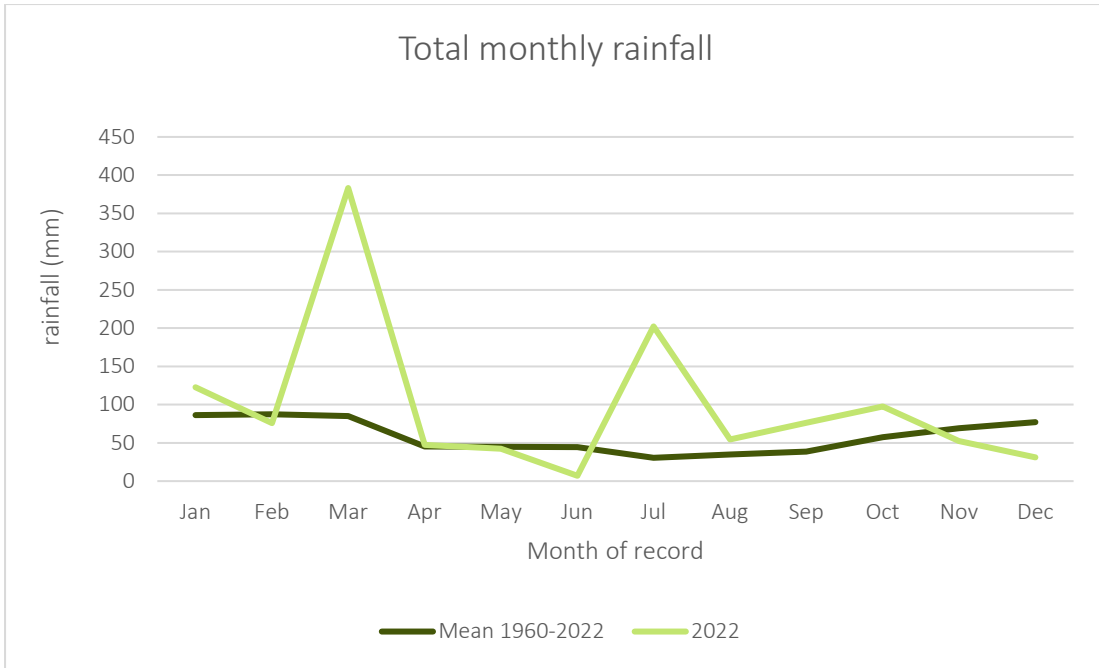
Figure 4-2. Total monthly rainfall comparison

The total rainfall for 2022 was 1,192.6mm, almost half of which fell within the months of March and July, which is 491.8mm higher than the annual mean of 700.8mm. The monthly rainfall totals for 2022 are generally similar to the historic total monthly rainfall averages (Figure 4-2) apart from the months of March and July where the site experienced unusually high rainfall (historic data taken from the Bureau of Meteorology at Bulga). These high rainfall events could influence the condition at monitoring, encourage higher levels of sediment transport or cause channel erosion.

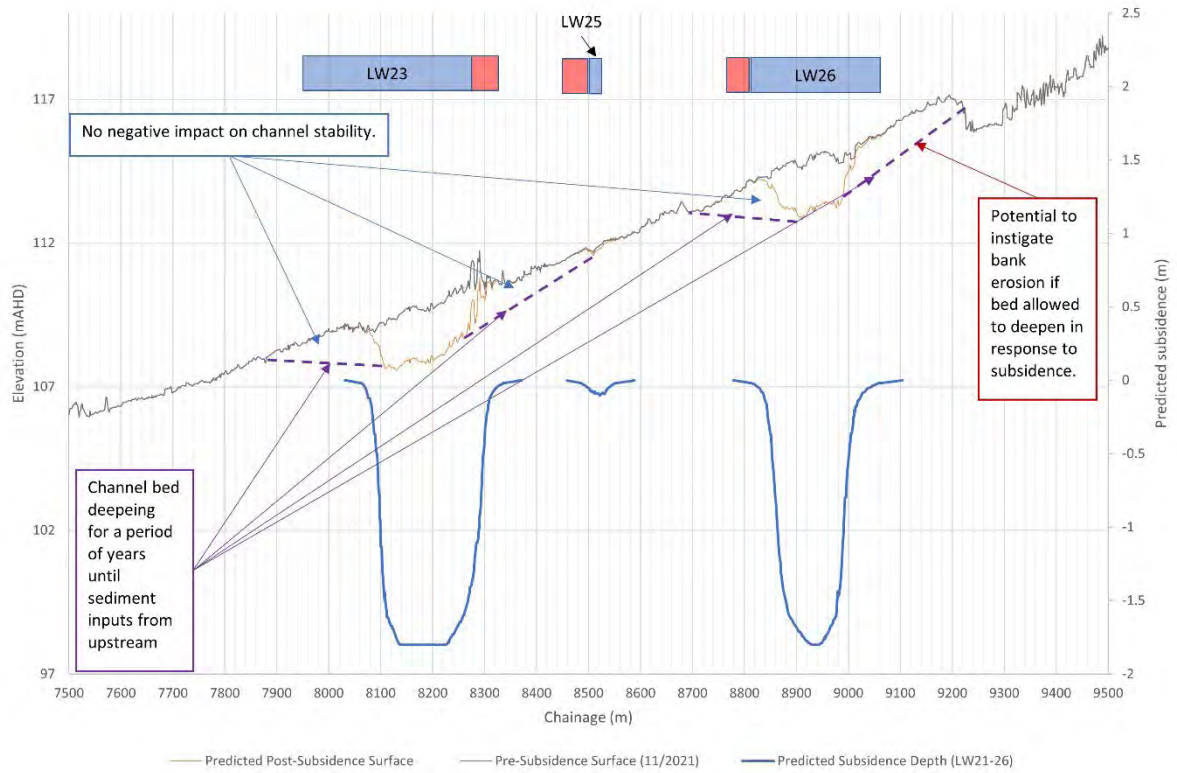
Figure 4-4. Longitudinal profile of NWC following subsidence and likely bed level response in the short to medium term
