# Emission Abatement Plan Audit Report

**P-EA-100658735**

Centurion North Pty Ltd

<b>Project name</b>		GHG Abatement plan - EA conditioned Audit					
<b>Document title</b>		Emission Abatement Plan Audit Report   P-EA-100658735					
<b>Project number</b>		12673975					
<b>File name</b>		12673975-REP-EA_Audit_Report_P-EA-100658735					
<b>Status Code</b>	<b>Revision</b>	<b>Author</b>	<b>Reviewer</b>		<b>Approved for issue</b>		
			<b>Name</b>	<b>Signature</b>	<b>Name</b>	<b>Signature</b>	<b>Date</b>
S4	0	A Zhang, I Deng	T. Jefferys

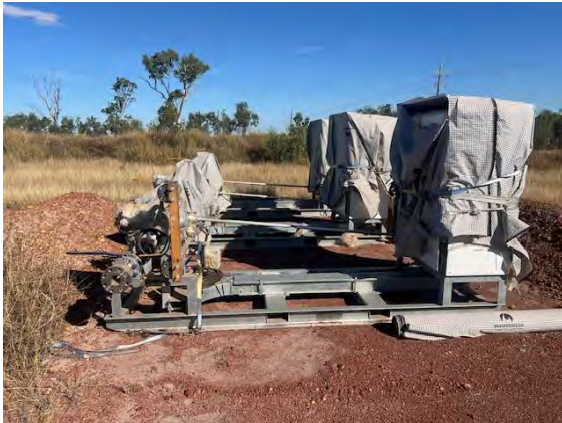
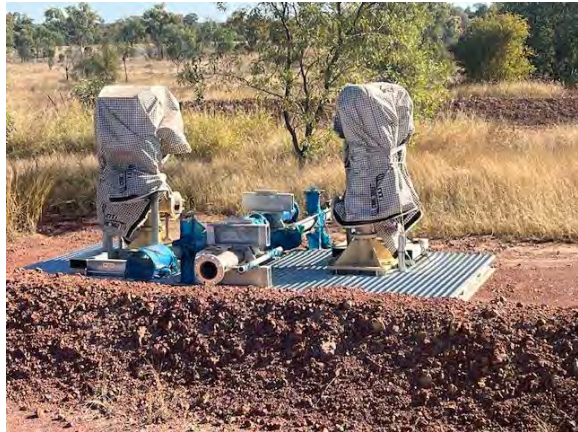
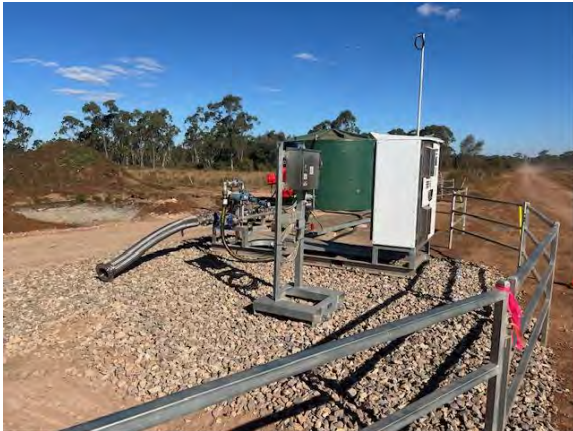
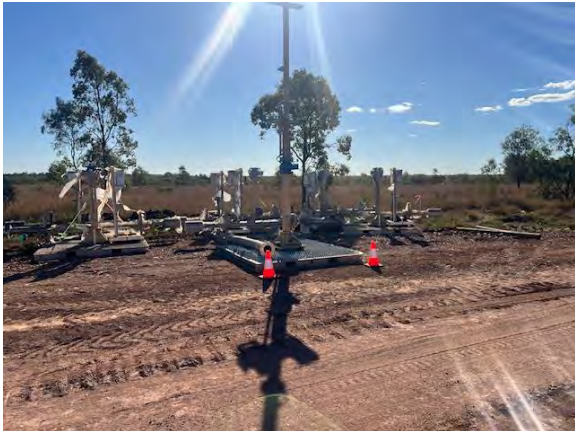
1.1	Operation of flares at >95% availability	Reviewed project schedule and site photos.	<p>The flare system includes a control skid, indicating that the proposed mitigation measures will be applicable (i.e. alarms, auto-ignition of flare). Site photos below indicate the skid units have already been purchased and is currently on site waiting to be installed.</p> <p>As of this audit period, the flares have not been installed.</p> <p><b>N/A – Flares have not yet been installed as the project is still in the early stages.</b></p> <div>

1.1	Operation of flares at >95% availability	Equipment observed on site via imagery.	<b>N/A – Flares have not yet been installed as the project is still in the early stages.</b> The flare system includes a control skid, referred to Appendix A, which is the skid unit they have already purchased and is currently on site waiting to be installed.	N/A
