METROPOLITAN COAL LONGWALLS 305-307

BIODIVERSITY MANAGEMENT PLAN

ME-TSE-MNP-0080

June 2021

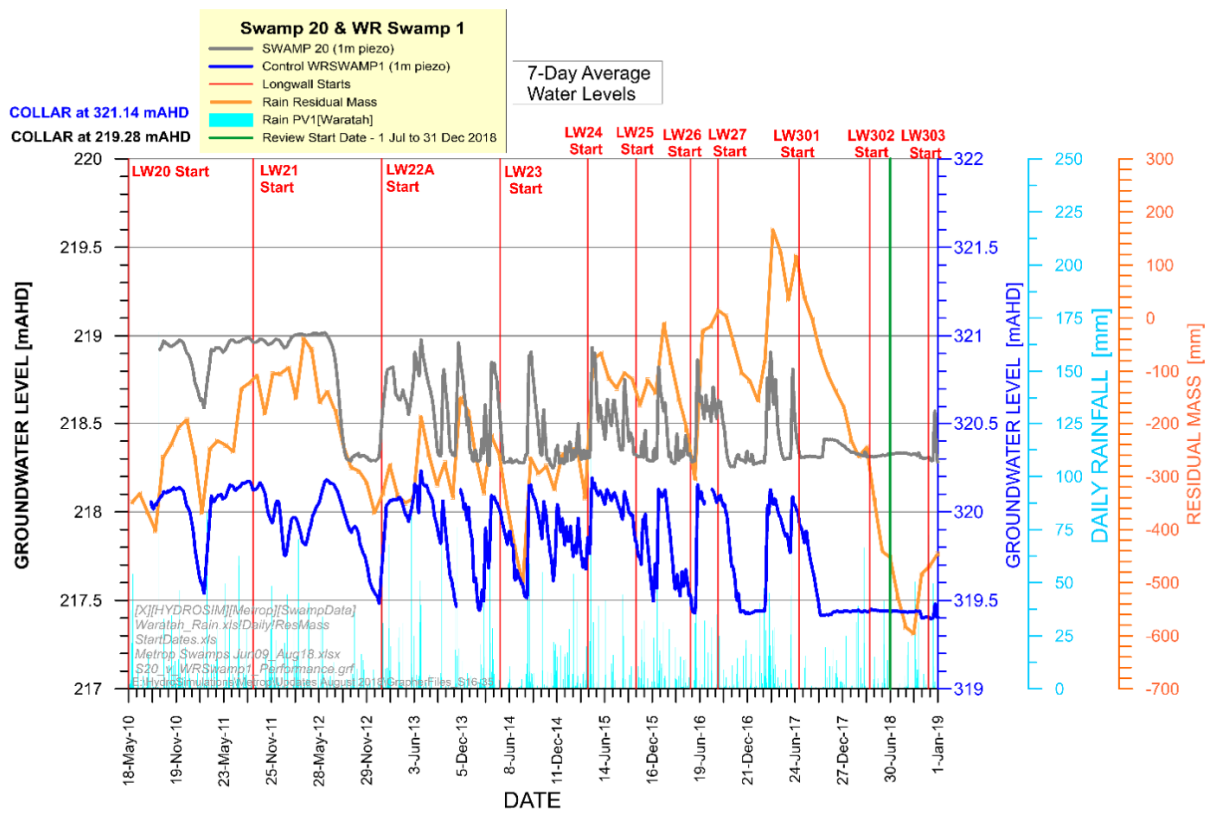
Chart 1 Comparison of Piezometer Responses at Swamp 20 and Woronora River 1 Control Swamp

The substrate water levels in Swamp 20 changed from being permanently saturated to being periodically saturated as a result of the passing of Longwall 21 (Chart 1) (HydroSimulations, 2018b). There is a very strong correlation with rainfall trend at Swamp 20 and control swamp Woronora River Swamp 1 over the period of record. As the rate of decline in the two piezometers is similar from 2013, but different in 2012, it is considered that Longwall 21 caused a mining effect at Swamp 20, but the effects were not exacerbated by Longwalls 22-27 (HydroSimulations, 2018b).

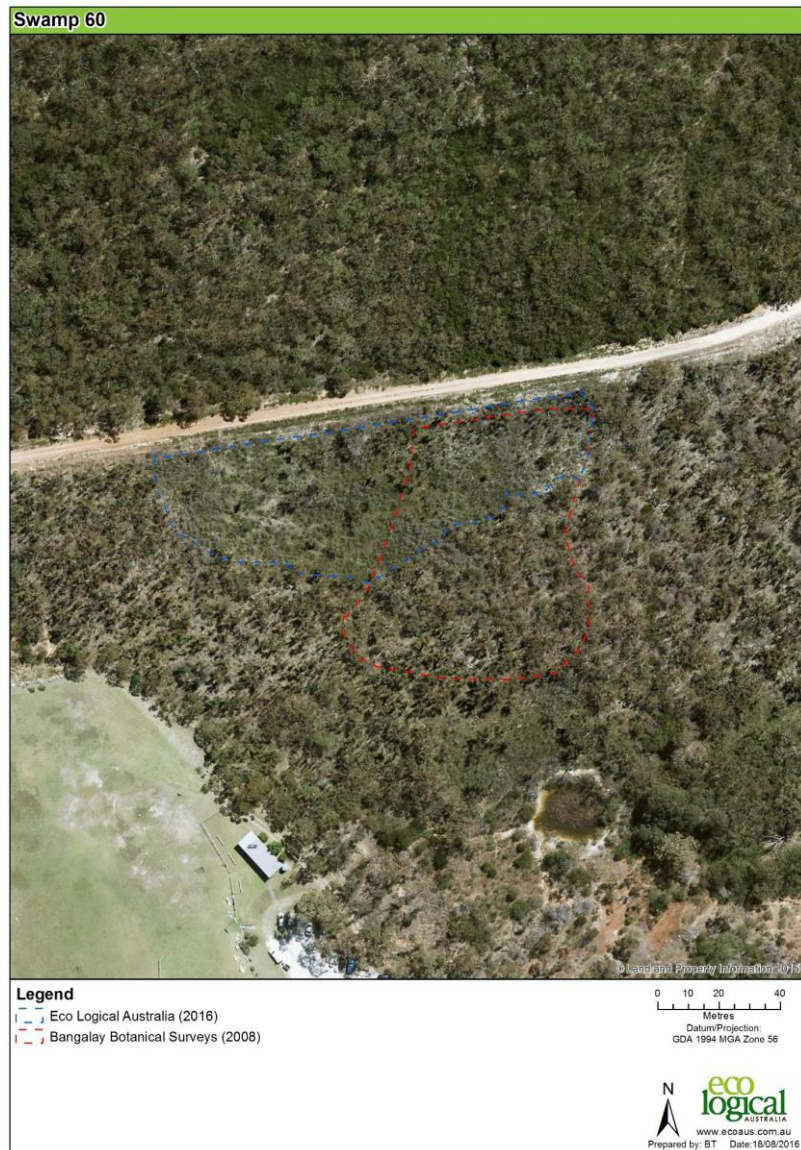
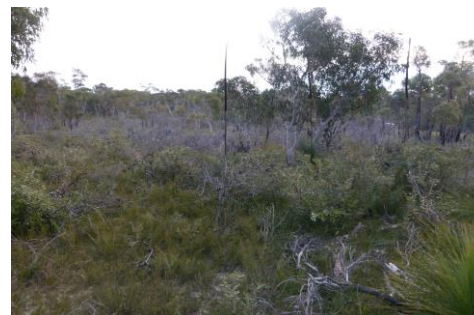
- Swamp 60 is a valley side swamp.
- Swamp 60 was previously mapped as Sedgeland-heath Complex by Bangalay Botanical Surveys (2008) and field inspections confirmed the presence of this community across the entire revised extent of this swamp.

- No terminal step or seepage was observed within this swamp, although soils were saturated at the time of inspection.

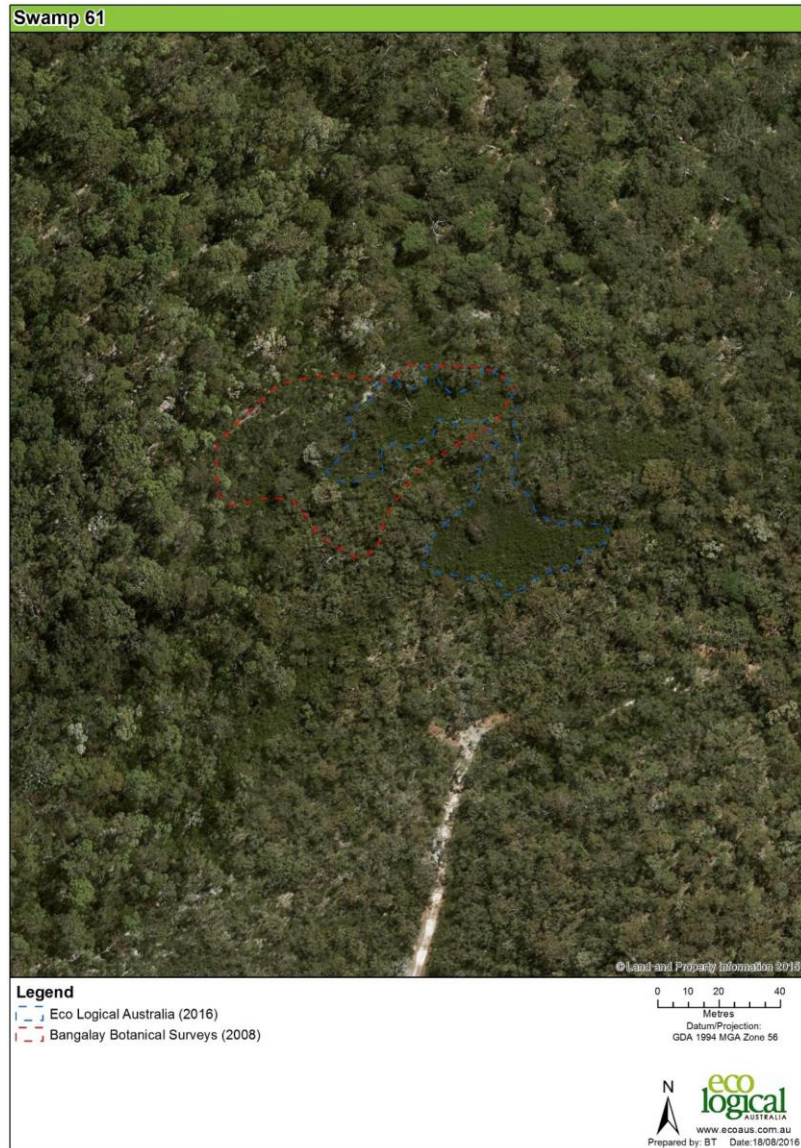
- Swamp 61 is a valley side swamp.
- Swamp 61 was previously mapped as Sedgeland-heath Complex by Bangalay Botanical Surveys (2008) though field inspections confirmed the presence of Banksia Thicket vegetation community across the entire revised extent of this swamp.

- This swamp is approximately 0.237 ha in area.
- This swamp is characterised as having a tall dense shrub layer (*Banksia ericifolia* subsp. *ericifolia* and *Leptospermum squarrosum* up to 4 m in height) over a comparatively sparse understorey dominated by sedges (*Lepidosperma neesii*, *Leptocarpus tenax*, *Empodisma minus* and *Schoenus brevifolius*).

- A very small area of outcropping sandstone is present at the lower end of this swamp, although this did not represent a ‘terminal step’ as Banksia Thicket Vegetation continued downslope of this outcrop.

- No seepage was observed across the small area of outcropping sandstone at the time of inspection (July 2016).

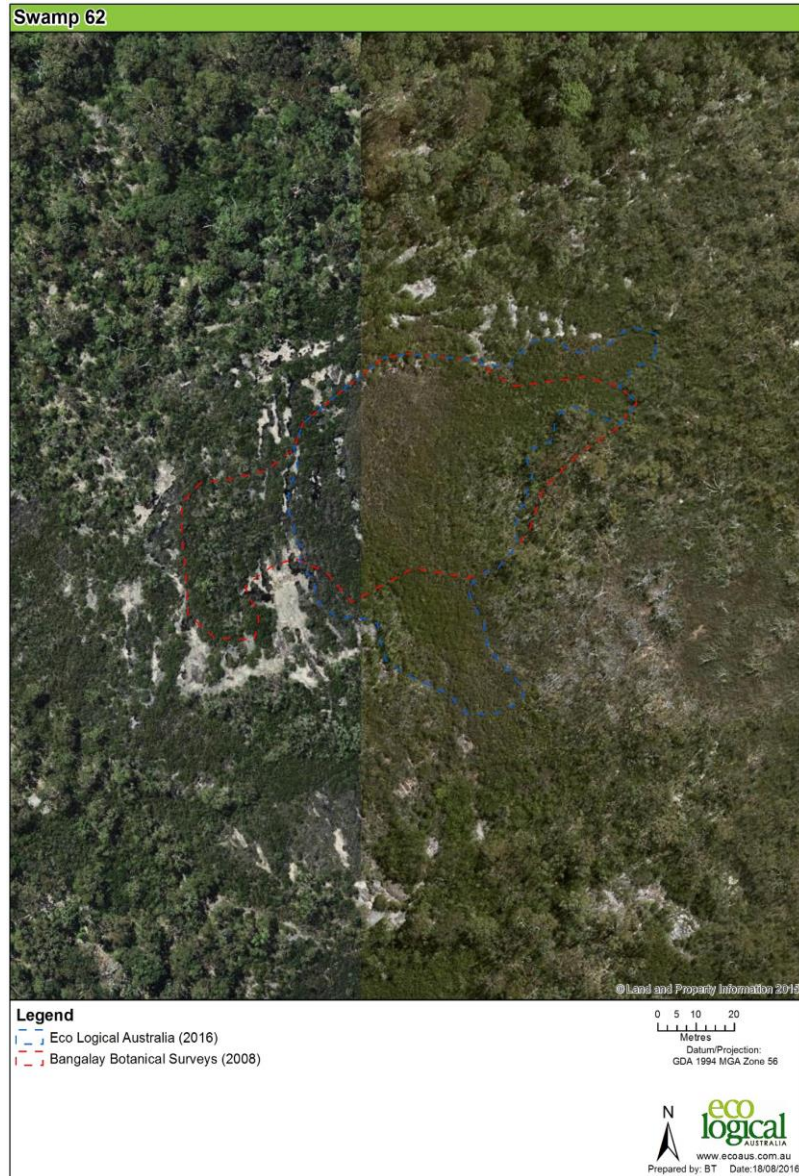
- Swamp 62 is a valley side swamp approximately 0.463 ha in area.
- Swamp 62 was previously mapped as Sedgeland-heath Complex by Bangalay Botanical Surveys (2008) though field inspections confirmed the presence of Banksia Thicket vegetation community across the entire revised extent of this swamp.
- This swamp is characterised as having a dense shrub layer (*Banksia ericifolia subsp. ericifolia*, *Leptospermum squarrosus* and *Epacris microphylla* up to 2 m in height) over a comparatively sparse understorey dominated by sedges (*Leptocarpus tenax*, *Chordifex fastigiatus*, *Lepidosperma filiforme* and *Schoenus brevifolius*).
- A terminal step of outcropping sandstone was present across the lower end of this swamp, and seepage and standing water was observed across this terminal step.

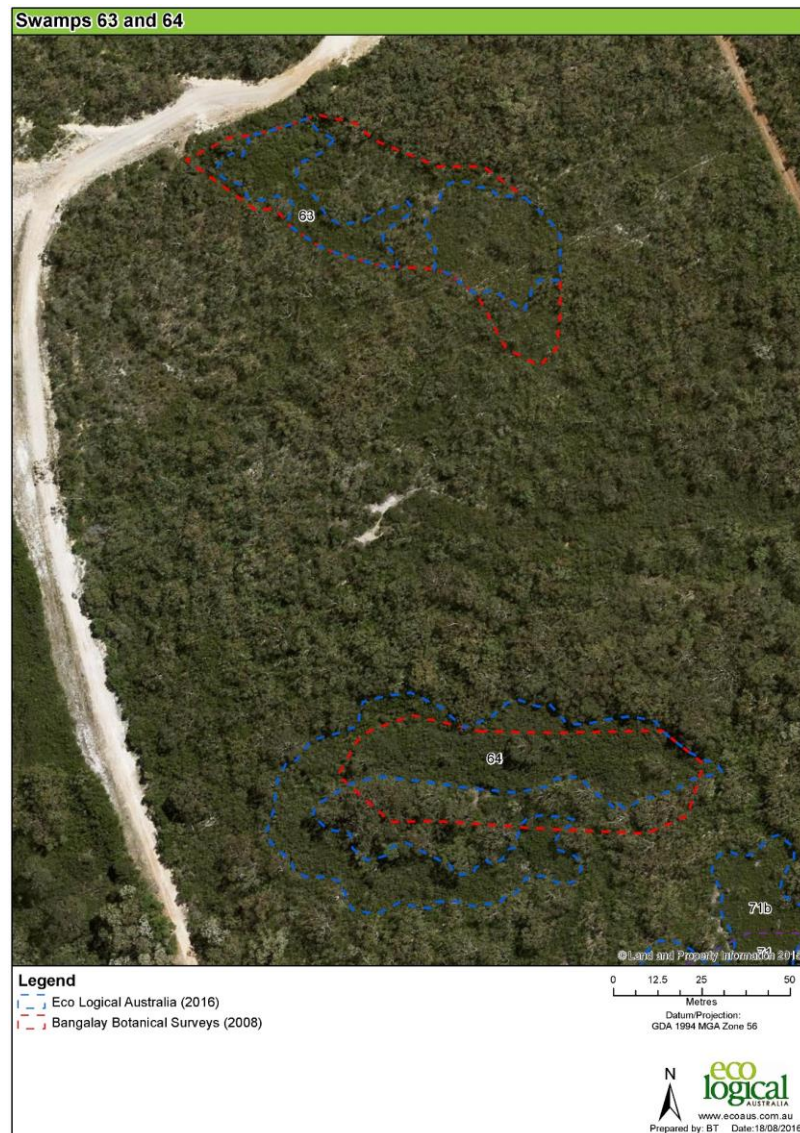
- Swamps 63 and 64 are valley side swamps, approximately 0.17 ha and 0.363 ha in area, respectively.
- These swamps were both previously mapped as Sedgeland-heath Complex by Bangalay Botanical Surveys (2008) though field inspections confirmed the presence of *Banksia* Thicket vegetation community across the entire revised extents of these swamps.

- These swamps are all characterised as supporting tall dense shrub layers dominated by *Banksia ericifolia* subsp. *ericifolia*, *Leptospermum squarrosum* and *Hakea teretifolia* over a sedge dominated ground layers (*Lepidosperma neesii*, *Empodisma minus*, *Lepyrodia scariosa*, *Cyathochaeta diandra* and *Ptilothrix deusta*).

- No terminal step was observed for either of these two swamps and no seepage was recorded at the time of inspections (July 2016).
- A large trench is present adjacent to Fire Trail 9I which is located to the west of Swamp 64. There appears to have been some alteration to the local hydrology of Swamp 64 caused by this deep trench intercepting water flows.

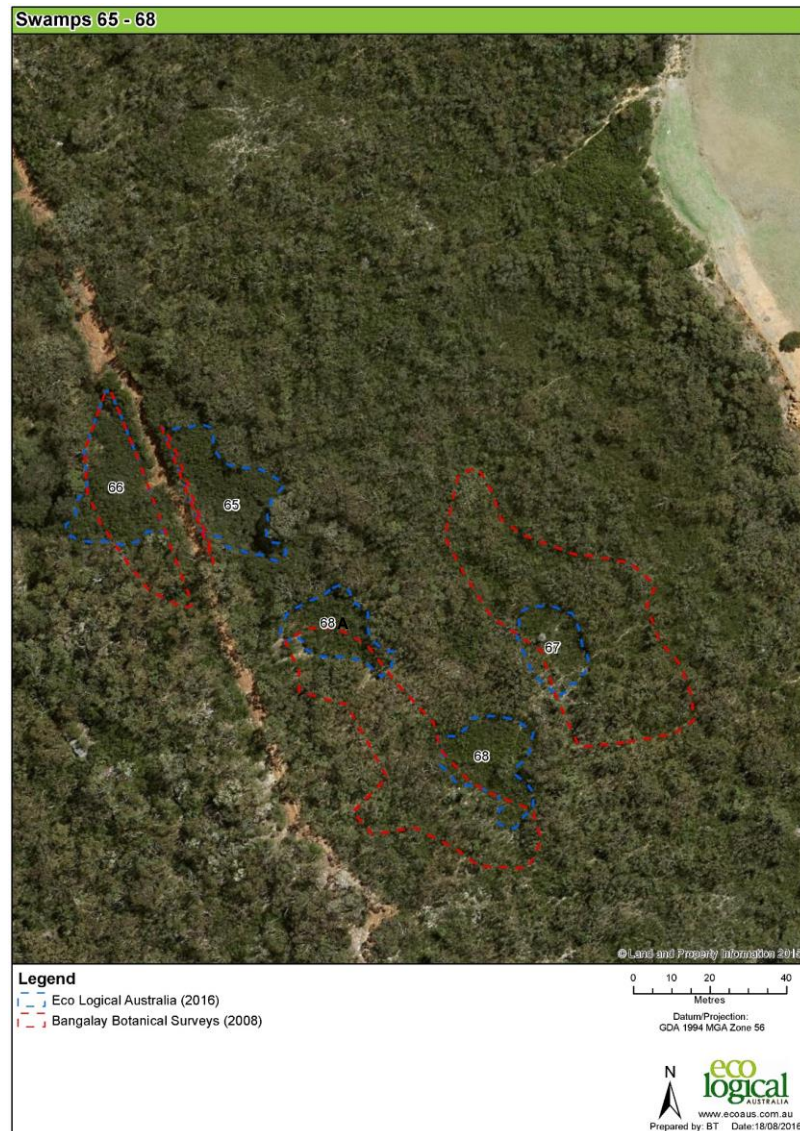
Swamps 65 - 68

- Swamps 65 to 68 are all valley side swamps, approximately 0.055 ha, 0.057 ha, 0.030 ha and 0.077 ha in area, respectively.
- These swamps were all previously mapped as Sedgeland-heath Complex by Bangalay Botanical Surveys (2008) although field inspections confirmed the presence of Banksia Thicket vegetation community across the entire revised extents of these swamps.

- These swamps are all characterised as supporting tall dense shrub layers dominated by *Banksia ericifolia* subsp. *ericifolia*, *Leptospermum squarrosum* and *Hakea teretifolia* over a sedge dominated ground layer.

- These swamps form a mosaic with adjacent woodland and heath vegetation types. No terminal steps were observed for any of Swamps 65 to 68.
- Field inspections revised the boundaries of all of these swamps including a much-increased extent of Swamp 65 which was identified as being part of a single swamp with Swamp 66, separated by a cleared track. Additionally, the extents of Swamps 67 and 68 were much reduced with Swamp 68 being identified as two discrete areas of Banksia Thicket vegetation (68a and 68b).

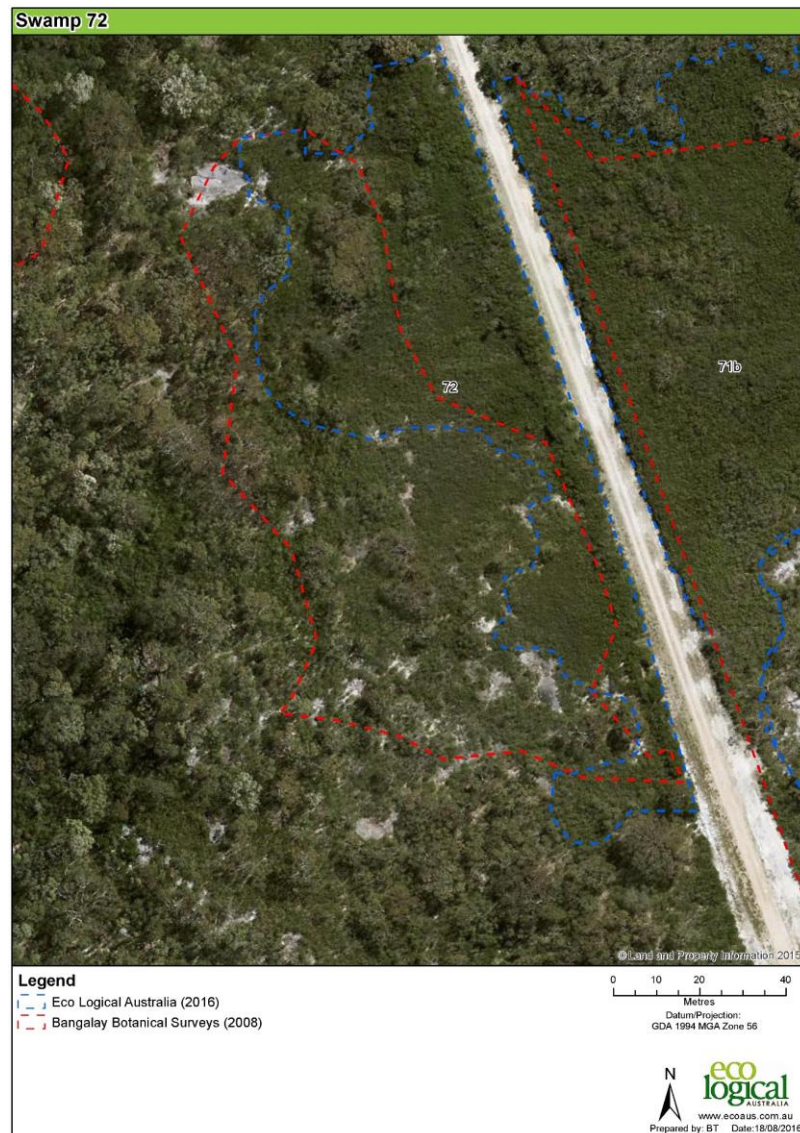
- Swamp 72 is a valley side swamp approximately 0.606 ha in area.
- This swamp was previously mapped as Sedgeland-heath Complex by Bangalay Botanical Surveys (2008) though field inspections confirmed the presence of Banksia Thicket vegetation community across the entire revised extent of this swamp.
- This swamp is characterised as having a dense shrub layer (*Banksia ericifolia subsp. ericifolia* and *Hakea teretifolia* generally up to 2 m in height) over an understorey dominated by sedges (*Chordifex fastigiatus* and *Lepyrodia scariosa*).
- Extensive areas of sandstone outcropping are present at the downslope limit of this swamp forming a terminal step, with seepage from the swamp observed across this area. The extensive sandstone outcropping supported the 'Rock Pavement Heath' vegetation community.
- Impacted by track creation and water infrastructure along roadside.

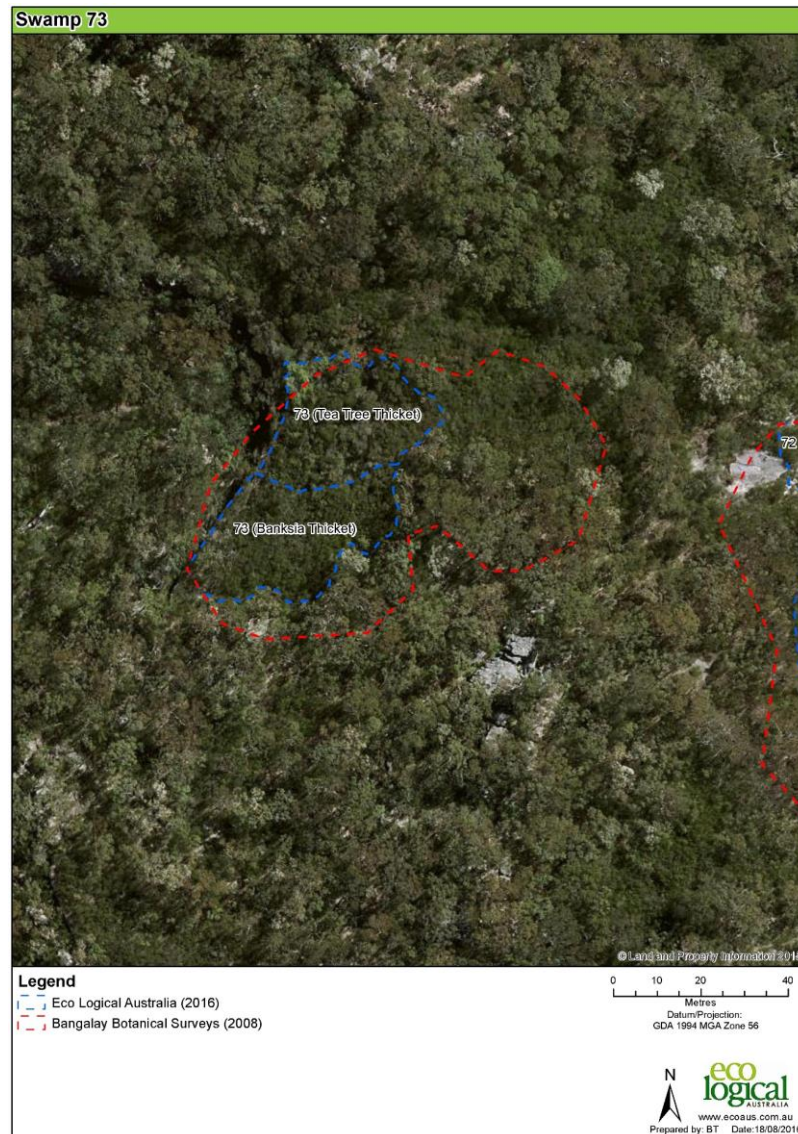
- Swamp 73 is a valley side swamp approximately 0.182 ha in area.
- This swamp was previously mapped as Sedgeland-heath Complex by Bangalay Botanical Surveys (2008) though field inspections confirmed the presence of Banksia Thicket and Tea Tree Thicket vegetation communities within the revised extent of this swamp.

- The northern portion of this swamp occurs in association with a poorly defined drainage line and supports Tea Tree Thicket vegetation with a moderately dense shrub layer (*Banksia robur*, *Persoonia pinifolia* and *Hakea teretifolia*) over an understorey dominated by the fern *Gleichenia microphylla*. The southern portion of this swamp is located away from the drainage line and supports Banksia Thicket vegetation with a tall dense shrub layer (*Banksia ericifolia* subsp. *ericifolia*, *Leptospermum squarrosus* and *Hakea teretifolia*) over and understorey dominated by sedges.

- A small to moderate cliff line forms the terminal step of this swamp. Abundant seepage was present at the time of inspection, creating a waterfall over the terminal step.

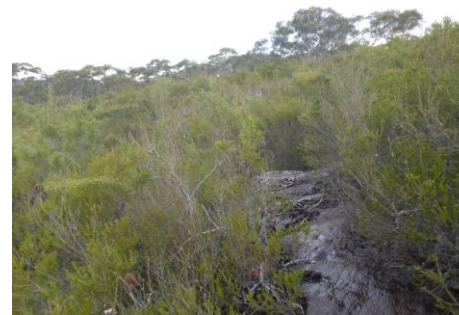
- Swamp 81 is a valley side swamp approximately 0.728 ha in area.
- This swamp was previously mapped as Sedgeland-heath Complex by Bangalay Botanical Surveys (2008) though field inspections confirmed the presence of Banksia Thicket vegetation community across the entire revised extent of this swamp.
- Fire history: burnt 1986-1987 and 1993-1994.
- This swamp is characterised as having a tall dense shrub layer (*Banksia ericifolia* subsp. *ericifolia* and *Leptospermum squarrosum* 2-3 m in height) over an understorey dominated by sedges (*Chordifex fastigiatus*, *Lepidosperma filiforme* and *L. neesii*).
- No terminal step was observed but an extensive mid-swamp step is present, with abundant seepage present.

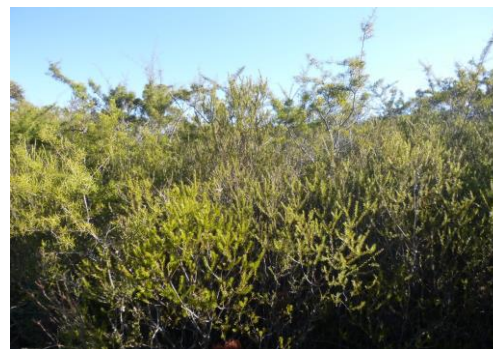
- Swamp 82 is a valley side swamp approximately 1.437 ha in area.
- This swamp was previously mapped as Sedgeland-heath Complex by Bangalay Botanical Surveys (2008) though field inspections confirmed the presence of Banksia Thicket vegetation community across the entire revised extent of this swamp.

- An intermittent area of outcropping sandstone/terminal step is present at the lower end of this swamp, below which a woodland community was present.
- A drainage line is present within the swamp, which flows out across part of the terminal step.

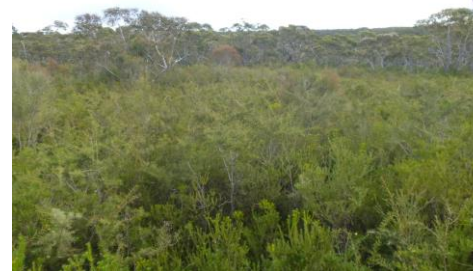
- Swamp 83 is a valley side swamp 0.202 ha in area.
- This swamp was previously mapped as Sedgeland-heath Complex by Bangalay Botanical Surveys (2008) though field inspections confirmed the presence of Banksia Thicket vegetation community across the entire revised extent of this swamp.

- No terminal step of outcropping sandstone was observed, however outcropping sandstone was present within the swamp.

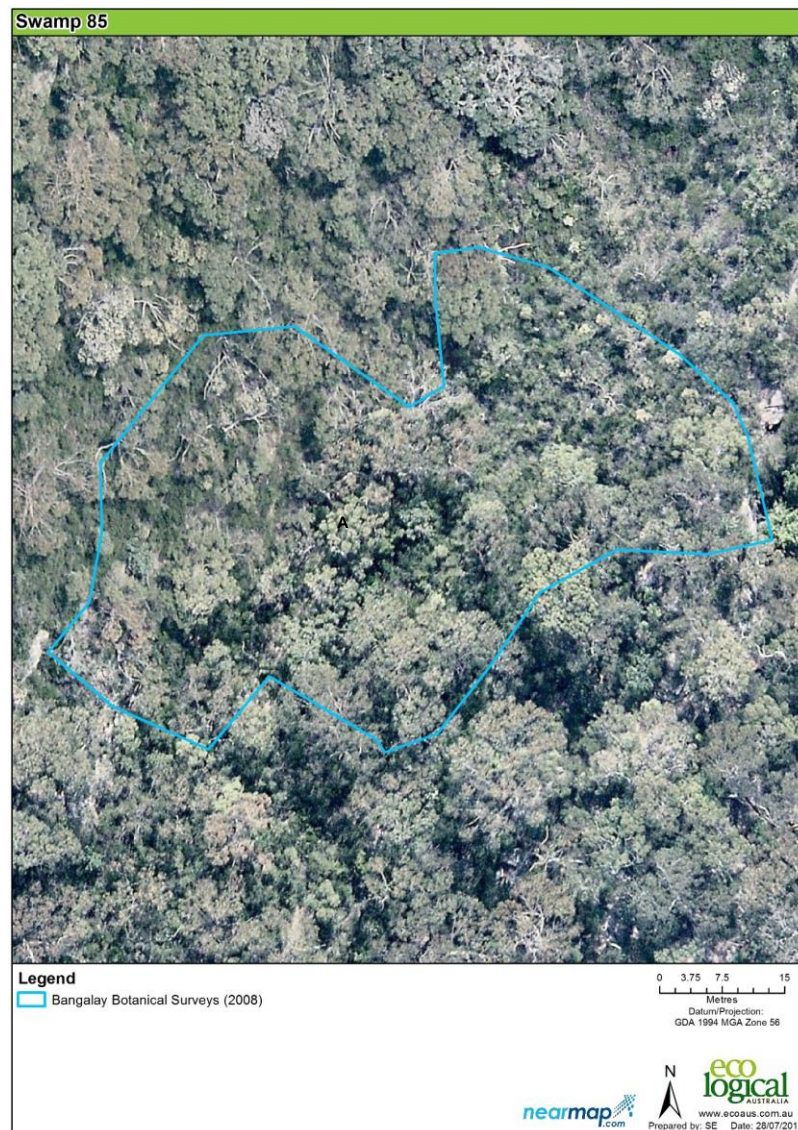
- Swamp 85 mapped by Bangalay Botanical Surveys (2008) is located on a steep south-east facing slope.
- This swamp was previously mapped as Sedgeland-heath Complex by Bangalay Botanical Surveys (2008) however from aerial photography and field inspection it is considered that this area is more akin to Sandstone Gully Apple-Peppermint Forest as described by Bangalay Botanical Surveys (2008).

- Fire history: unknown, greater than 30 years.
- Area: not mapped.
- The vegetation is characterised by a canopy dominated by *Angophora costata*, with an understorey comprising the shrubs *Banksia ericifolia* subsp. *ericifolia*, *B. marginata*, *B. serrata*, *Woolfsia pungens*, *Grevillea diffusa* and *Persoonia pinifolia*, and a ground layer of sedges and grasses including *Lepyrodia scariosa* and *Entolasia stricta*.

- Swamp boundaries have not been mapped in this instance as it is not a swamp. Rather, the vegetation is comprised of Sandstone Gully Apple-Peppermint Forest.

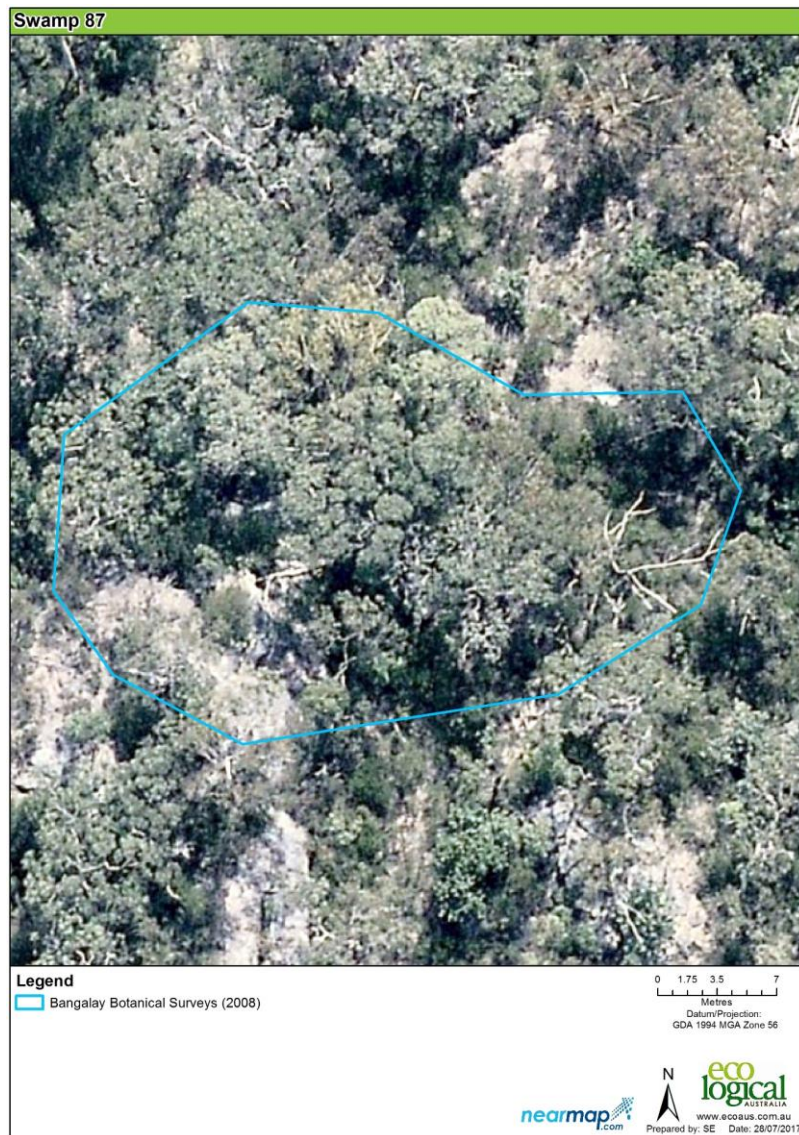
Swamp 87

- This swamp was previously mapped as Sedgeland-heath Complex by Bangalay Botanical Surveys (2008) though aerial photography and field inspections confirmed that this swamp is a good example of the Sandstone Gully Apple-Peppermint Forest located in a valley containing a drainage line.
- Fire history: unknown, greater than 30 years.
- Area: not mapped
- The vegetation is characterised by a canopy dominated by *Angophora costata* and *Eucalyptus piperita* over a shrub layer dominated by *Banksia ericifolia* subsp. *ericifolia*, *Doryanthes excelsa*, *Ceratopetalum gummiferum* and *Banksia serrata*.
- A terminal step was not observed.
- Swamp boundaries have not been mapped in this instance as it is not a swamp. Rather, the vegetation is comprised of Sandstone Gully Apple-Peppermint Forest.

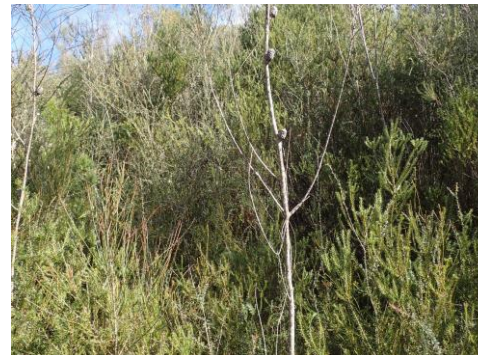
- Swamp 88 is a valley side swamp 0.164 ha in area.
- This swamp was previously mapped as Sedgeland-heath Complex by Bangalay Botanical Surveys (2008) though field inspections confirmed the presence of Banksia Thicket vegetation community across the entire revised extent of this swamp.
- Fire history: burnt 1993-1994.
- This swamp is characterised as having a tall dense shrub layer of *Banksia ericifolia* subsp. *ericifolia*, *Leptospermum squarrosum* and scattered *Hakea teretifolia* up to 4.5 m in height over a comparatively dense understorey dominated by sedges (*Empodisma minus*, *Chordifex dimorphus* and *Leptocarpus tenax*).
- A low sandstone step is present midway through the swamp.

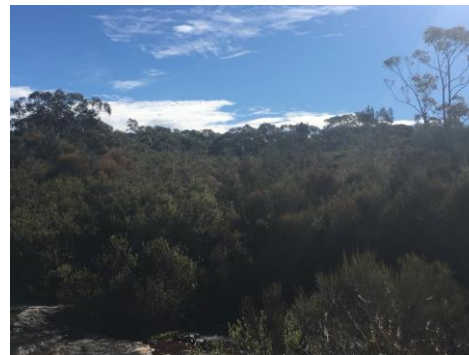
- Swamp 89 is a valley side swamp 1.983 ha in area.
- This swamp was previously mapped as Sedgeland-heath Complex by Bangalay Botanical Surveys (2008) though field inspections confirmed the presence of Banksia Thicket vegetation community across the entire revised extent of this swamp.

- An extensive area of sandstone outcropping is present along the south-eastern edge of this swamp where seepage and water flow exiting from the swamp was observed.

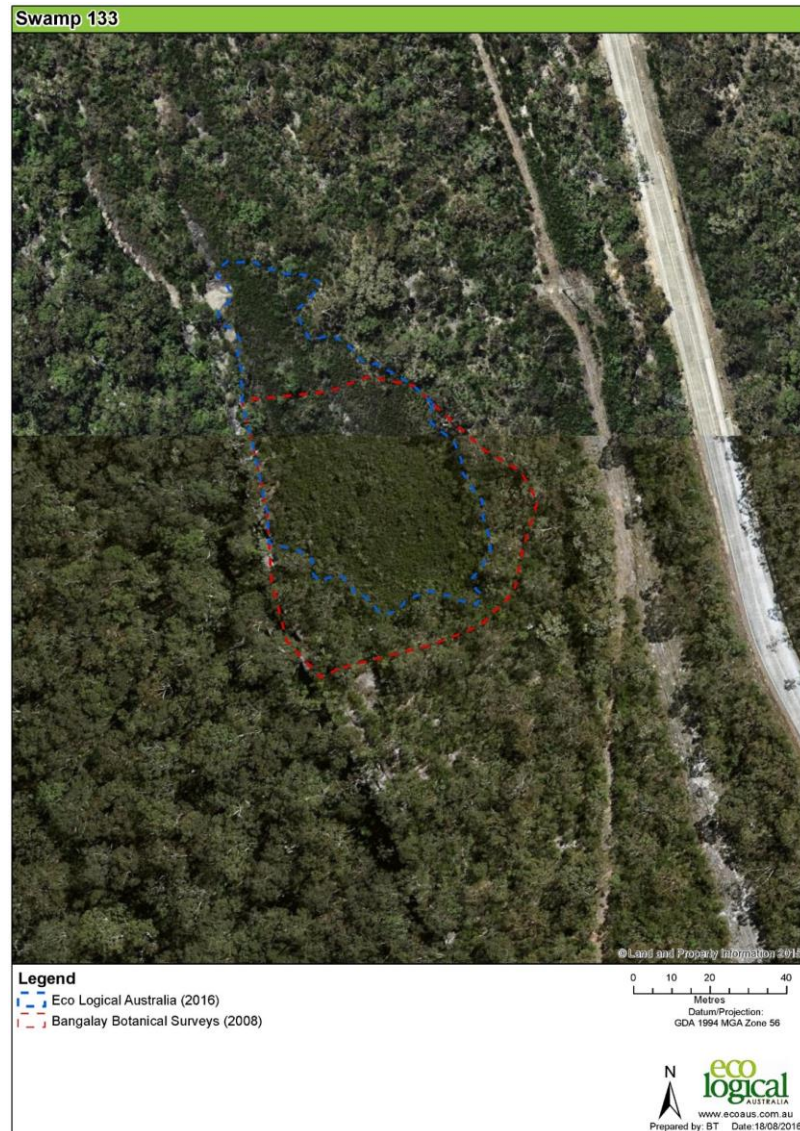
- Swamp 133 is a valley side swamp 0.362 ha in area.
- This swamp was previously mapped as Sedgeland-heath Complex by Bangalay Botanical Surveys (2008) though field inspections confirmed the presence of Banksia Thicket vegetation community across the entire revised extent of this swamp.
- This swamp is characterised as having a tall dense shrub layer (*Banksia ericifolia* subsp. *ericifolia*, *Hakea teretifolia* and *Leptospermum squarrosus* up to 4 m in height) over a comparatively sparse understorey dominated by sedges (*Lepyrodia scariosa* and *Leptocarpus tenax*). Emergent trees are present in low densities across this swamp including *Eucalyptus racemosa* with *Angophora costata* and *Eucalyptus piperita* occurring on the downslope margin of the swamp.
- A low sandstone cliff line represents the terminal step of this swamp, with seepage commonly observed across the terminal step.

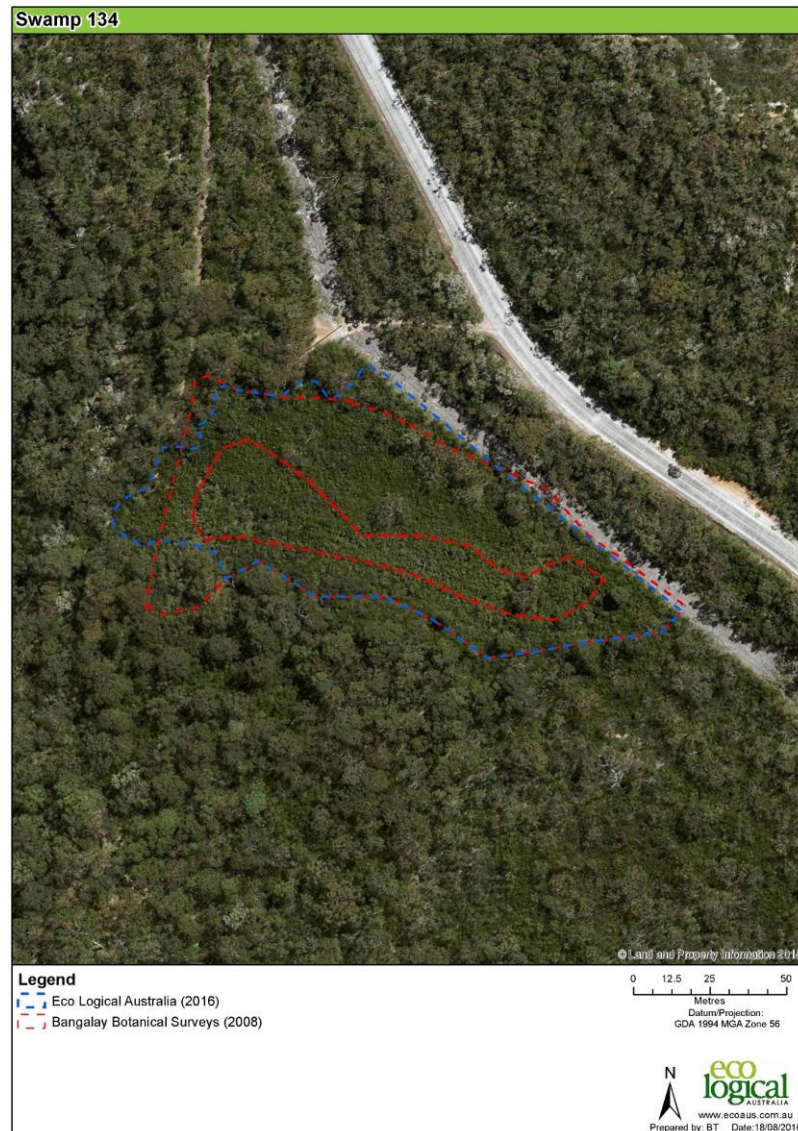
- Swamp 134 is a valley side 0.891 ha in area.
- This swamp was previously mapped as a combination of Sedgeland-heath Complex and Banksia Thicket by Bangalay Botanical Surveys (2008) though field inspections identified that Banksia Thicket vegetation occurred across the entire revised extent of this swamp.

- This swamp is characterised as having a tall dense shrub layer (*Banksia ericifolia subsp. ericifolia*, *Hakea teretifolia* and *Leptospermum juniperinum* up to 5 m in height) over an understorey dominated by sedges (*Empodisma minus*, *Lepyrodia scariosa* and *Leptocarpus tenax*). Emergent trees are present in low densities across the swamp including *Eucalyptus racemosa*, *Angophora costata* and *Eucalyptus piperita*.

- A terminal step comprising a small area of sandstone outcropping is present within this swamp, and seepage was not observed over the step at the time of inspection. The remains of an old vehicular track (which extends across the western edge of this swamp) and an associated table drain are present appearing to have diverted surface flows away from the terminal step.

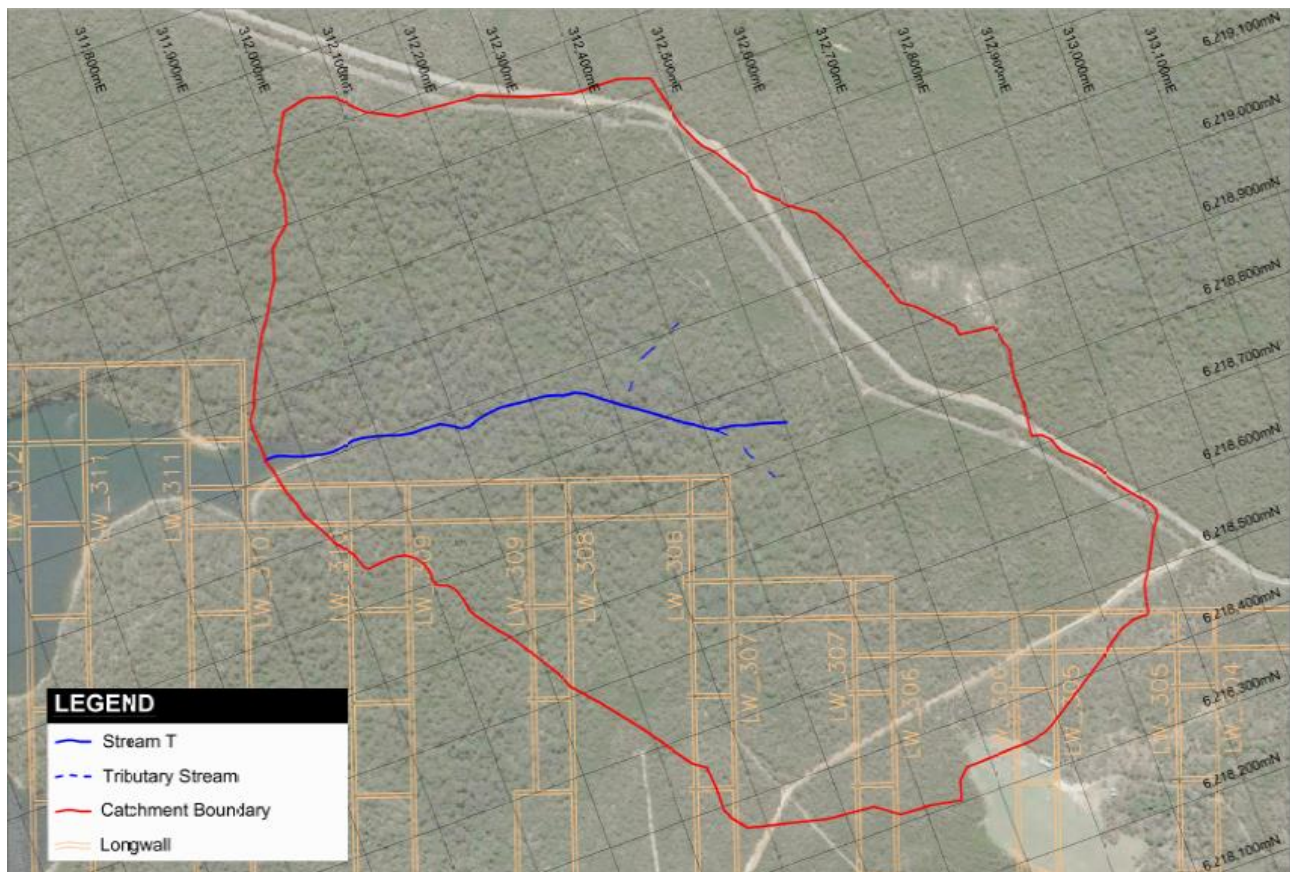
Figure 17 Stream T Catchment

Stream T is a small second order stream – refer Figure 17. The stream morphology is similar to Stream S. There was a small continuous flow in the lower reaches of the stream which carried through to the Woronora Reservoir. The medium and larger pools mapped were larger than those observed in Stream S.
