METROPOLITAN COAL LONGWALLS 311-316

BIODIVERSITY MANAGEMENT PLAN

LONGWALLS 311-316 BIODIVERSITY MANAGEMENT PLAN

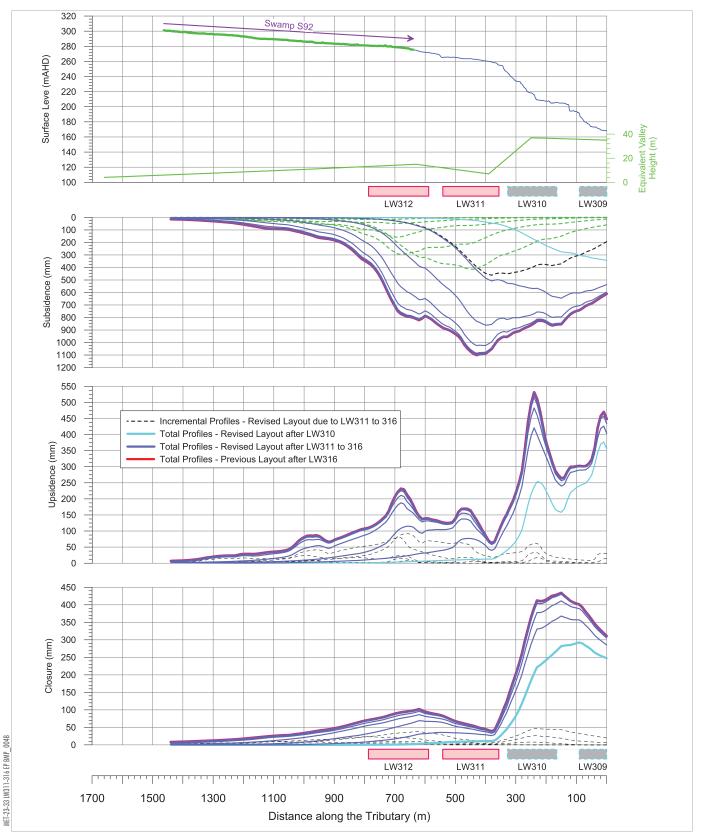
Predicted Profiles of Subsidence, Upsidence and Closure along Tributary P due to Longwalls 311-316

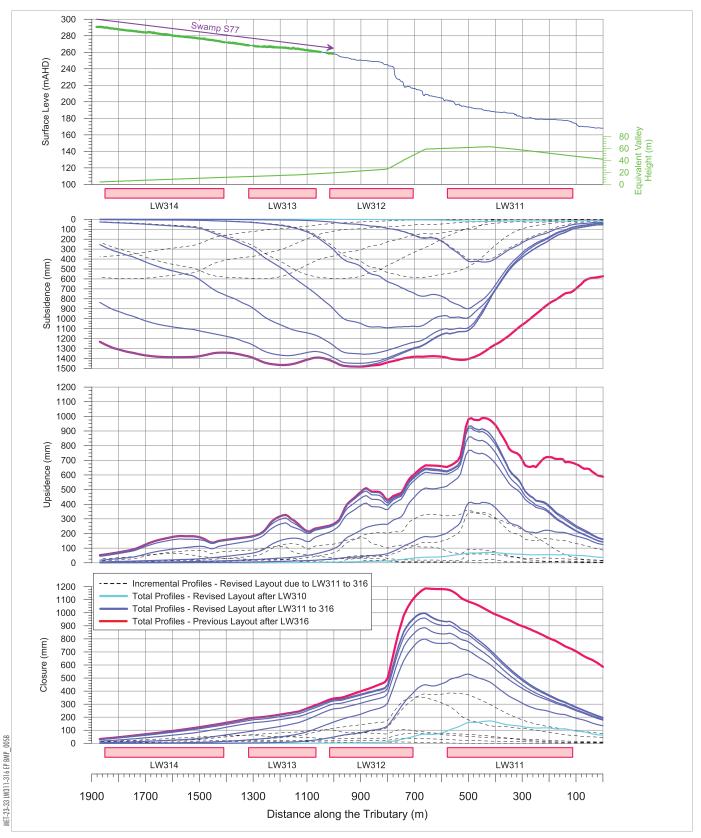
Predicted Profiles of Subsidence, Upsidence and Closure along Tributary R due to Longwalls 311-316

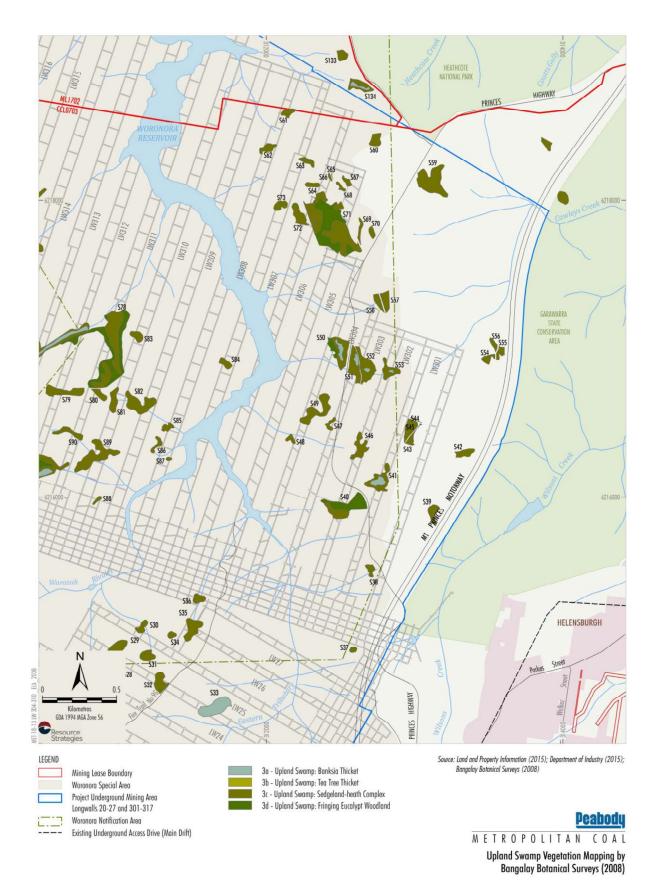
Figure 1

Swamps were mapped by Bangalay Botanical Surveys (2008) consistent with vegetation mapping by the NSW National Parks and Wildlife Service (NPWS) (2003) as either vegetation community 3a (Banksia Thicket), 3b (Tea Tree Thicket), 3c (Sedgeland-heath Complex), 3d (Fringing Eucalypt Woodland), or a combination of these communities.

The Bangalay Botanical Surveys (2008) mapping of upland swamps overlying or proximal to Longwalls 304-310 is shown on Figure 1.

The boundaries of 19 upland swamps situated within 600 m of Longwalls 301-303 were revised as appropriate by Eco Logical, namely, Swamps 37, 38, 40, 41, 42, 46, 47, 48, 49, 50, 51, 52, 53, 54, 58, 69, 70 and 71 (Figure 1). The revised upland swamp and associated vegetation community mapping by Eco Logical (2016) of upland swamps within 600 m of Longwalls 301-303 is shown on Figure 2, and the revised vegetation community mapping for the Underground Mining Area and surrounds is shown on Figure 3.

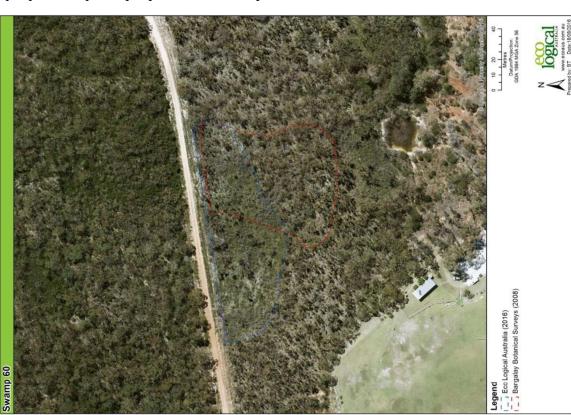
- Swamp 60 is a valley side swamp.
- Swamp 60 was previously mapped as Sedgeland-heath Complex by Bangalay Botanical Surveys (2008) and field inspections confirmed the presence of this community across the entire revised extent of this swamp.

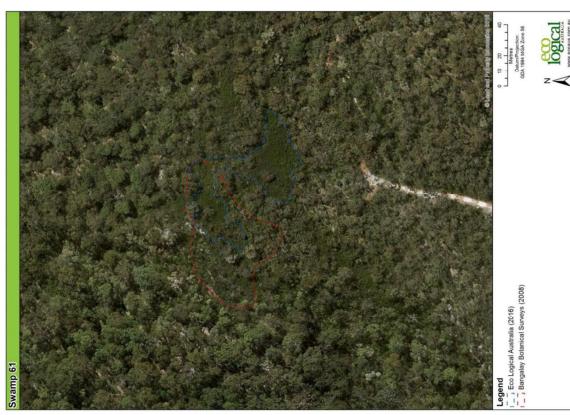
- Swamp 61 is a valley side swamp.
- Swamp 61 was previously mapped as Sedgeland-heath Complex by Bangalay Botanical Surveys (2008) though field inspections confirmed the presence of Banksia Thicket vegetation community across the entire revised extent of this swamp.

- This swamp is approximately 0.237 ha in area.
- This swamp is characterised as having a tall dense shrub layer (*Banksia ericifolia* subsp. ericifolia and *Leptospermum squarrosum* up to 4 m in height) over a comparatively sparse understorey dominated by sedges (*Lepidosperma neesii*, *Leptocarpus tenax*, *Empodisma minus* and *Schoenus brevifolius*).

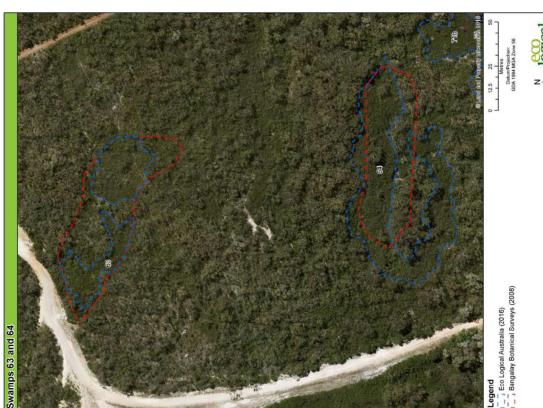
- Swamps 63 and 64 are valley side swamps, approximately 0.17 ha and 0.363 ha in area, respectively.
- These swamps were both previously mapped as Sedgeland-heath Complex by Bangalay Botanical Surveys (2008) though field inspections confirmed the presence of Banksia Thicket vegetation community across the entire revised extents of these swamps.

- These swamps are all characterised as supporting tall dense shrub layers dominated by Banksia ericifolia subsp. ericifolia, Leptospermum squarrosum and Hakea teretifolia over a sedge dominated ground layers (Lepidosperma neesii, Empodisma minus, Lepyrodia scariosa, Cyathochaeta diandra and Ptilothrix deusta).

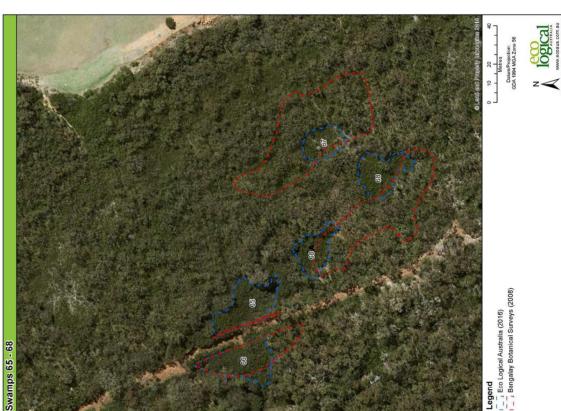
Swamps 65 - 68

- Swamps 65 to 68 are all valley side swamps, approximately 0.055 ha, 0.057 ha, 0.030 ha
 and 0.077 ha in area, respectively.
- These swamps were all previously mapped as Sedgeland-heath Complex by Bangalay Botanical Surveys (2008) although field inspections confirmed the presence of Banksia Thicket vegetation community across the entire revised extents of these swamps.

- These swamps are all characterised as supporting tall dense shrub layers dominated by Banksia ericifolia subsp. ericifolia, Leptospermum squarrosum and Hakea teretifolia over a sedge dominated ground layer.

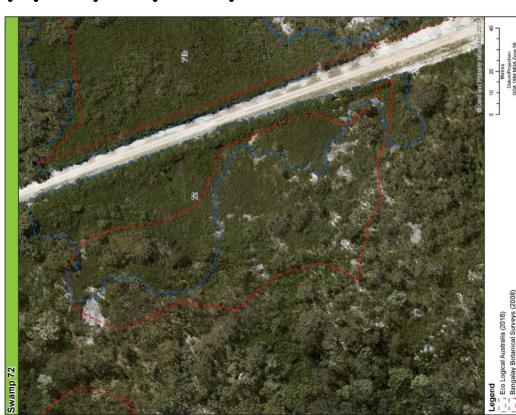
- Swamp 72 is a valley side swamp approximately 0.606 ha in area.
- This swamp was previously mapped as Sedgeland-heath Complex by Bangalay Botanical Surveys (2008) though field inspections confirmed the presence of Banksia Thicket vegetation community across the entire revised extent of this swamp.
- This swamp is characterised as having a dense shrub layer (Banksia ericifolia subsp. ericifolia and Hakea teretifolia generally up to 2 m in height) over an understorey dominated by sedges (Chordifex fastigiatus and Lepyrodia scariosa).
- Extensive areas of sandstone outcropping are present at the downslope limit of this swamp forming a terminal step, with seepage from the swamp observed across this area. The extensive sandstone outcropping supported the 'Rock Pavement Heath' vegetation community.
- Impacted by track creation and water infrastructure along roadside.

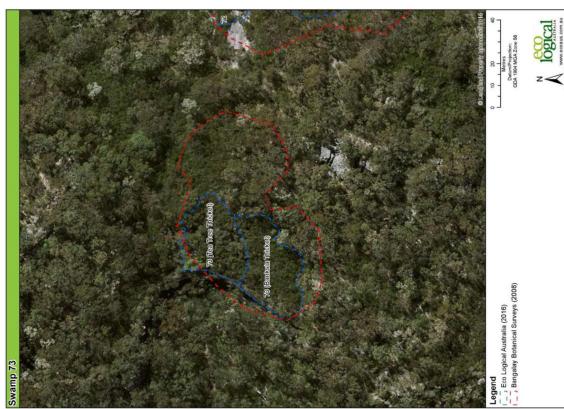
- Swamp 73 is a valley side swamp approximately 0.182 ha in area.
- This swamp was previously mapped as Sedgeland-heath Complex by Bangalay Botanical Surveys (2008) though field inspections confirmed the presence of Banksia Thicket and Tea Tree Thicket vegetation communities within the revised extent of this swamp.

- The northern portion of this swamp occurs in association with a poorly defined drainage line and supports Tea Tree Thicket vegetation with a moderately dense shrub layer (*Banksia robur*, *Persoonia pinifolia* and *Hakea teretifolia*) over an understorey dominated by the fern *Gleichenia microphylla*. The southern portion of this swamp is located away from the drainage line and supports Banksia Thicket vegetation with a tall dense shrub layer (*Banksia ericifolia* subsp. *ericifolia*, *Leptospermum squarrosum* and *Hakea teretifolia*) over and understorey dominated by sedges.

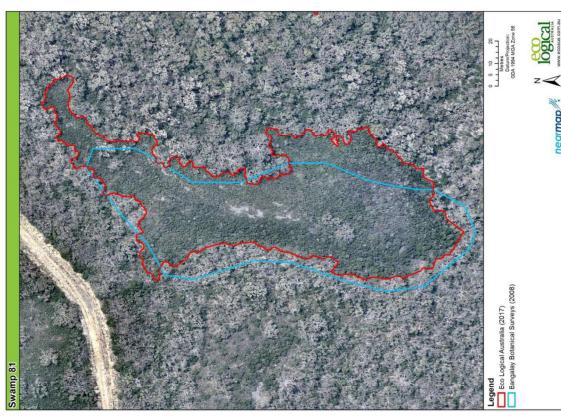
- Swamp 81 is a valley side swamp approximately 0.728 ha in area.
- This swamp was previously mapped as Sedgeland-heath Complex by Bangalay Botanical Surveys (2008) though field inspections confirmed the presence of Banksia Thicket vegetation community across the entire revised extent of this swamp.
- Fire history: burnt 1986-1987 and 1993-1994.
- This swamp is characterised as having a tall dense shrub layer (*Banksia ericifolia* subsp. *ericifolia* and *Leptospermum squarrosum* 2-3 m in height) over an understorey dominated by sedges (*Chordifex fastigiatus*, *Lepidosperma filiforme* and *L. neesii*).
- No terminal step was observed but an extensive mid-swamp step is present, with abundant seepage present.

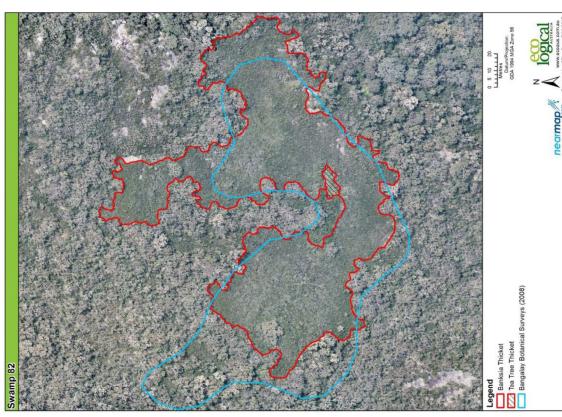
- Swamp 82 is a valley side swamp approximately 1.437 ha in area.
- This swamp was previously mapped as Sedgeland-heath Complex by Bangalay Botanical Surveys (2008) though field inspections confirmed the presence of Banksia Thicket vegetation community across the entire revised extent of this swamp.

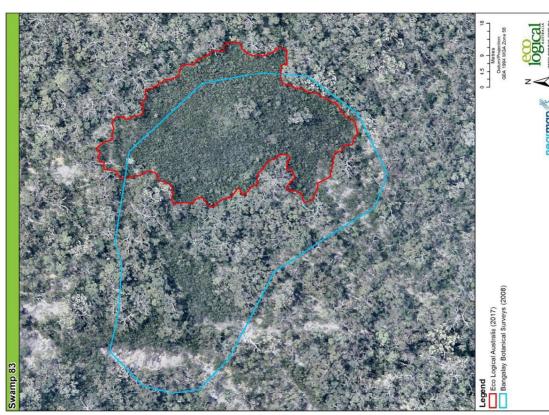
- Swamp 83 is a valley side swamp 0.202 ha in area.
- This swamp was previously mapped as Sedgeland-heath Complex by Bangalay Botanical Surveys (2008) though field inspections confirmed the presence of Banksia Thicket vegetation community across the entire revised extent of this swamp.

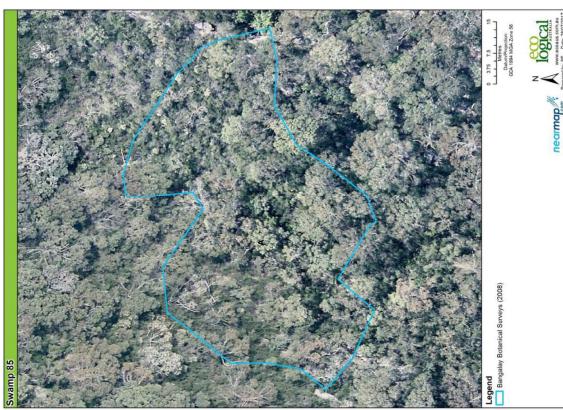
- Swamp 85 mapped by Bangalay Botanical Surveys (2008) is located on a steep south-east facing slope.
- This swamp was previously mapped as Sedgeland-heath Complex by Bangalay Botanical Surveys (2008) however from aerial photography and field inspection it is considered that this area is more akin to Sandstone Gully Apple-Peppermint Forest as described by Bangalay Botanical Surveys (2008).

- Fire history: unknown, greater than 30 years.
- Area: not mapped.
- The vegetation is characterised by a canopy dominated by Angophora costata, with an understorey comprising the shrubs *Banksia ericifolia* subsp. *ericifolia*, *B. marginata*, *B. serrata*, *Woollsia pungens*, *Grevillea diffusa* and *Persoonia pinifolia*, and a ground layer of sedges and grasses including *Lepyrodia scariosa* and *Entolasia stricta*.

- Swamp boundaries have not been mapped in this instance as it is not a swamp. Rather, the vegetation is comprised of Sandstone Gully Apple-Peppermint Forest.

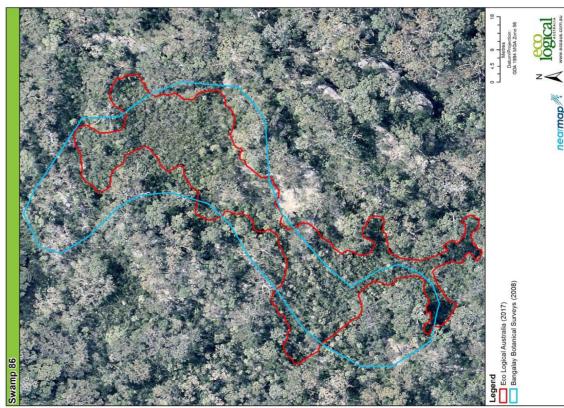
- Swamp 86 is a valley side swamp 0.209 ha in area.
- This swamp was previously mapped as Sedgeland-heath Complex by Bangalay Botanical Surveys (2008) though field inspections confirmed the presence of Banksia Thicket vegetation community across the entire revised extent of this swamp. The boundaries of this swamp are not well defined and woodland species of the Apple-Peppermint Gully Forest are interspersed within this community.

- Fire history: unknown, greater than 30 years.
- This swamp is characterised by the presence of scattered canopy trees of *Angophora costata* and *Eucalyptus piperita* over a dense shrub layer of *Banksia ericifolia* subsp. *ericifolia*, *Leptospermum squarrosum* and *Hakea teretifolia* up to 5 m in height. Other shrub species include *Banksia serrata*, *Logania albiflora*, *Hakea dactyloides* and *Leptospermum trinervium*. The understorey is dominated by smaller shrubs and sedges (*Hibbertia riparia* and *Lepyrodia scariosa*, *Lepidosperma filiforme* and *L. neesii*).

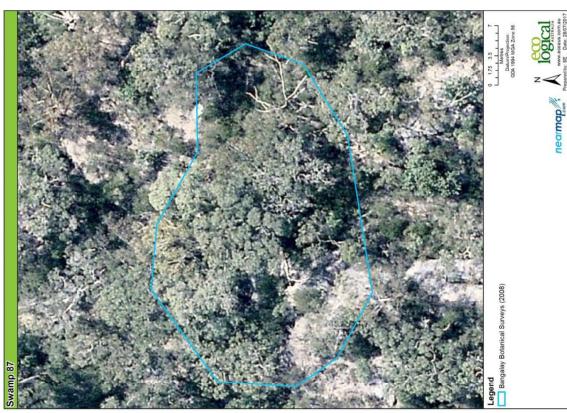
Swamp 87

- This swamp was previously mapped as Sedgeland-heath Complex by Bangalay Botanical Surveys (2008) though aerial photography and field inspections confirmed that this swamp is a good example of the Sandstone Gully Apple-Peppermint Forest located in a valley containing a drainage line.
- Fire history: unknown, greater than 30 years.
- Area: not mapped
- The vegetation is characterised by a canopy dominated by Angophora costata and Eucalyptus piperita over a shrub layer dominated by Banksia ericifolia subsp. ericifolia, Doryanthes excelsa, Ceratopetalum gummiferum and Banksia serrata.
- A terminal step was not observed.
- Swamp boundaries have not been mapped in this instance as it is not a swamp. Rather, the vegetation is comprised of Sandstone Gully Apple-Peppermint Forest.

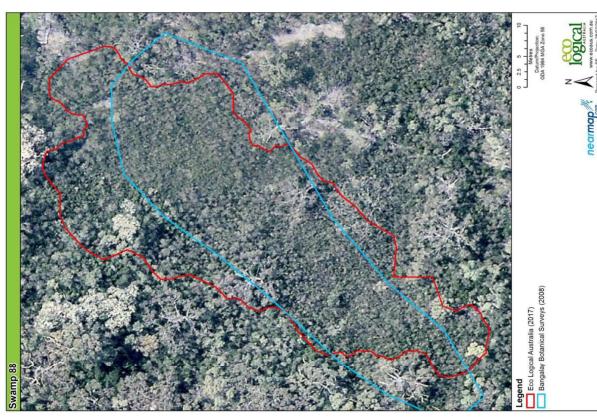
- Swamp 88 is a valley side swamp 0.164 ha in area.
- This swamp was previously mapped as Sedgeland-heath Complex by Bangalay Botanical Surveys (2008) though field inspections confirmed the presence of Banksia Thicket vegetation community across the entire revised extent of this swamp.
- Fire history: burnt 1993-1994.
- This swamp is characterised as having a tall dense shrub layer of *Banksia ericifolia* subsp. ericifolia, *Leptospermum squarrosum* and scattered *Hakea teretifolia* up to 4.5 m in height over a comparatively dense understorey dominated by sedges (*Empodisma minus*, *Chordifex dimorphus* and *Leptocarpus tenax*).
- A low sandstone step is present midway through the swamp.

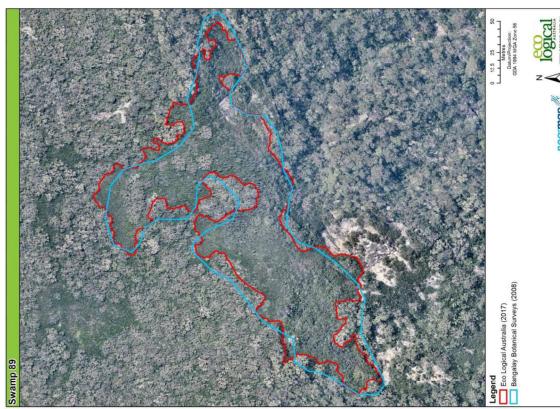
- Swamp 89 is a valley side swamp 1.983 ha in area.
- This swamp was previously mapped as Sedgeland-heath Complex by Bangalay Botanical Surveys (2008) though field inspections confirmed the presence of Banksia Thicket vegetation community across the entire revised extent of this swamp.

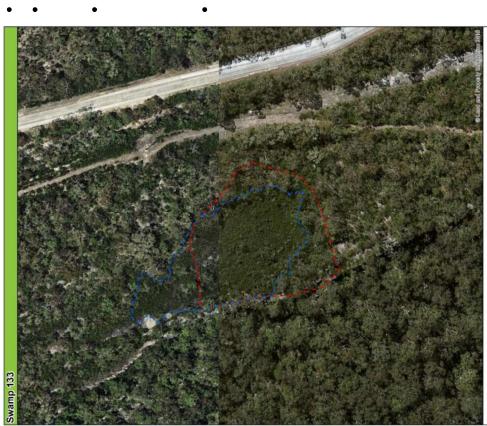
- Swamp 133 is a valley side swamp 0.362 ha in area.
- This swamp was previously mapped as Sedgeland-heath Complex by Bangalay Botanical Surveys (2008) though field inspections confirmed the presence of Banksia Thicket vegetation community across the entire revised extent of this swamp.
- This swamp is characterised as having a tall dense shrub layer (*Banksia ericifolia* subsp. ericifolia, Hakea teretifolia and Leptospermum squarrosum up to 4 m in height) over a comparatively sparse understorey dominated by sedges (*Lepyrodia scariosa* and *Leptocarpus tenax*). Emergent trees are present in low densities across this swamp including *Eucalyptus racemosa* with *Angophora costata* and *Eucalyptus piperita* occurring on the downslope margin of the swamp.
- A low sandstone cliff line represents the terminal step of this swamp, with seepage commonly observed across the terminal step.

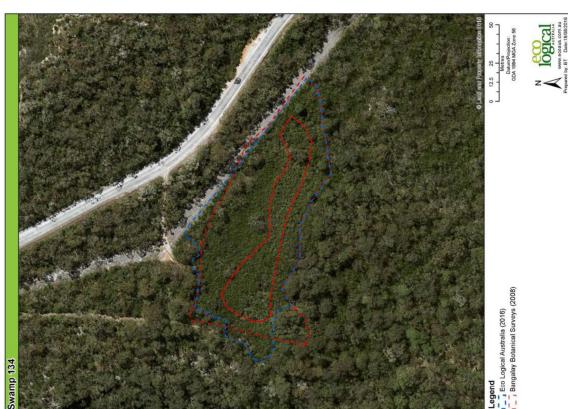
- Swamp 134 is a valley side 0.891 ha in area.
- This swamp was previously mapped as a combination of Sedgeland-heath Complex and Banksia Thicket by Bangalay Botanical Surveys (2008) though field inspections identified that Banksia Thicket vegetation occurred across the entire revised extent of this swamp.

- This swamp is characterised as having a tall dense shrub layer (*Banksia ericifolia subsp. ericifolia*, *Hakea teretifolia* and *Leptospermum juniperinum* up to 5 m in height) over an understorey dominated by sedges (*Empodisma minus*, *Lepyrodia scariosa* and *Leptocarpus tenax*). Emergent trees are present in low densities across the swamp including *Eucalyptus racemosa*, *Angophora costata* and *Eucalyptus piperita*.

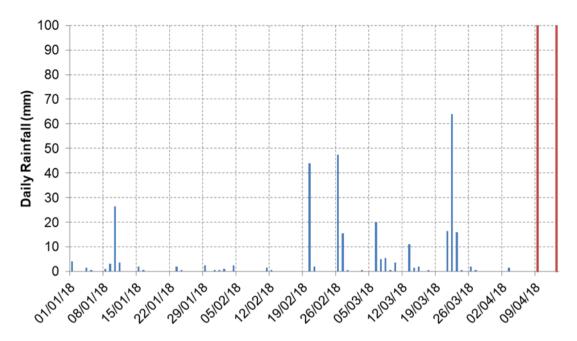
Figure 2 Rainfall Recorded at PV7 January to April 2018

The stream reconnaissance was conducted between the 9th and 13th of April 2018. The weather was fine during the course of the reconnaissance. The period leading up to the reconnaissance had relatively low rainfall (refer Figure 2). January and early February experienced unusually low rainfall with only minor falls being recorded through to late February. Two moderate rainfall events on the 20th and 26th of February (44 and 47.5 mm respectively) were recorded at Metropolitan Coal's pluviometer PV7. Following these events there was no significant rainfall recorded until the 21st of March when a total of 96.5 mm was recorded between the 21st and 23rd of March. There was no significant rainfall recorded between the 23rd of March and the reconnaissance survey – indicated by the red lines on Figure 2. Flow in the surface catchments would therefore have been in recession from the 21st to the 23rd March rainfall event.

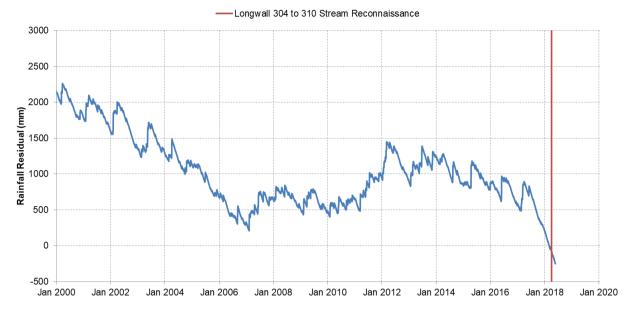
Groundwater-fed baseflow in streams responds to dominant wetting (aquifer recharging) and drying (aquifer discharging) cycles. These cycles are typically evident in rainfall residual plots which can be correlated to periods when aquifers are predominantly recharging when groundwater levels are rising; and periods when aquifers are discharging and groundwater levels are declining. Figure 3 shows the rainfall residual for the period 1st January 2000 to 31st April 2018 derived from the rainfall record from the Bureau of Meteorology rain gauge at Darkes Forest – Station 68024. Periods where the residual rainfall curve is trending upward correspond to above average rainfall. Periods where the residual rainfall line decreases (slopes downward) reflect below average rainfall. The reconnaissance, shown by the vertical red line, was conducted during a pronounced drying period. The steep downward trend in the rainfall from mid-2017 indicates drying catchment conditions with declining groundwater outflows to streams (compared to the average) in the lead-up to the survey. The rainfall residual over this period is sloping unusually steeply downward for a prolonged period indicating likely low groundwater outflows to streams from groundwater sources.

Figure 3 Darkes Forest Rainfall Residual Plot, January 2000 to May 2018

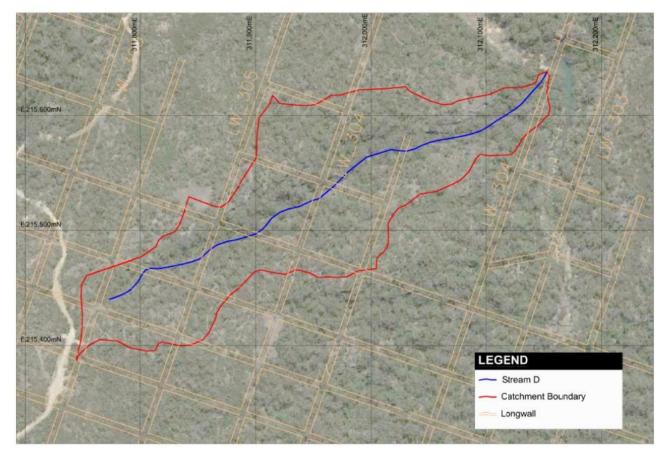
Figure 4 Stream D Catchment

Stream D comprised a small first order stream which drained into Eastern Tributary (Figure 4) adjacent to the flow monitoring flume at Pool ETAU.

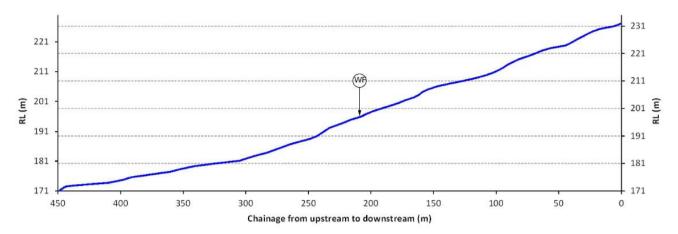
Figure 5 Features in Stream D

The observed features in Stream D are shown on Figure 5.

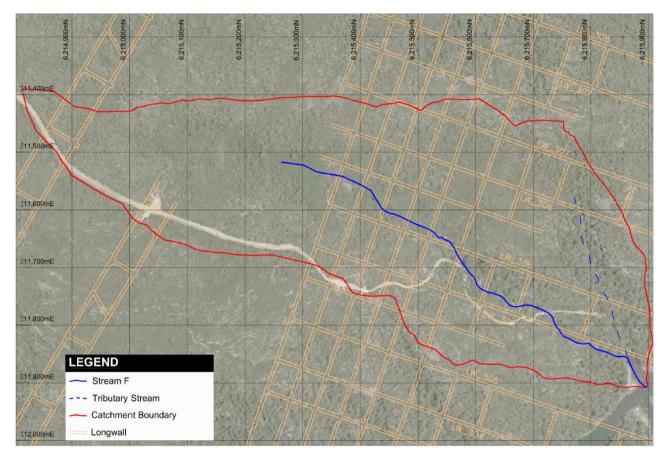
Figure 6 Stream F Catchment

The reach downstream of the swamp comprised a series of rock cascades, small waterfalls, instream pools, rock shelves and sections of straight incised channel. Small semi-continuous flow was observed along the downstream reach. The instream pools became larger and more dominant in the lower sections of the stream.

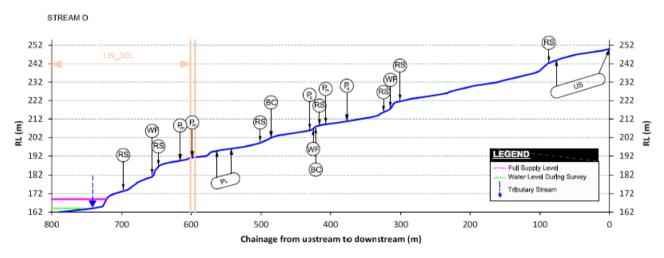
Figure 7 Features in Stream F

The observed features in Stream F are shown in Figure 7.

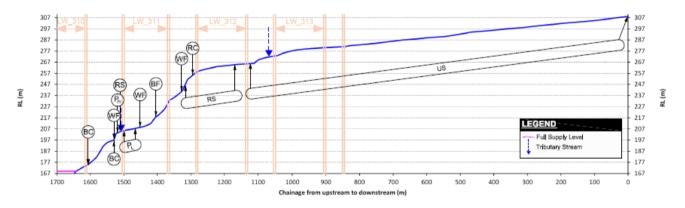
Figure 9 Features in Stream P

The observed features in Stream P are shown in Figure 9.

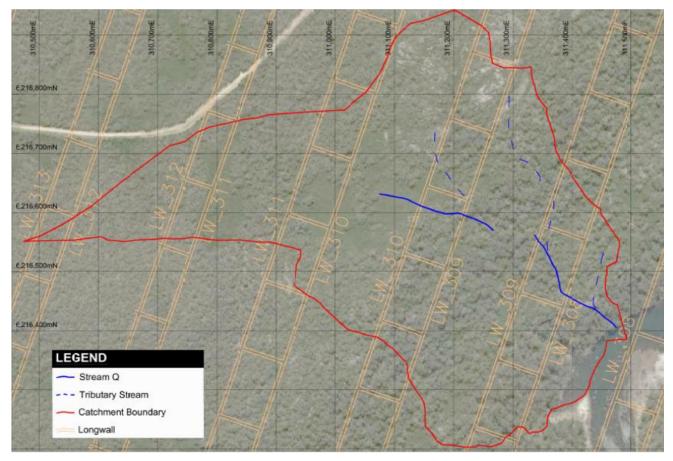
Figure 10 Stream Q Catchment

Stream Q comprised a small semi-continuous stream with small tributaries joining in three locations – refer Figure 10. The upper reaches comprised an ill-defined drainage path in a moderately steep gully. There was no water observed upstream of a significant waterfall which was partially obscured by dense vegetation. Access to the lower reaches of the stream was deemed too dangerous and completion of the planned reconnaissance of the lower sections of the creek was abandoned due to safety concern with very dense vegetation potentially obscuring steep drops.

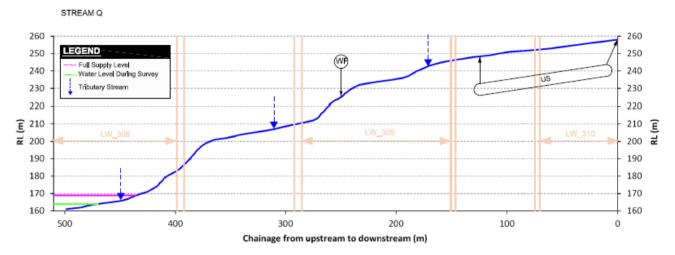
Figure 11 Stream Q Features

The observed features in Stream Q are shown in Figure 11.

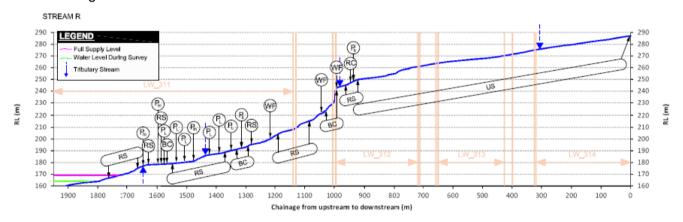
Figure 14 Stream R Features

The tributary stream which flowed into the main arm some 250 m upstream of the outfall into Woronora Reservoir was dry. The largest pools downstream of this confluence were up to 25 m long which formed in depressions between low rock bars. The observed features in Stream R are shown in Figure 14.

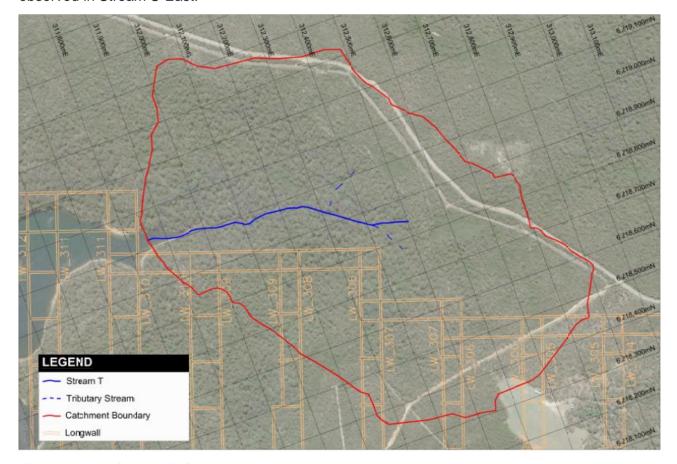
Figure 17 Stream T Catchment

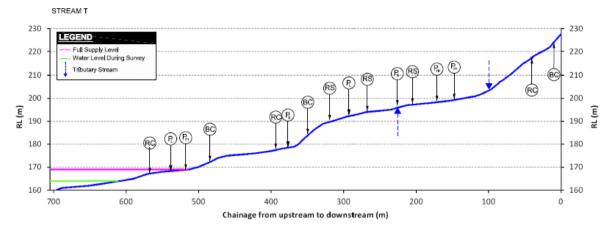
Figure 18 Stream T Features

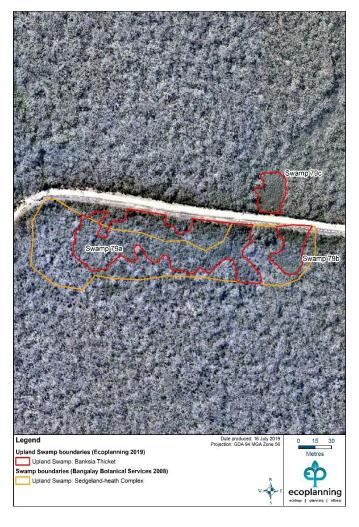
- Swamp 79 is a small linear swamp located over Longwall 312, Longwall 312-313 chain pillar and in part over Longwall 313.
- This swamp was previously mapped as Sedgeland-heath Complex (BBS 2008). Field inspections identified that the vegetation conforms to Banksia Thicket across the swamp and the adjoining vegetation is Sandstone Heath Woodland. Field survey also identified that Swamp 79 can be subdivided into three smaller swamps, herein referred to as Swamps 79a and 79b located south of Fire Trail 9E and 79c located north of Fire Trail 9E. Swamp 79a is the largest of the three with areas of Sandstone Heath Woodland dividing Swamp 79a and Swamp 79b.

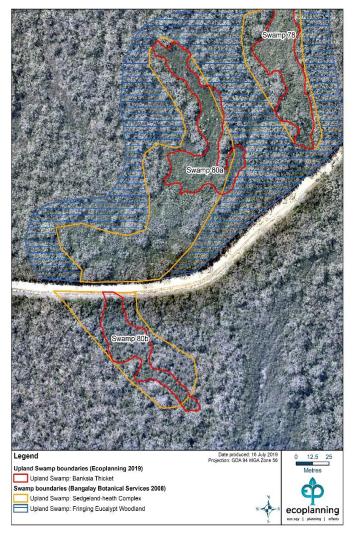
- Swamp 80 is a curved swamp located over Longwall 311 and over the Longwall 311-312 chain pillar in part.
- This swamp was previously mapped as Sedgeland-heath Complex (BBS 2008). Field inspections identified that the vegetation conforms to Banksia Thicket across the swamp with the adjoining vegetation identified as Sandstone Heath Woodland. Field survey also identified that Swamp 80 can be subdivided into two smaller swamps, herein referred to as Swamp 80a, the largest, and Swamp 80b located north and south of Fire Trail 9E respectively. Similar to Swamp 78, Fringing Eucalypt Woodland was also mapped adjoining this swamp (BBS 2008), however, field survey identified Sandstone Heath Woodland to be a more appropriate community given the density of canopy species including *Eucalyptus racemosa*, *E. sieberi and Corymbia gummifera*.

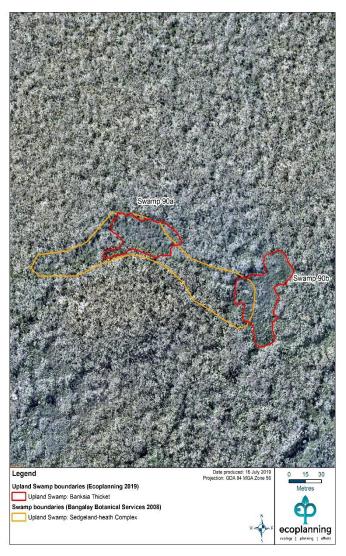
- Swamp 90 is a small east-west curved swamp located in part over Longwalls 311 and 312 and over the Longwall 311-312 chain pillar.
- This swamp was previously mapped as Sedgeland-heath Complex (BBS 2008). Field inspections identified that the extent of swamp vegetation is much reduced and located in two separate areas herein referred to as Swamp 90a and Swamp 90b located to the east of Swamp 90a. The vegetation across Swamp 90a and 90b conforms to Banksia Thicket with the adjoining vegetation identified as Sandstone Heath Woodland. Both areas are located south of Fire Trail 9E.

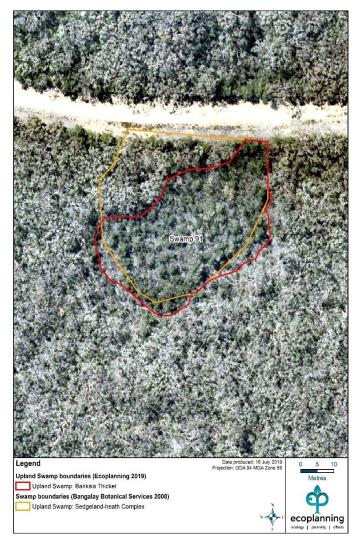
- Swamp 91 is a small oval-shaped swamp located over Longwall 315.
- This swamp was previously mapped as Sedgeland-heath Complex (BBS 2008). Field inspections identified that the extent of swamp vegetation is reduced in area and conforms to Banksia Thicket with the adjoining vegetation identified as Sandstone Heath Woodland. Swamp 91 is located south of Fire Road 9E
