METROPOLITAN COAL LONGWALLS 301-303

BIODIVERSITY MANAGEMENT PLAN

November 2016

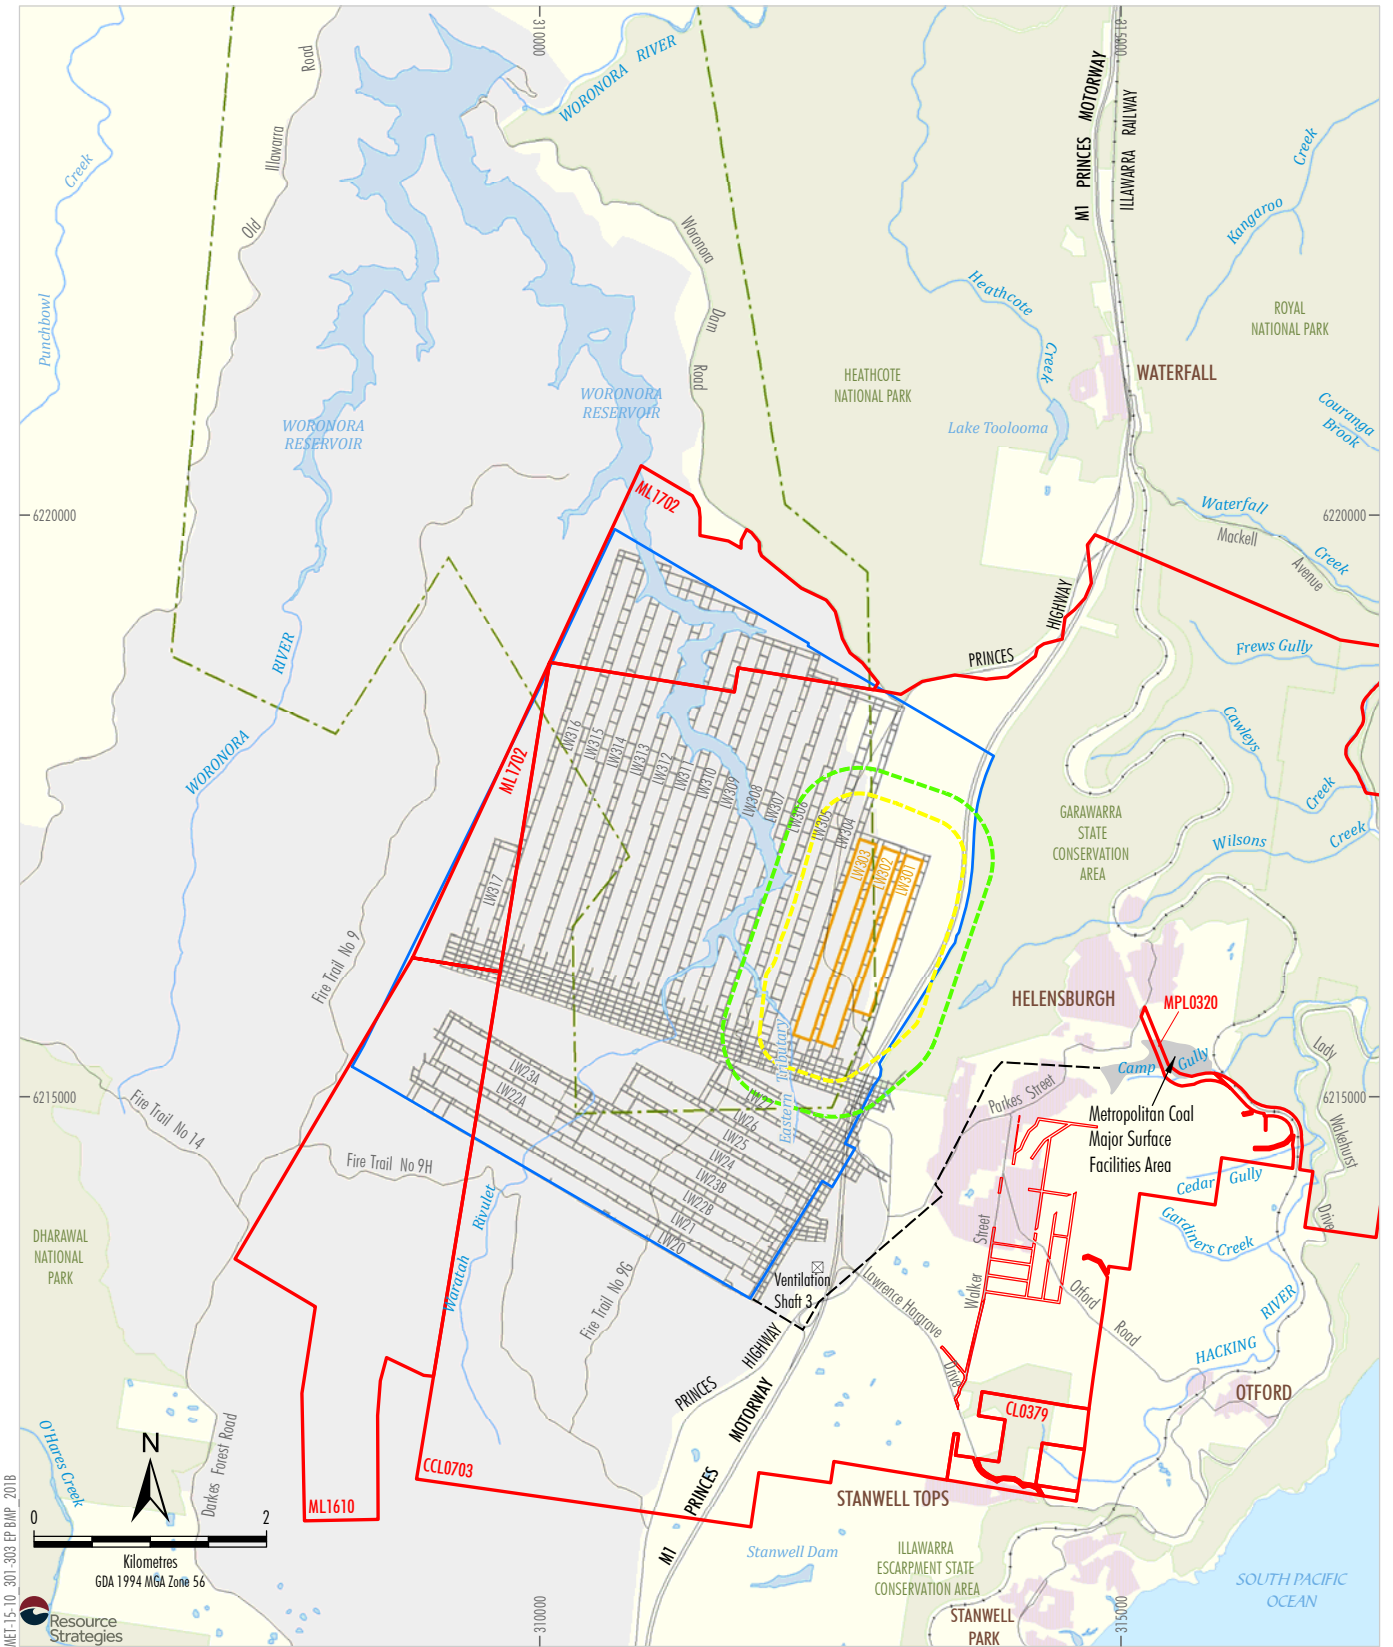
Figure 1

METROPOLITAN COAL
 Project Longwalls 20 - 27 and
 Longwalls 301 - 317 Layout

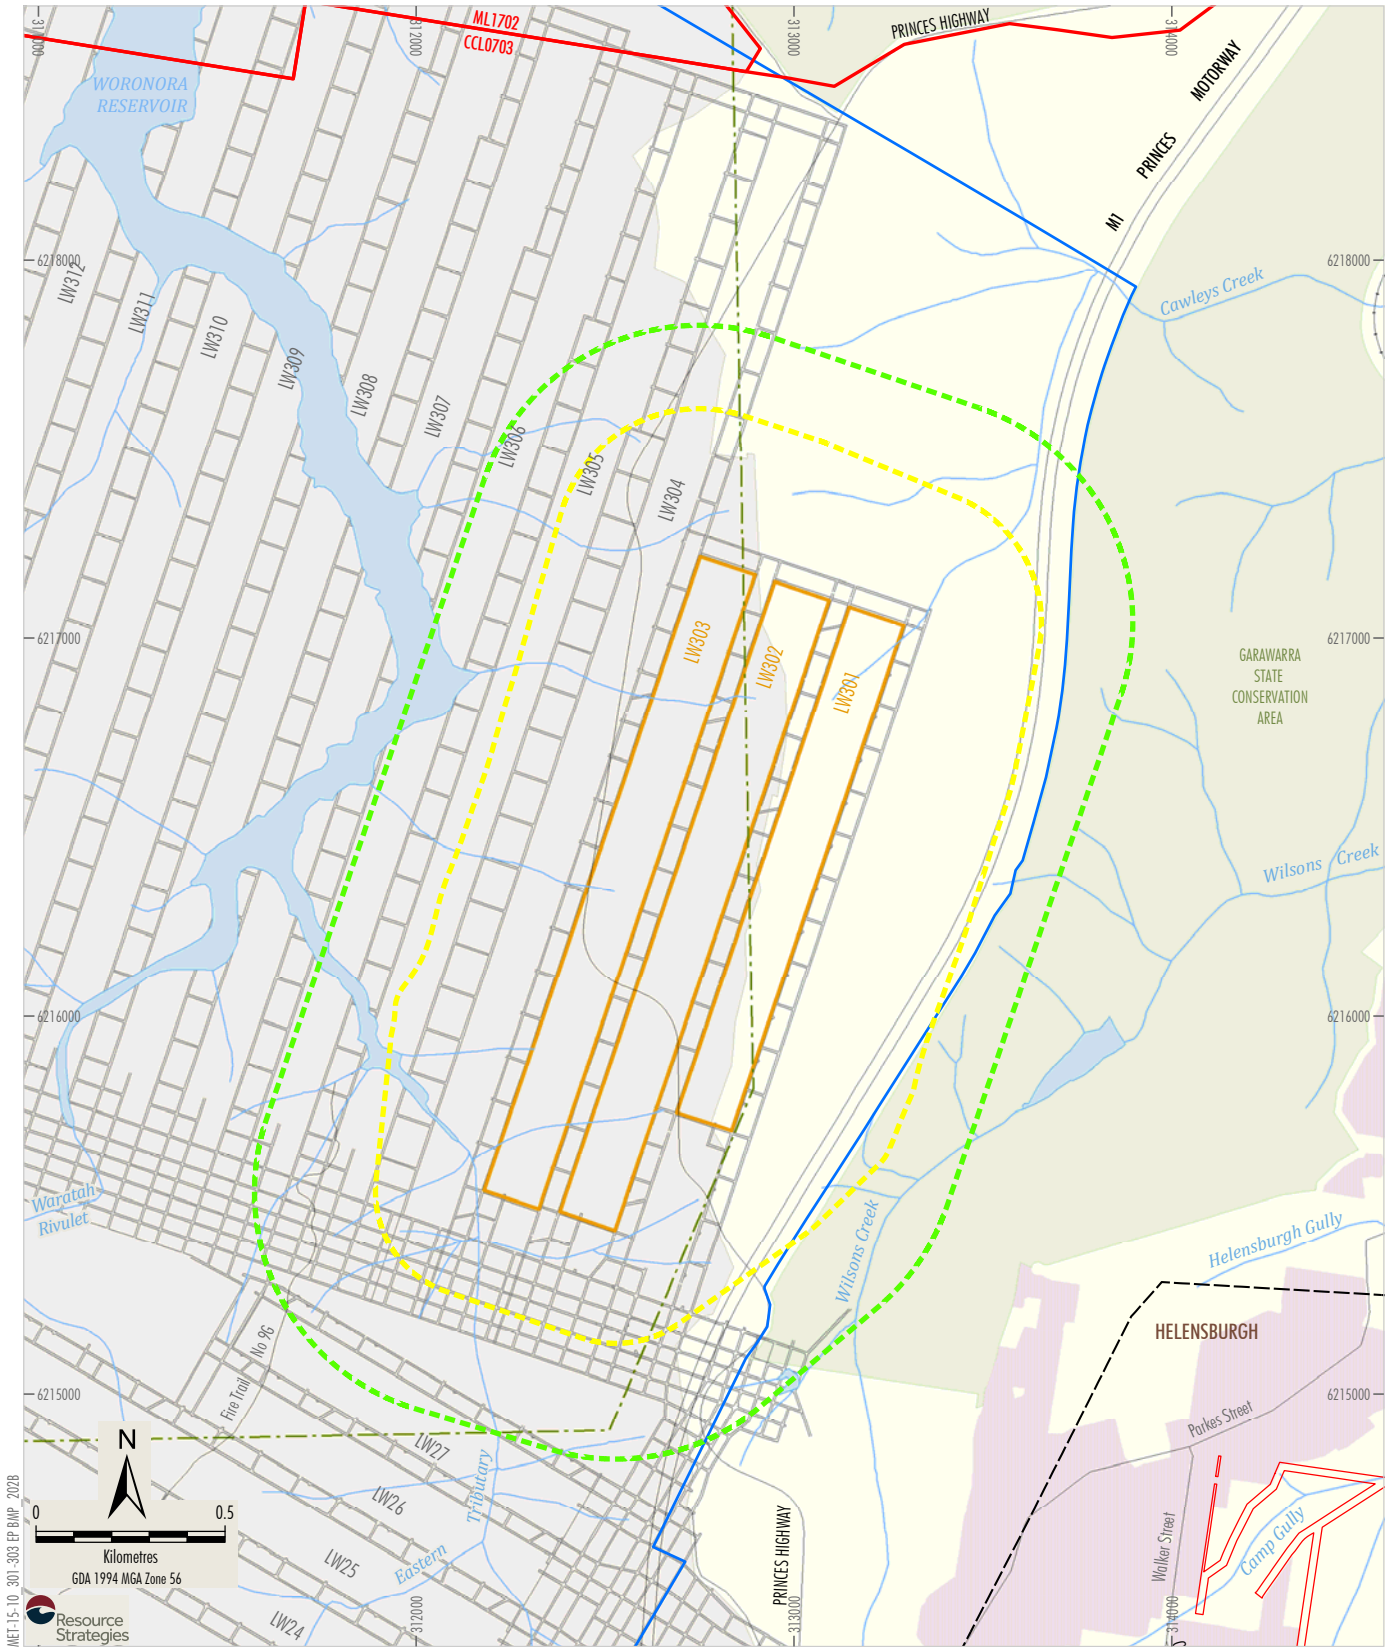
Figure 2

METROPOLITAN COAL
 Longwalls 301 - 303 Layout

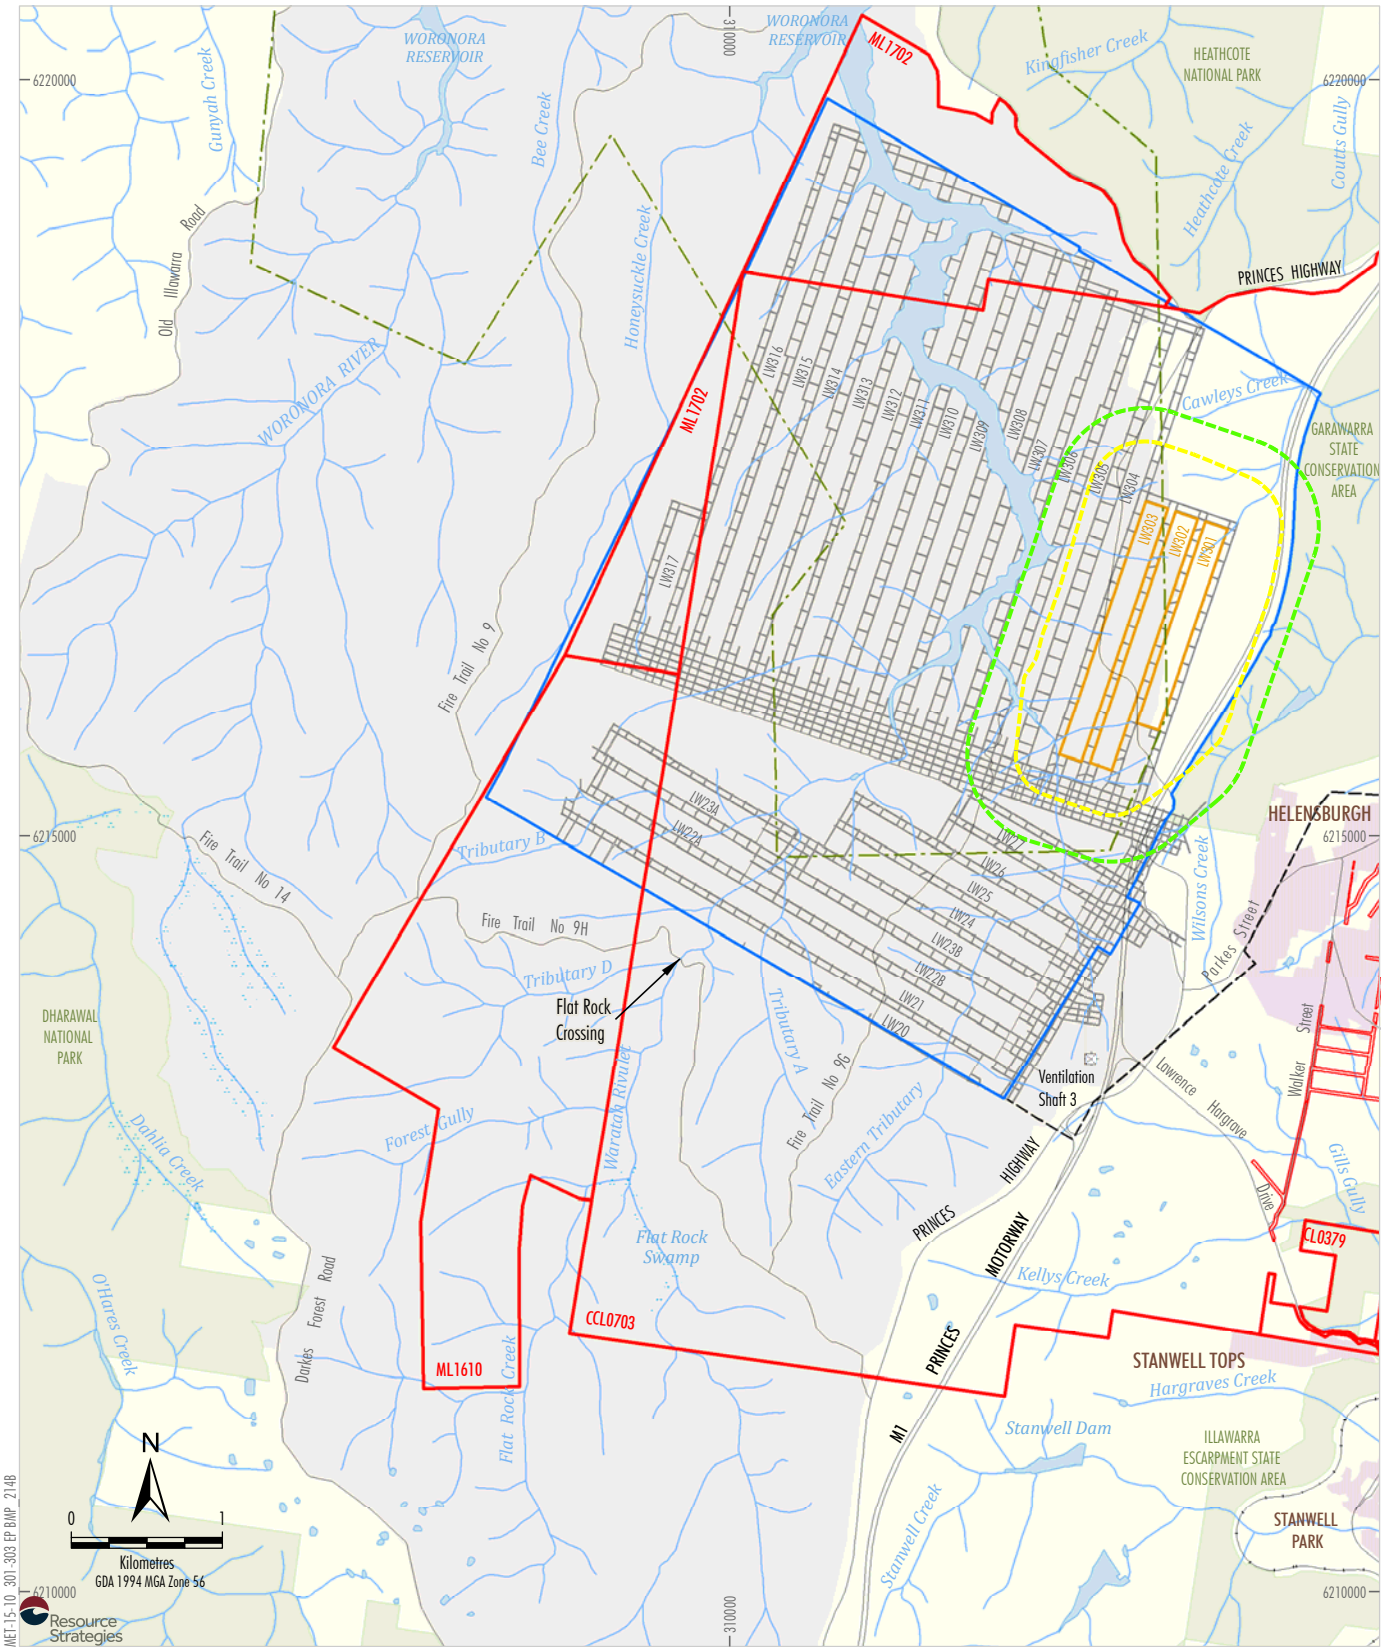
Figure 4

METROPOLITAN COAL
 Streams Within the Project
 Underground Mining Area and Surrounds

Streams occurring within 600 m of Longwalls 20-22 and Longwalls 23-27 secondary extraction include the Waratah Rivulet and its tributaries (such as Tributary A and B) and the Eastern Tributary and its tributaries (Figure 4). The locations of pools on the Waratah Rivulet and the Eastern Tributary are shown on Figure 5.

In accordance with Condition 1, Schedule 6 of the Project Approval, Metropolitan Coal is required to achieve the rehabilitation objective: *Restore surface flow and pool holding capacity as soon as reasonably practicable* for (Figure 4):

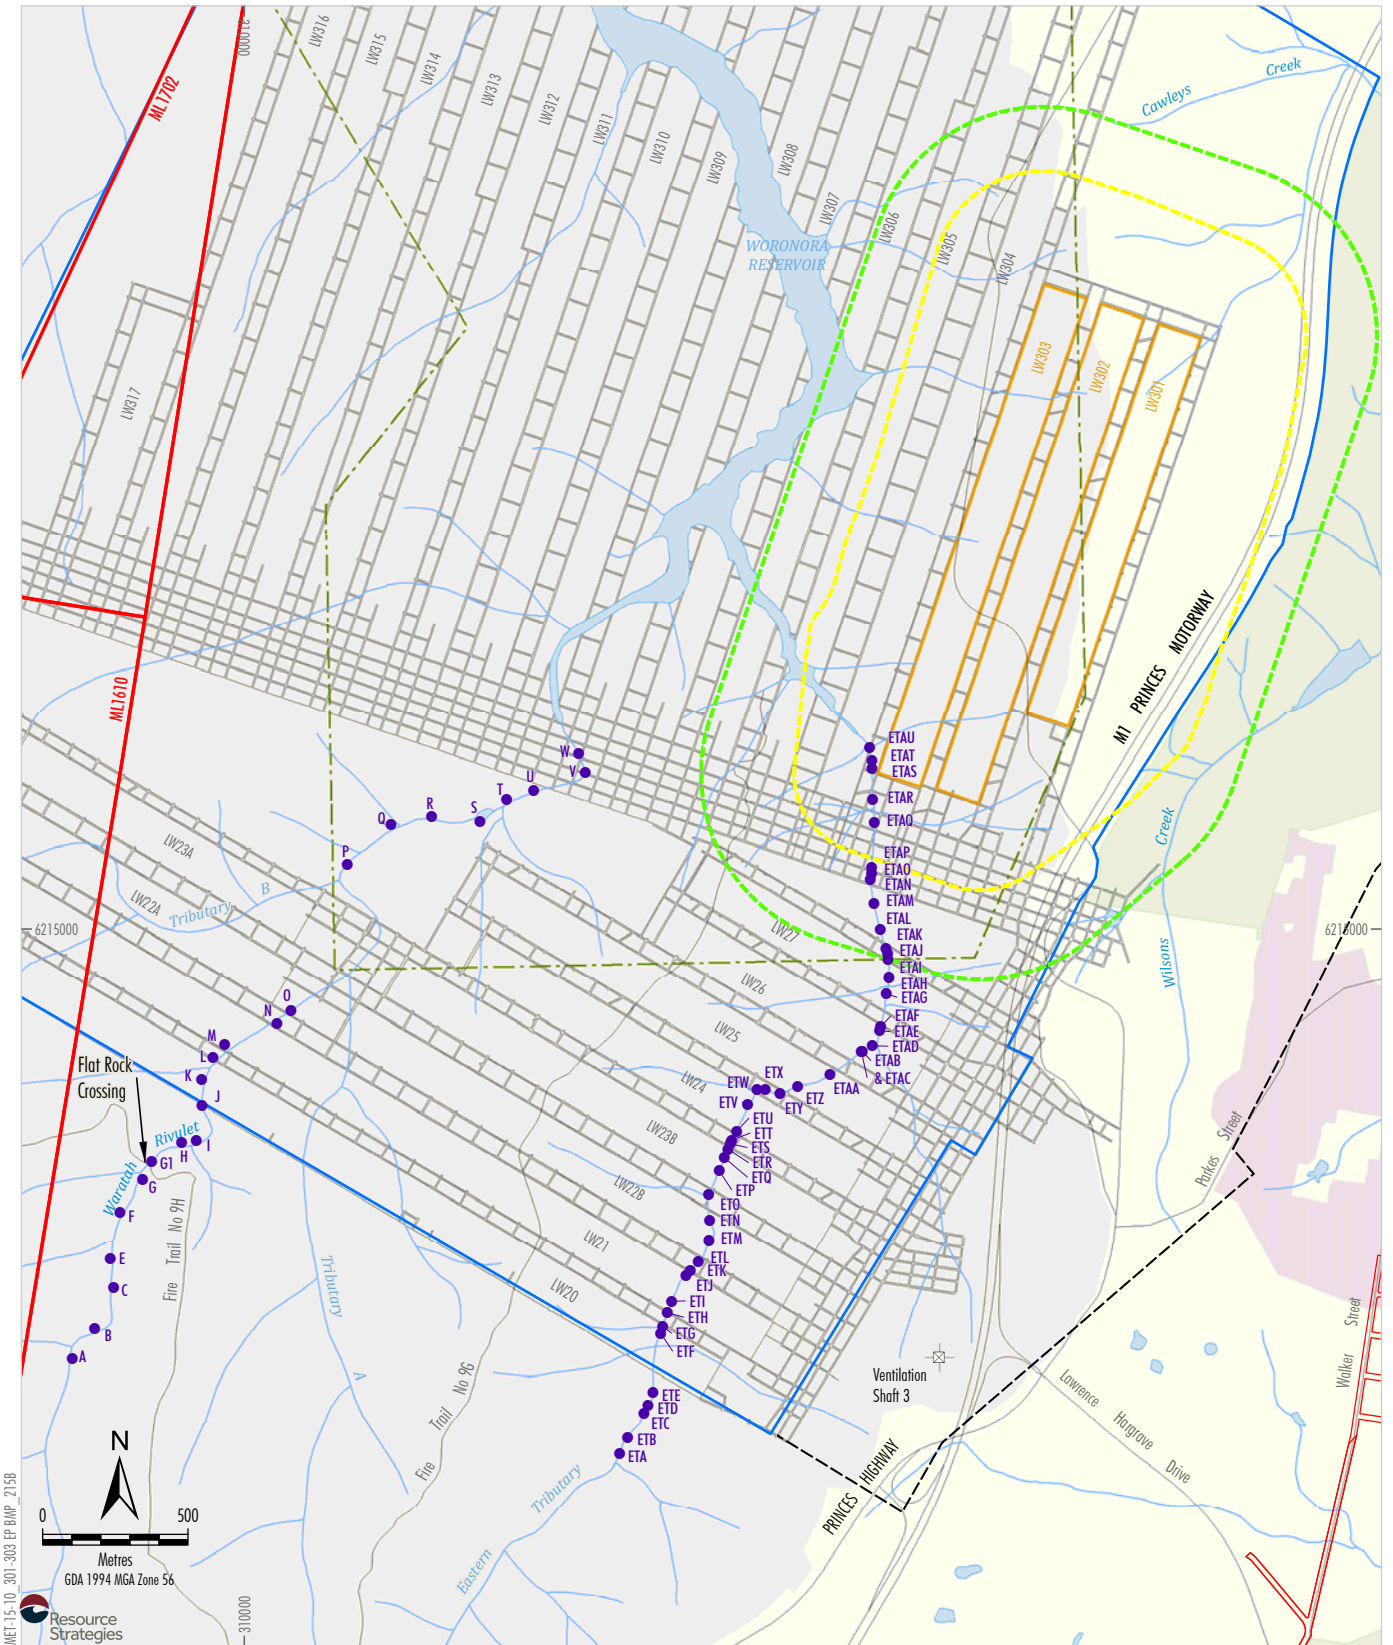
- MEF-15-10-301-303-EP-BMP-2158
Resource Strategies
- LEGEND**
- Mining Lease Boundary
 - Woronora Special Area
 - Project Underground Mining Area Longwalls 20-27 and 301-317
 - Longwalls 301 - 303 Secondary Extraction
 - 35° Angle of Draw and/or Predicted 20 mm Subsidence Contour
 - 600 m from Secondary Extraction of Longwalls 301-303
 - Woronora Notification Area
 - Existing Underground Access Drive (Main Drift)
 - Pool

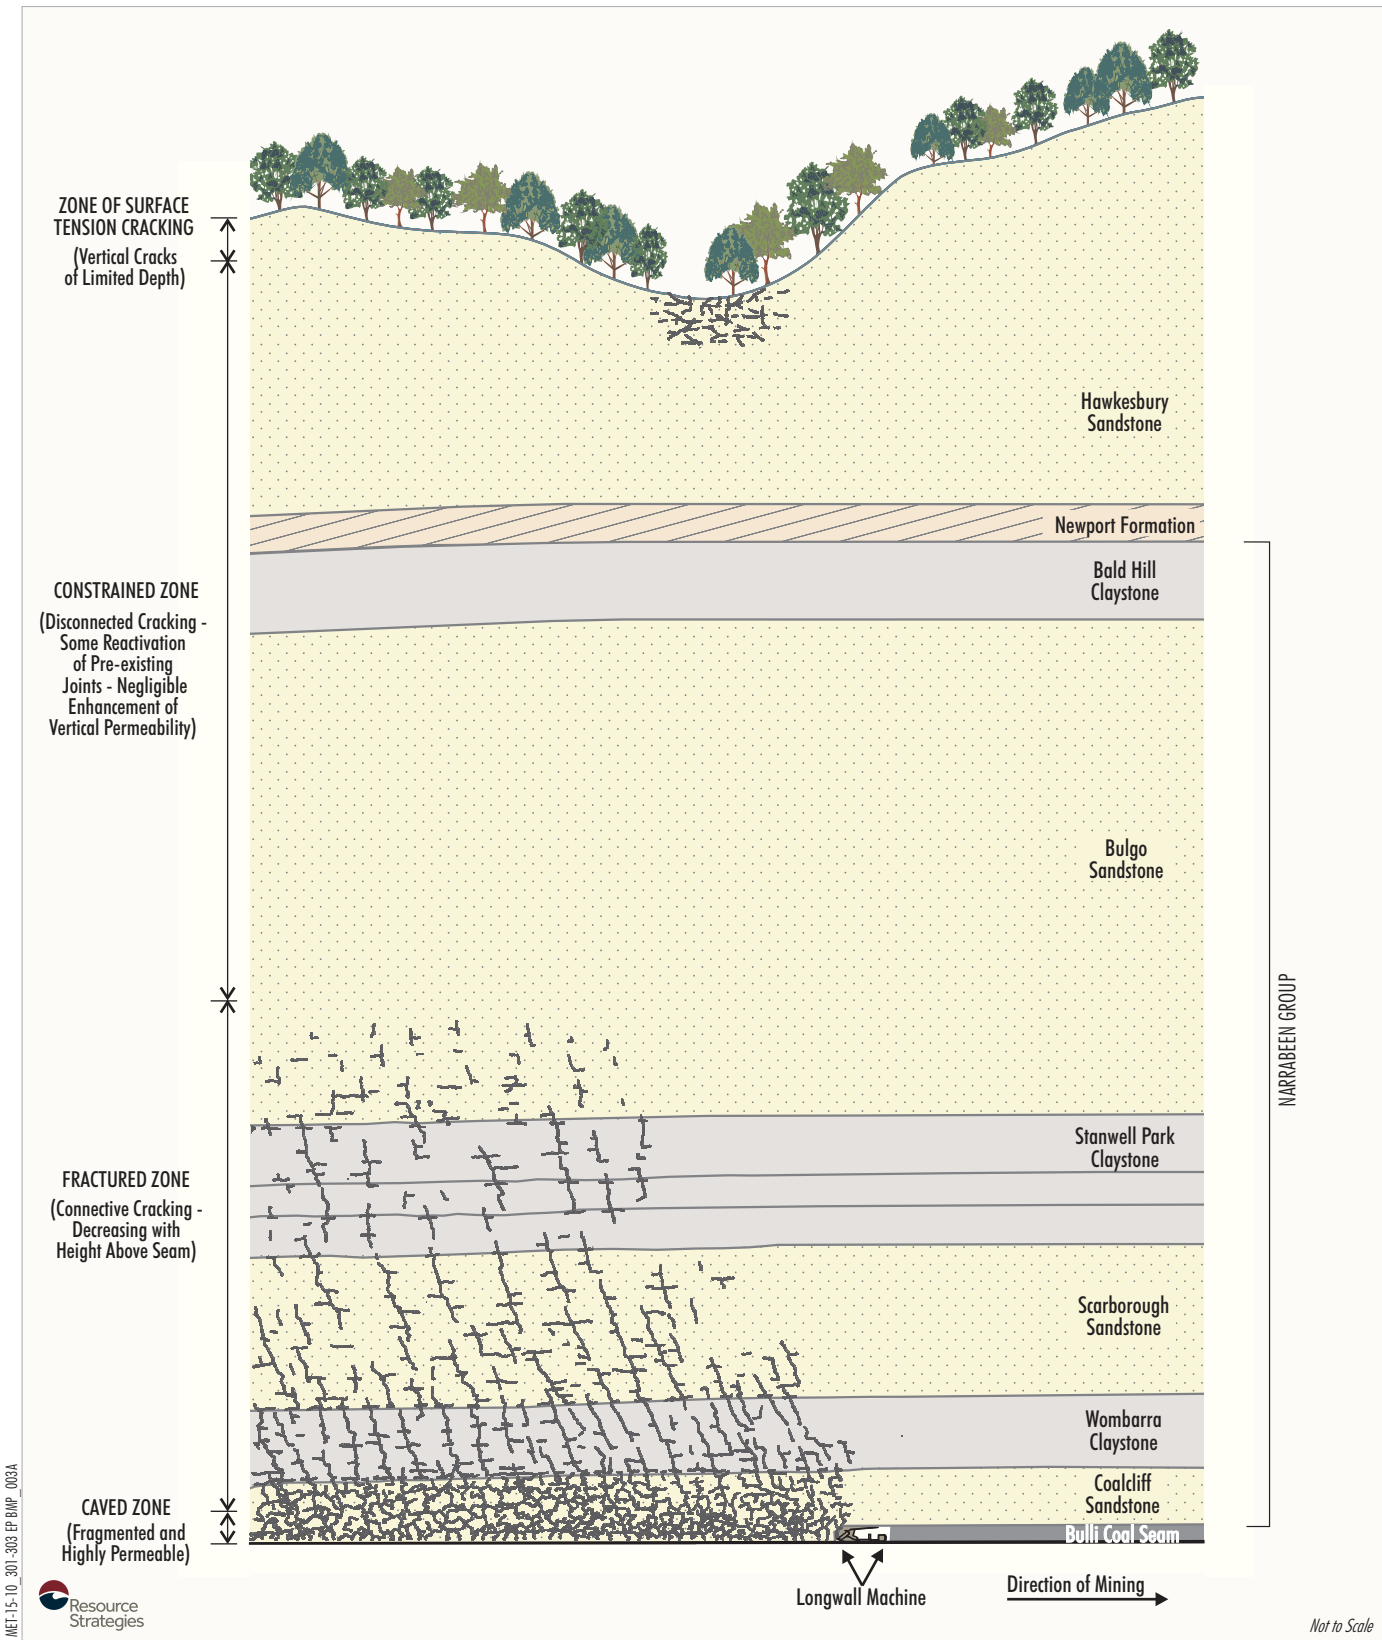
Figure 8

Immediately above a mined coal seam, rocks collapse into the void created by the removal of coal to form a caved zone and a fractured zone develops above the caved zone (Figure 8). This causes aquifer properties to change (e.g. permeability and porosity) and results in a higher vertical permeability as a result of mining.

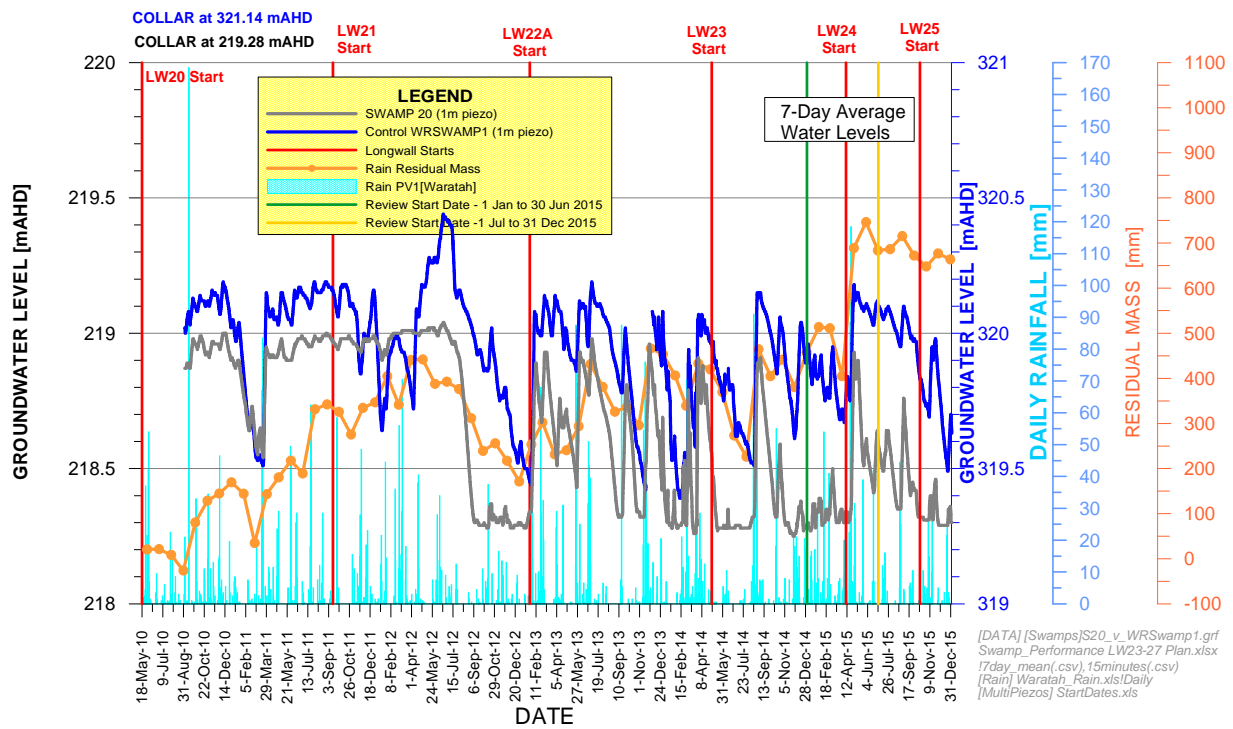
Chart 1: Comparison of Piezometer Responses at Swamp 20 and Woronora River 1 Control Swamp

To date, the swamp substrate water levels of Swamps 25, 28³, 30, 33 and 35 (all valley side swamps) have remained perched (HydroSimulations, 2016). However, the substrate water levels in Swamp 20 changed from being permanently saturated to being periodically saturated as a result of the passing of Longwall 21 (Chart 1) (HydroSimulations, 2016). This trend continues to be observed (HydroSimulations, 2016).

The results of upland swamp groundwater monitoring for Longwalls 20-22 and Longwalls 23-27 are considered to be consistent with the potential subsidence impacts and environmental consequences described in the Project EA, Preferred Project Report, and Metropolitan Coal Longwalls 20-22 and Longwalls 23-27 Water Management Plans and Biodiversity Management Plans. However, while the water lost from Swamp 20 was retained in the unsaturated sandstone above the regional water table, the changes in swamp water levels as a result of cracking are measurable when compared to seasonal individual rainfall event based changes in swamp groundwater levels. Whether or not this change in swamp water level is adversely impacting Swamp 20 is uncertain at this stage. However there are no visual signs that swamp vegetation is being impacted by the changed hydrological conditions.

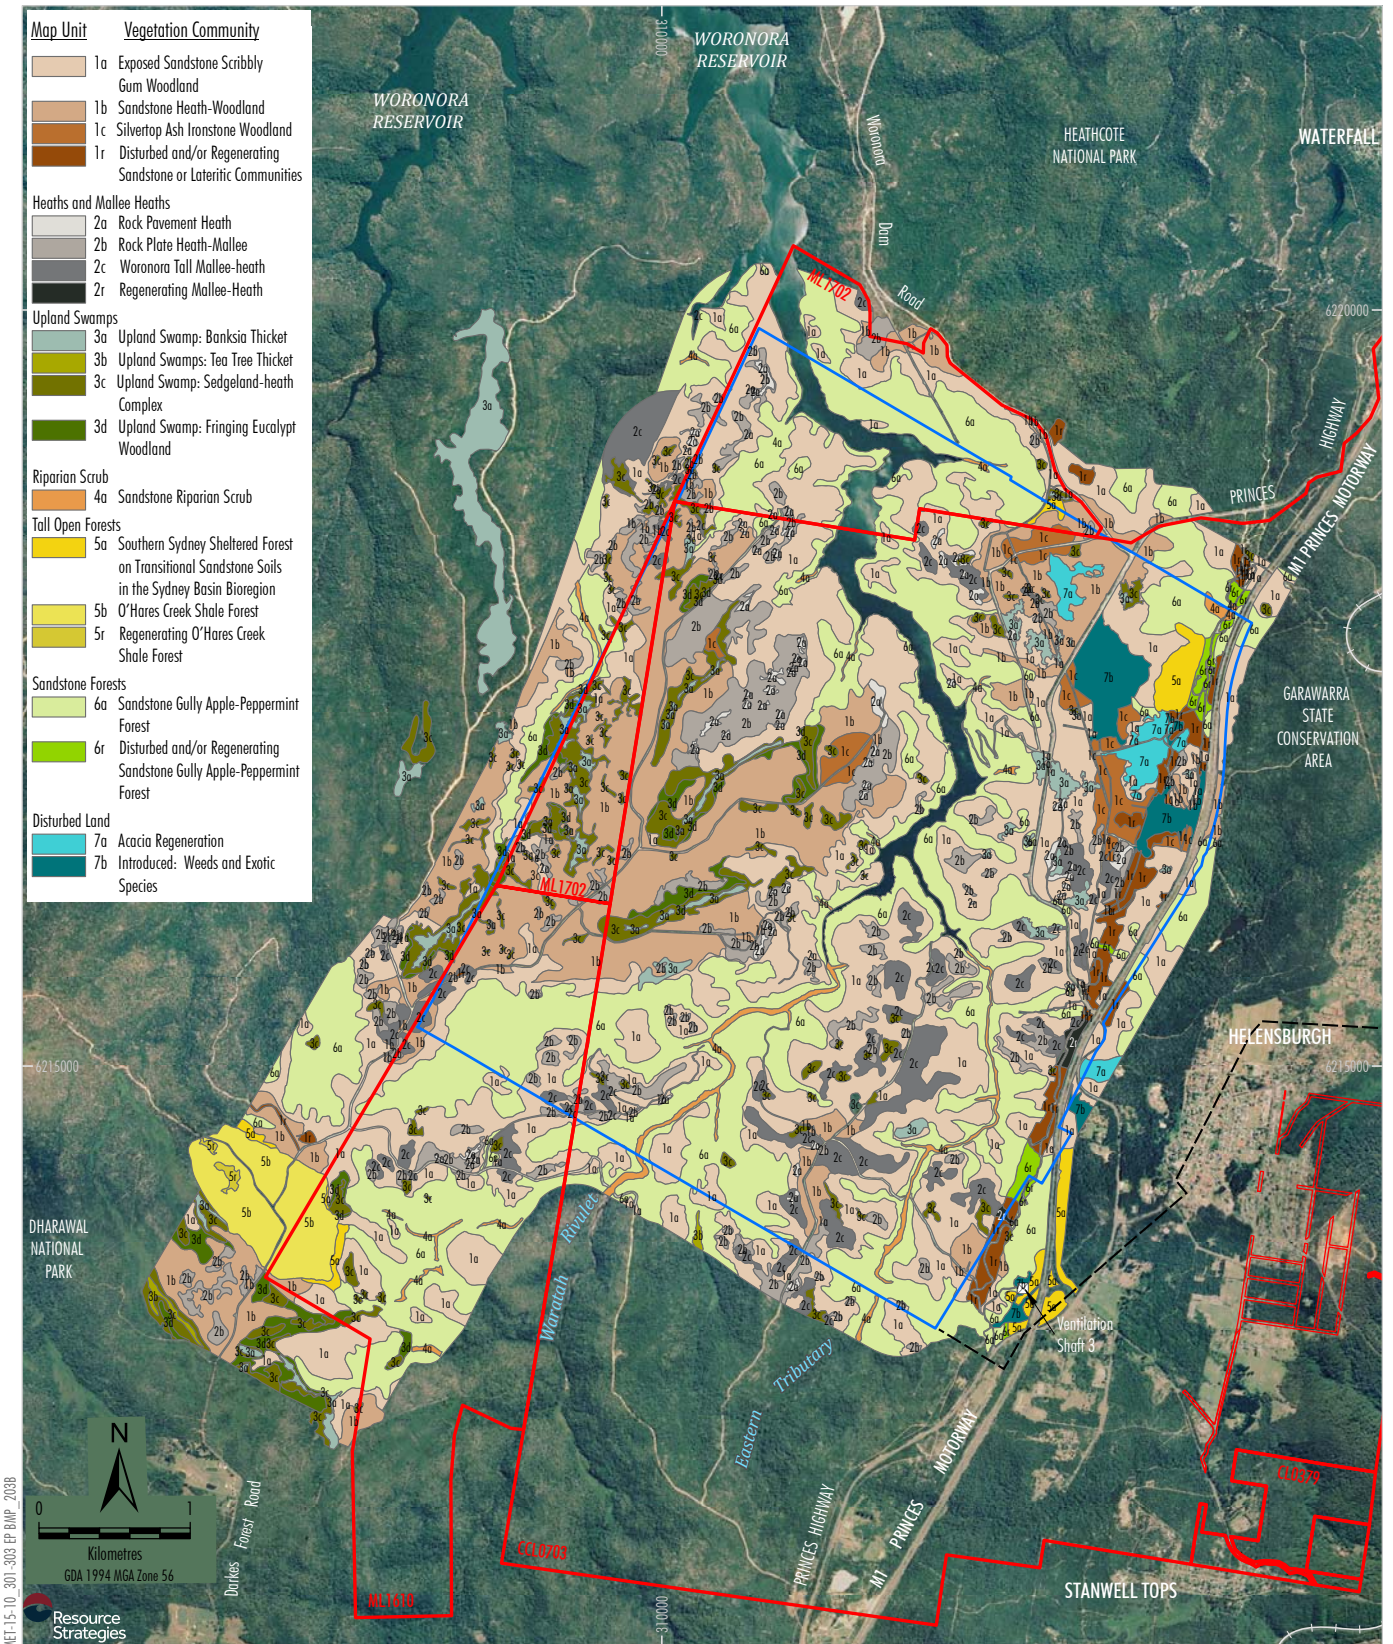
Figure 11

Peabody ENERGY
METROPOLITAN COAL
Mapped Vegetation Communities
Within the Project Underground
Mining Area and Surrounds

During the conduct of the Longwalls 20-27 upland swamp vegetation monitoring, the swamp boundary of control swamps 101, 111a, 135, 136, 137a, 137b, 138 and Bee Creek Swamp were updated by Eco Logical (as shown on Figure 11).

Riparian vegetation within the Project underground mining area occurs along streams which flow to the Woronora Reservoir, including Waratah Rivulet and the Eastern Tributary, and some of their tributaries. Vegetation mapping within the Project underground mining area is shown on Figure 11. Riparian vegetation includes vegetation mapped as community 4a (Sandstone Riparian Scrub).

Endangered Ecological Communities (EECs) listed under the TSC Act at the time of Project Approval and identified as occurring in the Project underground mining area or surrounds includes the Southern Sydney Sheltered Forest on Transitional Sandstone Soils in the Sydney Basin Bioregion EEC (Map Unit 5a) and the O'Hares Creek Shale Forest EEC (Map Units 5b and 5r) (Figure 11).

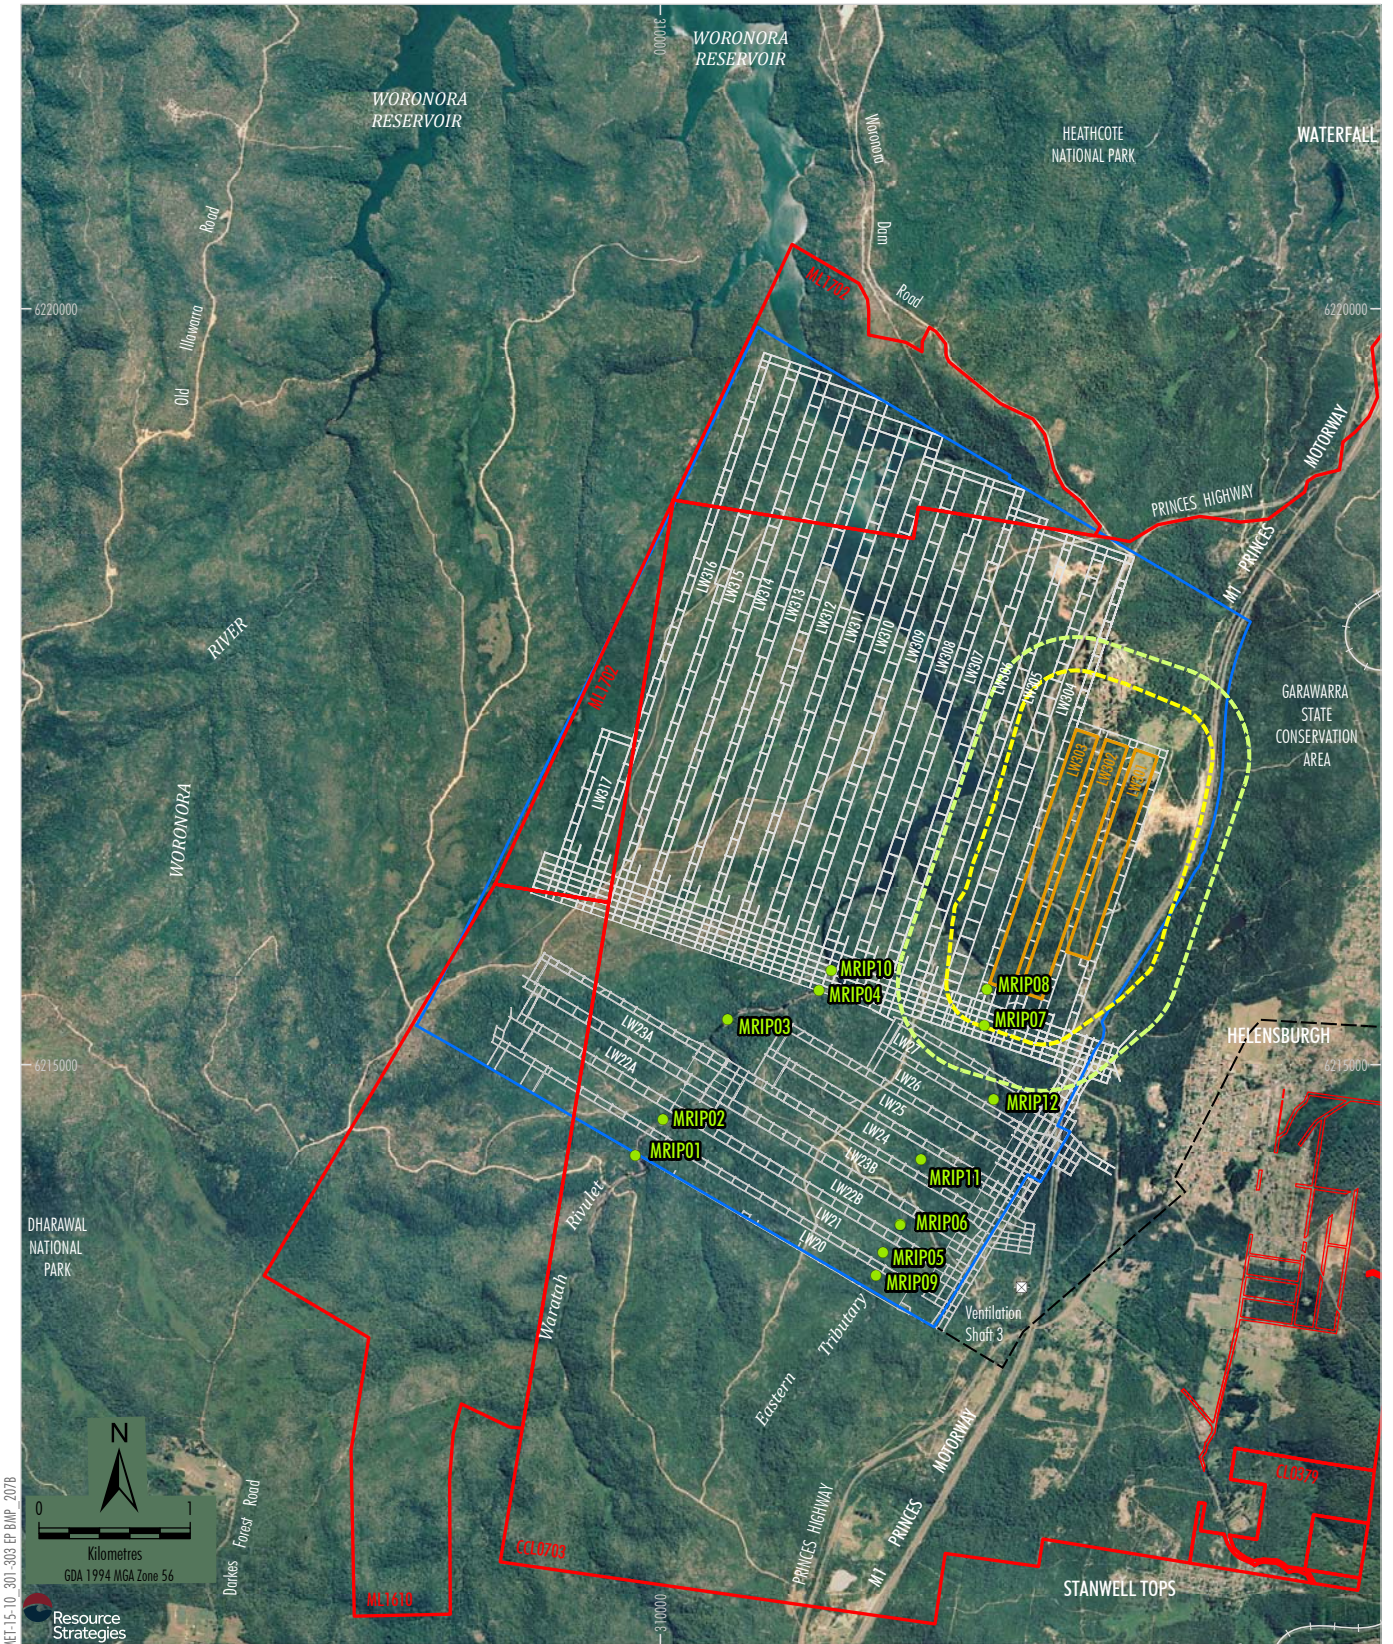
- Monitoring Site**
- Riparian Vegetation Monitoring Site

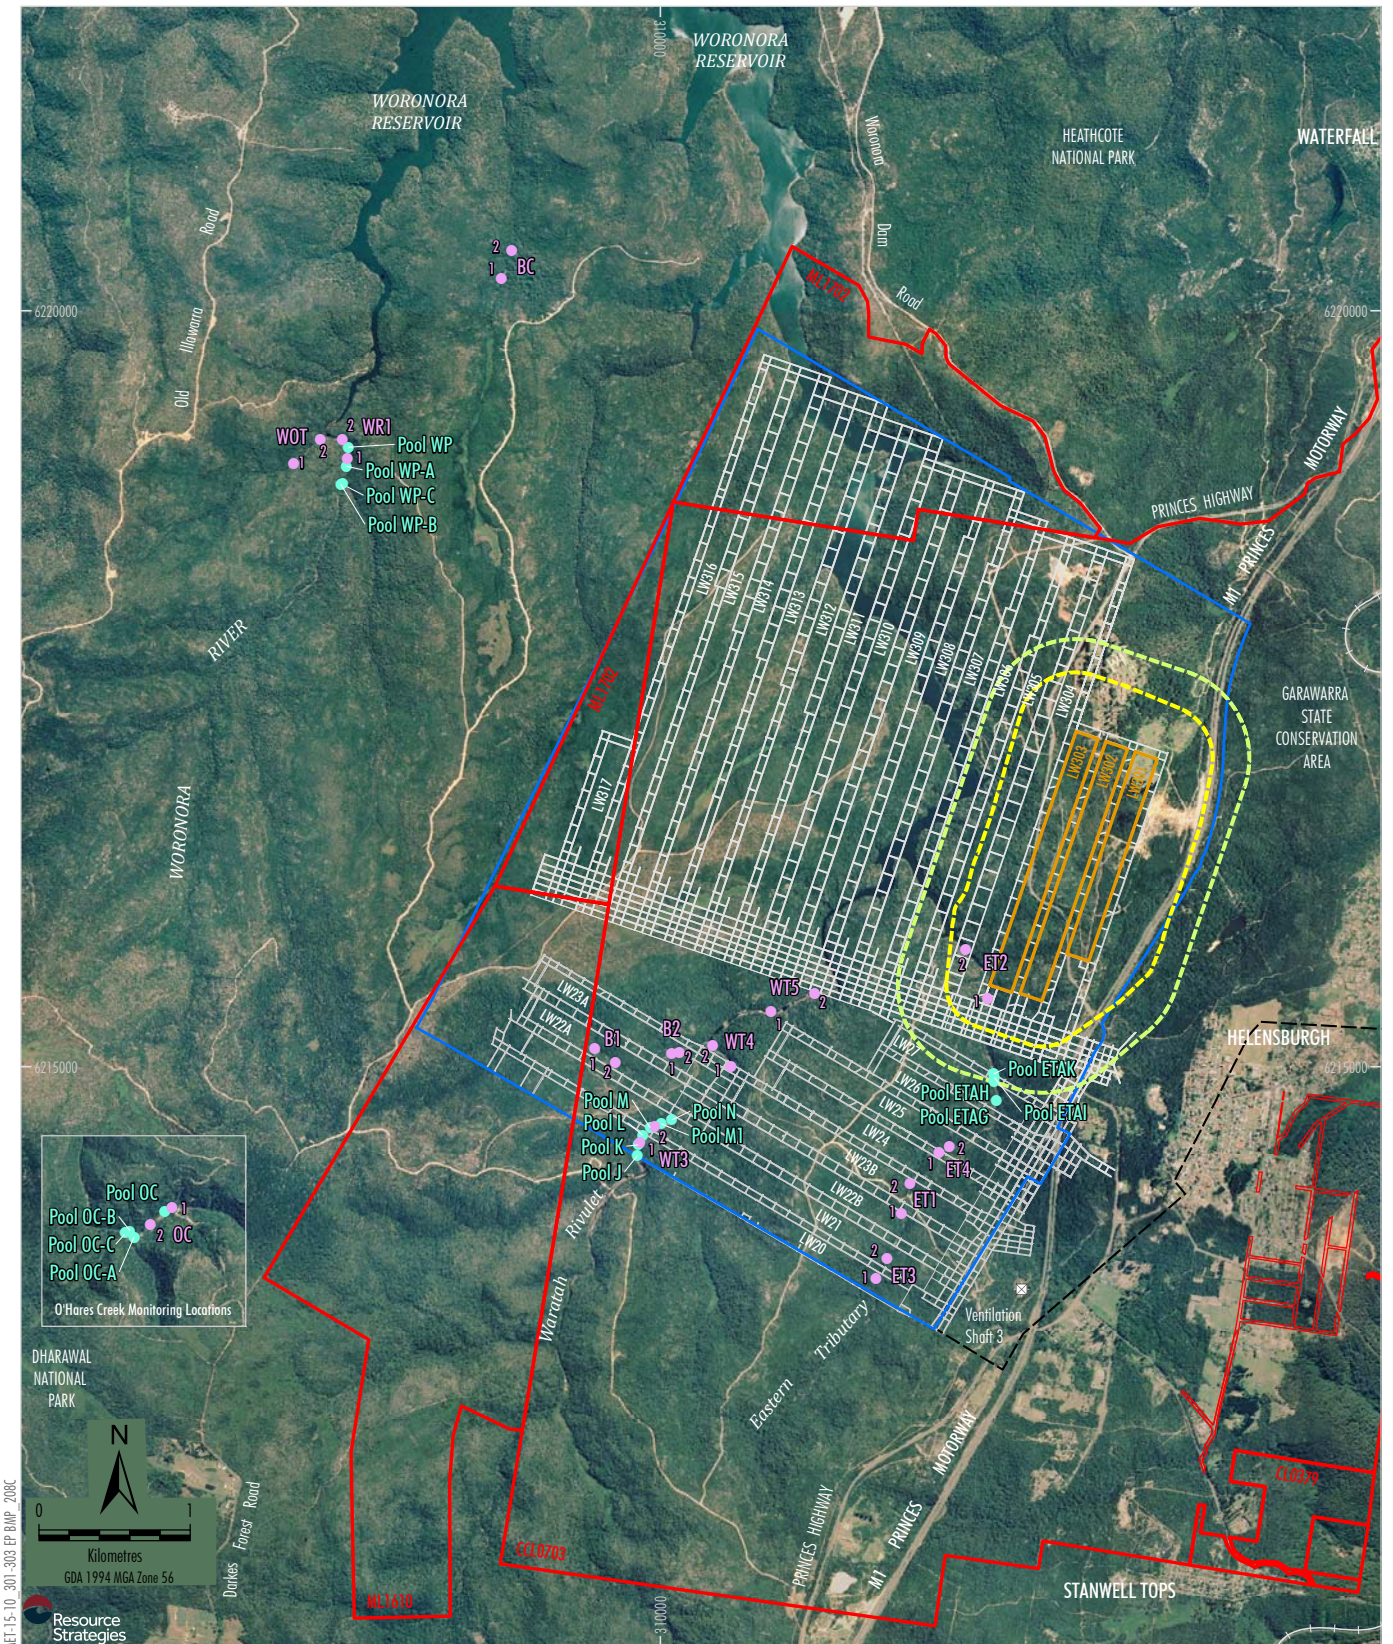
- Monitoring**
- Pool Aquatic Ecology Sampling Site
 - Stream Aquatic Ecology Sampling Site

Baseline aquatic ecology surveys of macroinvertebrates and macrophytes were conducted biannually from spring 2008 or spring 2009¹³ to autumn 2010 for Longwalls 20-22 stream monitoring at Locations WT3, WT4 and WT5 on Waratah Rivulet, Locations ET1, ET2 and ET3 on the Eastern Tributary, Location B1 on Tributary B, Location WR1 on Woronora River, Location OC on O’Hares Creek, Location BC on Bee Creek and Location WOT on Woronora Tributary (Figure 13). Baseline surveys of macroinvertebrates and macrophytes were conducted prior to the commencement of Longwall 23 (biannually from spring 2009 to spring 2013) for the additional Longwalls 23-27 stream monitoring sites at Location ET4 on the Eastern Tributary and Location B2 on Tributary B (Figure 13).

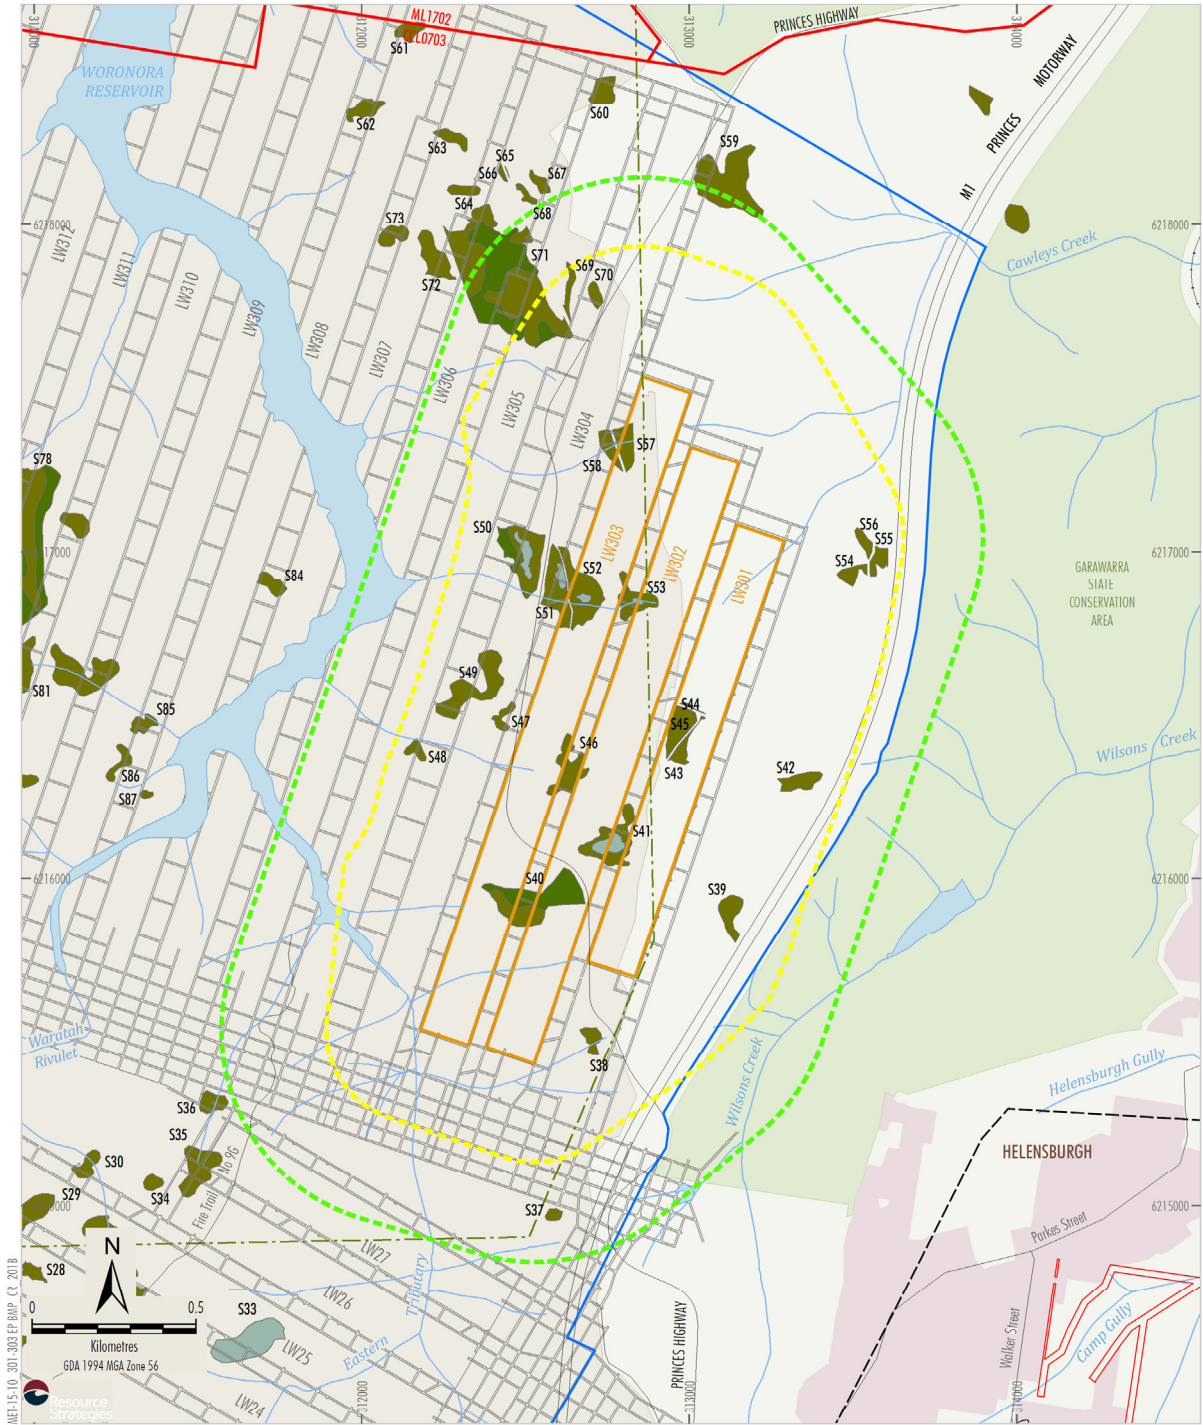
A total of 25 Upland Swamps were identified by Bangalay Botanical Surveys (2008) within 600 m of Longwalls 301-303 secondary extraction. The Bangalay Botanical Surveys (2008) mapping of upland swamps is shown on **Figure 1**. A summary of the vegetation mapping and location relative to Longwalls 301-303 for each of these swamps is provided in **Table 1**.
