METROPOLITAN COAL LONGWALLS 301-303

BIODIVERSITY MANAGEMENT PLAN

November 2016

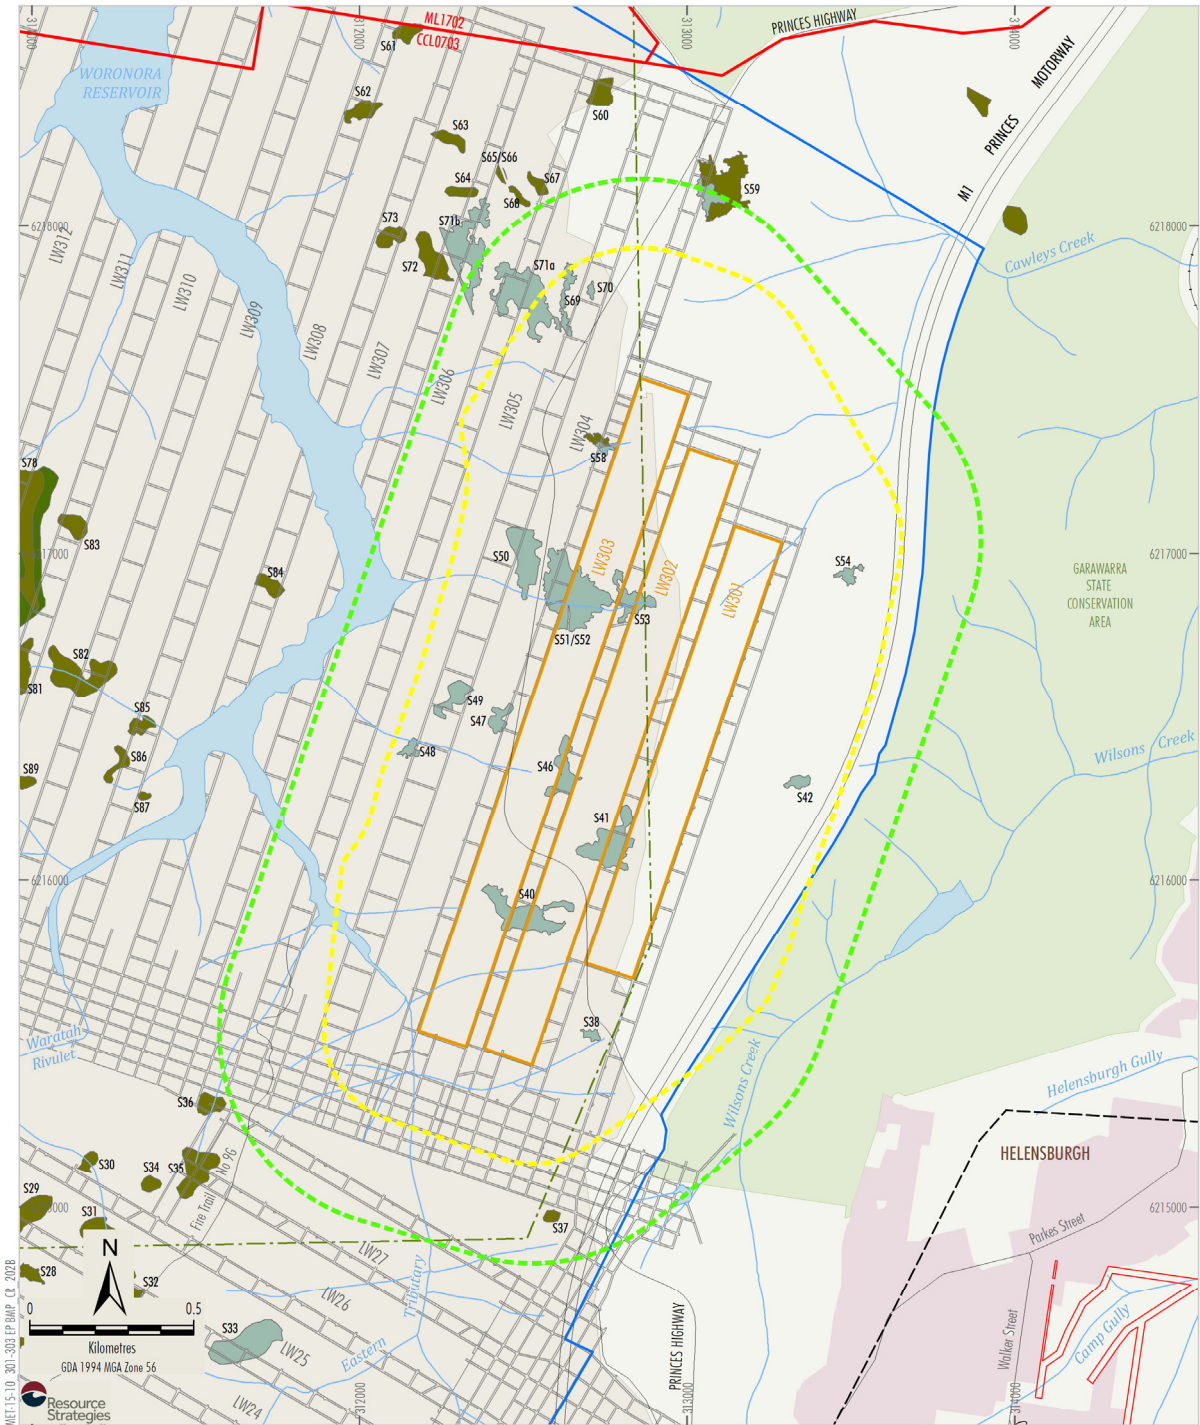
The upland swamps within 600 m of Longwalls 301-303 secondary extraction were all identified as supporting the Banksia Thicket vegetation community, with the exception of Swamps 58 and 59 (**Figure 2**), which were identified as supporting both Banksia Thicket and Sedgeland-heath Complex. The occurrence of Sedgeland-heath Complex was limited to these two swamps (Swamps 58 and 59) and only in the portions of these swamps with evidence of recent fire disturbance (following hazard reductions burns undertaken in this area during the last two years). Much of the Banksia Thicket identified within 600 m of Longwalls 301-303 secondary extraction was mapped by Bangalay Botanical Surveys (2008) as Sedgeland-heath Complex. The mapping of Bangalay Botanical Surveys (2008) was based upon field surveys undertaken between late 2006 and early 2008, approximately five years post the fire of December 2001 and January 2002, which extensively burnt the catchments of Woronora, O'Hares, Nepean and Avon. The identification of the Banksia Thicket vegetation community in areas previously mapped as Sedgeland-heath Complex (**Figures 1 and 2**) may relate to the finer scale of vegetation mapping undertaken as part of the Longwalls 301-303 surveys, or may be related to the timing of surveys since recent fire events.

The revised swamp boundaries are shown on Figure 2 and in **Appendix A**. Profiles for each of the swamps including the specific vegetation community confirmed as occurring, updated boundaries, photos and key vegetation characteristics of each swamp are also provided in **Appendix A**. The revised vegetation community mapping (as a result of the revised upland swamp boundaries and vegetation community classification within 600 m of Longwalls 301-303 secondary extraction) by Eco Logical Australia is shown on **Figure 3**.

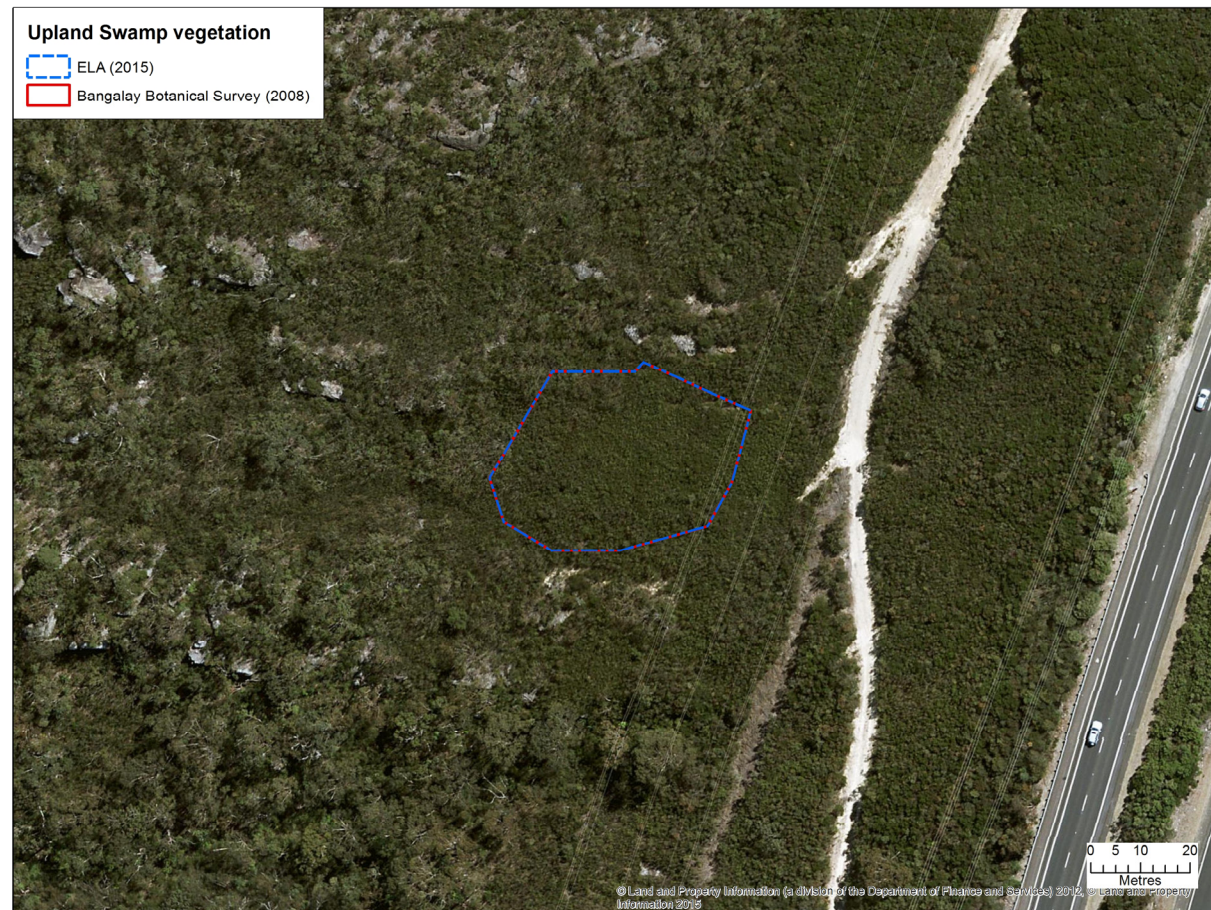
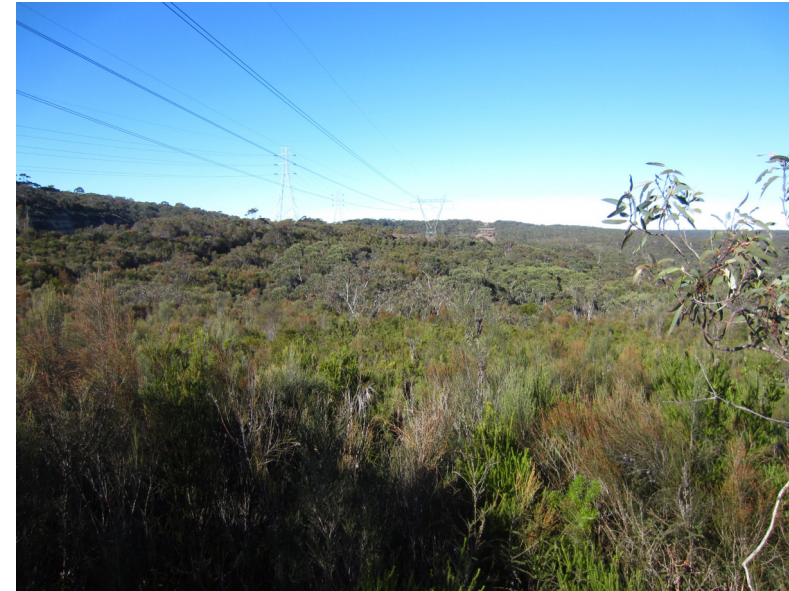
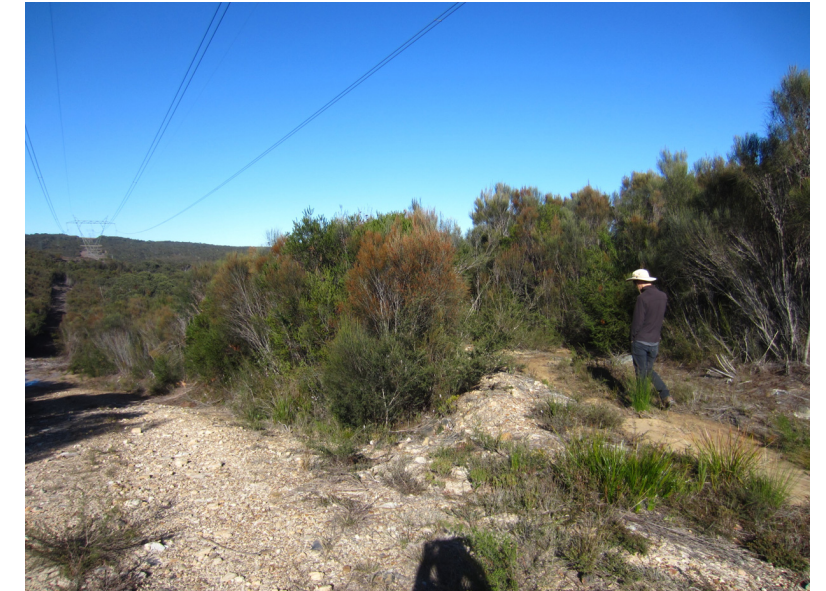
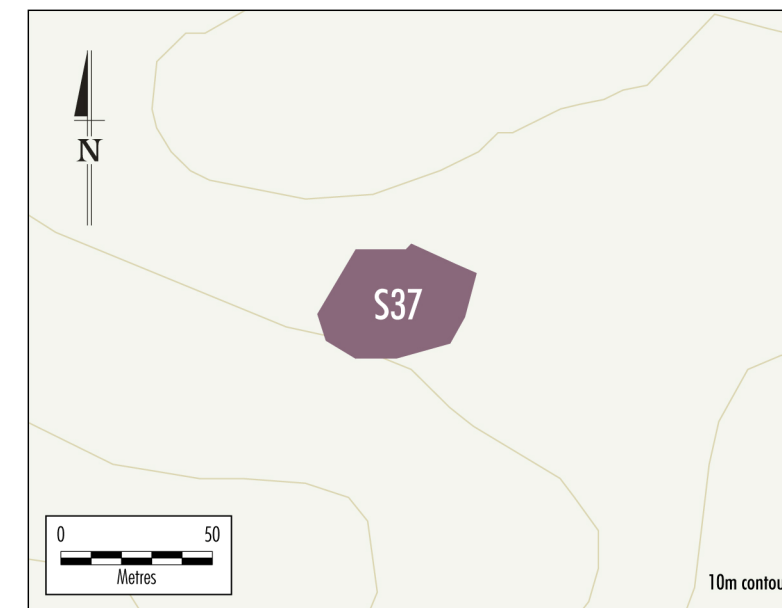
- Swamp 37 is a valley side swamp located within 600 m of Longwall 301-303 secondary extraction.
- This swamp was previously mapped as Sedgeland-heath Complex by Bangalay Botanical Surveys (2008).

- Field inspections undertaken as part of this report confirmed Banksia Thicket as occurring across the extent of this swamp, with no revisions made to existing swamp boundaries.

- In Swamp 37, no swamp indicator species were observed.
- In Swamp 38, no swamp indicator species were observed.
- In Swamp 40, indicator species were present including *Epacris obtusifolia* (>20 individuals) and *Sprengelia incarnata* (>20 individuals). *Pultenaea aristata* was not recorded.

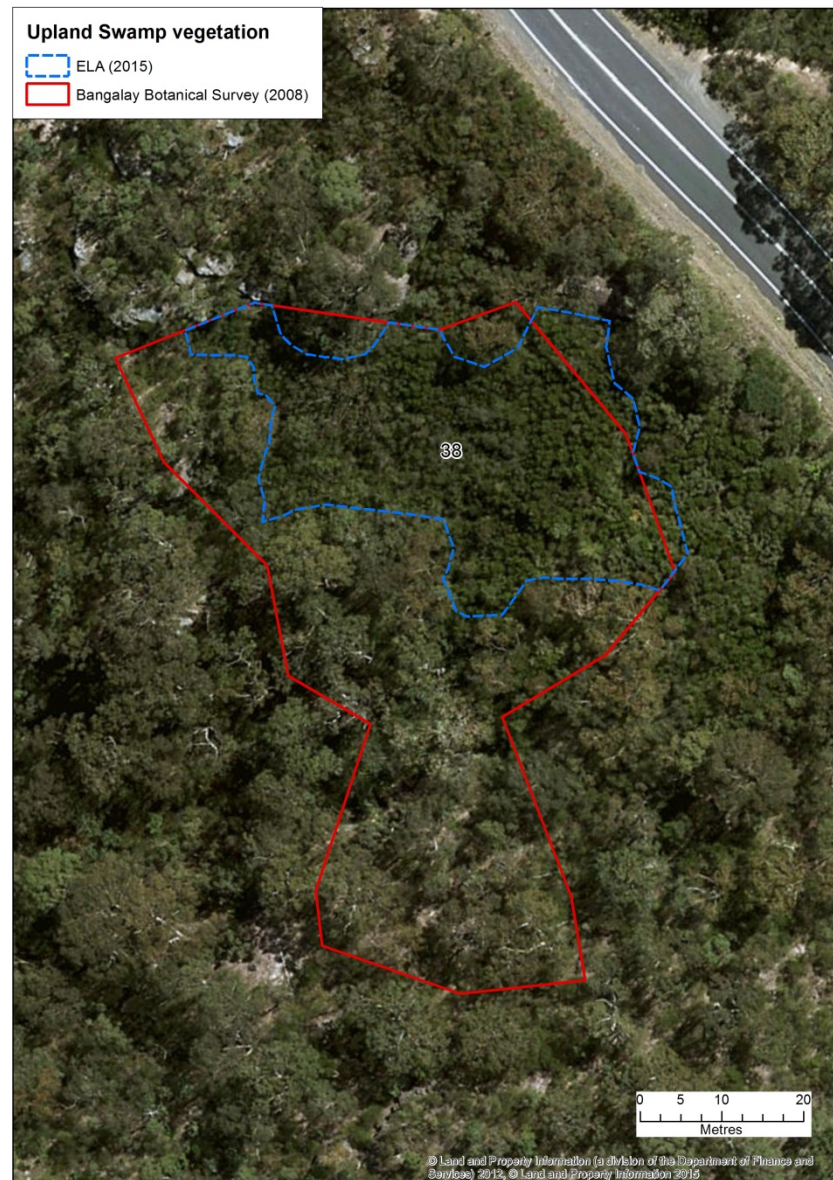
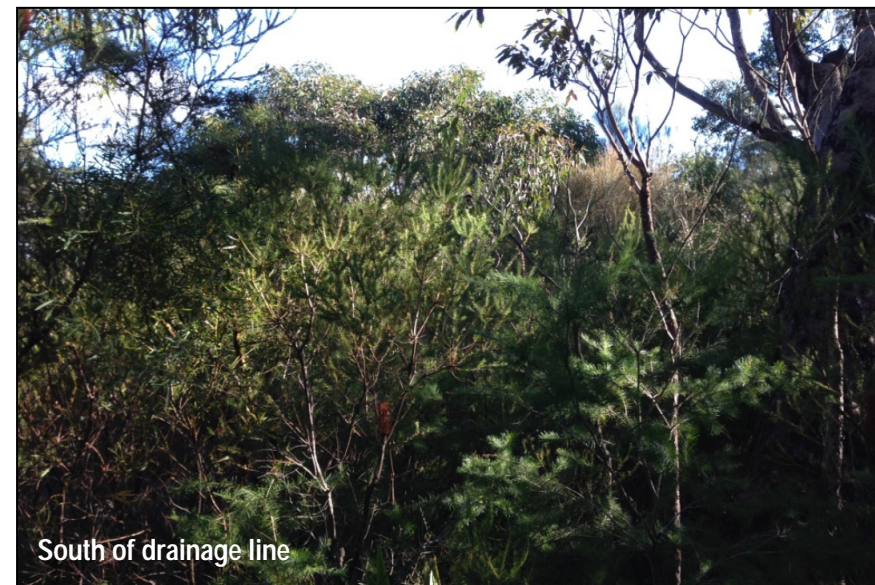
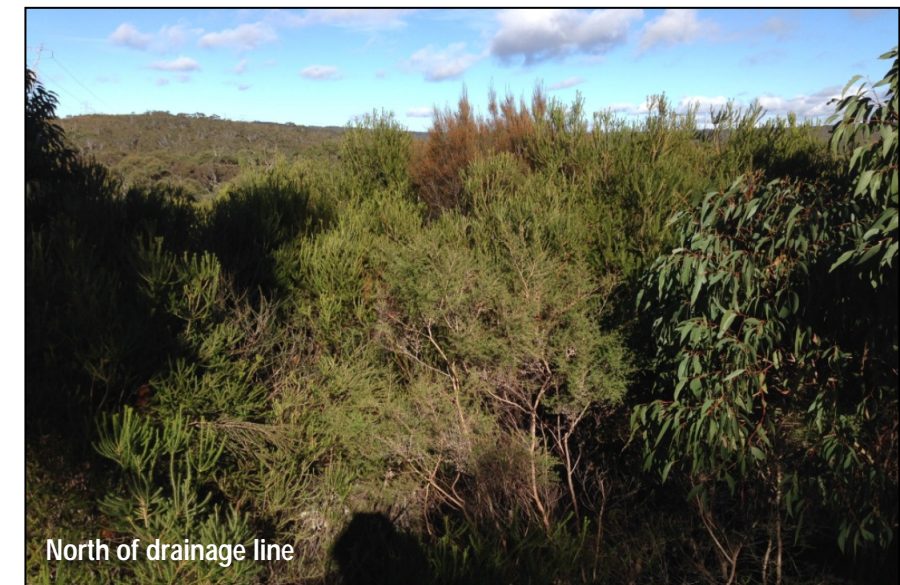
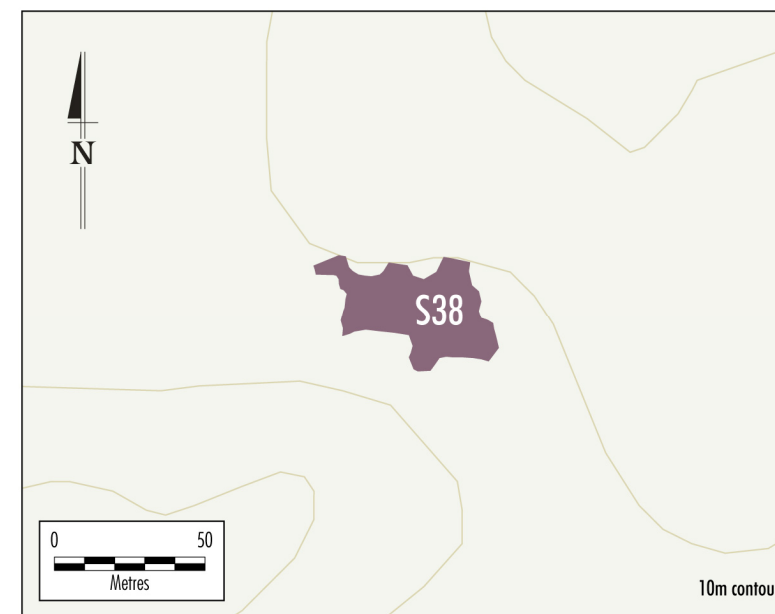
- Swamp 38 is a valley side swamp located to the south of Longwall 301 secondary extraction.
- This swamp was previously mapped as Sedgeland-heath Complex (Bangalay Botanical Surveys 2008).

- Inspections undertaken as part of this report identified a reduced area of Banksia Thicket with Sandstone Gully Apple-Peppermint Forest identified across southern portions of the previously mapped swamp extent.

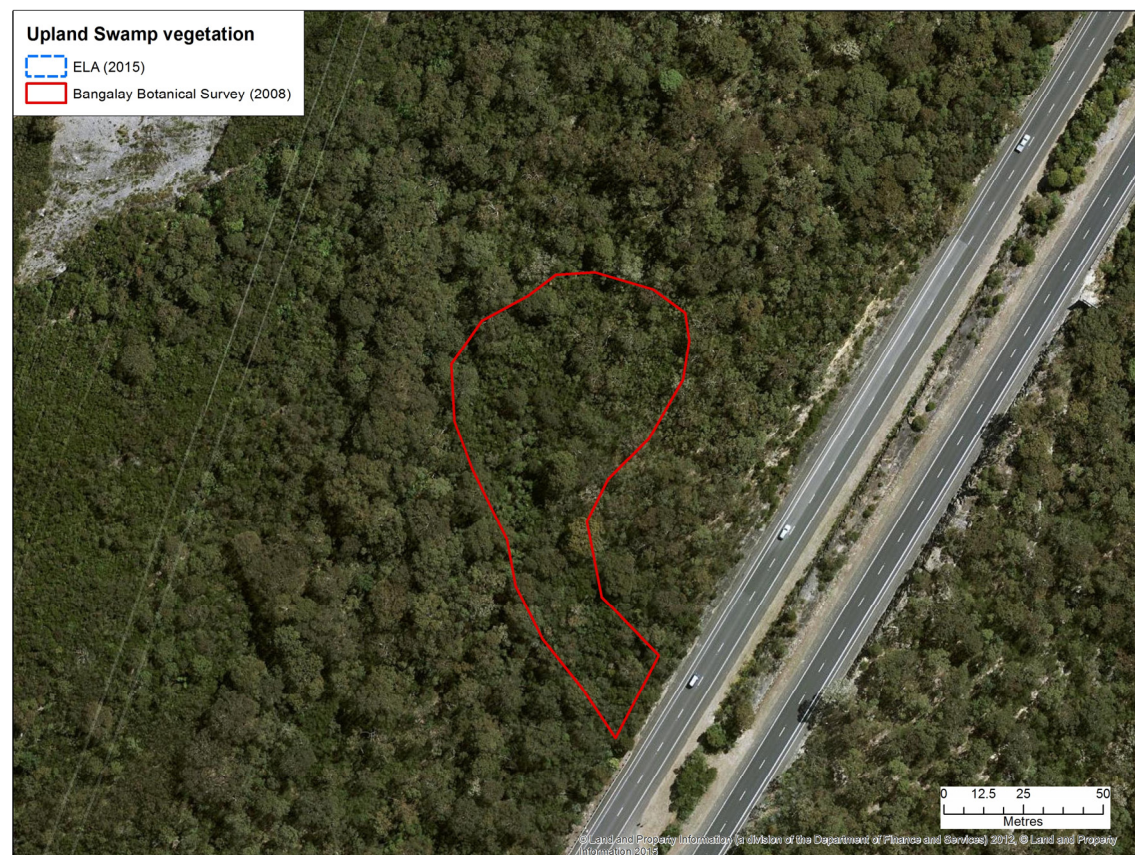
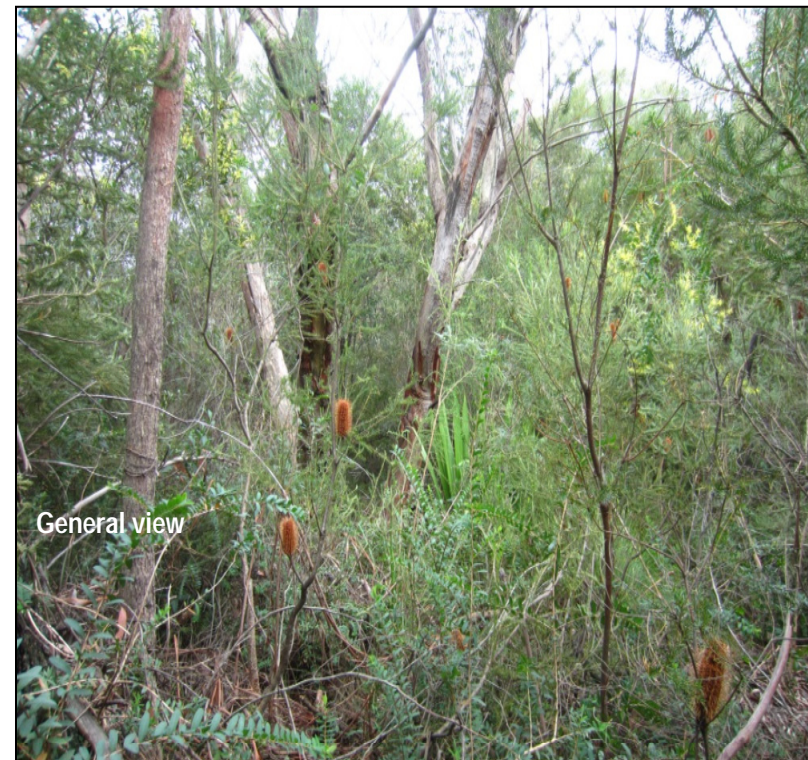
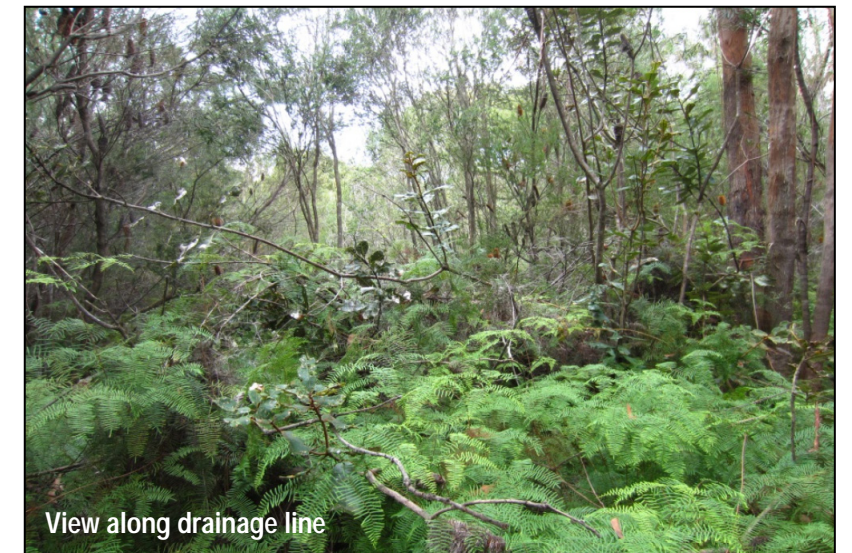
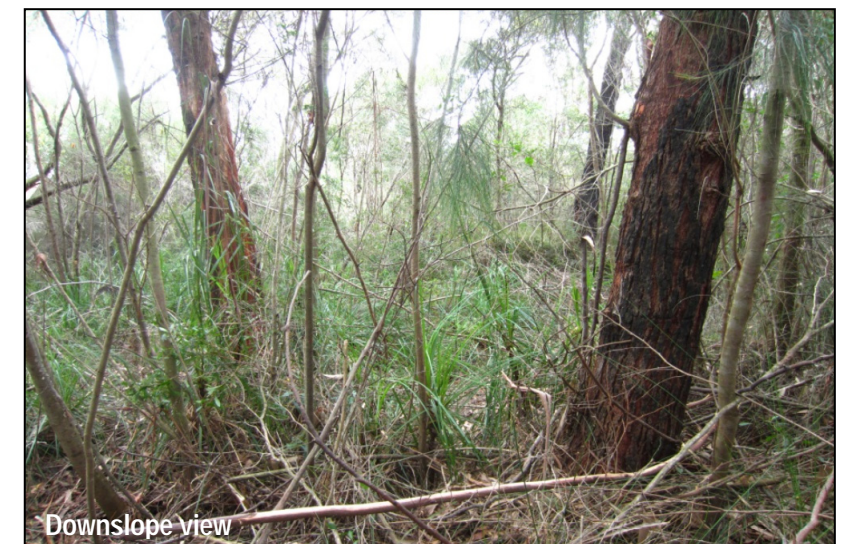
- Swamp 39 is a narrow south-facing gully located within the 35° angle of draw and/or predicted 20 mm subsidence contour.
- This area was previously mapped as Sedgeland-heath Complex (Bangalay Botanical Surveys 2008).
- Field inspections undertaken as part of this report identified Sandstone Gully Apple-Peppermint Forest occurring across the previously mapped swamp extent, with no swamp vegetation community present at this location.
- Some characteristic swamp species were observed occurring with non-swamp species such as *Doryanthes excelsa*, *Callicoma serratifolia*, *Lomatia silaifolia*, *Acacia longifolia* subsp. *longifolia* and *Melaleuca hypericifolia*.
- No terminal step was observed and the area converges into a drainage line flowing adjacent to the M1 Princes Motorway.
- No swamp indicator species were observed.
- Not a swamp.

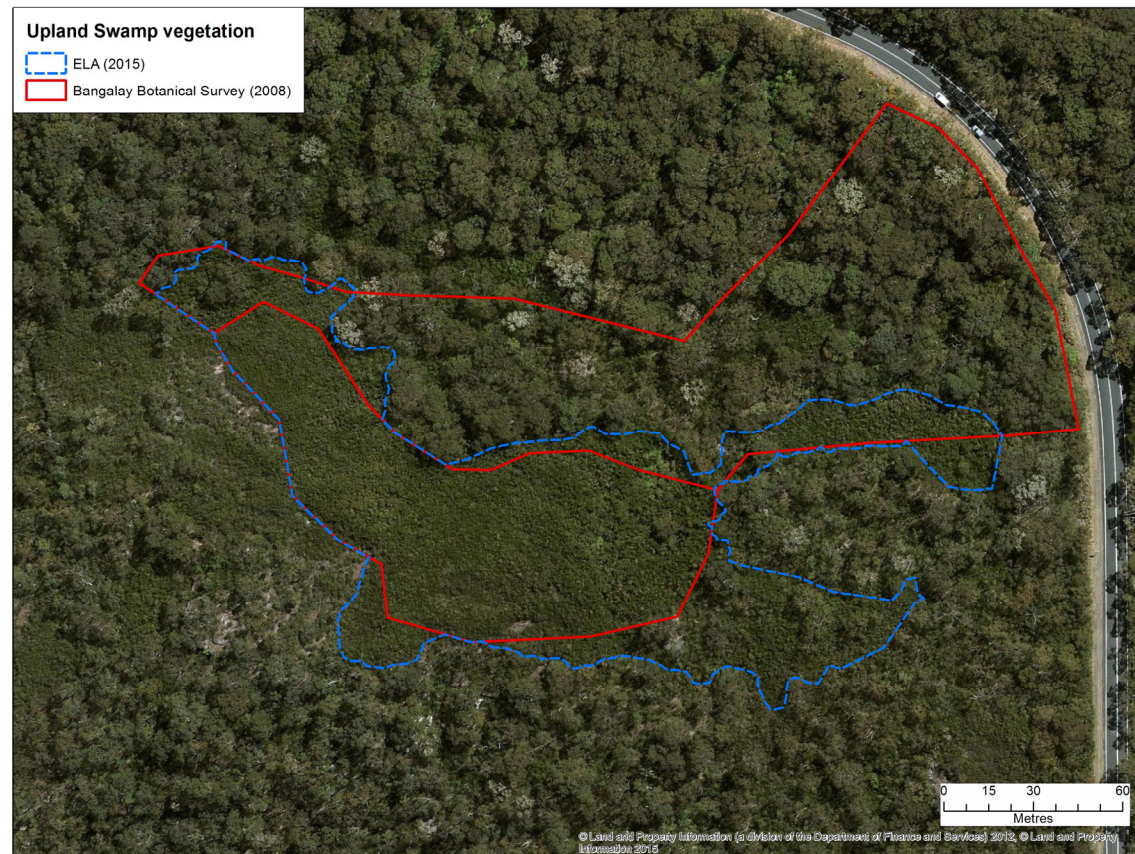
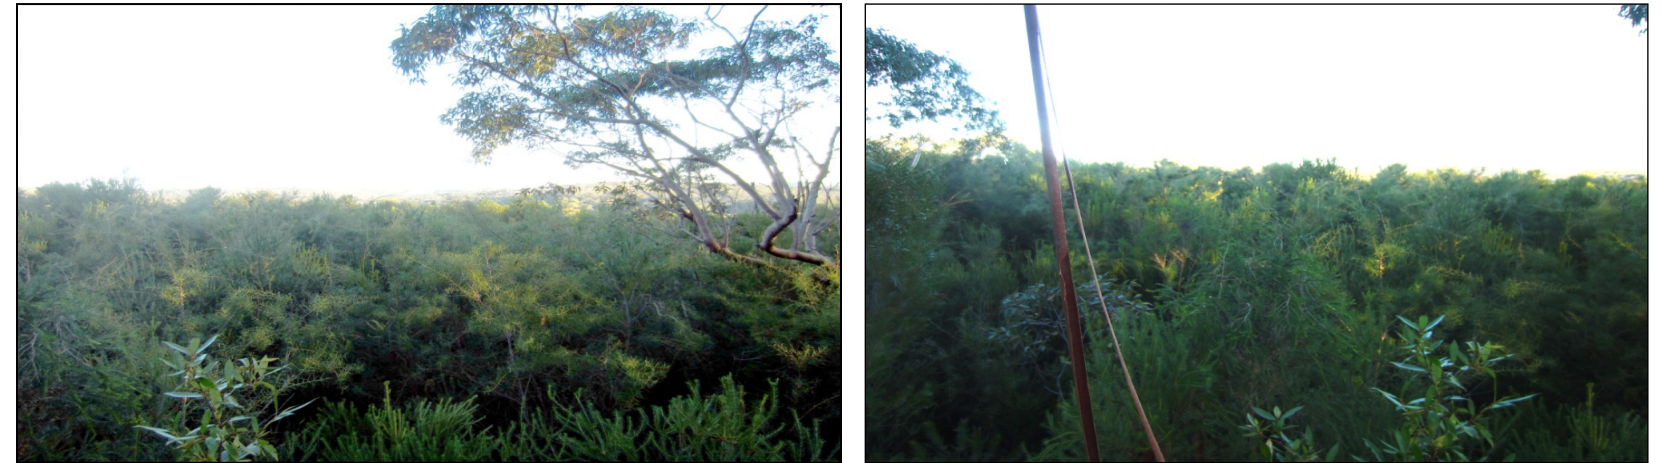
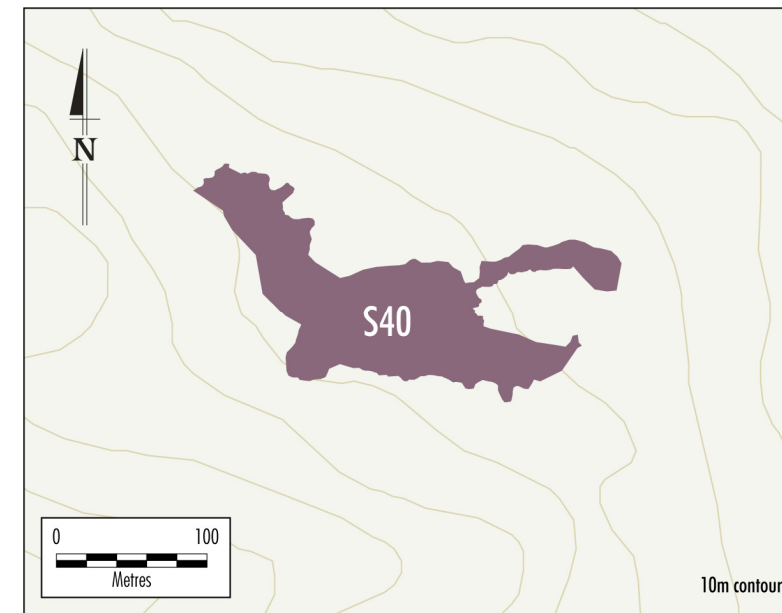
- Swamp 40 is a valley side swamp located over Longwalls 302 and 303 and the associated chain pillar.
- This swamp was previously mapped as Sedgeland-heath Complex and Fringing Eucalypt Woodland (Bangalay Botanical Surveys 2008).

- A revised area of Banksia Thicket was identified as part of this study with the area previously mapped as Fringing Eucalypt Woodland (Bangalay Botanical Surveys 2008) identified as Sandstone Gully Apple-Peppermint Forest. Additionally some minor revisions to the swamp boundary were made from field inspections and aerial photography interpretation. The revised Banksia Thicket is approximately 1.5 hectares in area.

- Seepage was observed across areas of exposed sandstone at the time of survey.

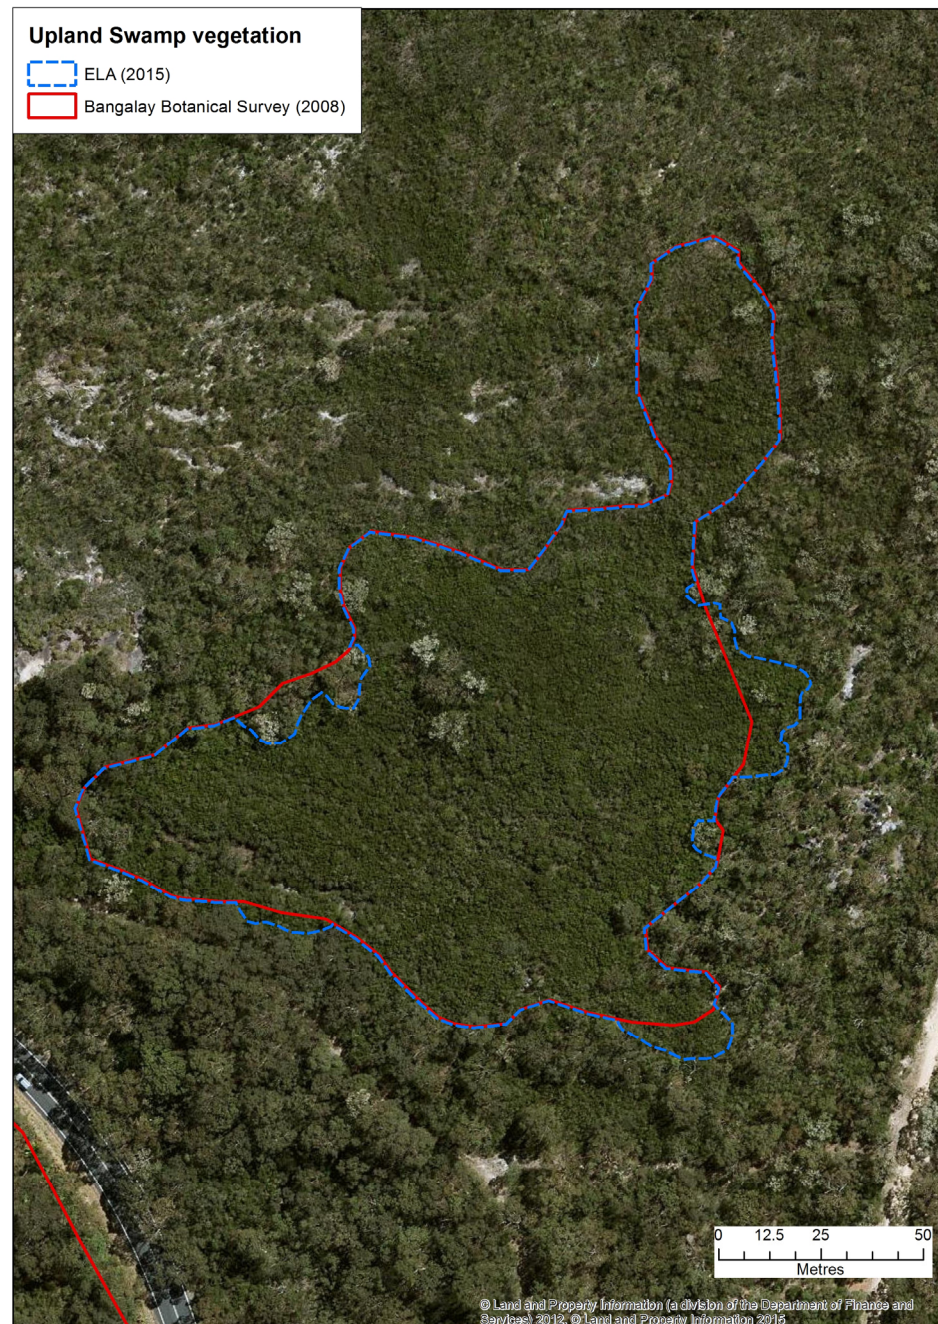
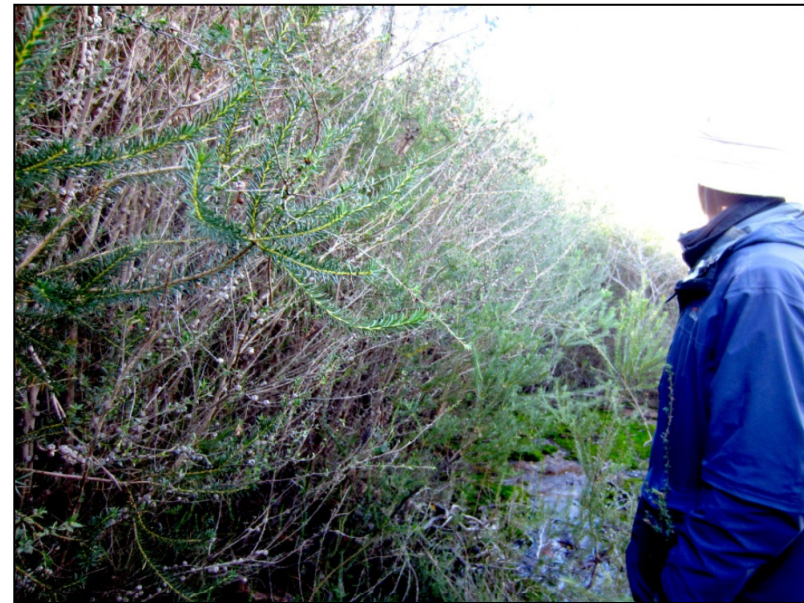
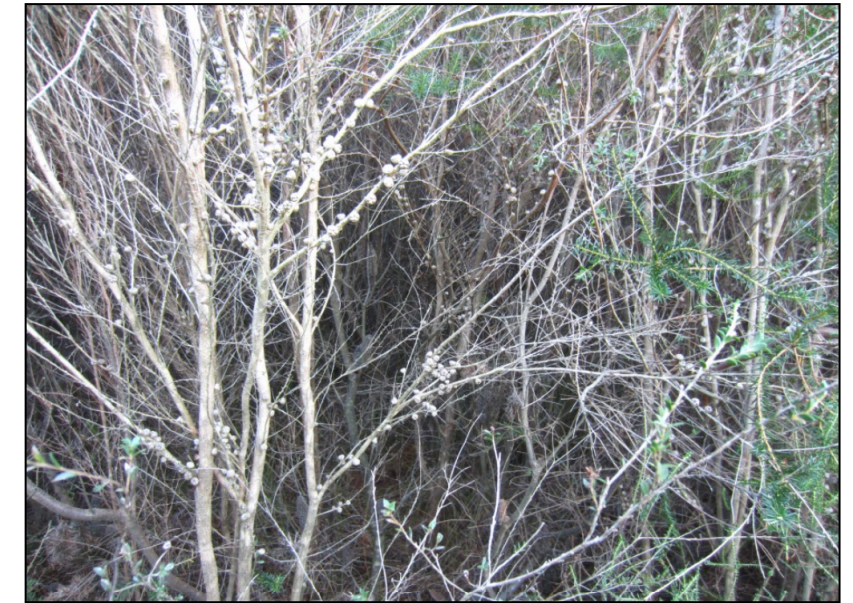
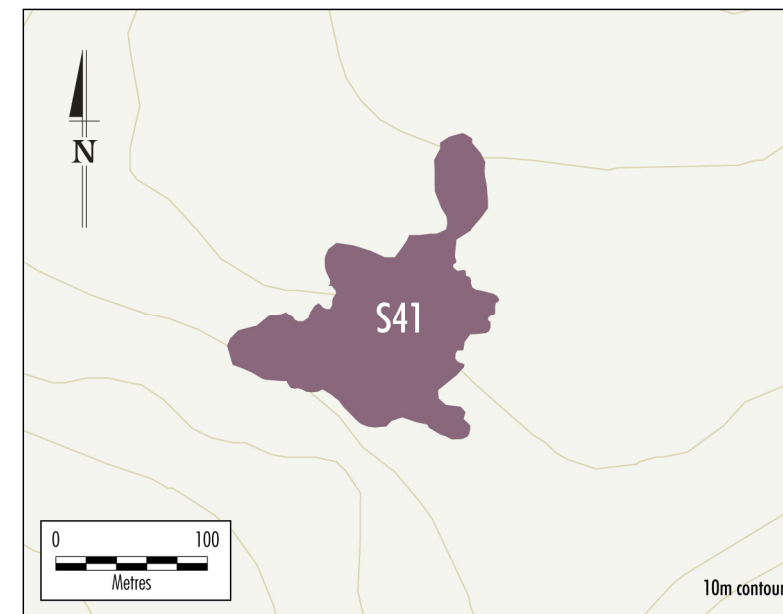
- Swamp 41 is a valley side swamp located over Longwalls 301 and 302 and the associated chain pillar.
- This swamp was previously mapped as Sedgeland-heath Complex surrounding a small central area of Banksia Thicket (Bangalay Botanical Surveys 2008).

- Field inspections undertaken as part of this report identified Banksia Thicket as occurring across the entire extent of the swamp. Additionally some minor revisions to the swamp boundary were also identified from field inspections and aerial photography interpretation. The revised area of Banksia Thicket is approximately 1.5 hectares in area.

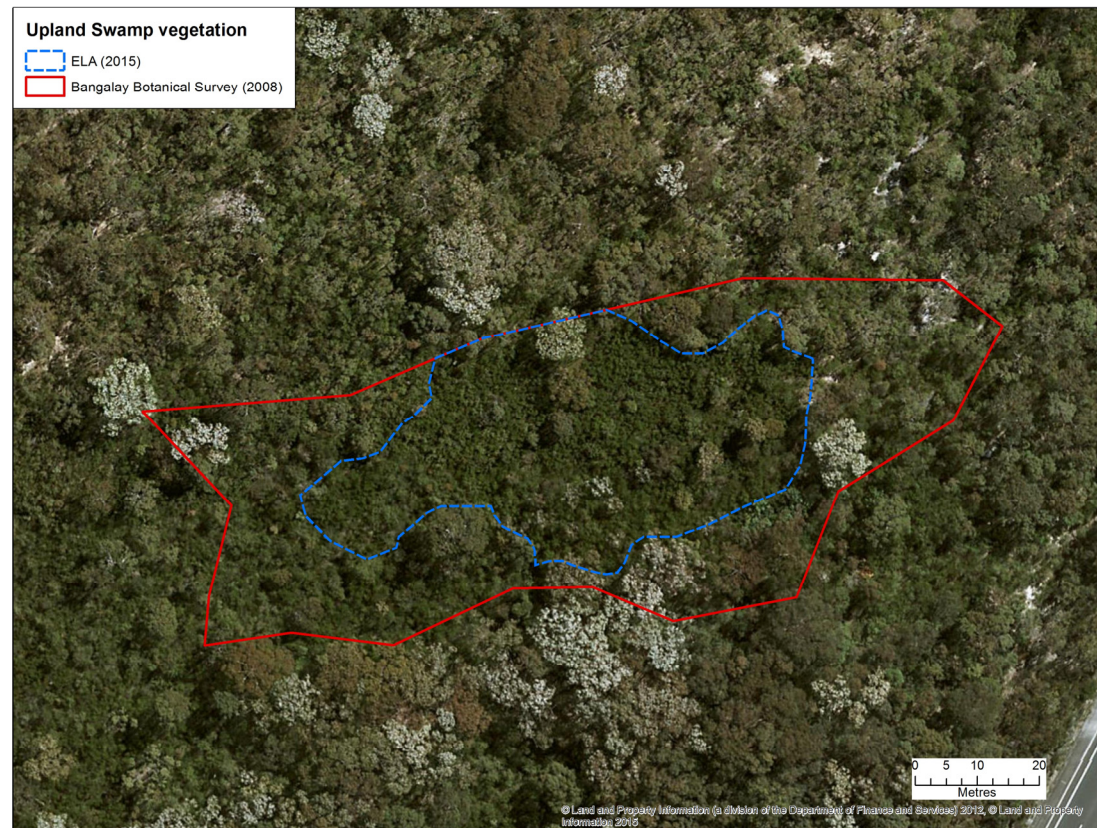
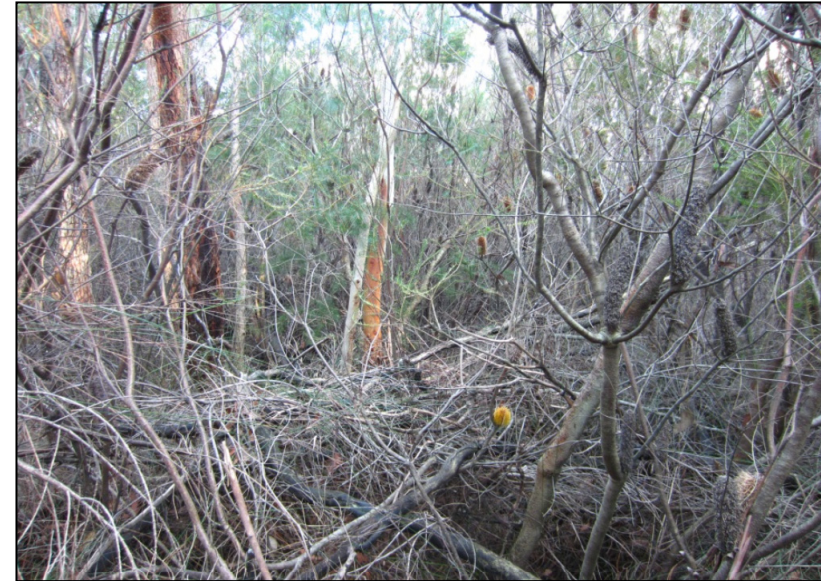
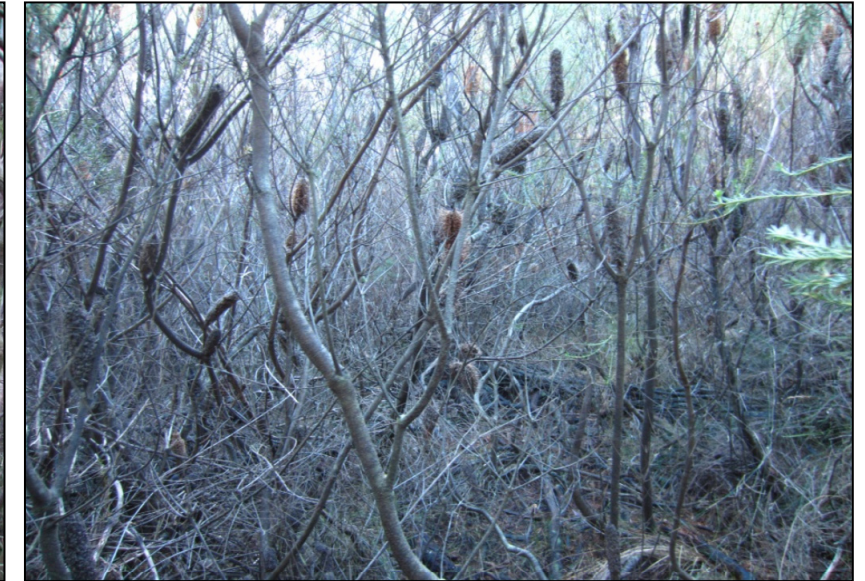
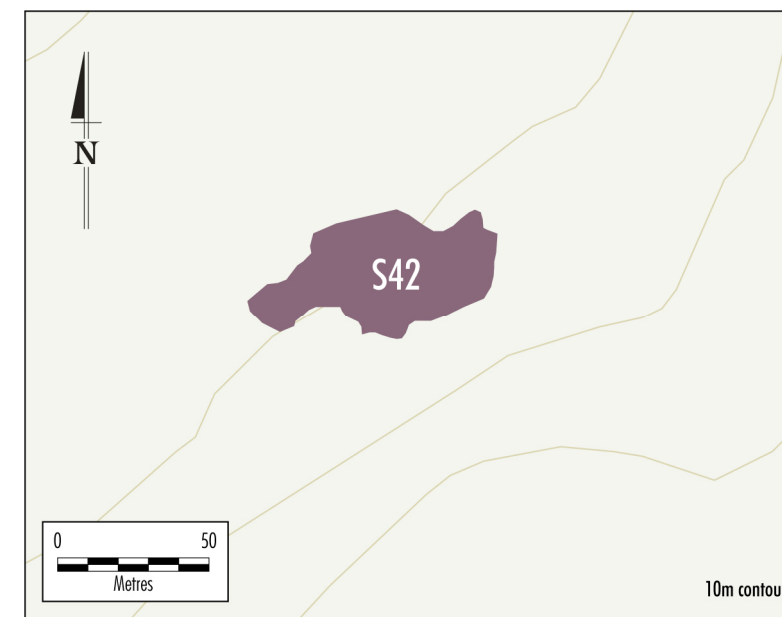
- Swamp 42 is a valley side swamp located within the 35° angle of draw and/or predicted 20 mm subsidence contour.
- This swamp was previously mapped as Sedgeland-heath Complex (Bangalay Botanical Surveys 2008).

- Field inspections undertaken as part of this report identified Banksia Thicket as occurring across the swamp. Additionally some revisions to the swamp boundary were made based upon field inspections and aerial photography interpretation (Swamp 42 is approximately 0.2 hectares in area).

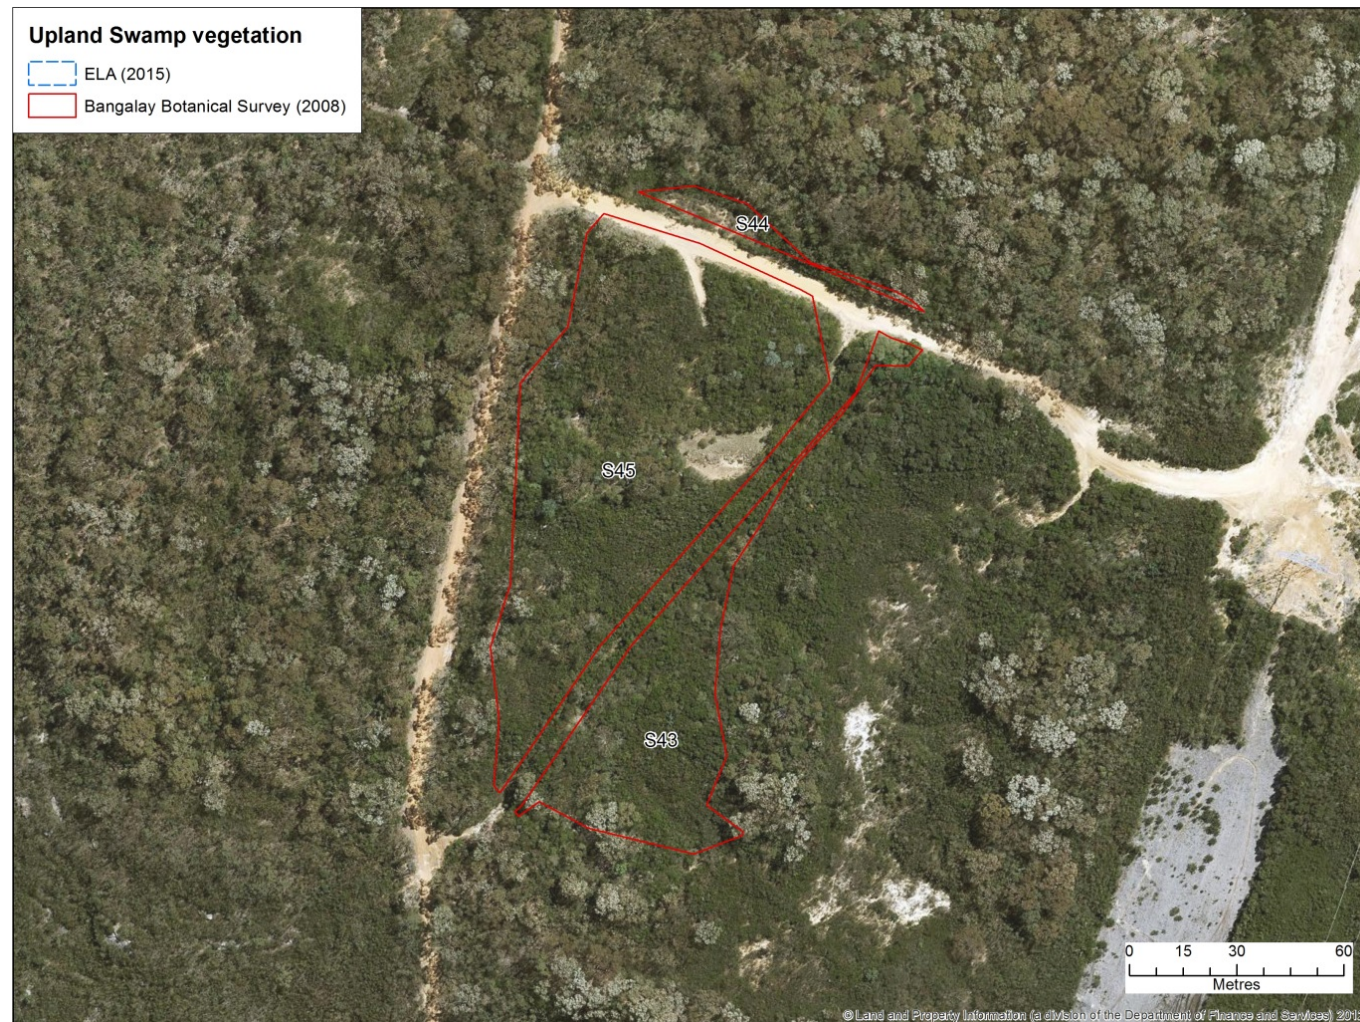
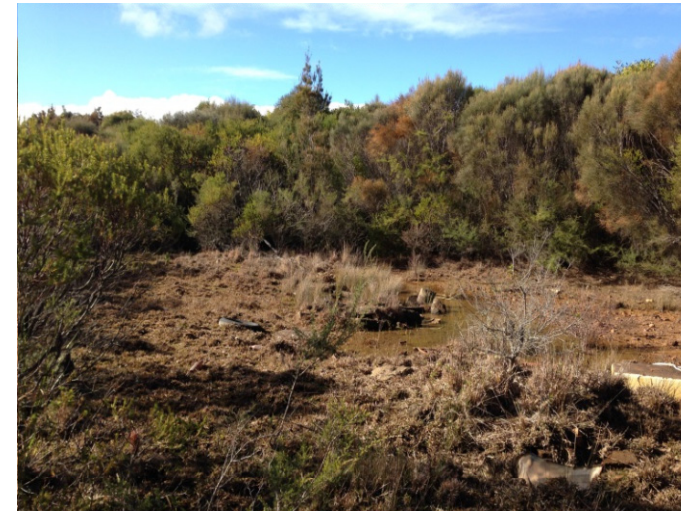
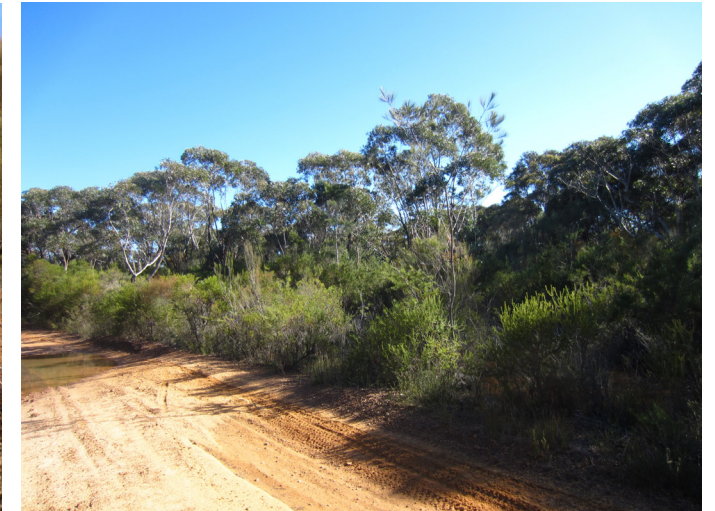
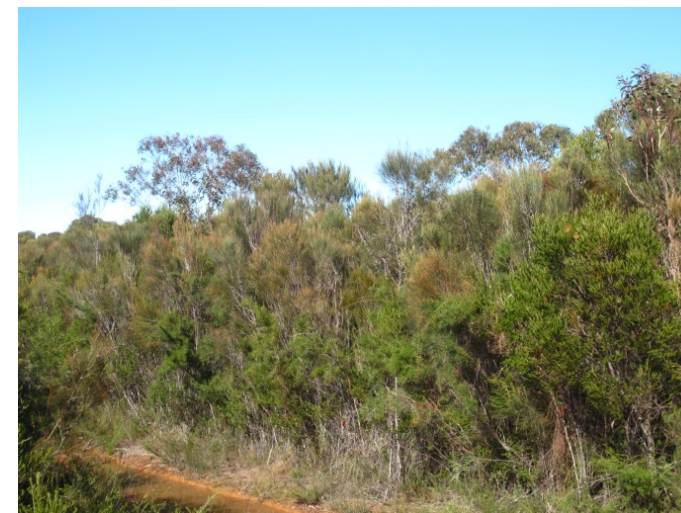
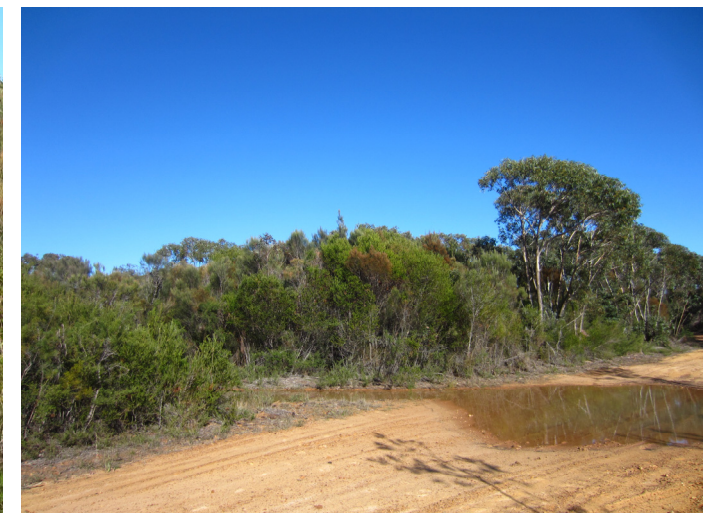
- Swamps 43, 44 and 45 are located on the top of a broad ridge overlying Longwall 301 with ironstone outcropping common.
- These swamps were all previously mapped as Sedgeland-heath Complex (Bangalay Botanical Surveys 2008).

- Field inspections undertaken as part of this report identified dense regrowth of previously cleared Silvertop Ash Ironstone Woodland (consistent with the 'Disturbed and/or Regenerating Sandstone or Lateritic Communities' vegetation community of Bangalay Botanical Surveys [2008]) across the mapped extent of these swamps.
