METROPOLITAN COAL LONGWALLS 301-303

BIODIVERSITY MANAGEMENT PLAN

November 2016

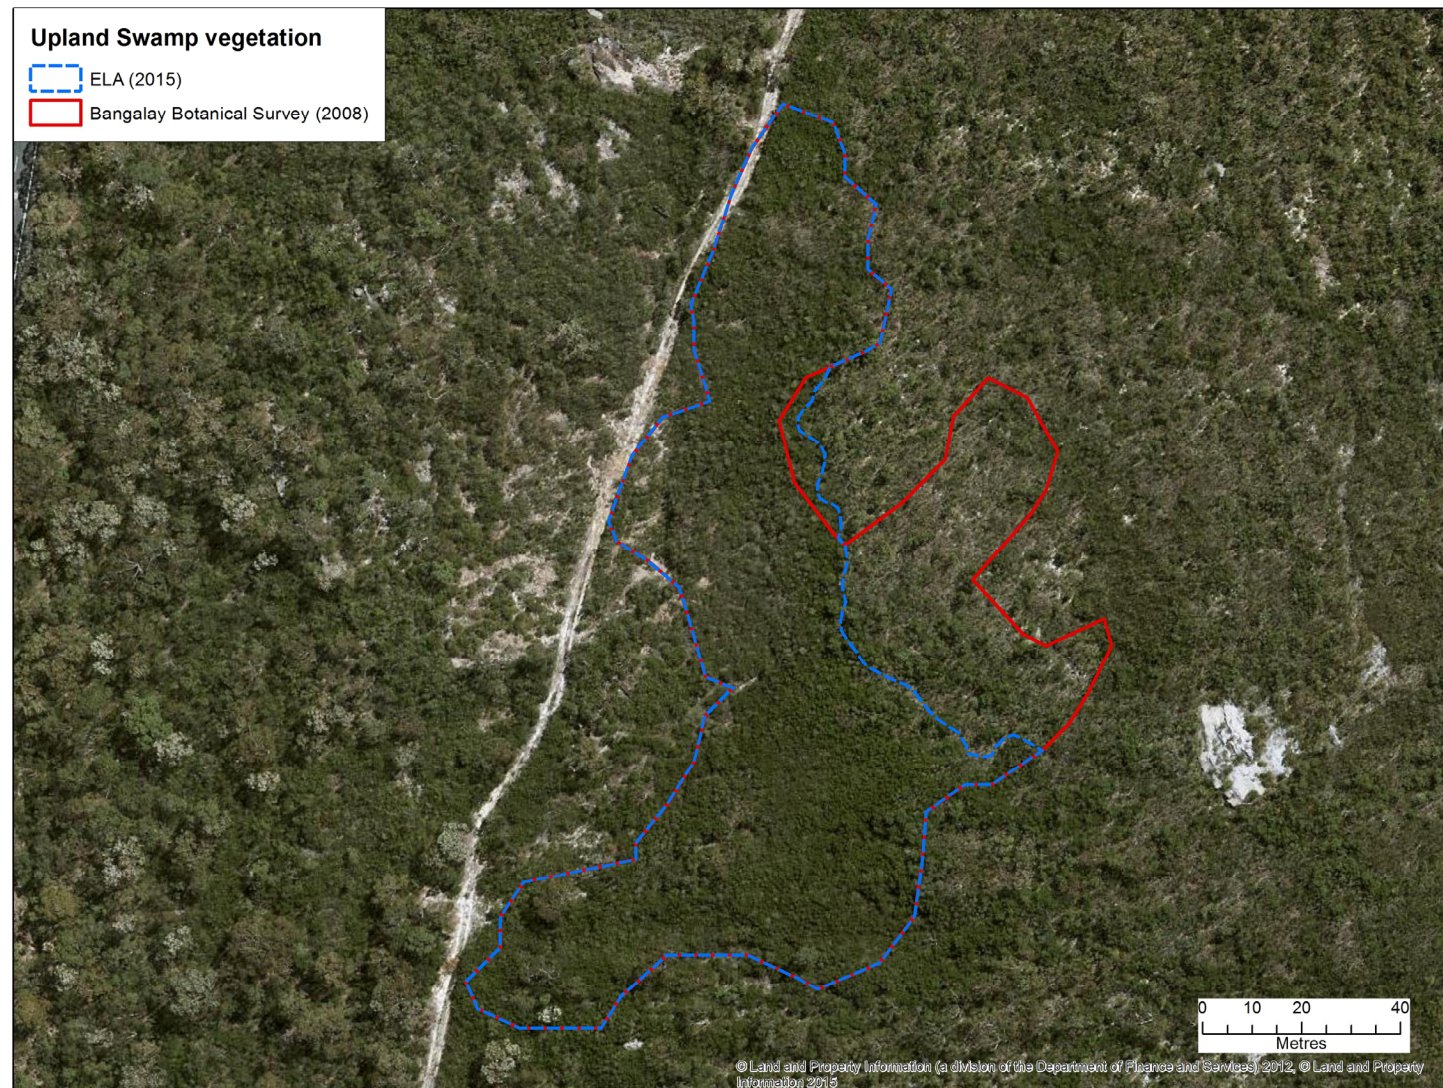
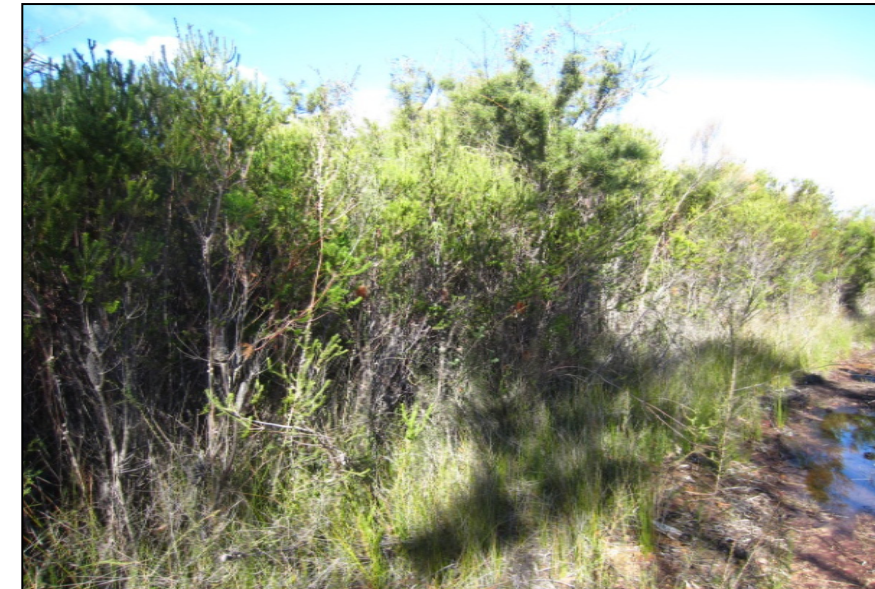
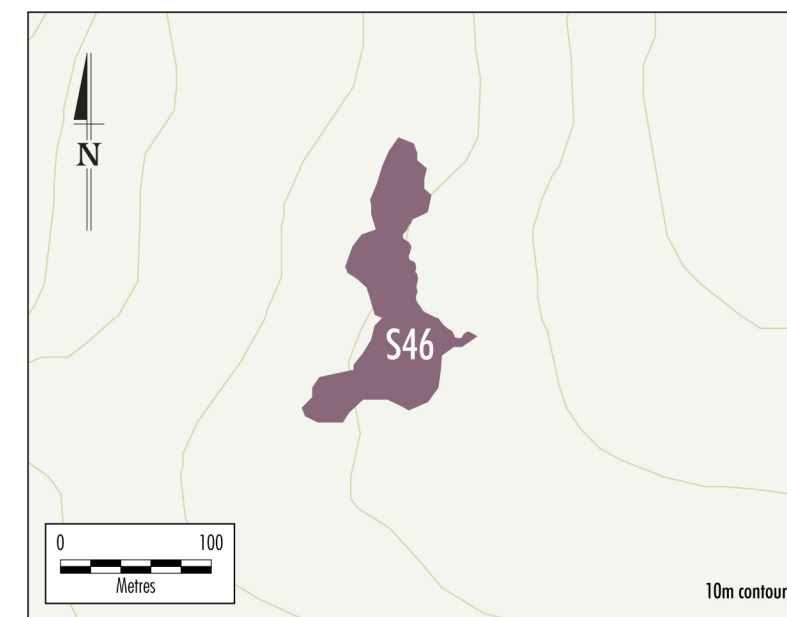
- Swamp 46 is a linear valley side swamp located over the chain pillar separating Longwalls 302 and 303.
- This swamp was previously mapped as Sedgeland-heath Complex (Bangalay Botanical Surveys 2008).

- Field inspections undertaken as part of this report identified Banksia Thicket across the extent of the swamp. Additionally some small revisions were made to the mapping of the boundary of the swamp based upon field inspections and aerial photography interpretation (Swamp 46 is approximately 0.7 hectares in area).

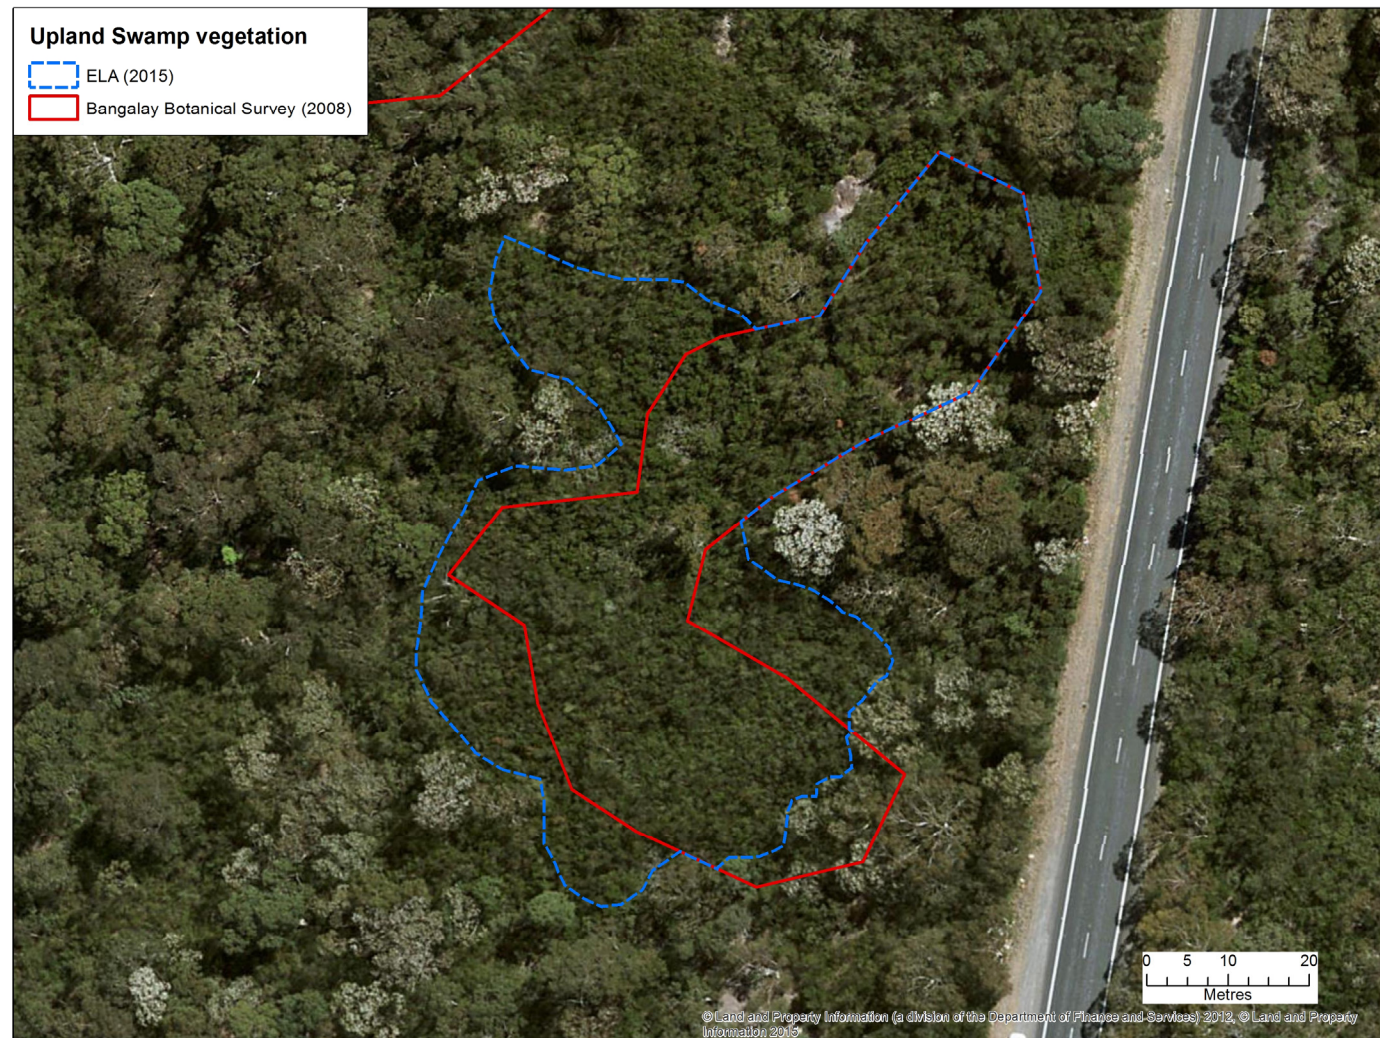
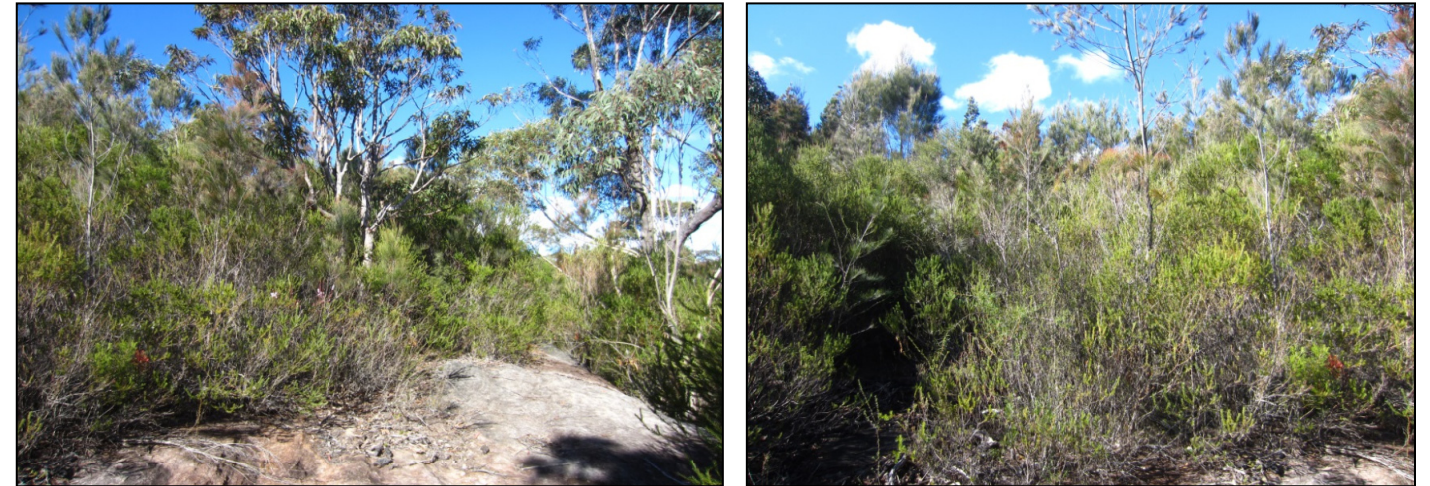
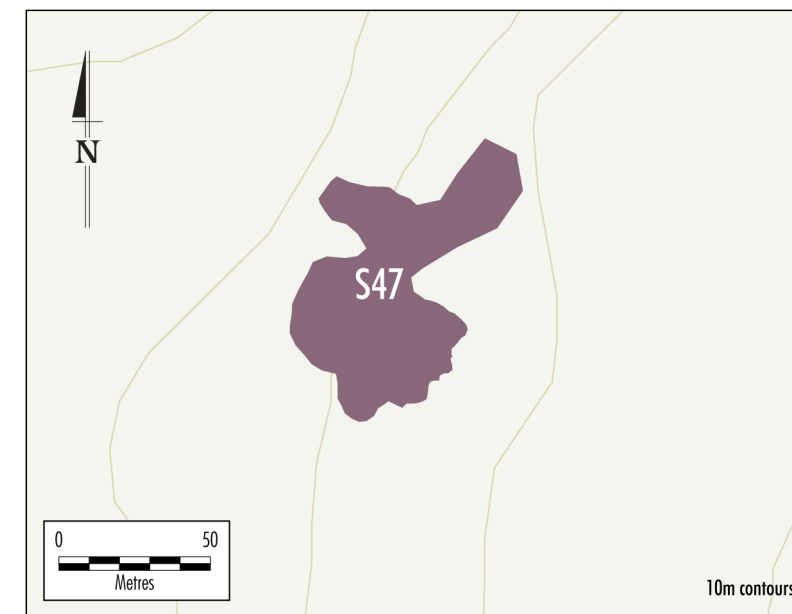
- Swamp 47 is a valley side swamp located over the chain pillar between Longwalls 303 and 304 and within the 35° angle of draw and/or predicted 20 mm subsidence contour of Longwalls 301-303.

- This swamp was previously mapped as Sedgeland-heath Complex (Bangalay Botanical Surveys 2008).
- Field inspections undertaken as part of this report identified Banksia Thicket across the swamp. Additionally some minor revisions to the mapping of the swamp boundary were made based upon field inspections and aerial photography interpretation (Swamp 47 is approximately 0.3 hectares in area).

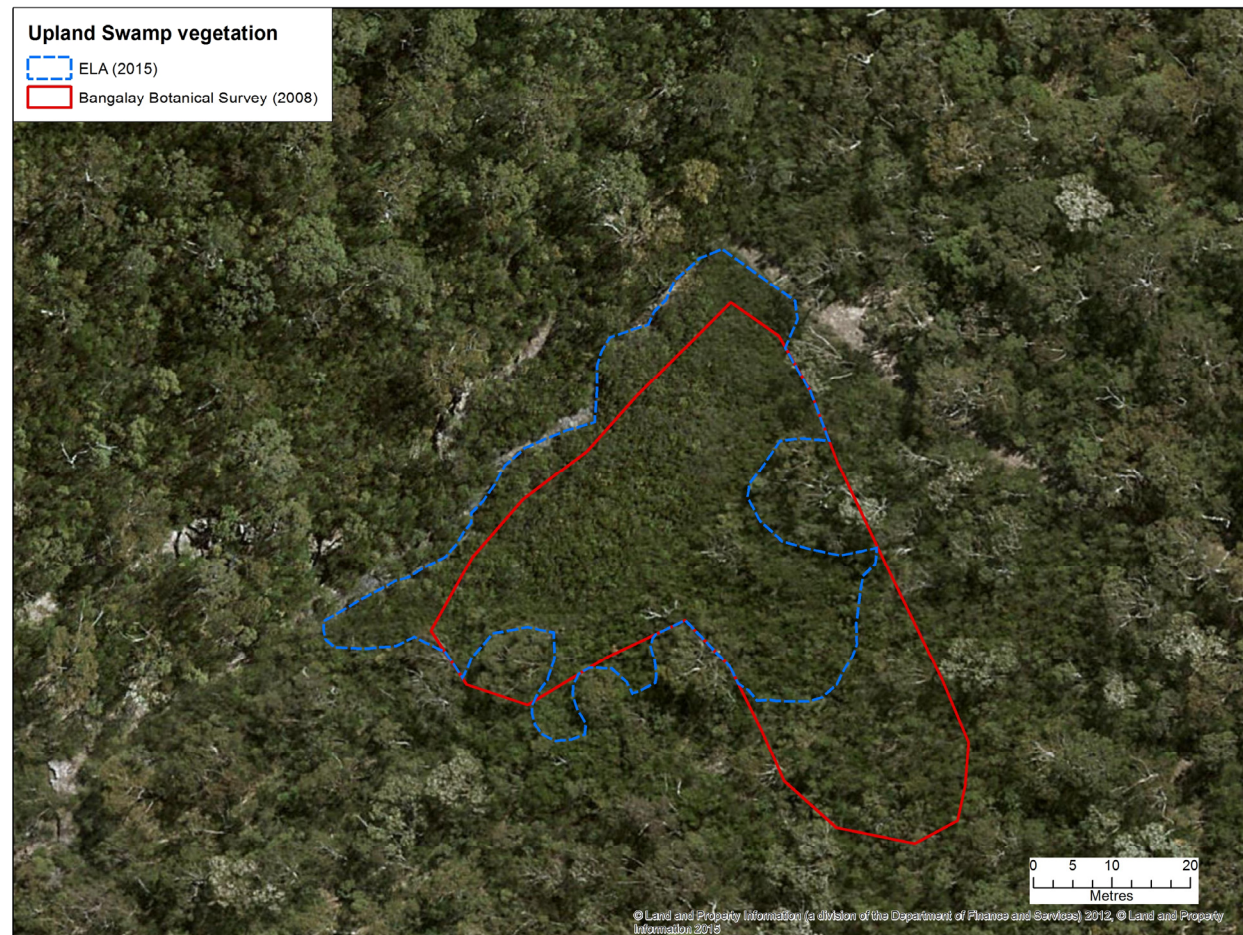
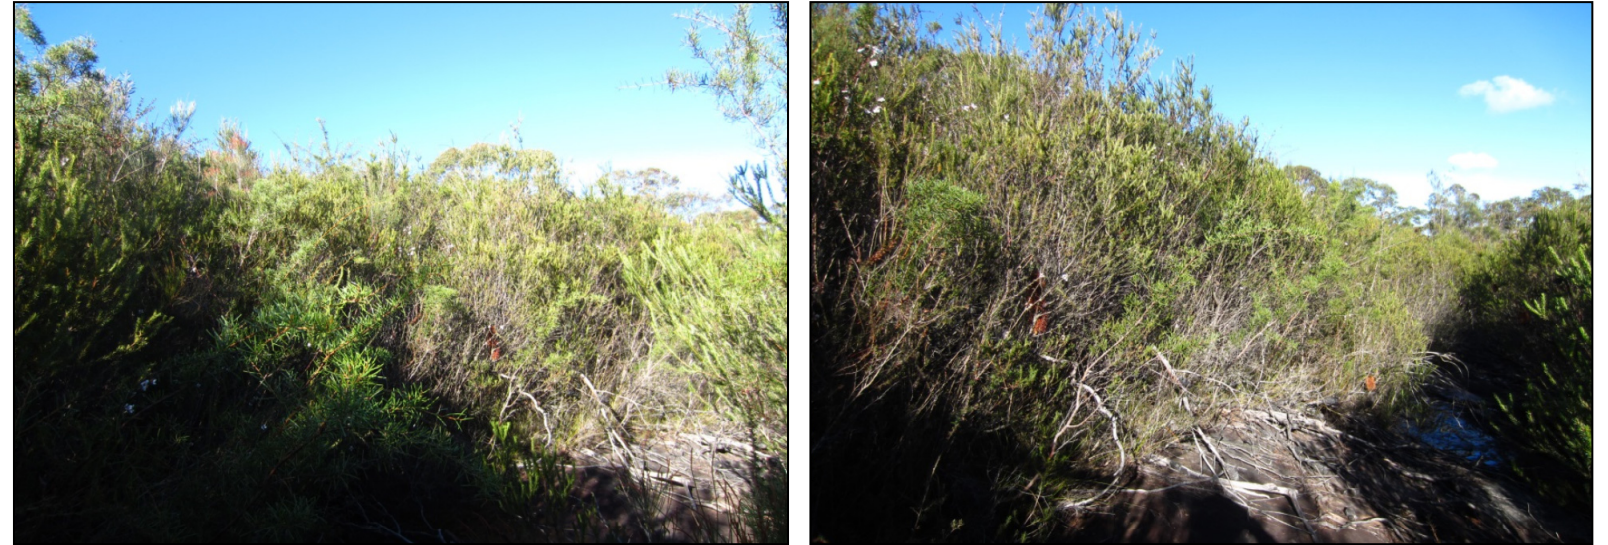
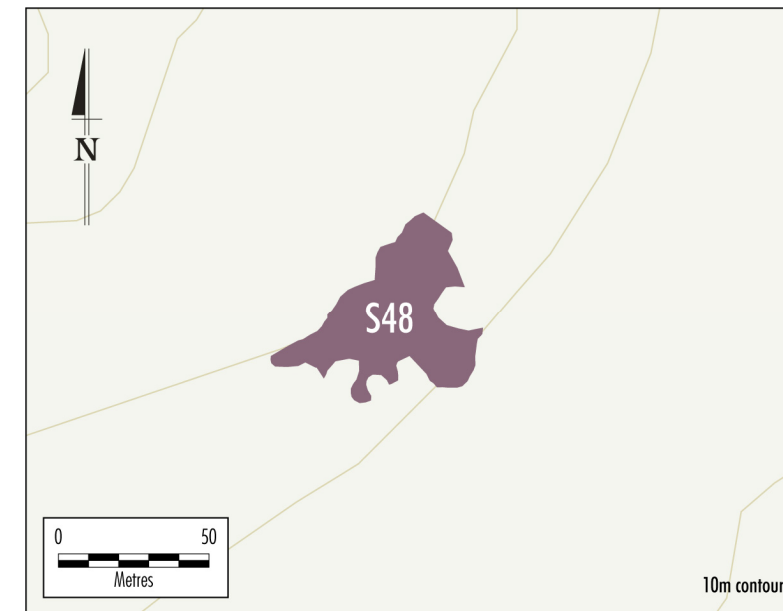
- Swamp 48 is a valley side swamp with well-defined boundaries. It is located within the 35° angle of draw and/or predicted 20 mm subsidence contour of Longwalls 301-303 primarily over Longwall 305.

- This swamp was previously mapped as Sedgeland-heath Complex (Bangalay Botanical Surveys 2008).
- Field inspections undertaken as part of this report identified Banksia Thicket as occurring across the swamp. Additionally some minor revisions to the mapping of the swamp boundary were made based upon field inspections and aerial photography interpretation (Swamp 48 is approximately 0.1 hectares in area).

- In Swamp 47, no swamp indicator species were observed.
- In Swamp 48, indicator species were observed, although they were limited to *Epacris obtusifolia* (>20 individuals) and a single individual of *Pultenaea aristata* (more individuals may subsequently be located). No individuals of *Sprengelia incarnata* were recorded within this swamp.

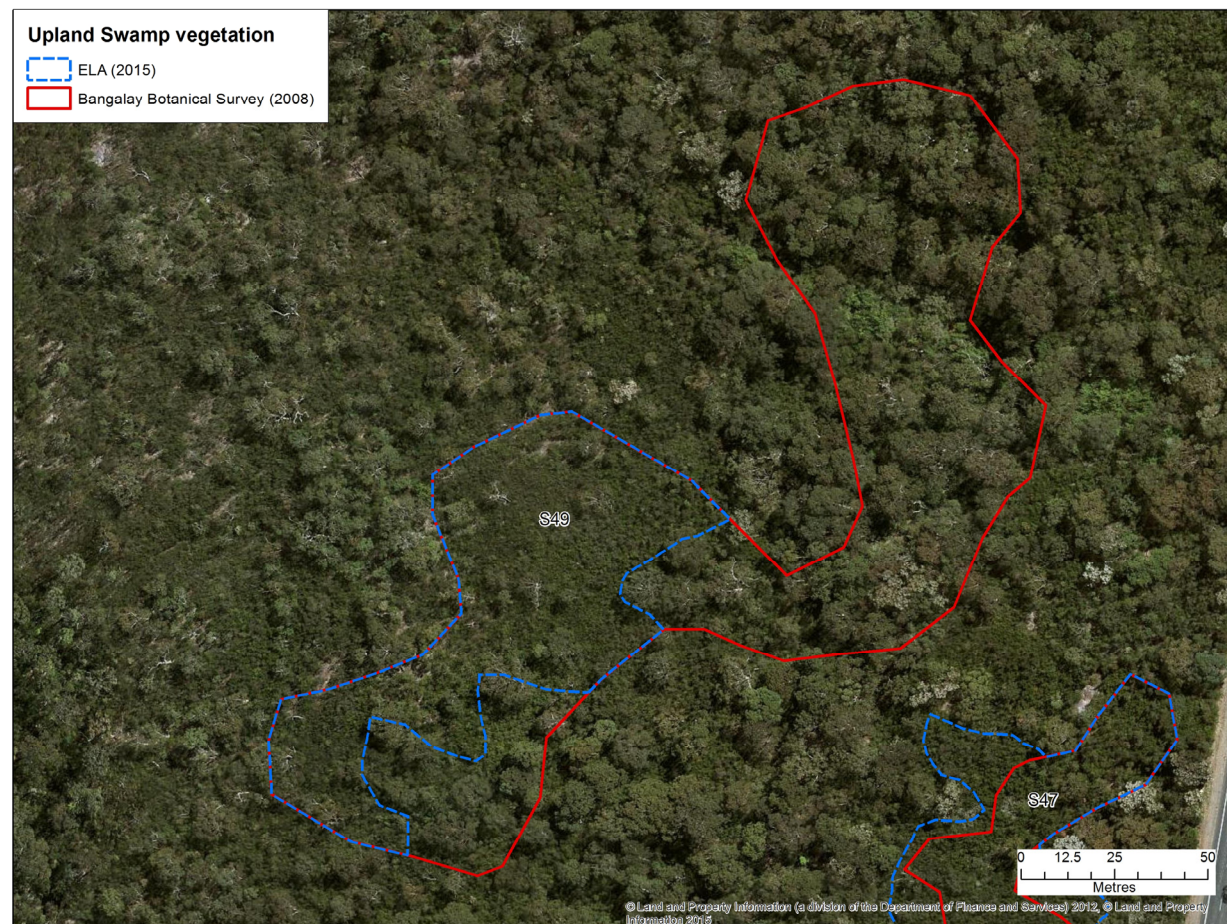
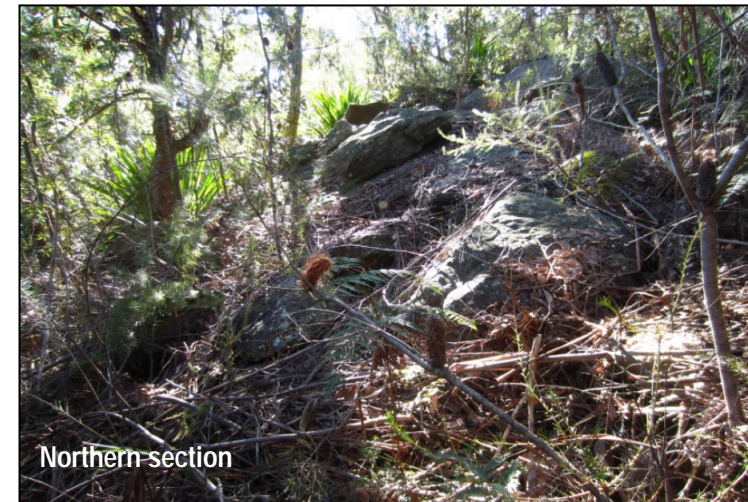
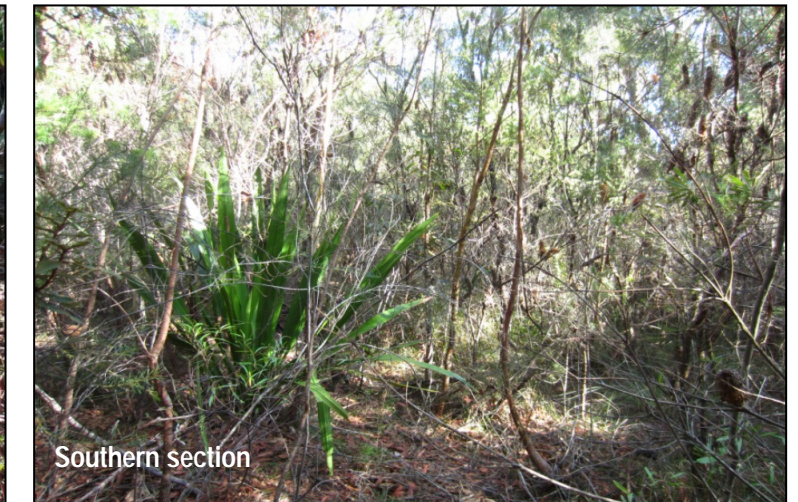
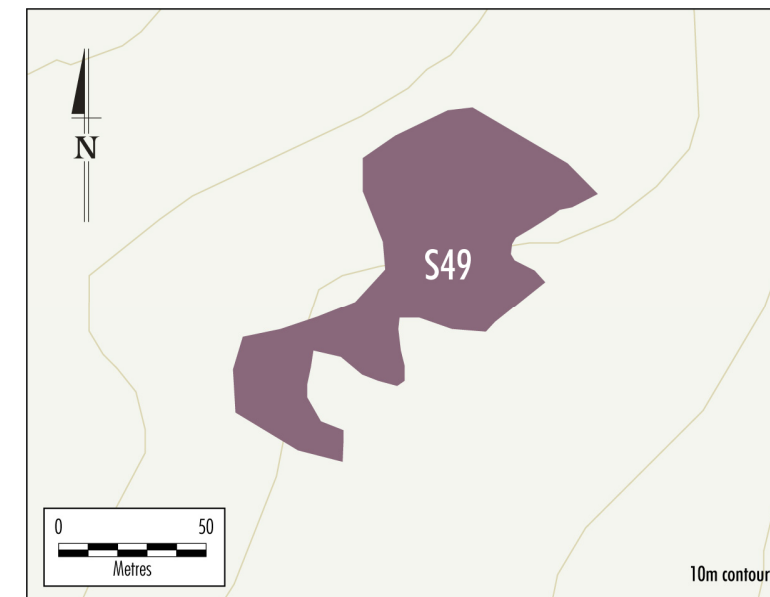
- Swamp 49 is a valley side swamp located within the 35° degree angle of draw and/or predicted 20 mm subsidence contour of Longwalls 301-303 and over the chain pillar between Longwalls 304 and 305.

- This swamp was previously mapped as Sedgeland-heath Complex (Bangalay Botanical Surveys 2008).
- Field inspections undertaken as part of this report identified Banksia Thicket occurring across a small portion of the previously mapped extent of this swamp. The northern portion of the previously mapped extent of this swamp was identified as Sandstone Gully Apple-Peppermint Forest (Swamp 49 is approximately 0.5 hectares in area).

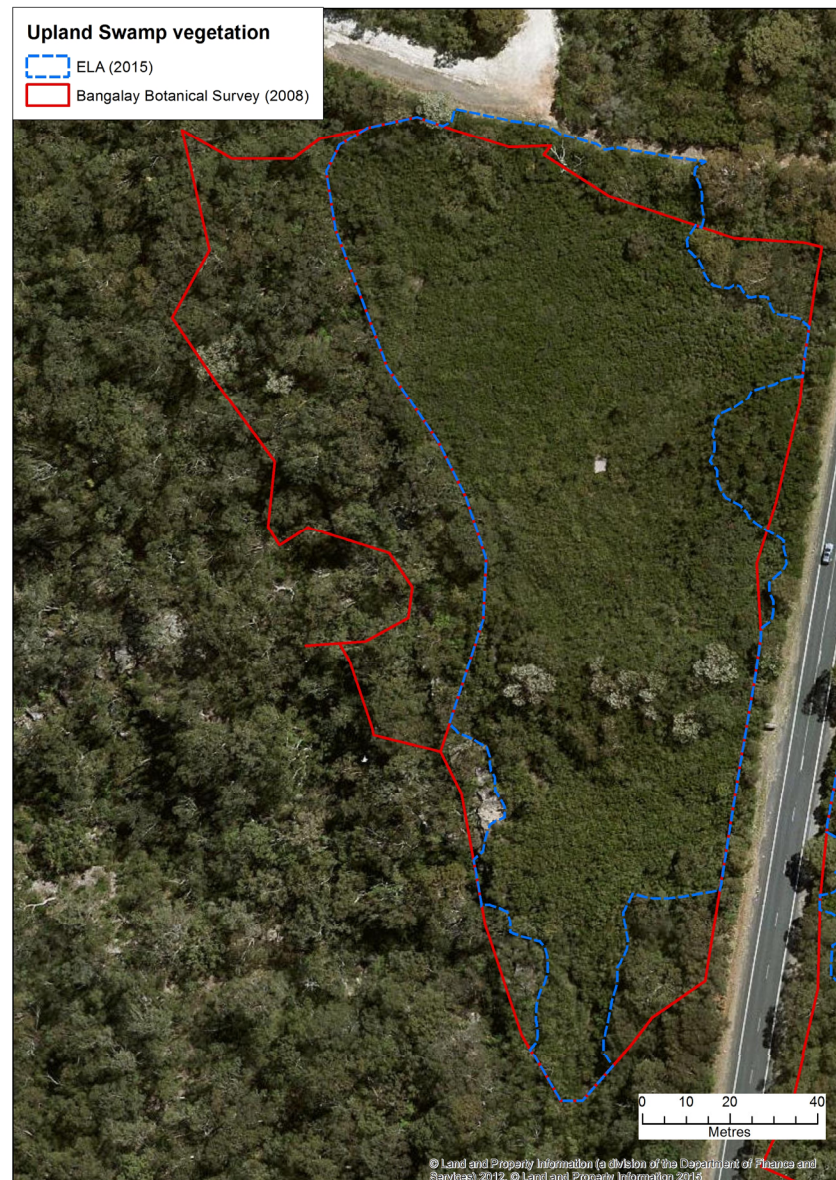
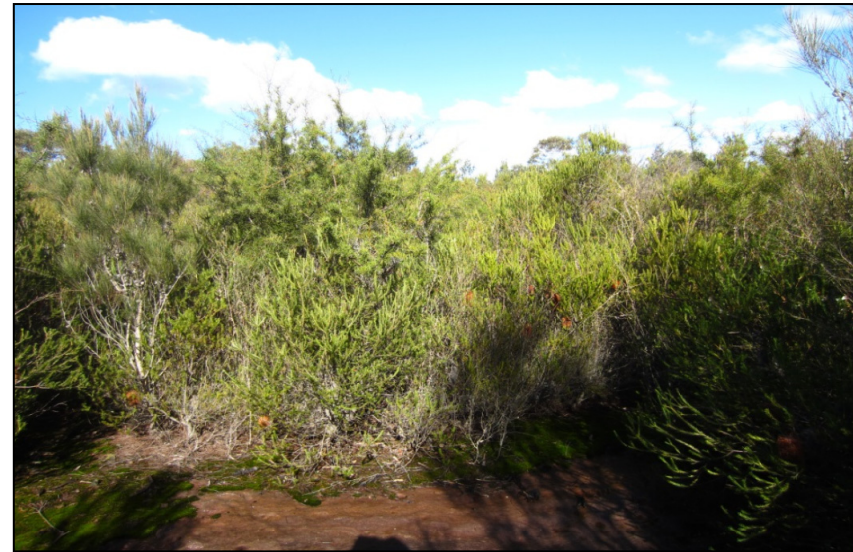
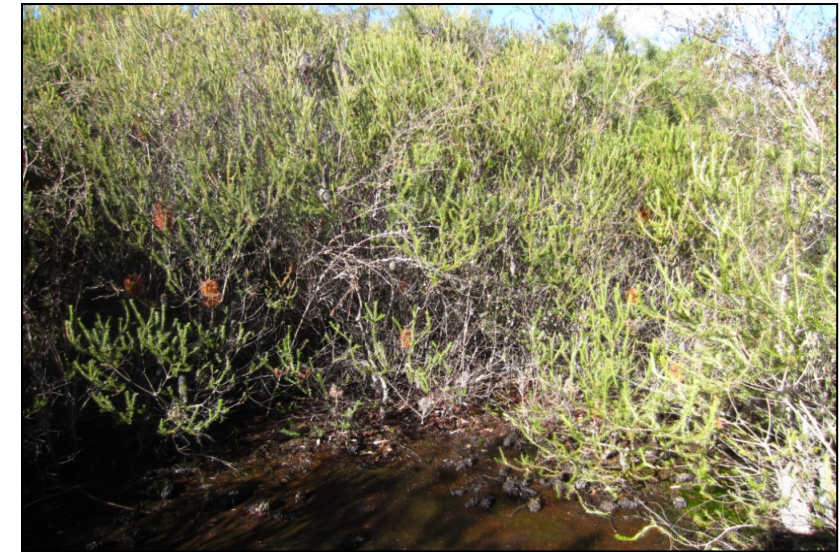
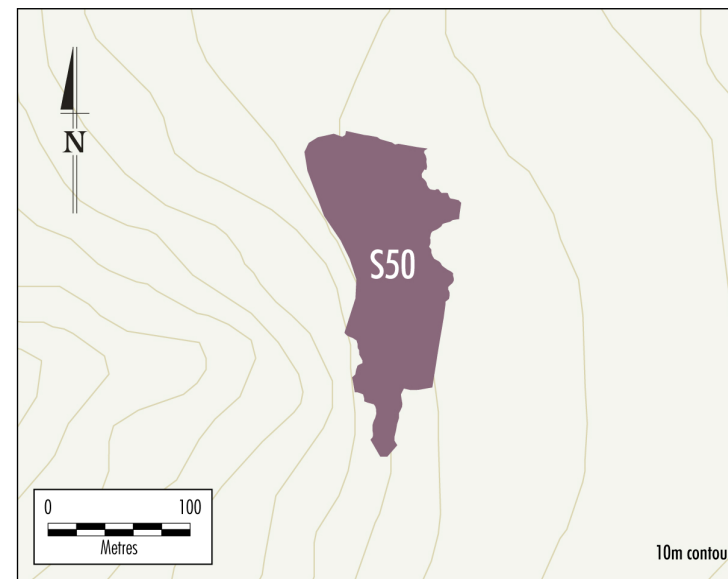
- Swamp 50 is a valley side swamp located within the 35° angle of draw and/or predicted 20 mm subsidence contour for Longwalls 301-303, over Longwall 304, and the chain pillar between Longwalls 304 and 305.

- This swamp was previously mapped as Sedgeland-heath Complex with a small area of Banksia Thicket in the central portions of the swamp and Fringing Eucalypt Woodland along the western edge of the swamp (Bangalay Botanical Surveys 2008).

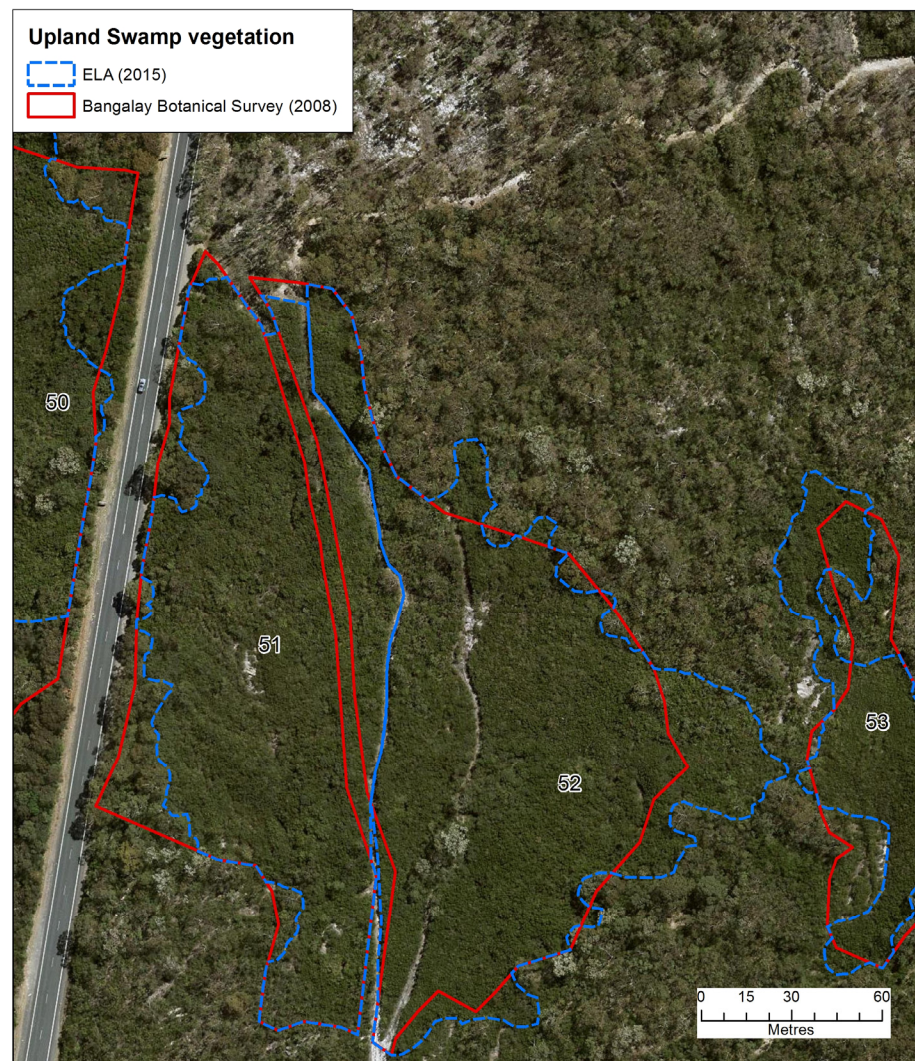
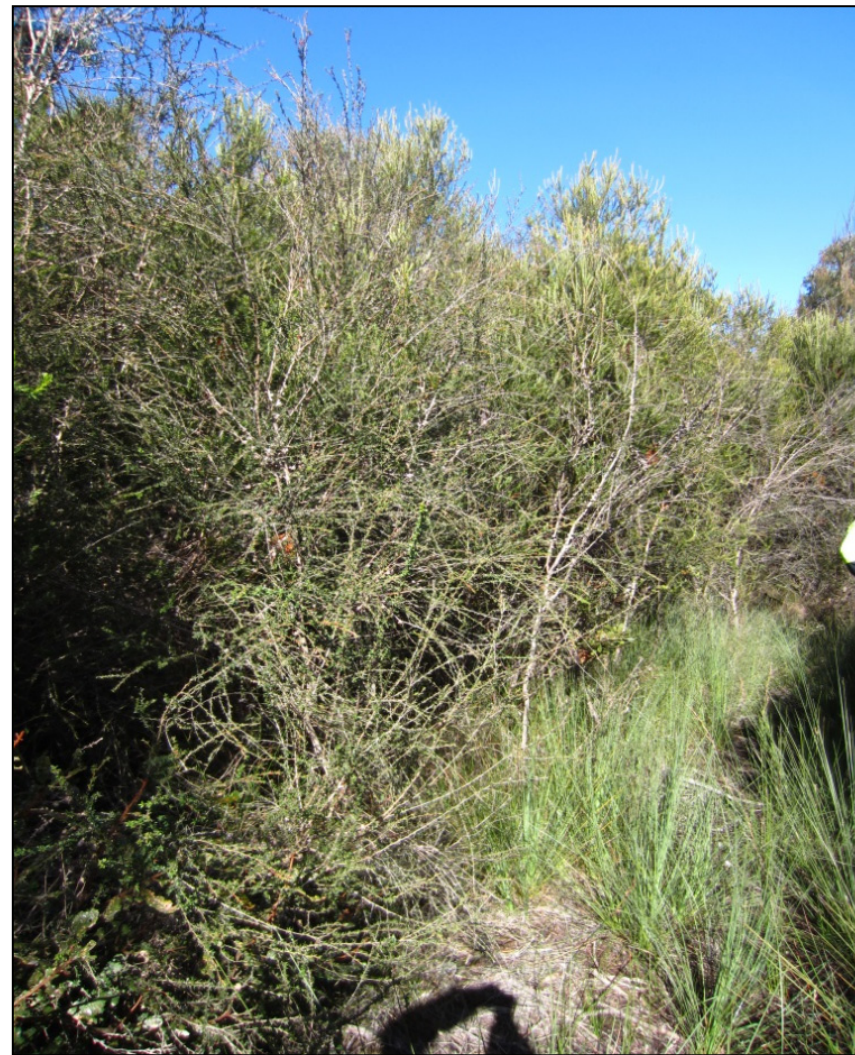
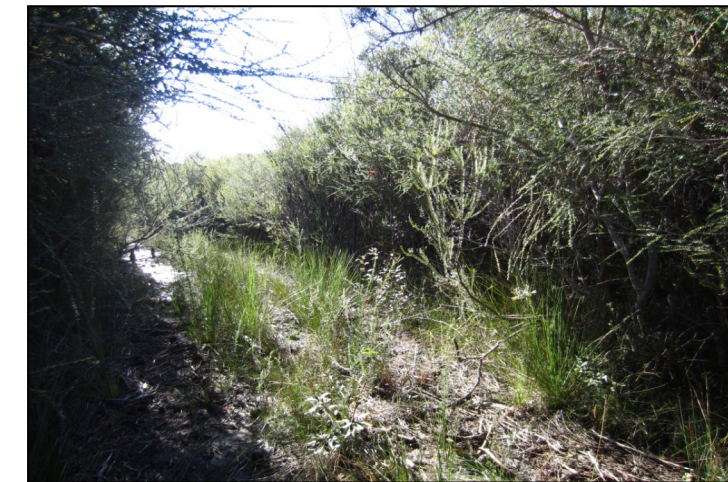
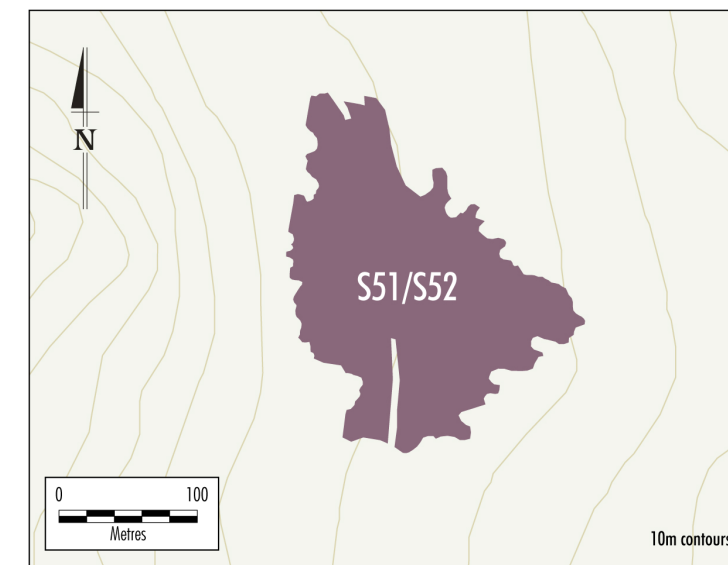
Swamps 51/52

- Swamps 51 and 52 are two valley side swamps located over Longwall 303, the chain pillar between Longwalls 303 and 304 and over Longwall 304 (within the 35° angle of draw and/or predicted 20 mm subsidence contour for Longwalls 301-303).

- Swamps 51 and 52 were previously mapped as Sedgeland-heath Complex, each with a small central area of Banksia Thicket (Bangalay Botanical Surveys 2008). Previous mapping of Swamps 51 and 52 showed these two swamps as being separated by a large track.

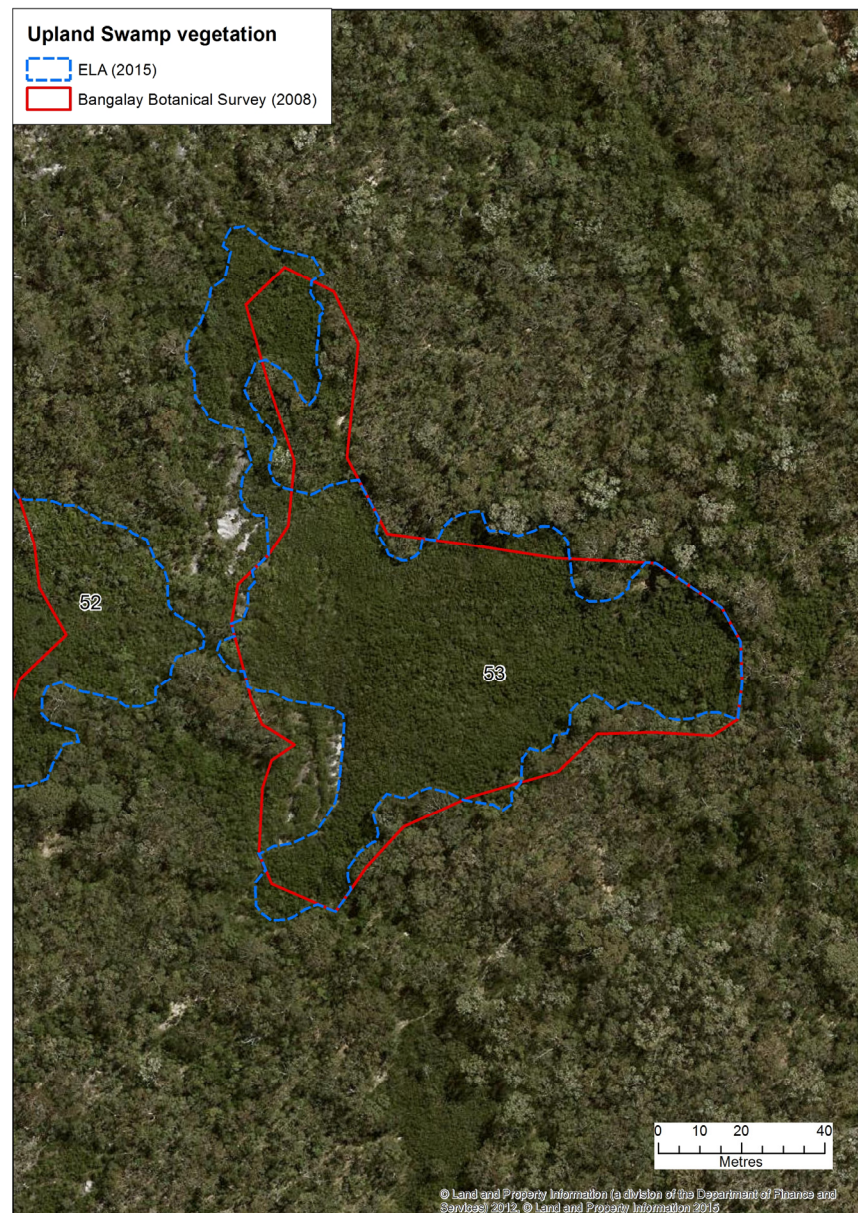
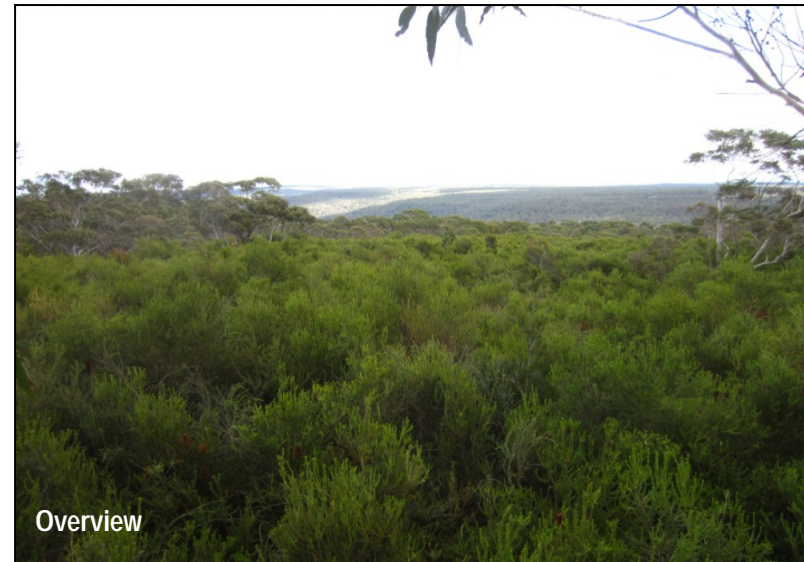
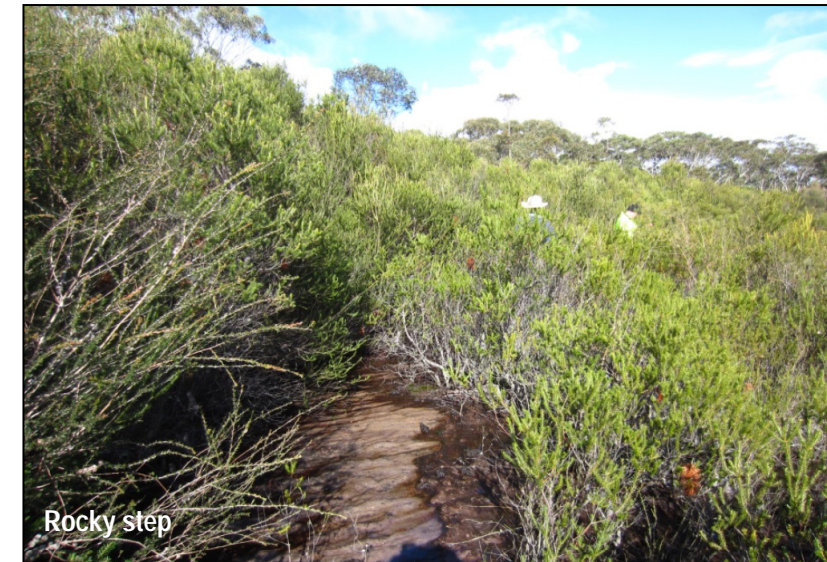
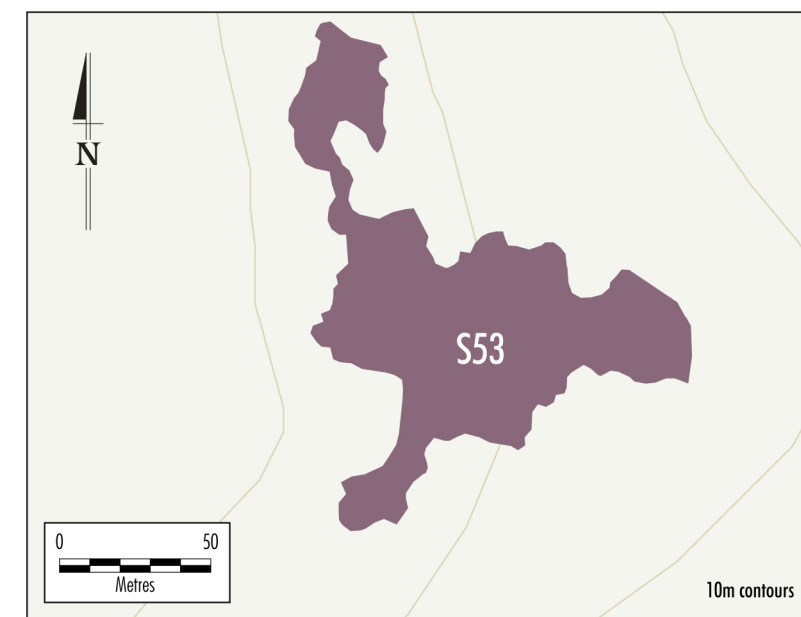
- Swamp 53 is a valley side swamp located over Longwalls 302 and 303, and over the chain pillar between Longwalls 302-303.
- This swamp was previously mapped as Sedgeland-heath Complex with a small area of Banksia Thicket in the centre of the swamp (Bangalay Botanical Surveys 2008).

- Inspections undertaken as part of this report identified Banksia Thicket as occurring across the entire extent of the swamp. Additionally some minor revisions were made to the mapping of the swamp boundary based upon field inspections and aerial photography interpretation (Swamp 53 is approximately 0.7 hectares in area).

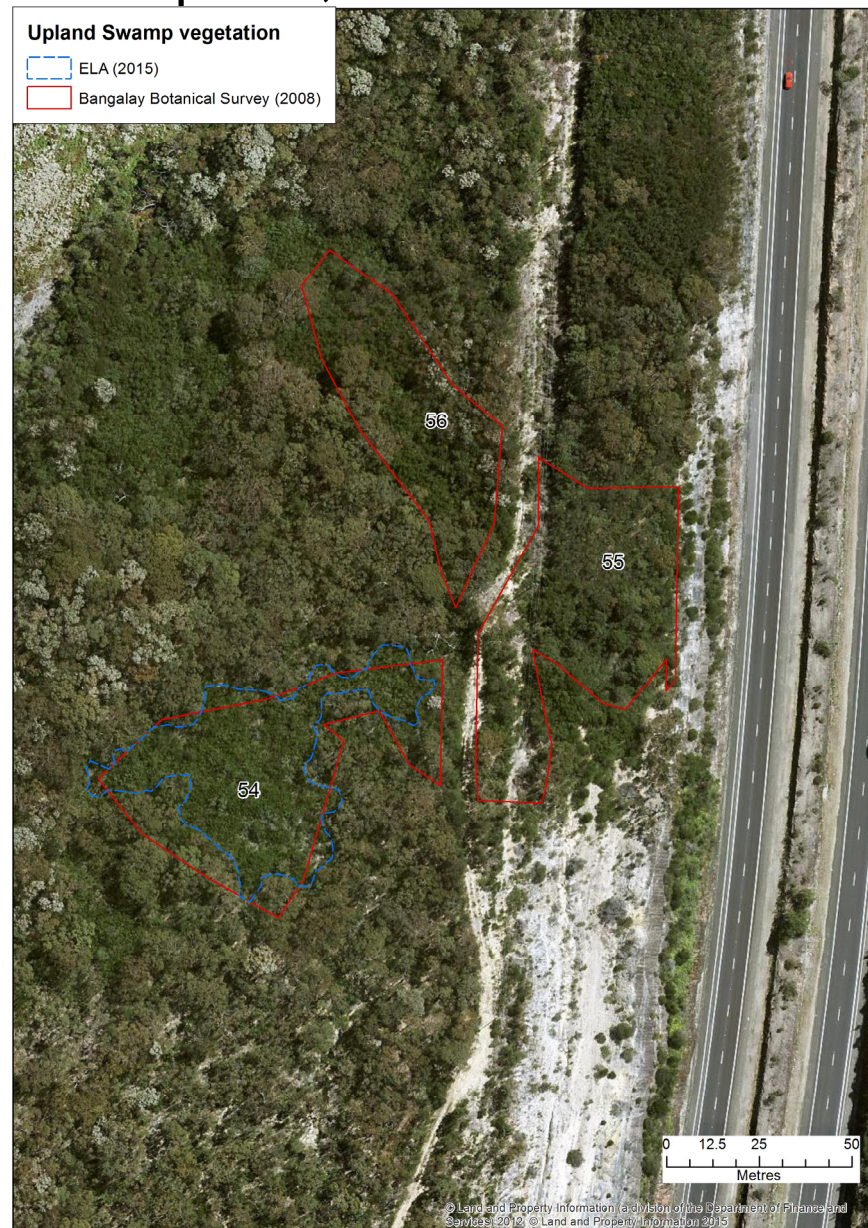
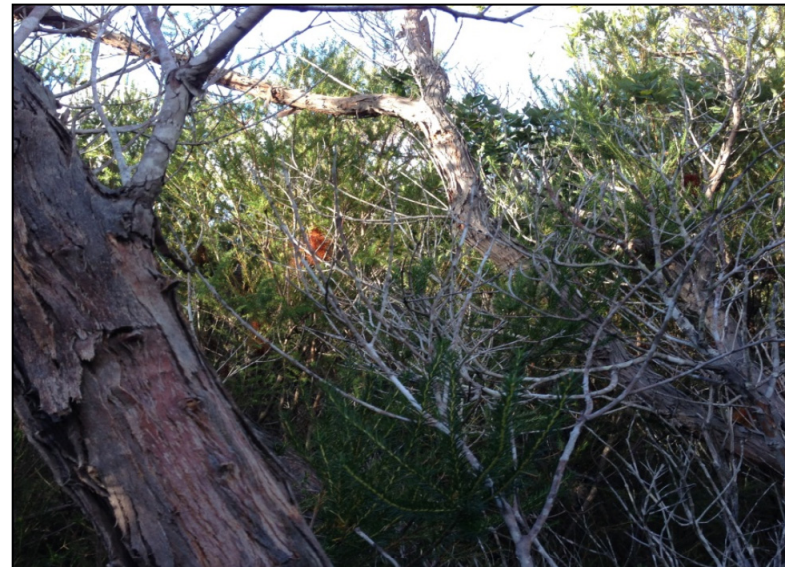
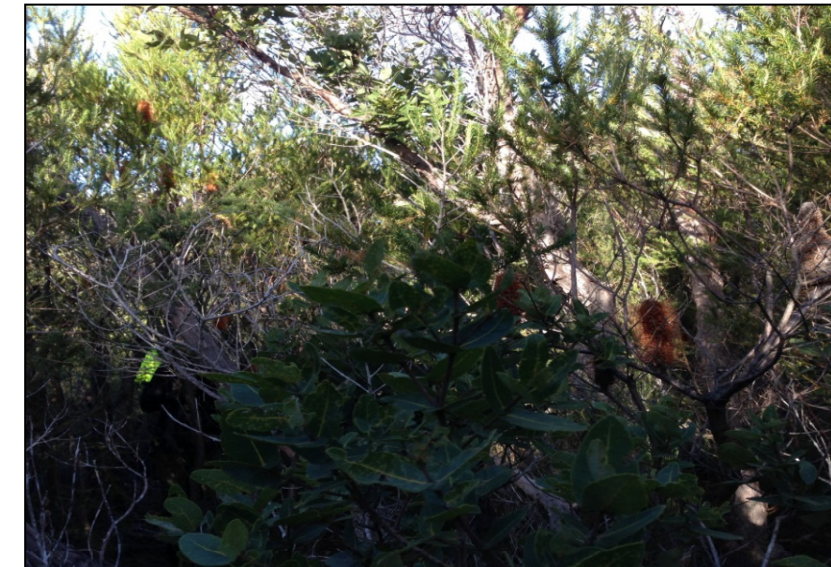
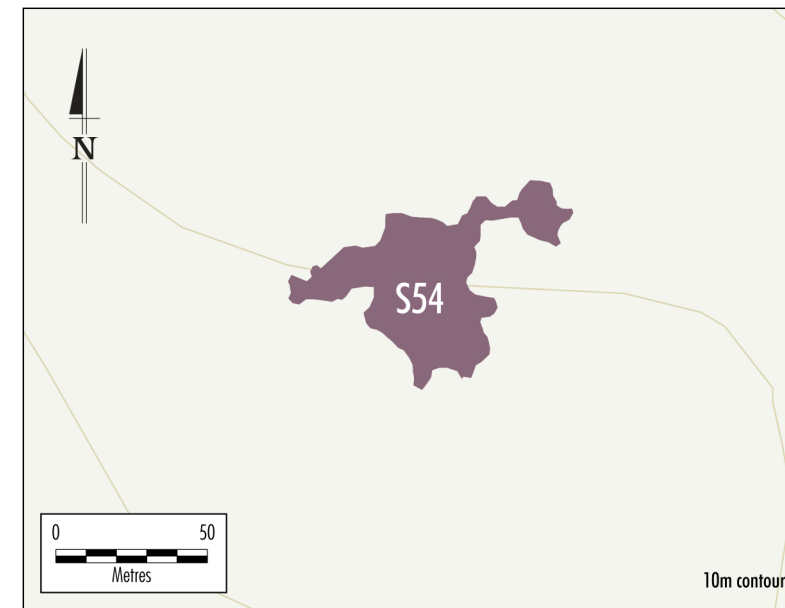
- Swamps 54, 55 and 56 are located on the upper slopes of a broad ridge in proximity to the M1 Princes Motorway and an existing transmission line. They are located to the east of Longwall 301 and within the 35° angle of draw and/or predicted 20 mm subsidence contour for Longwalls 301-303.

- These three swamps were previously mapped as Sedgeland-heath Complex (Bangalay Botanical Surveys 2008).
- Field inspections undertaken as part of this report identified Banksia Thicket (S54), previously slashed vegetation below the transmission line comparable to 'Disturbed and/or Regenerating Sandstone or Lateritic Communities' (S55) of Bangalay Botanical Surveys (2008) and Sandstone Heath-Woodland (S56) occurring across these swamps. That is Swamps 55 and 56 are not swamps. Additionally some minor revisions to the mapping of the boundary of Swamp 54 were made based upon field inspections and aerial photography interpretation. Swamp 54 is approximately 0.2 hectares in area.
