METROPOLITAN COAL LONGWALLS 301-303

BIODIVERSITY MANAGEMENT PLAN

November 2016

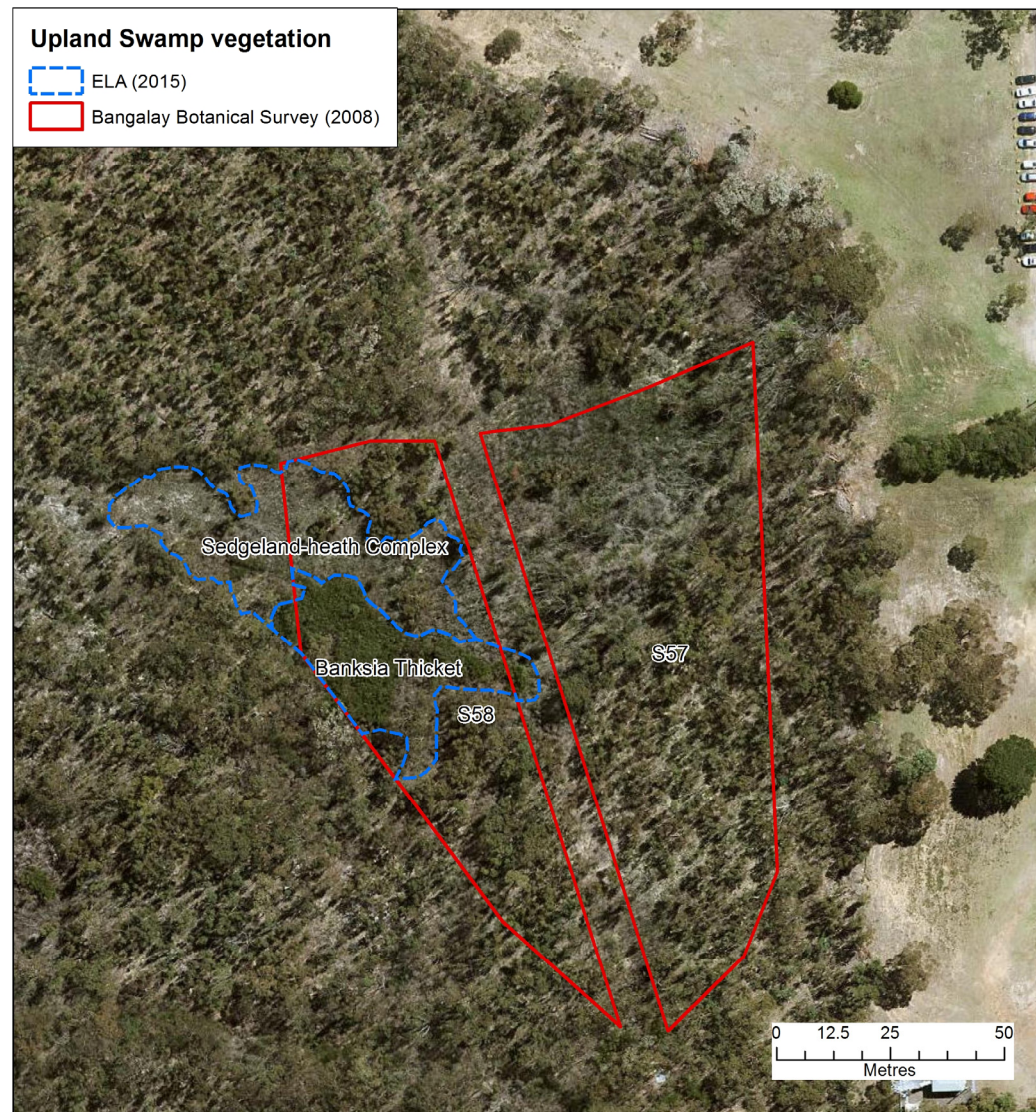
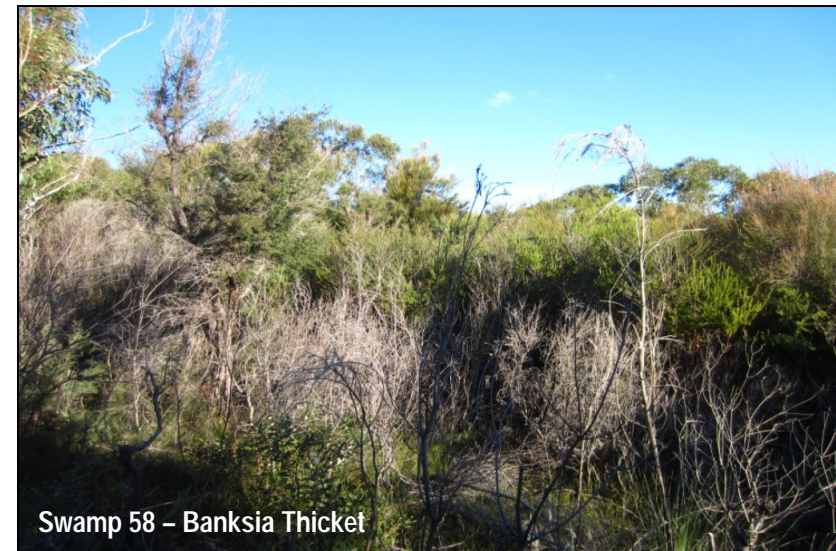
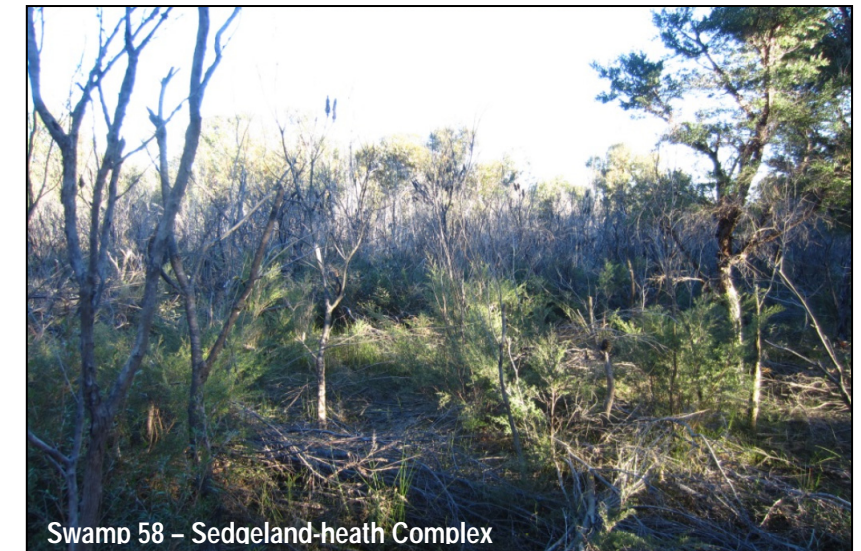
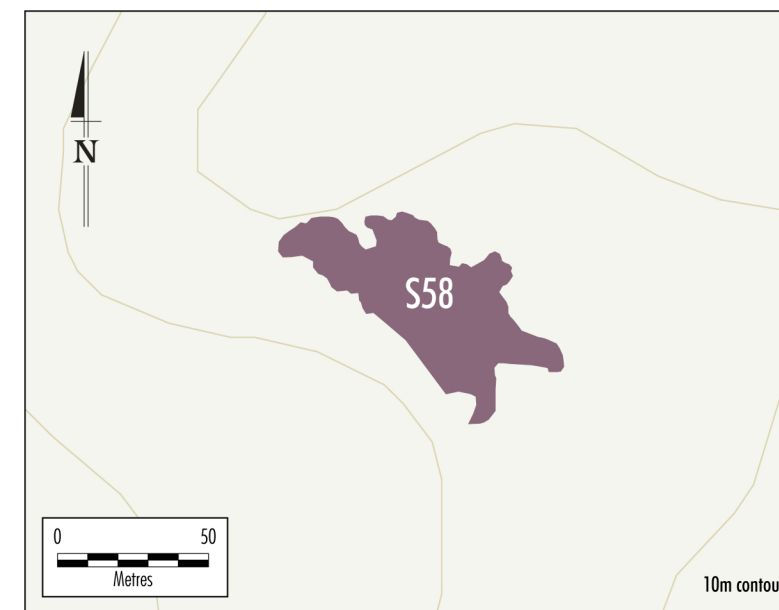
- Swamps 57 and 58 were mapped as two swamps overlying the chain pillar between Longwalls 303 and 304 (Bangalay Botanical Surveys 2008).
- These areas were previously mapped as Sedgeland-heath Complex (Bangalay Botanical Surveys 2008).

- Inspections undertaken as part of this report identified Exposed Sandstone Scribbly Gum Woodland (as described by Bangalay Botanical Surveys 2008) occurring across the mapped extent of Swamp 57 and portions of Swamp 58. The extent of Swamp 58 was revised and it supports a combination of Sedgeland-heath Complex and Banksia Thicket. Some minor revisions were made to the mapped boundary of Swamp 58 based upon field inspections and aerial photography interpretation. Swamp 57 is not a swamp.

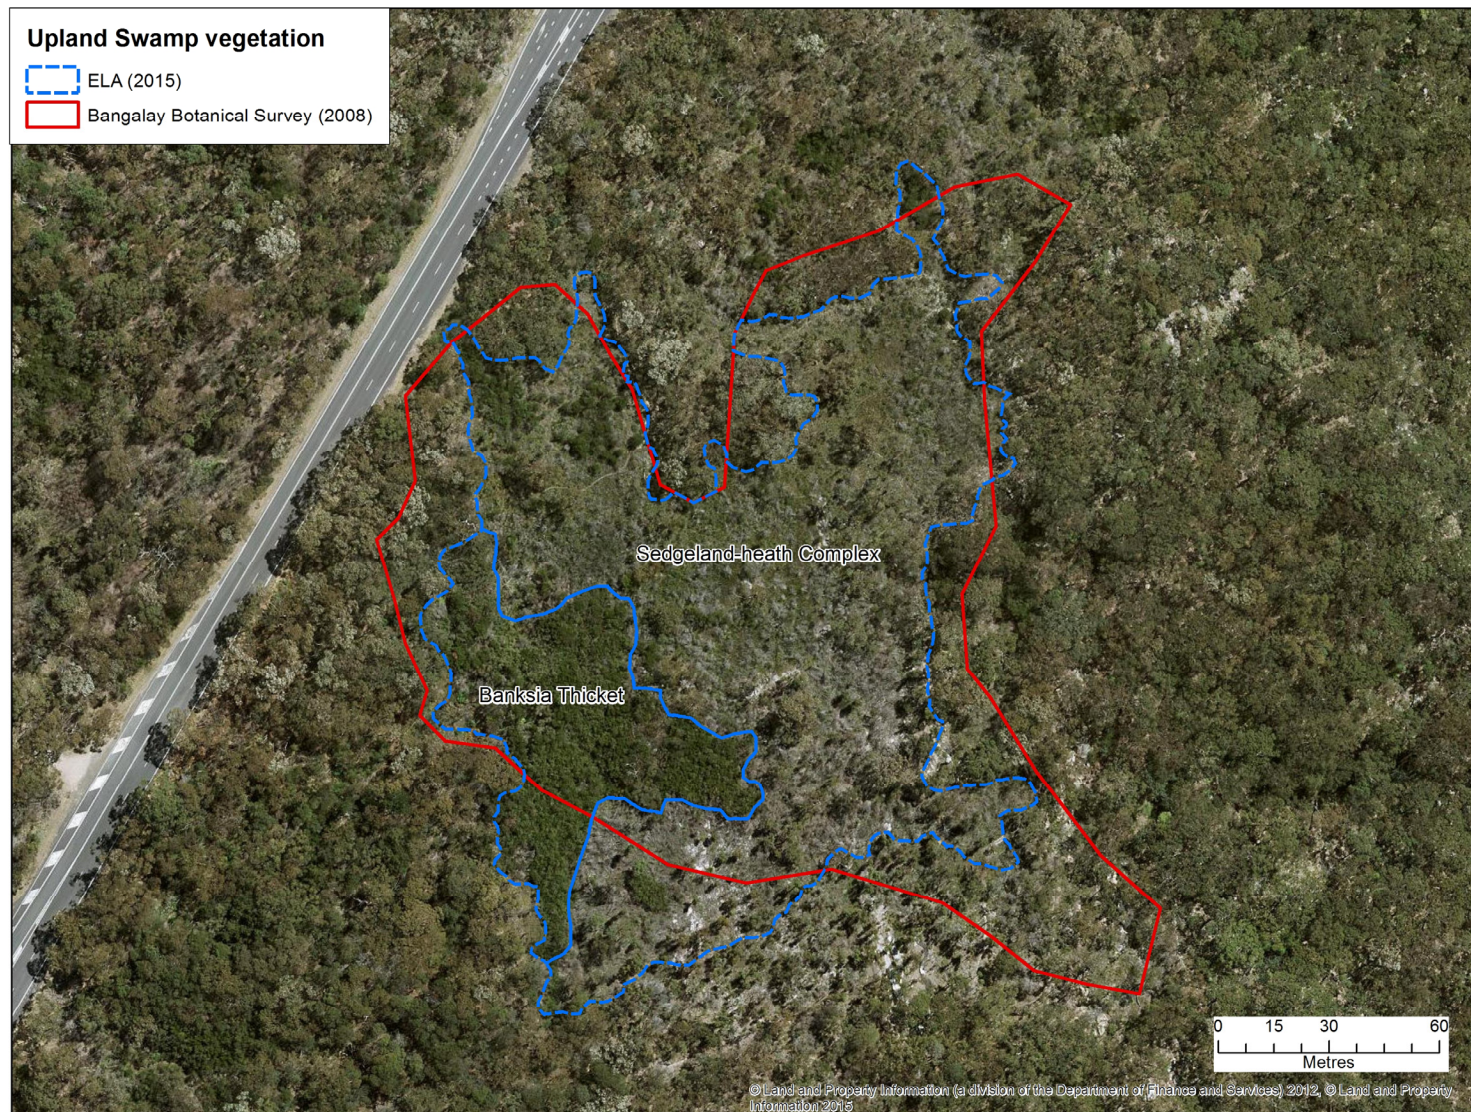
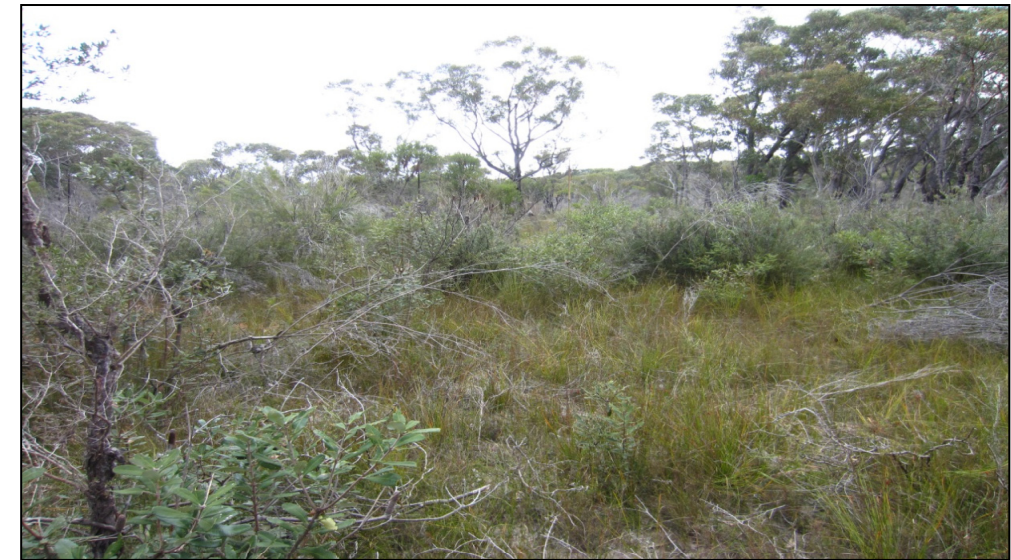
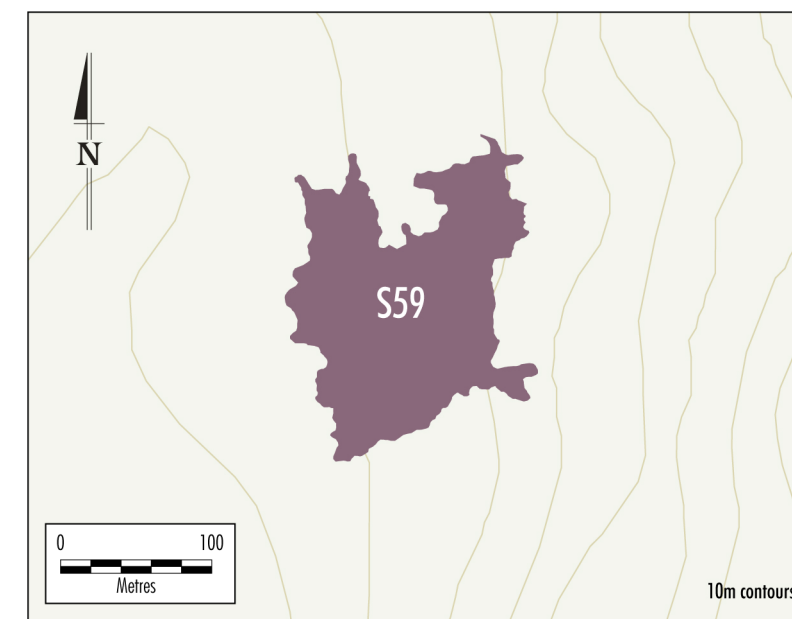
- Swamp 59 is just located within 600 m from Longwalls 301-303 secondary extraction, with portions of the swamp overlying the chain pillar of Longwall 304.

- This swamp was previously mapped as Sedgeland-heath Complex (Bangalay Botanical Surveys 2008).
- Field inspections undertaken as part of this report identified a combination of Banksia Thicket and Sedgeland-heath Complex within this swamp corresponding to areas subjected to a hazard reduction burn within the last two years (Sedgeland-heath Complex) and unburnt areas (Banksia Thicket).

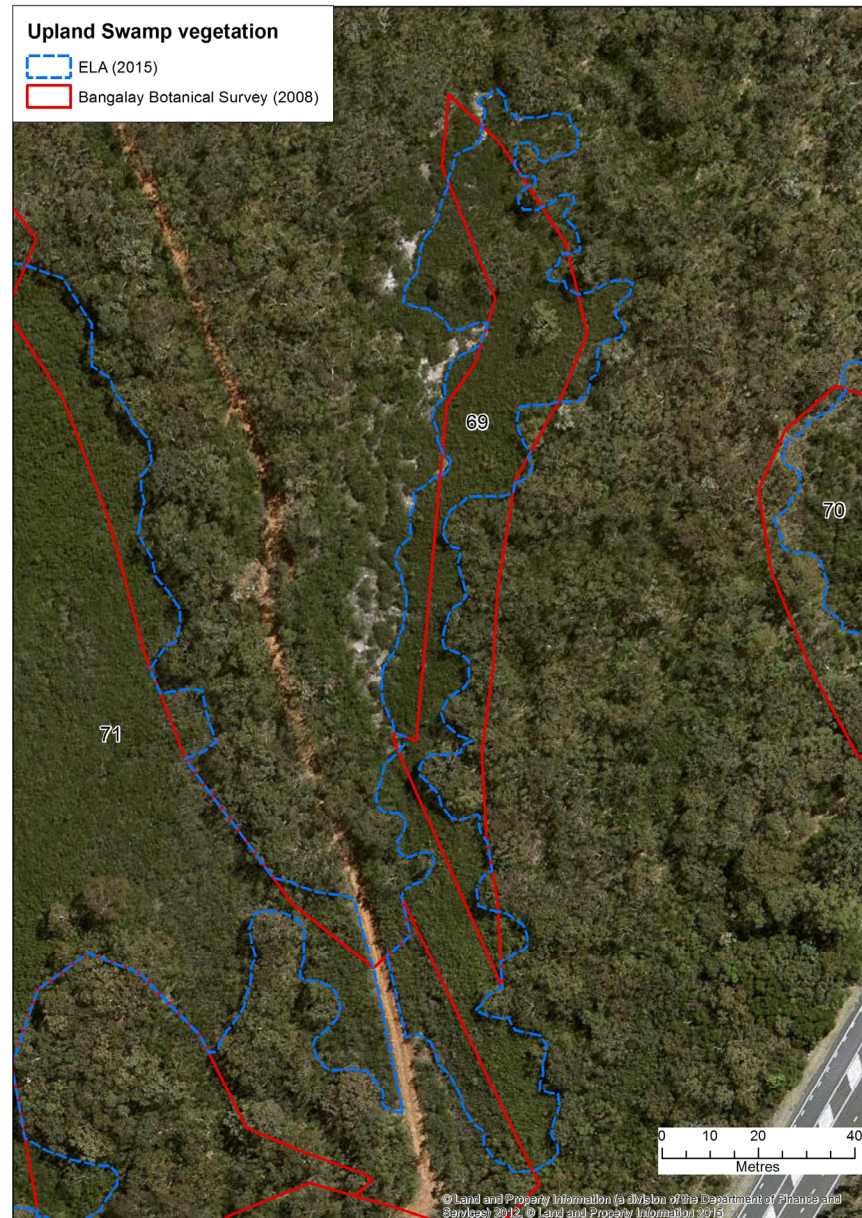
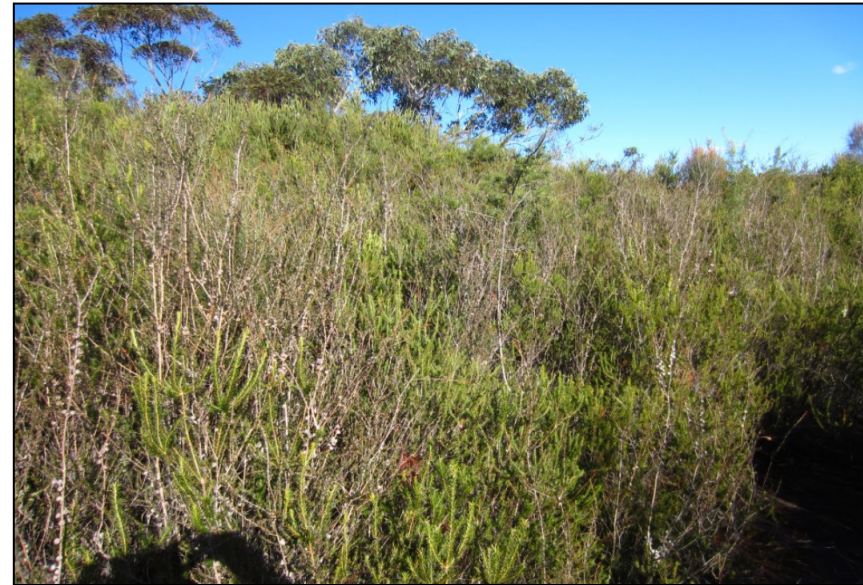
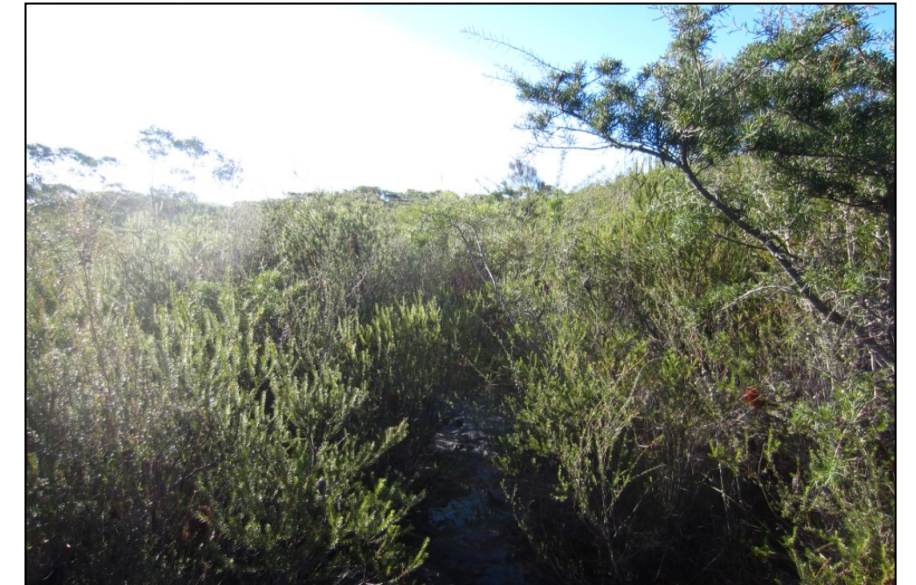
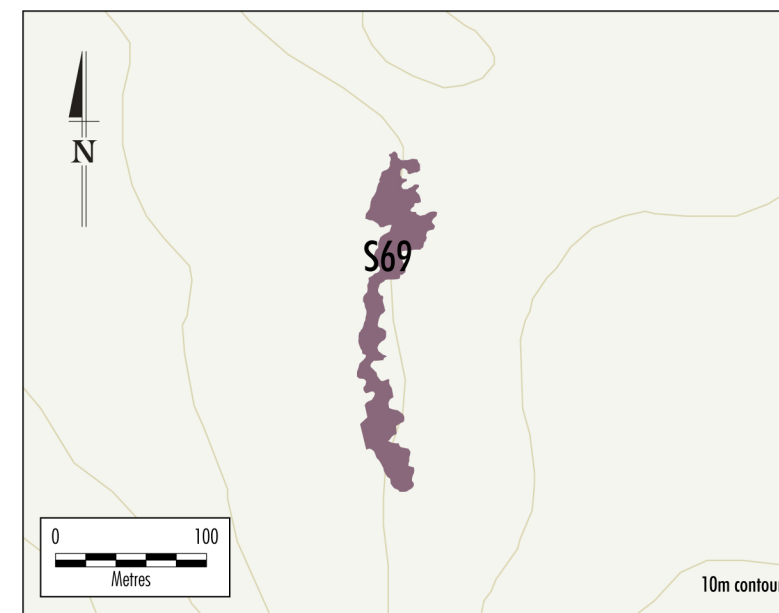
- Swamp 69 is a long narrow side valley swamp located over Longwall 305 and within the 35° angle of draw and/or predicted 20 mm subsidence contour of Longwalls 301-303 secondary extraction.

- This swamp was previously mapped as Sedgeland-heath Complex (Bangalay Botanical Surveys 2008).
- Inspections undertaken as part of this report identified Banksia Thicket across the extent of the swamp. Additionally some minor revisions to the mapping of the swamp boundary were made based upon field inspections and aerial photography interpretation (Swamp 69 is approximately 0.4 hectares in area).

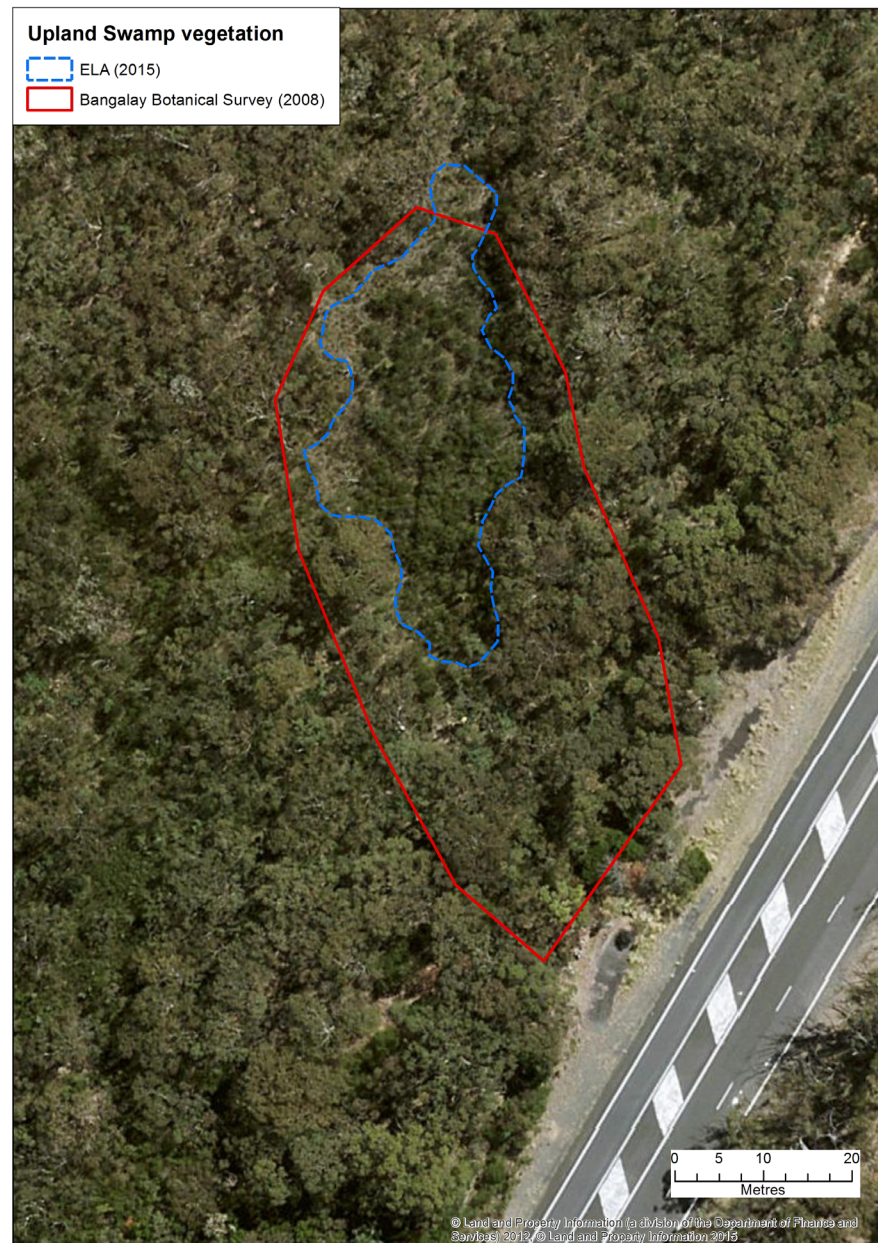
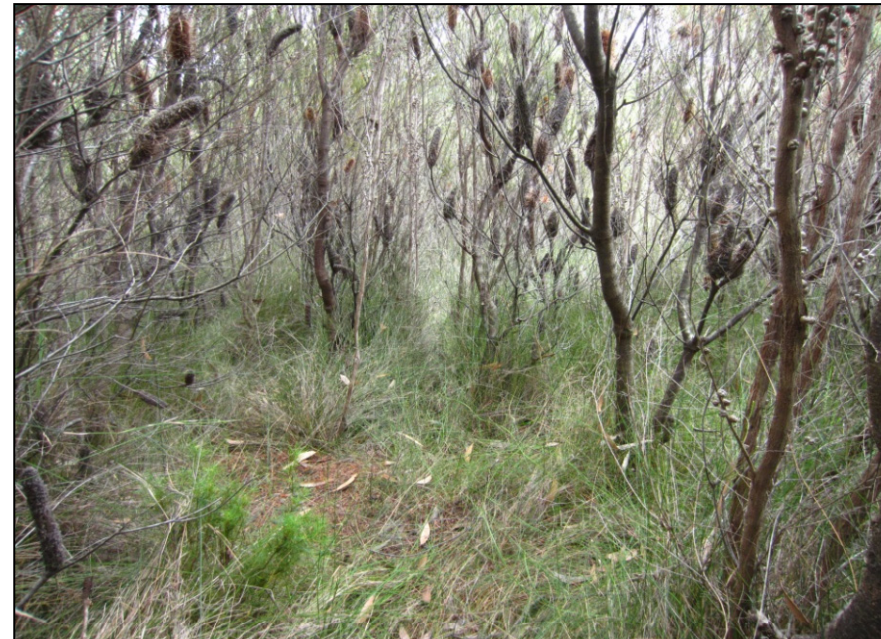
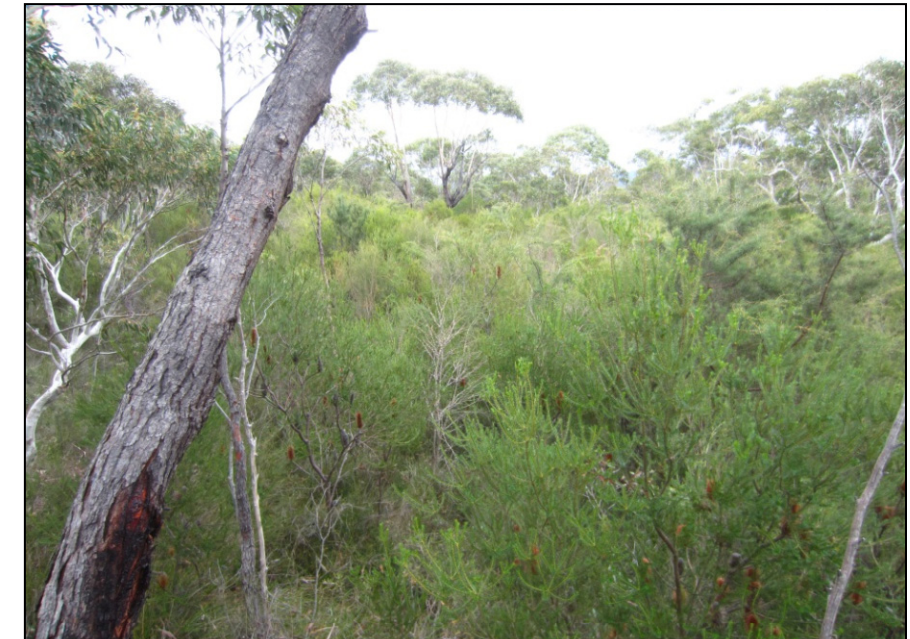
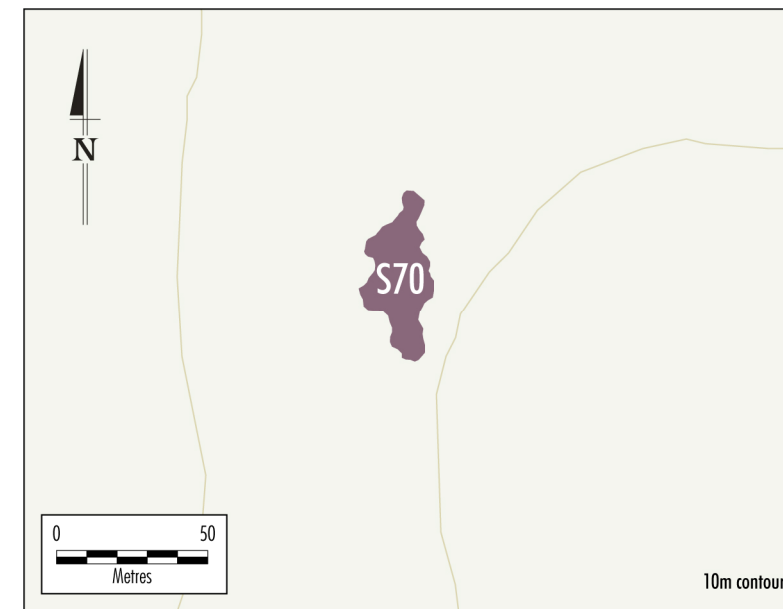
- Swamp 70 is a valley side swamp located over the chain pillar between Longwalls 304 and 305 and within the 35° angle of draw and/or predicted 20 mm subsidence contour of Longwalls 301-303 secondary extraction.

- This swamp was previously mapped as Sedgeland-heath Complex (Bangalay Botanical Surveys 2008).
- Inspections undertaken as part of this report identified a reduced extent of swamp vegetation and identified the Banksia Thicket vegetation community as occurring across the revised extent of this swamp (Swamp 70 is approximately 0.1 hectares in area).

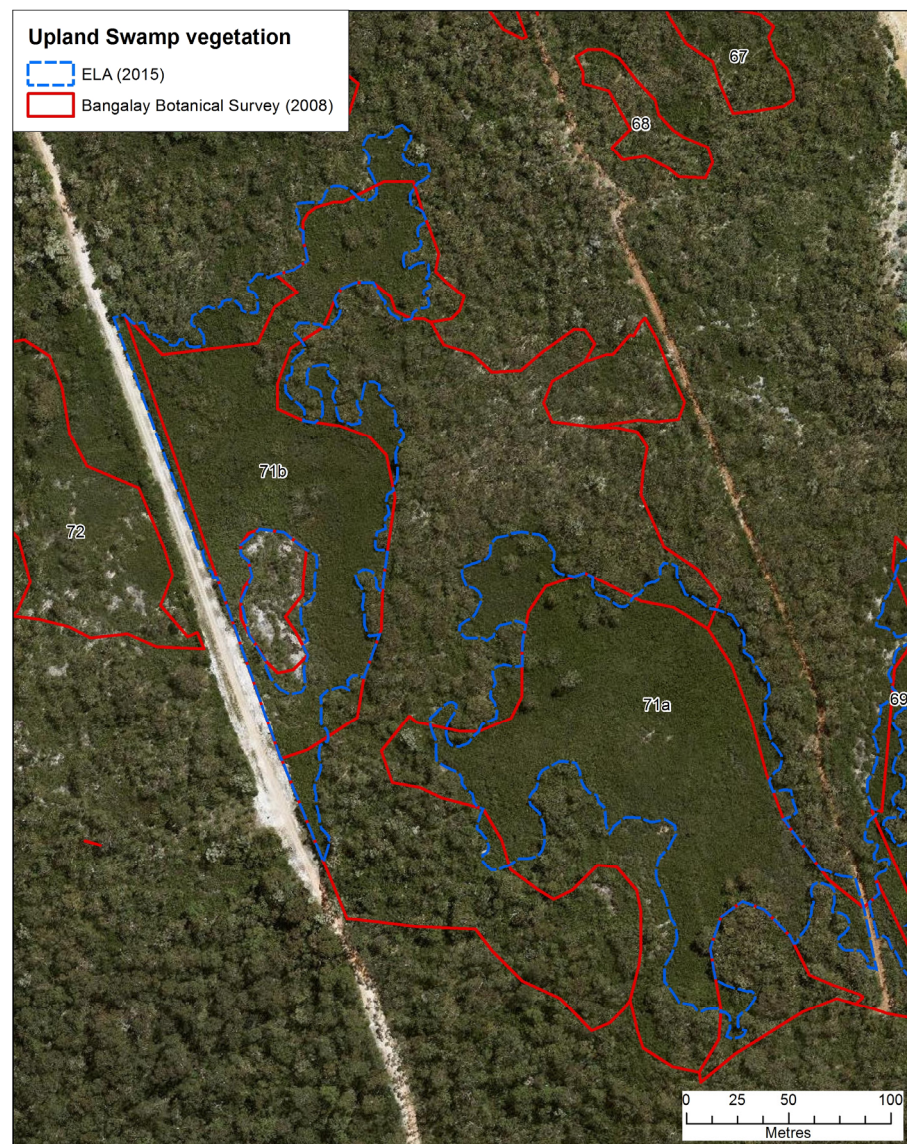
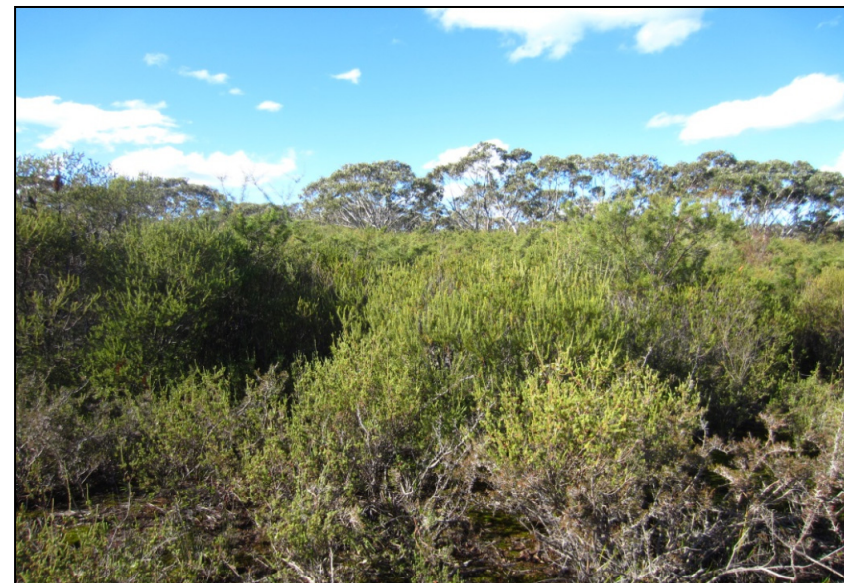
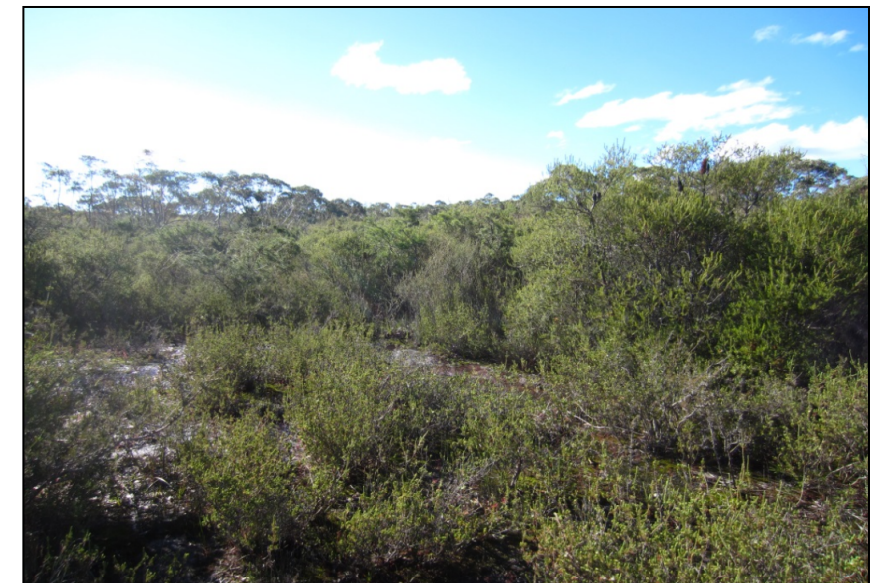
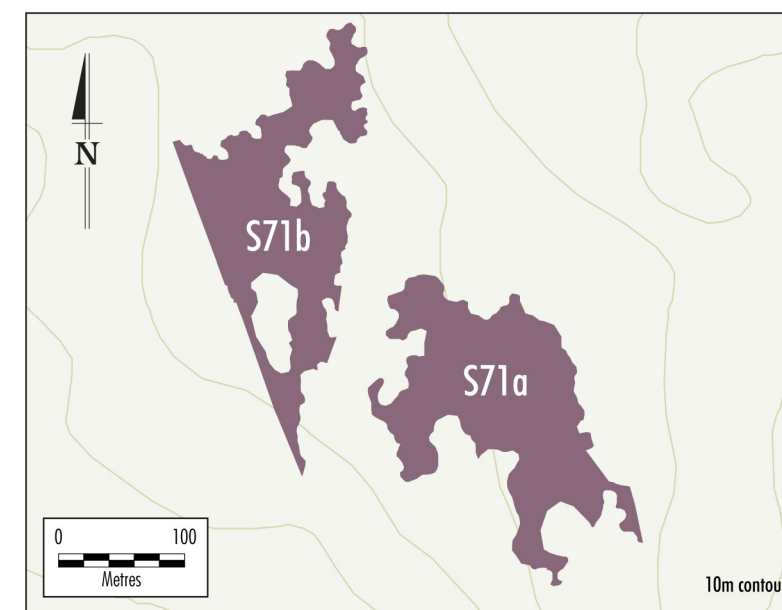
Swamps 71a and 71b

- Swamp 71 is just located within the 35° angle of draw and/or predicted 20 mm subsidence contour of Longwalls 301-303 secondary extraction, with the majority of Swamp 71 being located within 600 m of Longwalls 301-303 or beyond the 600 m.

- This swamp was previously mapped as Sedgeland-heath Complex with areas of Fringing Eucalypt Woodland through the centre of the swamp (Bangalay Botanical Surveys 2008).

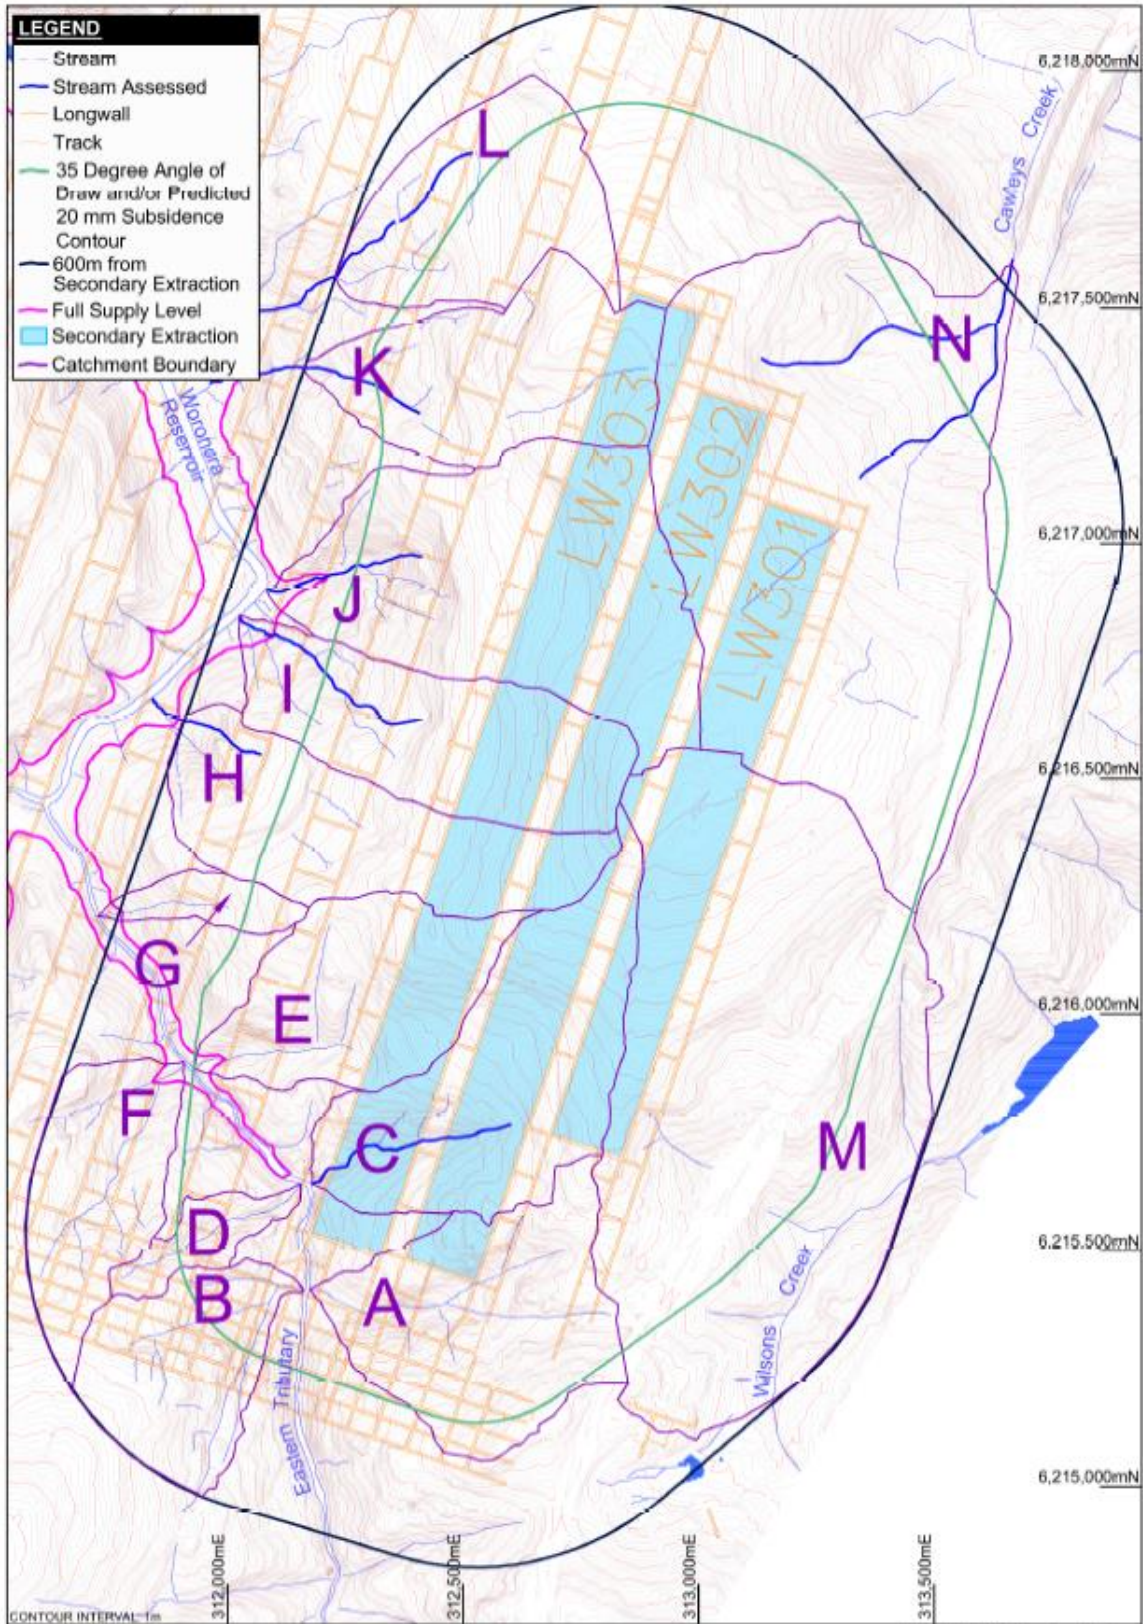
Figure 1 Sub-catchments in the vicinity of Longwalls 301 to 303

Sub-catchment Designation	Sub-catchment Area (km ²)	Stream Order ¹
A	0.24	2
B	0.15	2
C	0.28	2
D	0.04	1
E	0.19	2
F	0.14	2
G	0.04	1
H	0.22	2
I	0.22	2
J	0.38	2
K	0.21	2
L	0.19	2
M	0.79	2
N	0.79	3

The streams which flow to Eastern Tributary and the Woronora Reservoir comprise small (between 0.04 km² and 0.38 km²) first and second order streams.

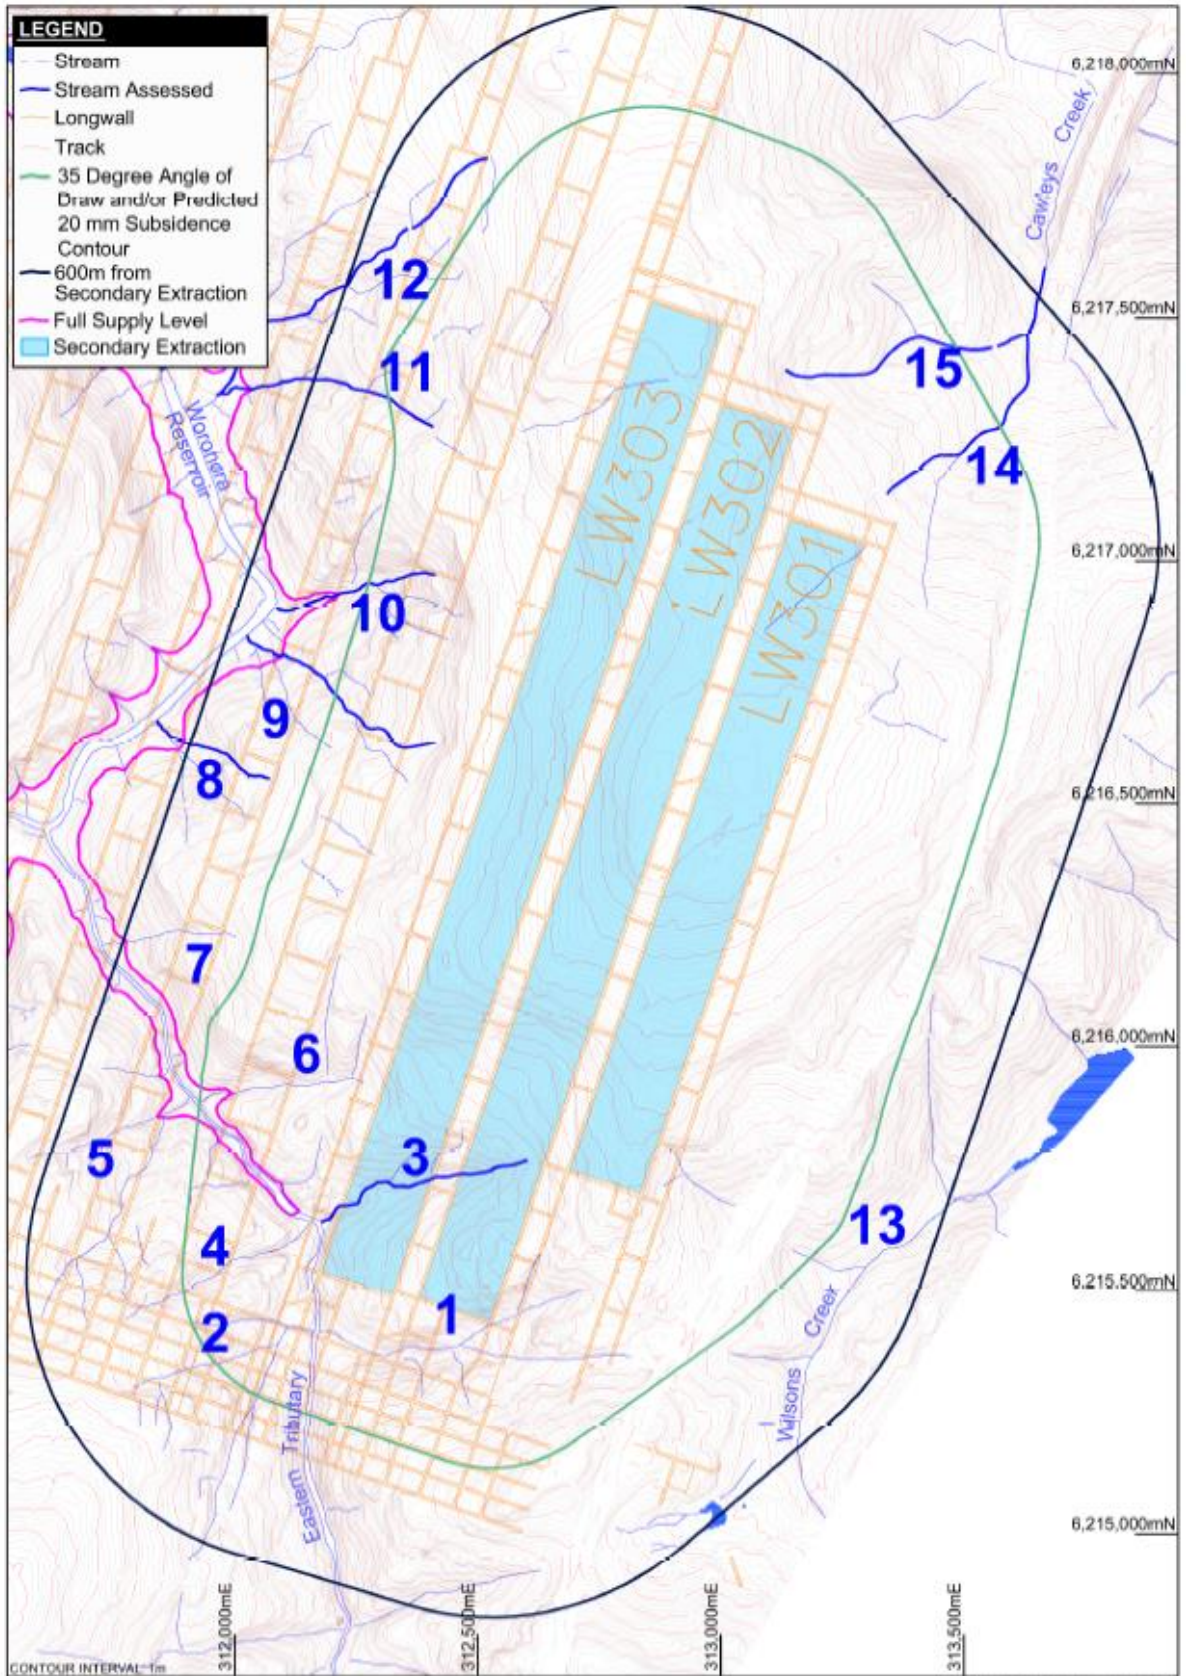
Figure 2 Streams in the vicinity of Longwalls 301 to 303

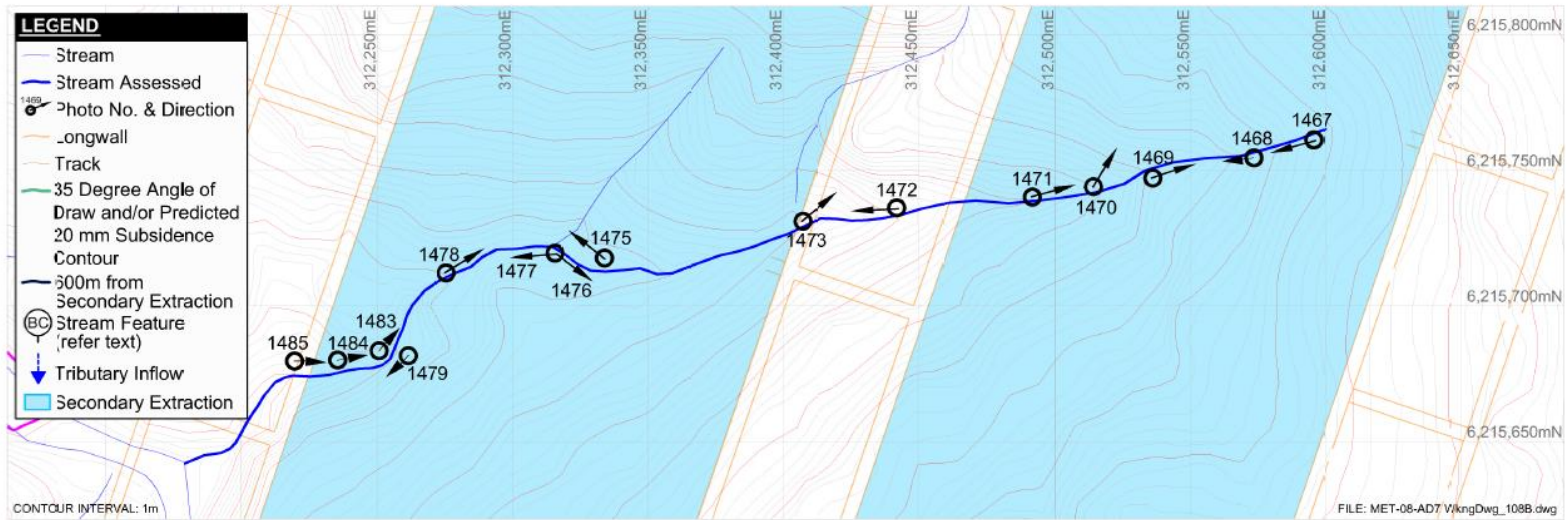
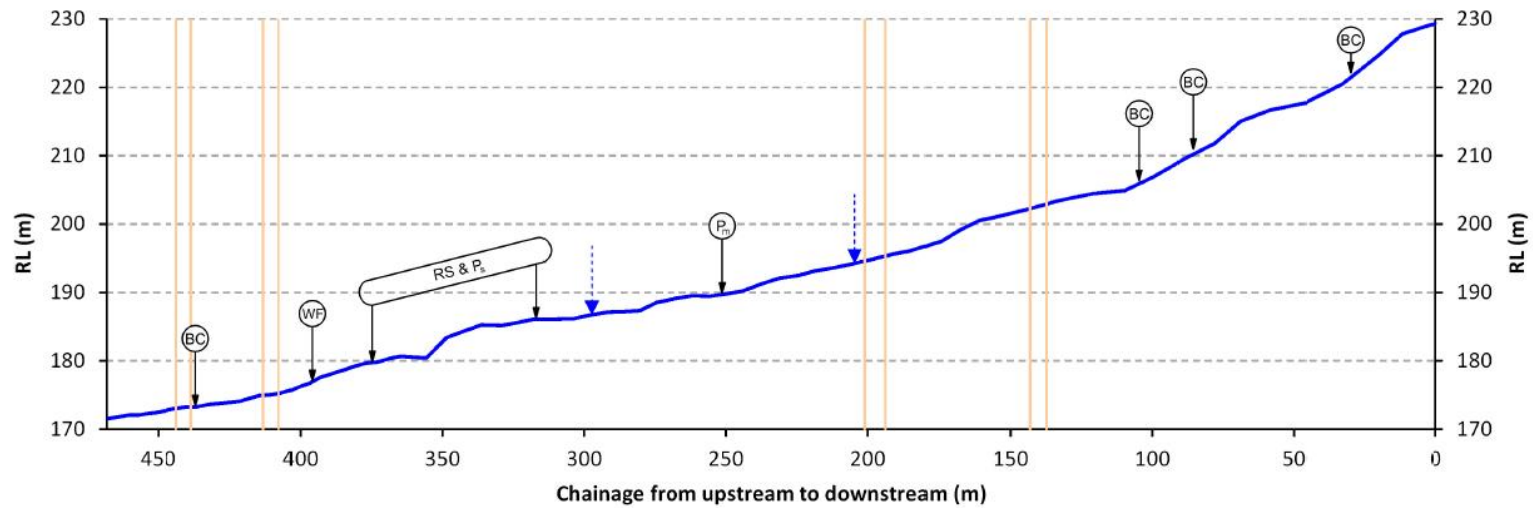
Figure 3 Stream 3 Photo Locations and Stream Features

The streams on the western side (i.e. those flowing into the Eastern Tributary and Woronora Reservoir), were steep, single channel flow paths with sections of very steep boulder cascades and waterfalls. The steeper sections were separated by relatively flatter sections. The distribution and location of flatter and steep sections are apparent on the stream long-sections included in Figure 3 to Figure 8. The photographs taken at the points shown in Figure 3 to Figure 8 are provided in Attachment 1.

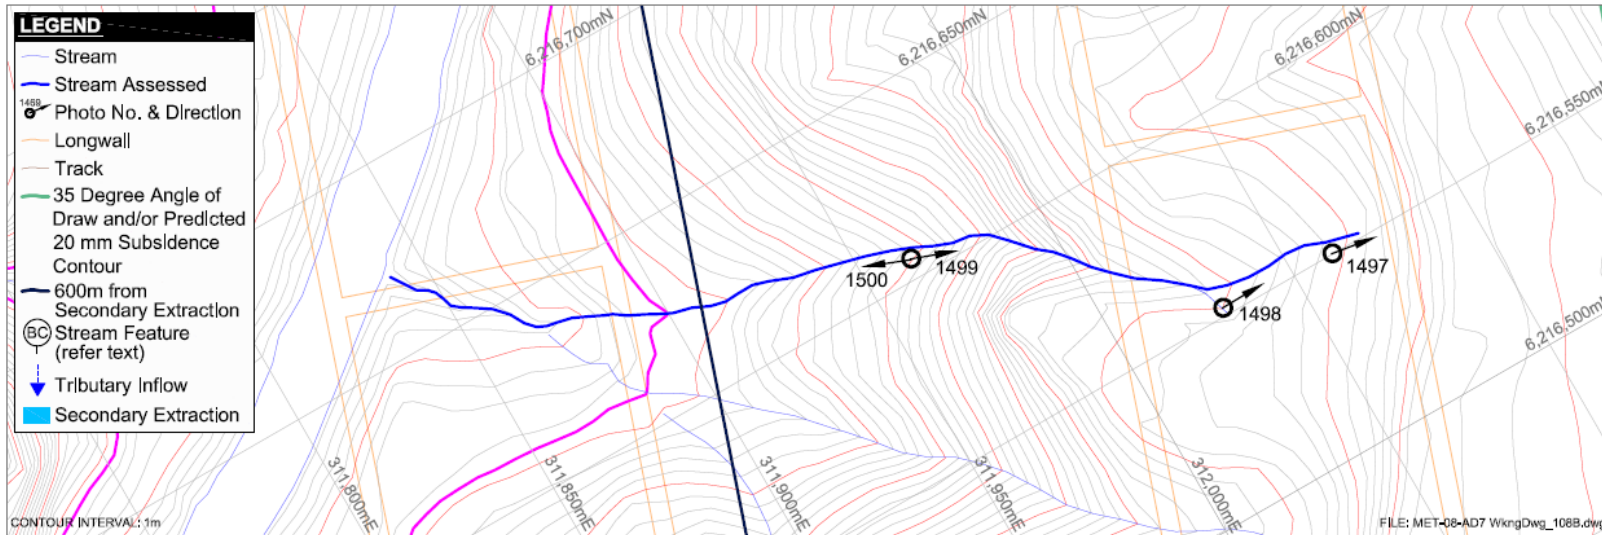
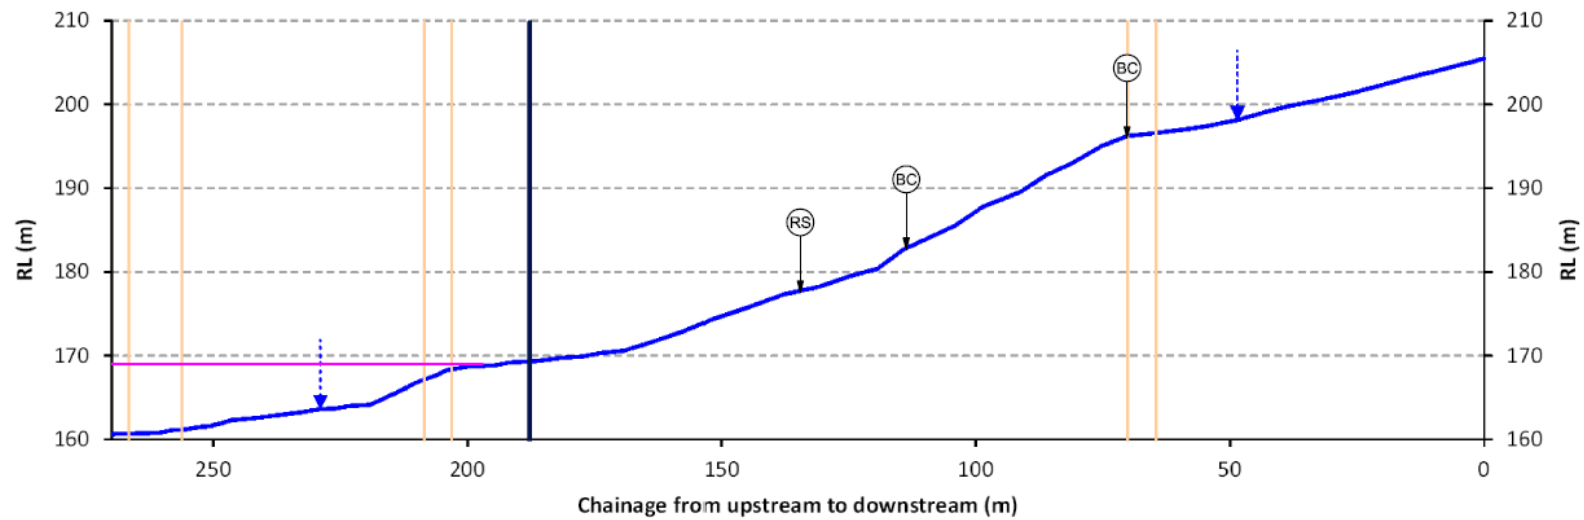
Figure 4 Stream 8 Photo Locations and Stream Features

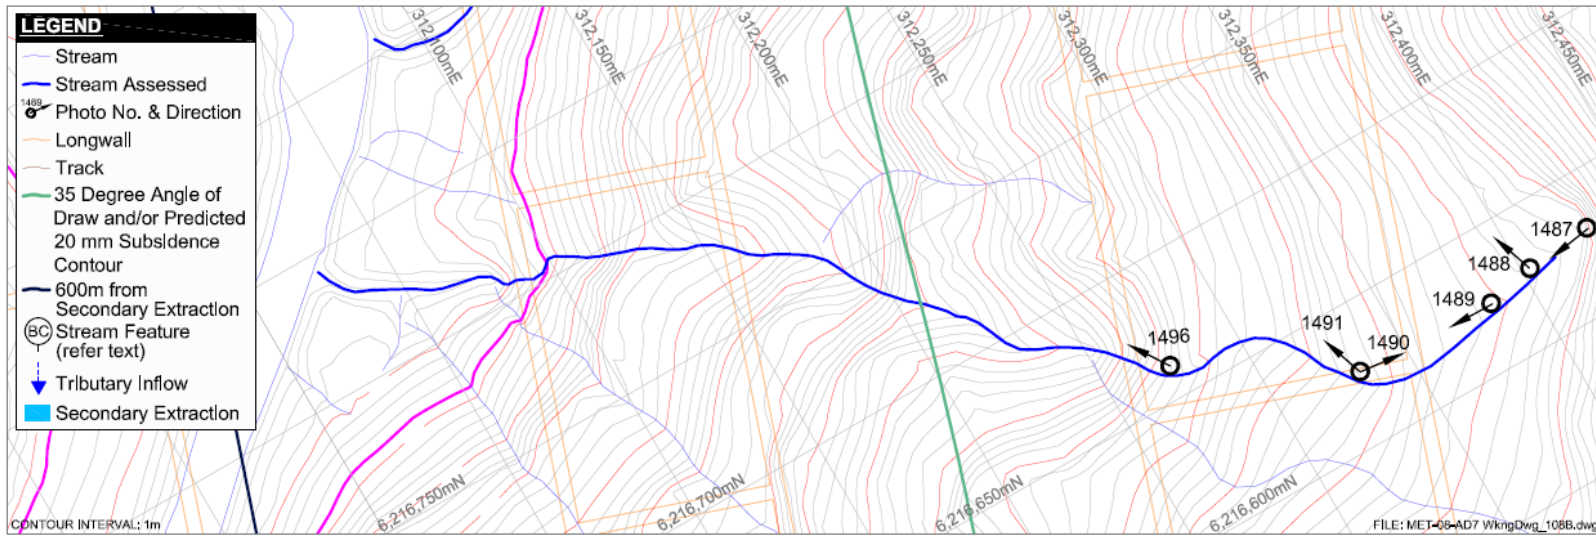
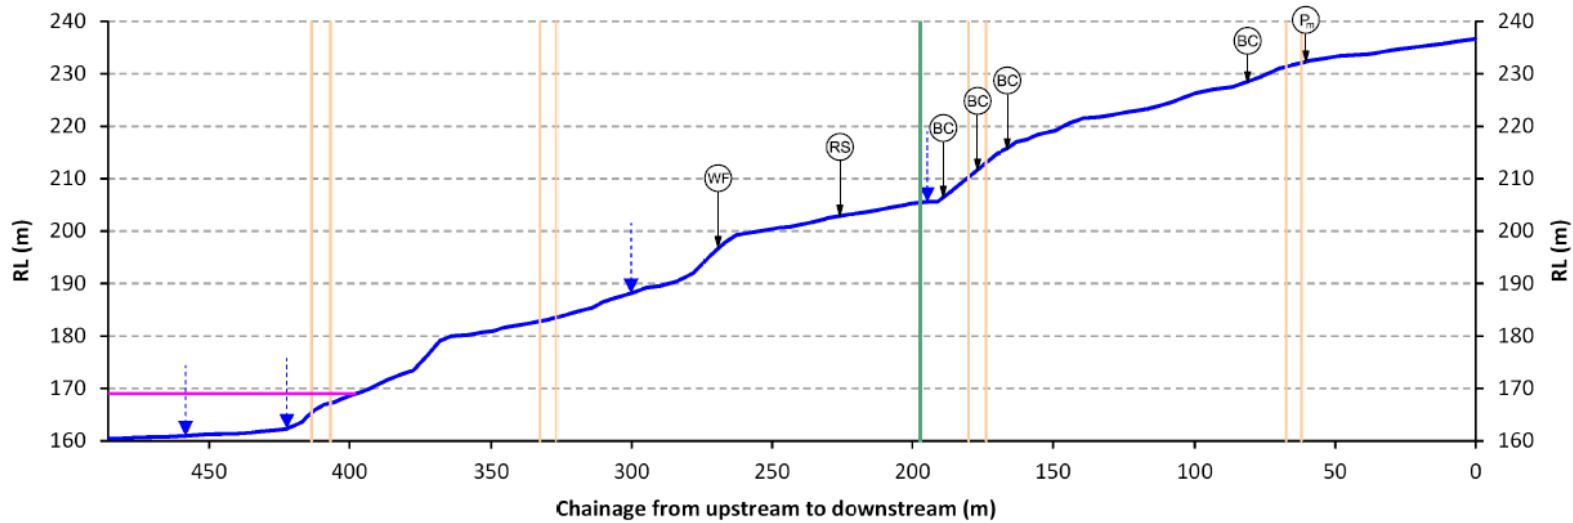
Figure 5 Stream 9 Photo Locations and Stream Features
