METROPOLITAN COAL LONGWALLS 301-303

BIODIVERSITY MANAGEMENT PLAN

November 2016

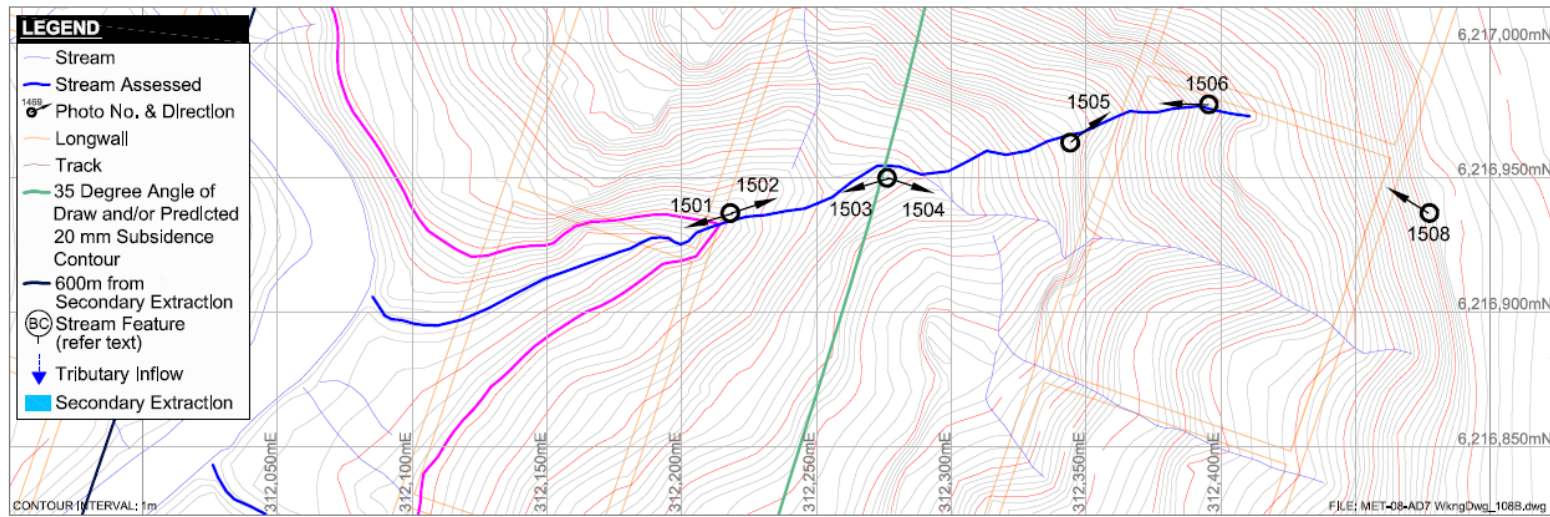
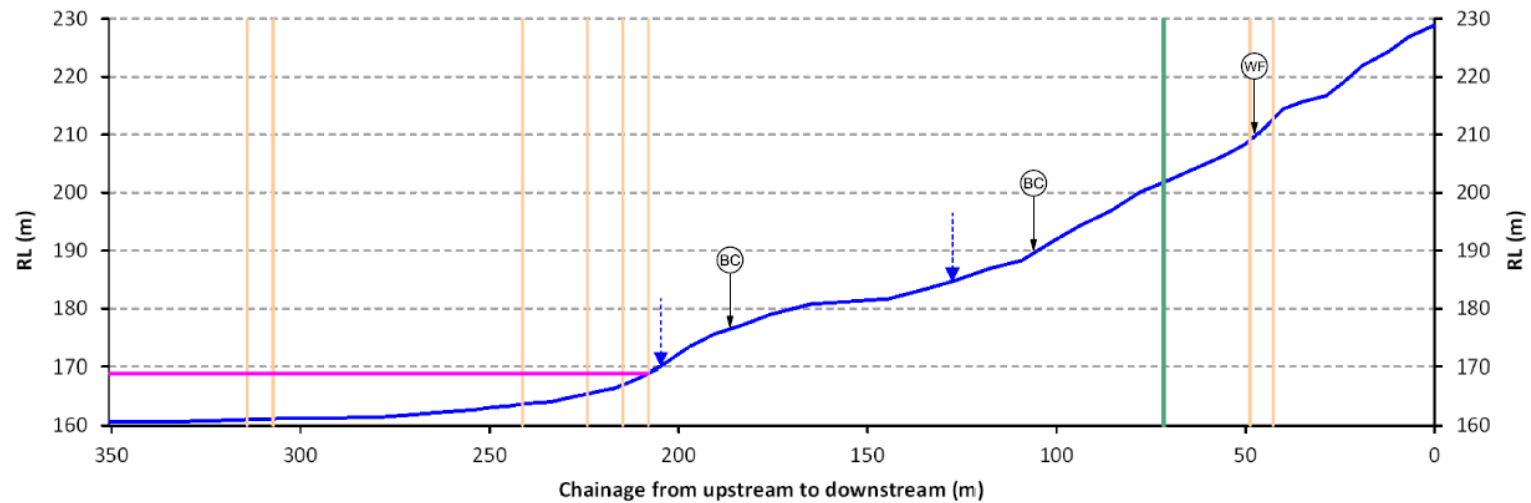
Figure 6 Stream 10 Photo Locations and Stream Features

The streams on the western side (i.e. those flowing into the Eastern Tributary and Woronora Reservoir), were steep, single channel flow paths with sections of very steep boulder cascades and waterfalls. The steeper sections were separated by relatively flatter sections. The distribution and location of flatter and steep sections are apparent on the stream long-sections included in Figure 3 to Figure 8. The photographs taken at the points shown in Figure 3 to Figure 8 are provided in Attachment 1.

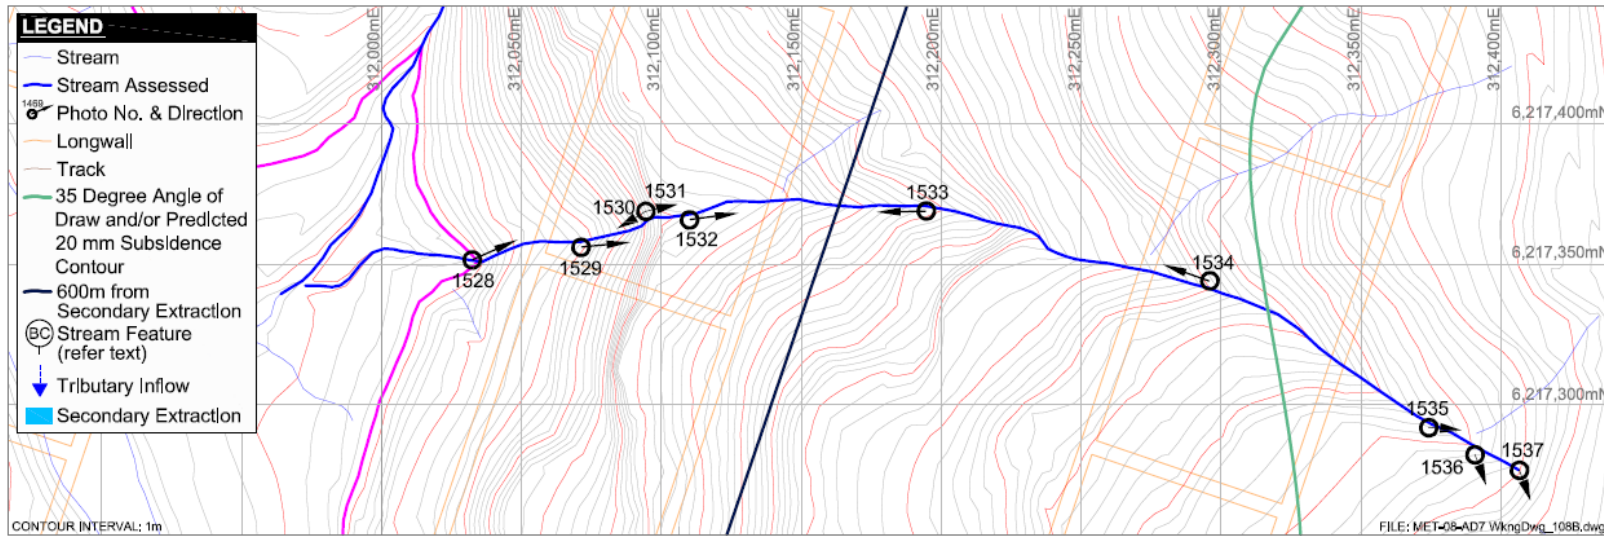
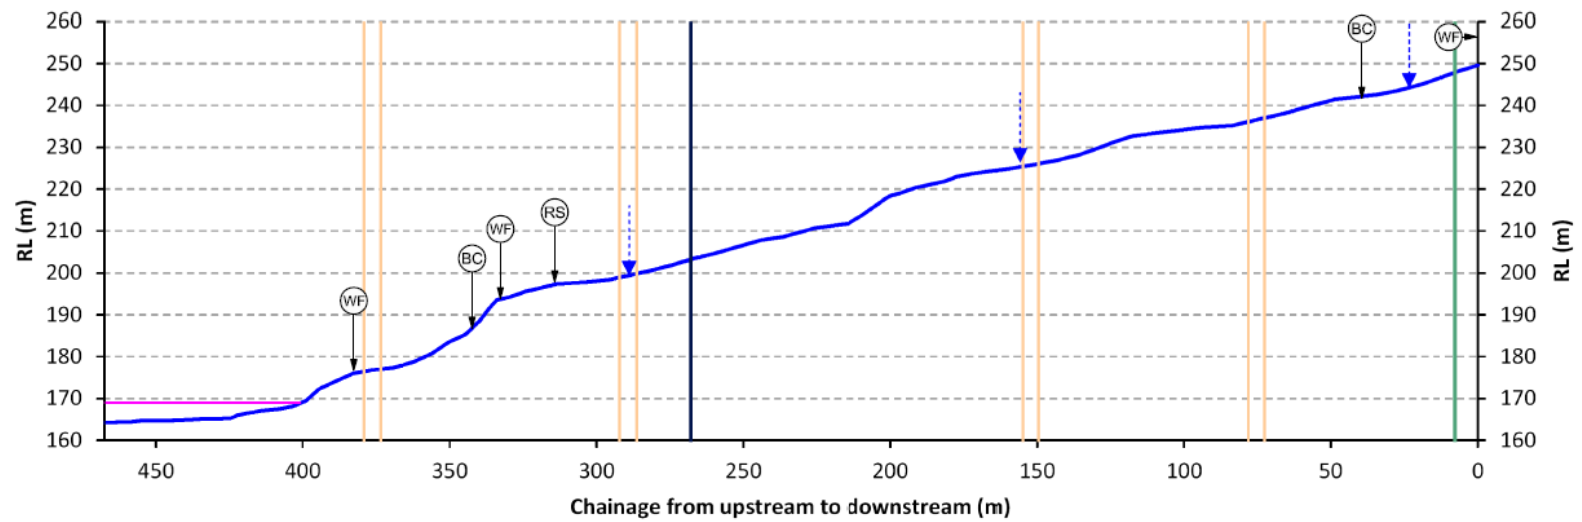
Figure 7 Stream 11 Photo Locations and Stream Features

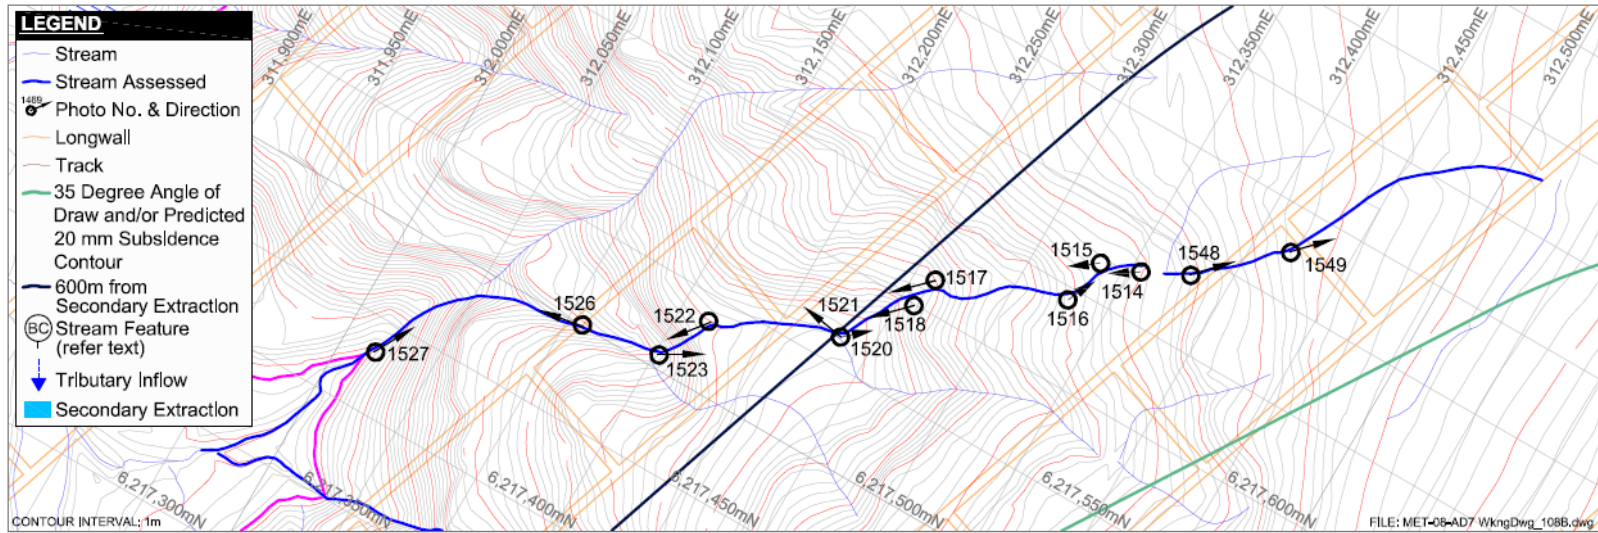
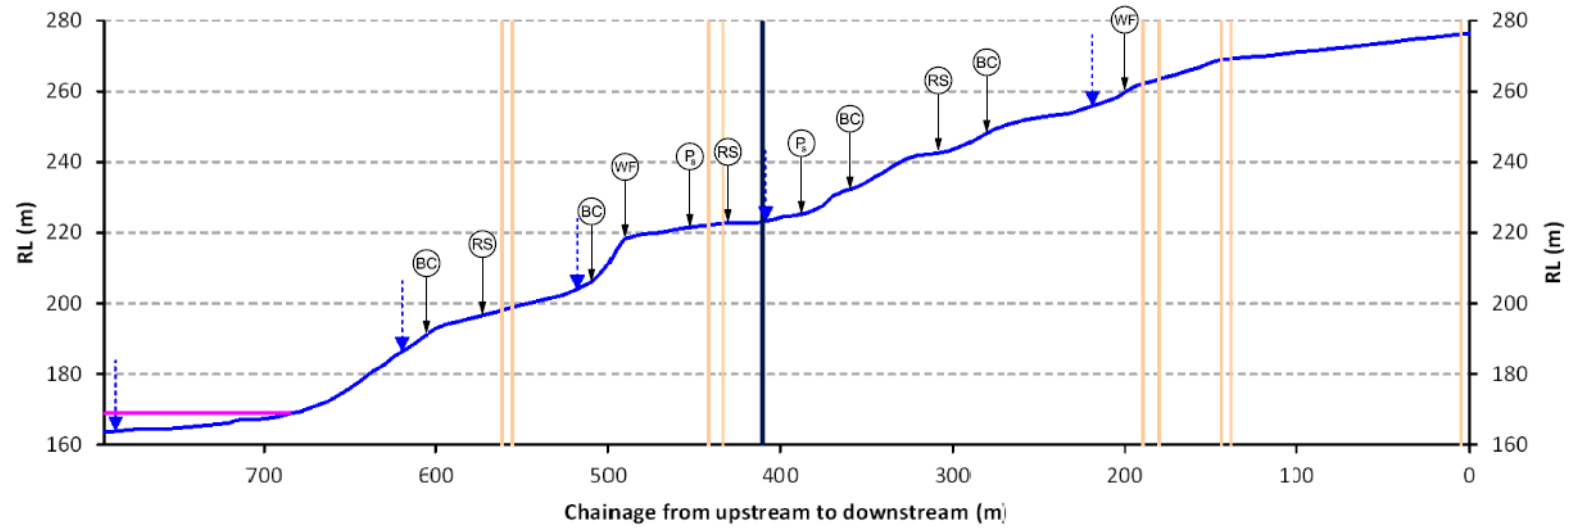
Figure 8 Stream 12 Photo Locations and Stream Features

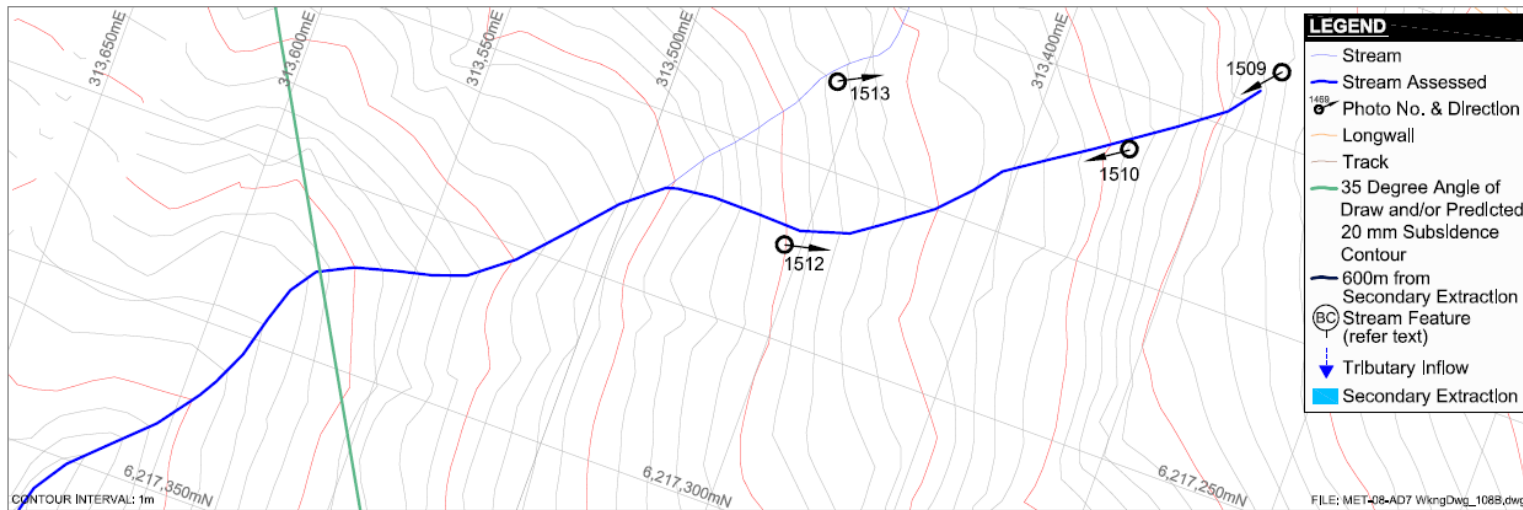
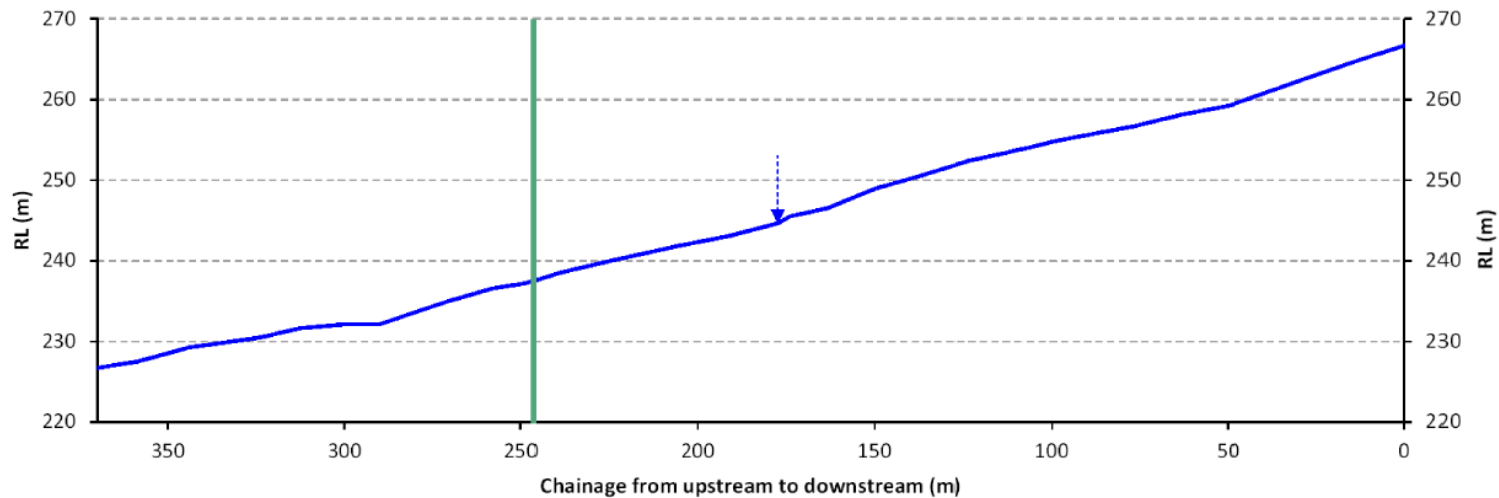
Figure 9 Stream 14 Photo Locations and Stream Features

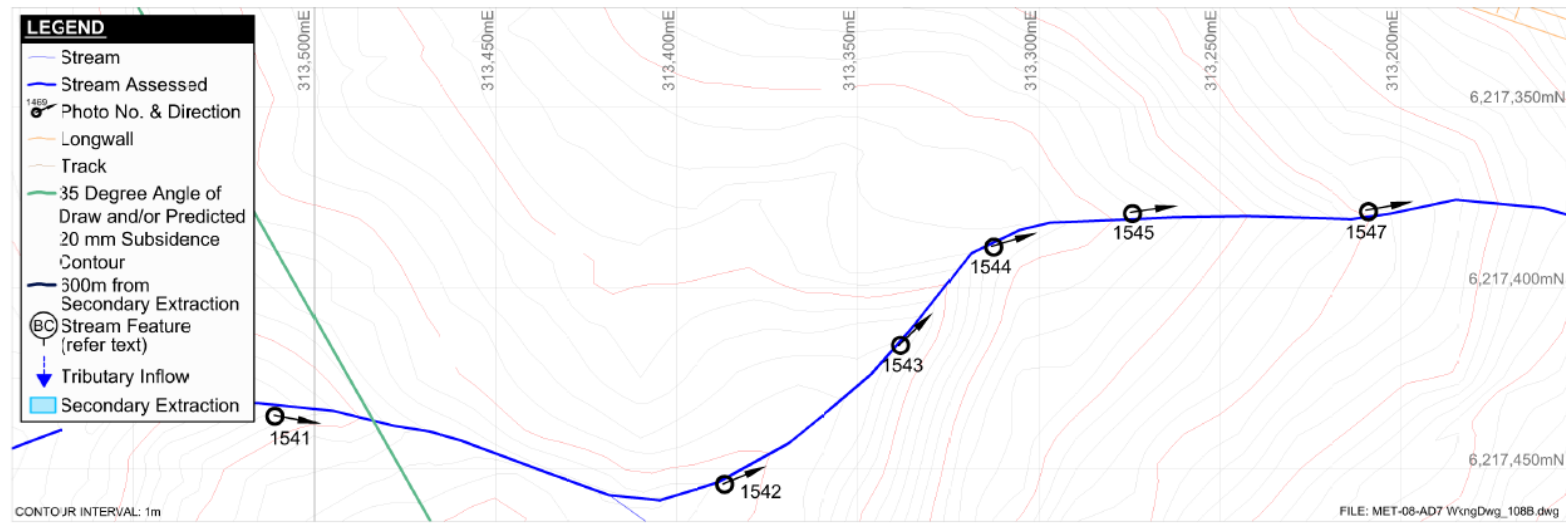
The streams on the eastern side of the study area (streams 14 and 15, Figure 9 and Figure 10) which flow into Cawleys Creek were significantly different in condition and character to those on the western side. They comprise shallow ill-defined channels in an open valley setting. Substantial clearing and weed invasion was observed in parts. The streams followed a moderate grade with predominantly alluvial bed material comprising silts and sand. There were no pools observed. Conditions observed in the streams are shown on the stream condition maps included as Figure 9 and Figure 10). The photographs taken at the points shown on Figure 9 and Figure 10 are provided in Attachment 1.

The inspection and survey involved walking along the accessible length of the streams, mapping the geomorphic characteristics and features of the stream, and compiling a photographic record. The mapping provided in Figure 3 to Figure 10 shows the locations where photographs were taken and the location of particular stream features observed along the stream.
