WAMBO COAL MINING OPERATIONS PLAN 2018 – 2020

Prepared by Wambo Coal Pty Ltd
Document No. WCPL_MOP_2018-2020
March 2019

Mining Operations Plan

Name of Mine: Wambo Coal Pty Ltd
MOP Commencement Date: 1 January 2018
MOP Completion Date: 31 December 2020
Mining Authorisations (Lease / Licence No.): CL397, CCL743, CL374, CL365, ML1402, ML1594, ML1572, **MLA557.**

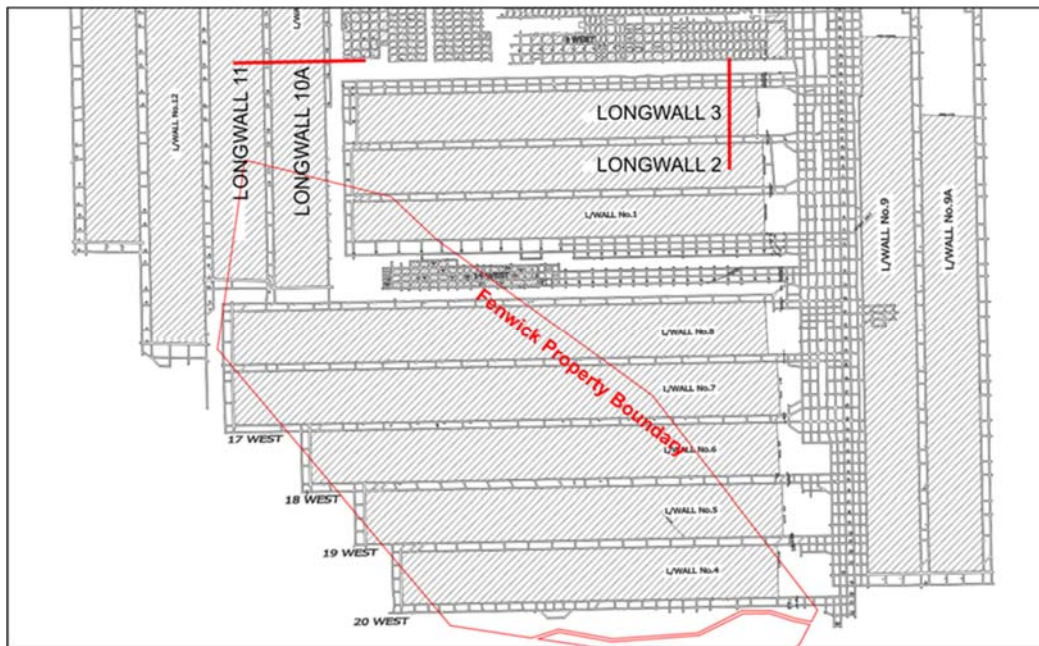
Subsidence lines were monitored during mining of Longwalls 2 and 3 and Longwalls 10A and 11 adjacent to Kharlibe (refer **Figure 4**).

Figure 4 Location of Subsidence Monitoring Lines (SCT, 2018)

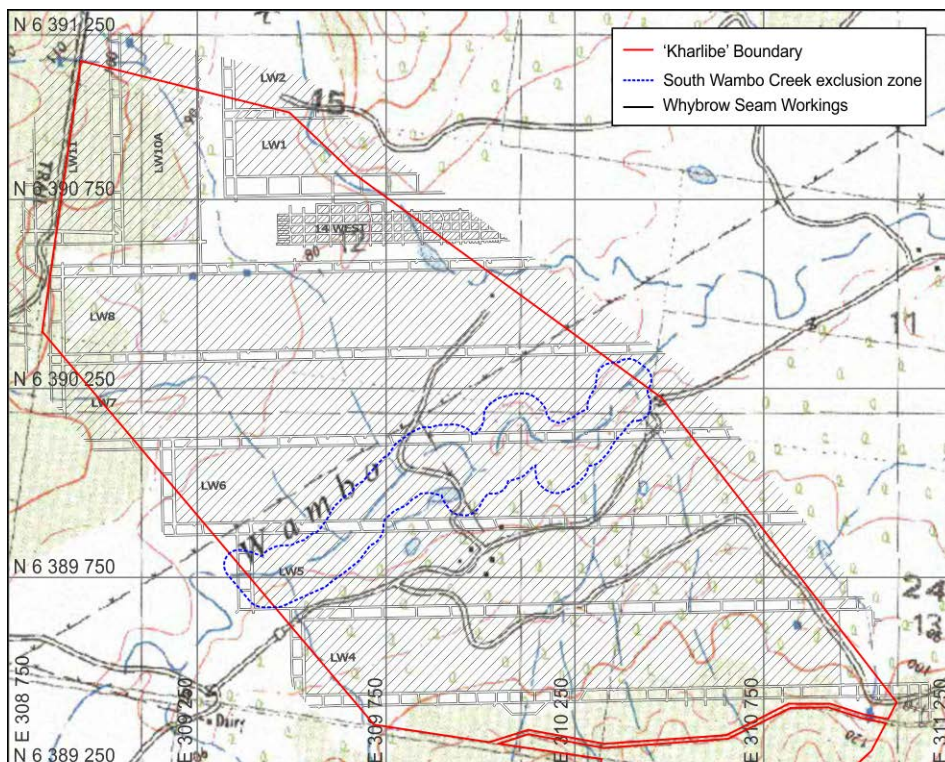
Figure 1 shows an outline of 'Kharlibe' relative to the Wambo longwall panels superimposed onto a 1:25,000 topographic series map of the area. This map was produced in 1975 and, therefore, pre-dates any mining in the area.

Figure 1: Site plan of 'Kharlibe' with underground workings

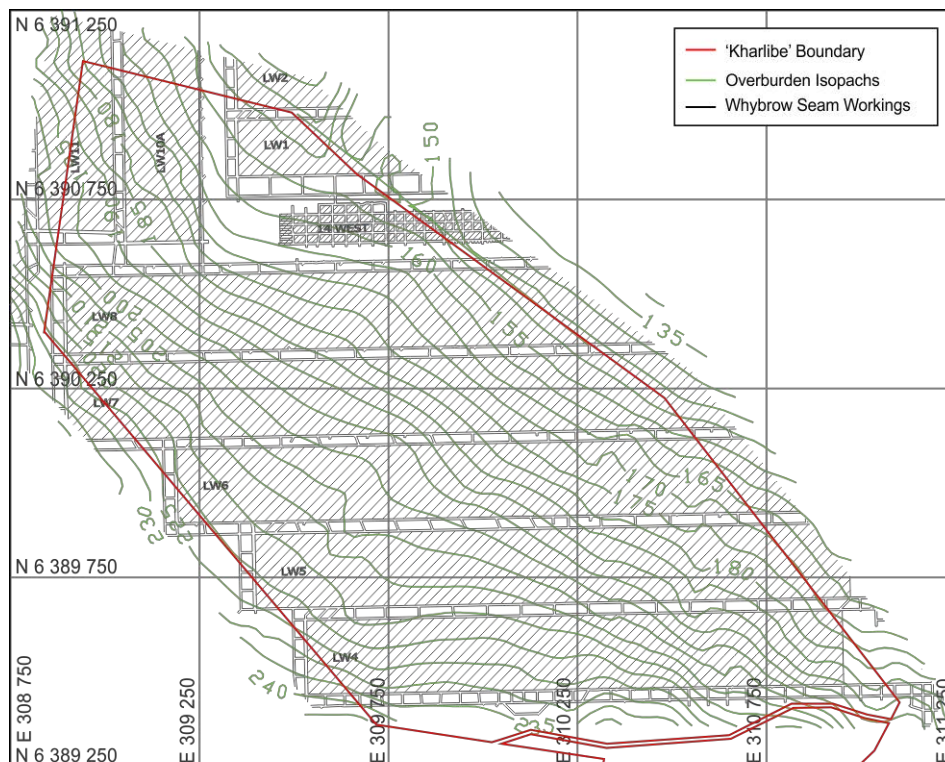
Figure 2: Contours of overburden depth

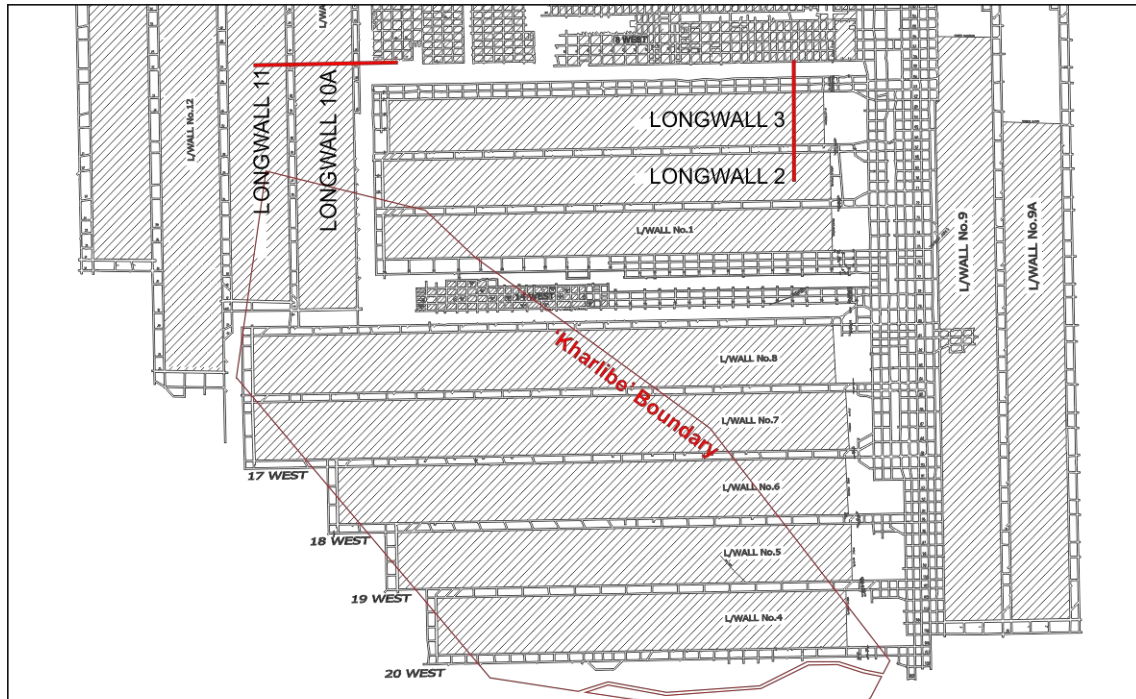
Figure 3: Location of subsidence monitoring lines

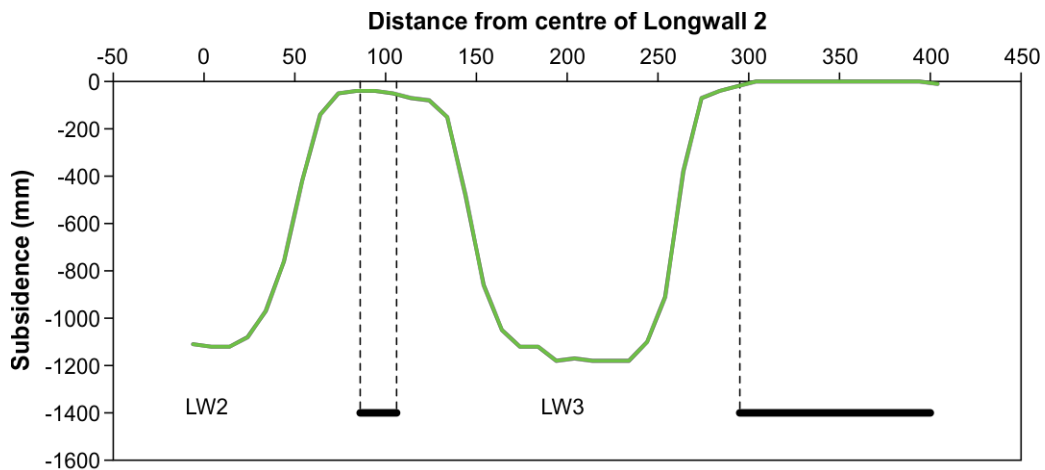
Figure 4 shows a profile of the subsidence that was measured above Longwalls 2 and 3. This profile illustrates subsidence behaviour referred to as supercritical width subsidence where the panels are wide relative to overburden depth. This behaviour is representative of subsidence behaviour at overburden depths less than about 120m i.e. over most of the eastern part of 'Kharlibe'.

Figure 4: Subsidence profile of Longwalls 2 and 3

The overburden depth along the Longwall 2 / 3 subsidence line ranges from 95m to 100m. Longwall 2 is 172m wide. Longwall 3 is 189m wide. The subsidence profile has characteristics that are typical of panels that are wide relative to the overburden depth (known as supercritical in subsidence engineering terms).

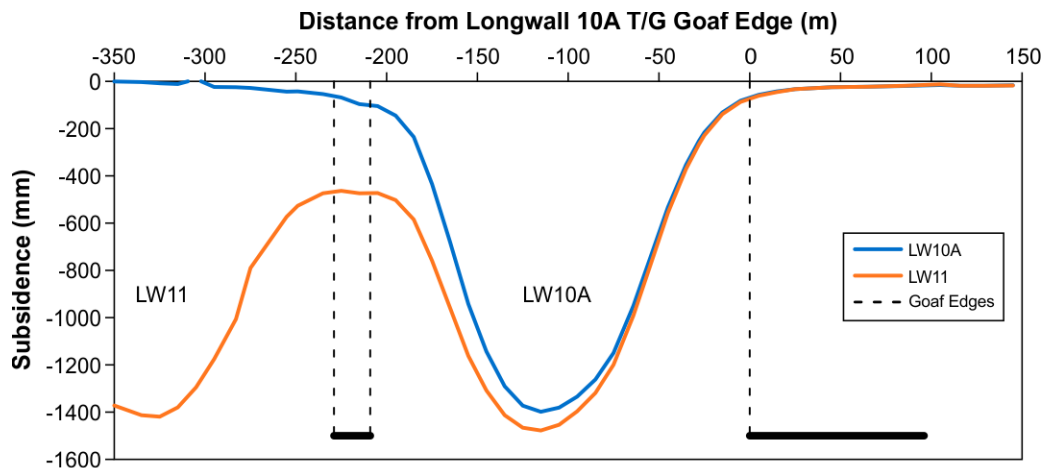
The overburden depth along the Longwall 10A / 11 subsidence line ranges from 140m in the east and over most of Longwall 10 to 160m over Longwall 11. Both Longwall 10A and Longwall 11 are 210m wide. The chain pillar is 20m wide. The subsidence profile has characteristics that are typical of panels that are of similar width to the overburden depth (known as critical width panels in subsidence engineering terms).

Figure 5: Subsidence profile of Longwalls 10A and 11

There is a section in the middle of the panel where maximum subsidence approaches 1.5m. This maximum subsidence is 55% of the 2.7m nominal mining height (DgS 2011) consistent with general experience in this area of the Hunter Valley.

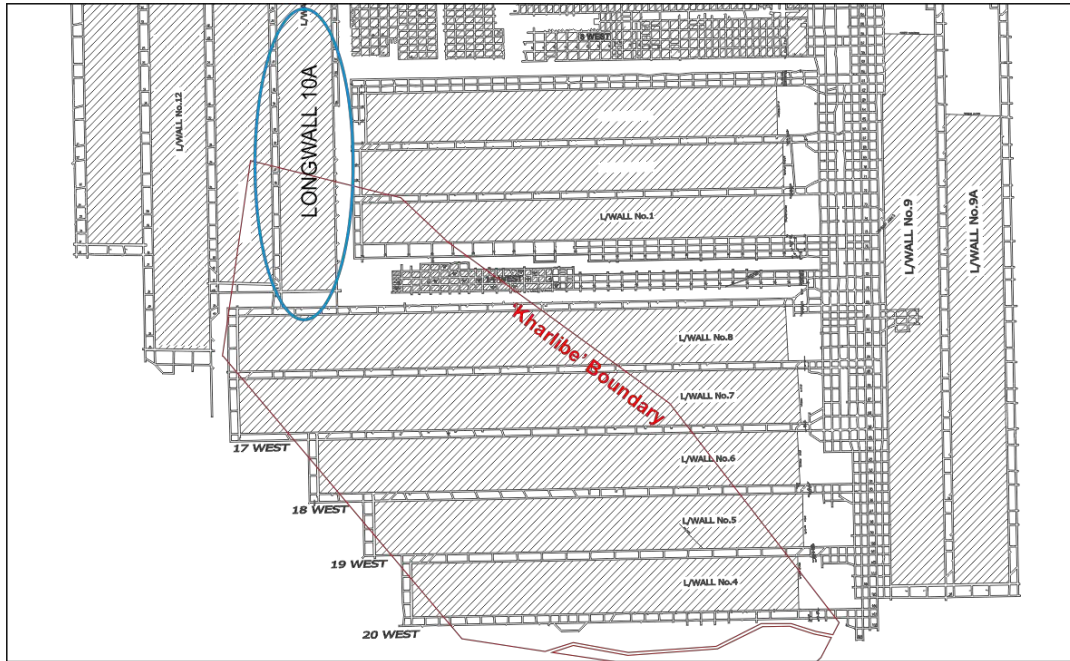
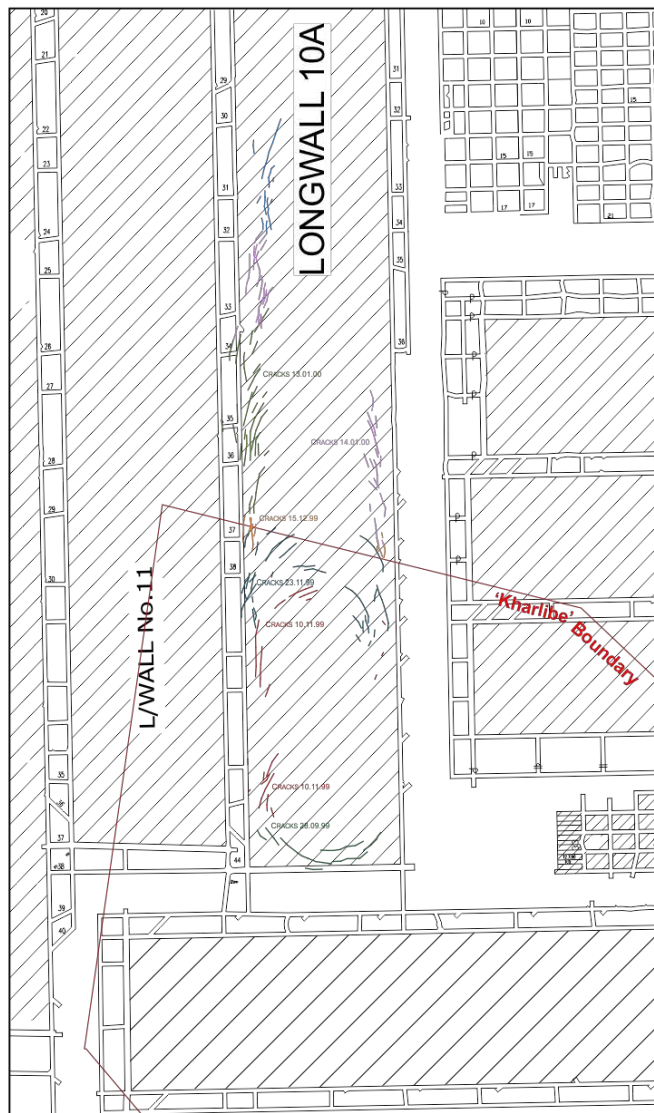
Cracks are more prolific on the uphill side of the panel consistent with the phenomenon of downslope horizontal movements described by Mills (2001). This phenomenon involves a tendency for subsiding strata to move horizontally in a downslope direction.

Figure 6: Location of cracks observed over Longwall 10A

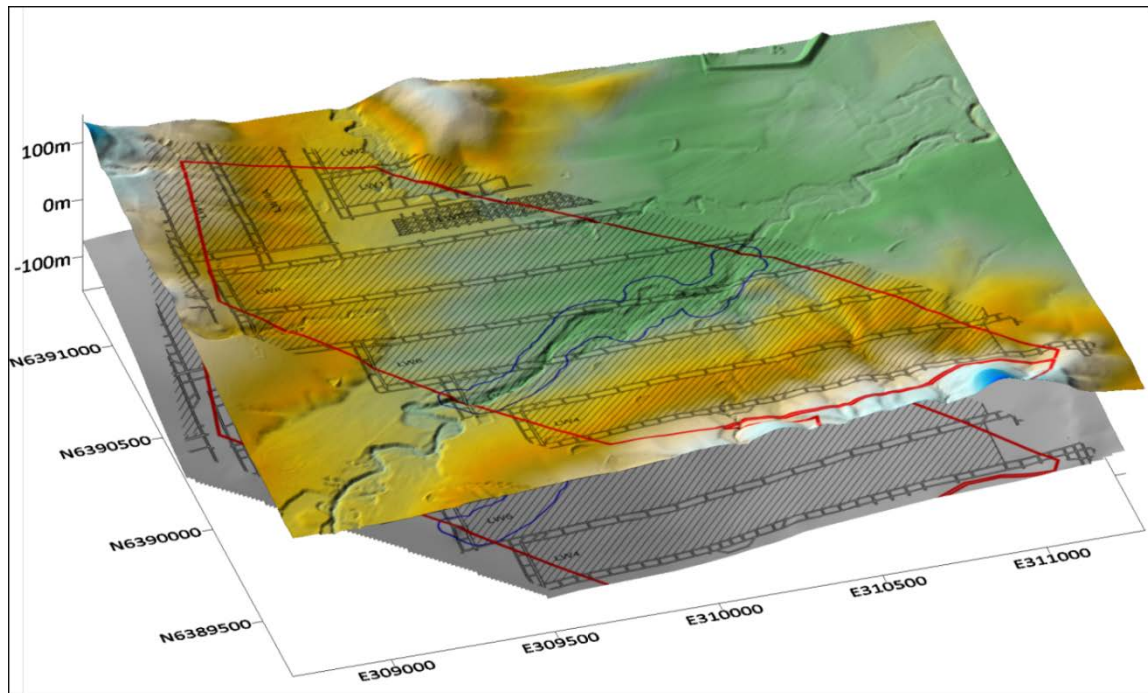
Figure 7 shows a three dimensional model of the surface as it is currently (2017 survey). Parts of the surface are also available based on photogrammetric surveys completed prior to mining. There are some limitations in the dataset available, so a complete surface has not yet been possible to construct.

Figure 7: 3D view of current surface and underground workings below 'Kharlibe'

The accuracy of the LIDAR surveys is estimated to be $\pm 0.2\text{m}$. The photogrammetric surveys appear to have a similar accuracy for the individual panel survey but there are some inconsistencies that degrade confidence in the overall surface generated.

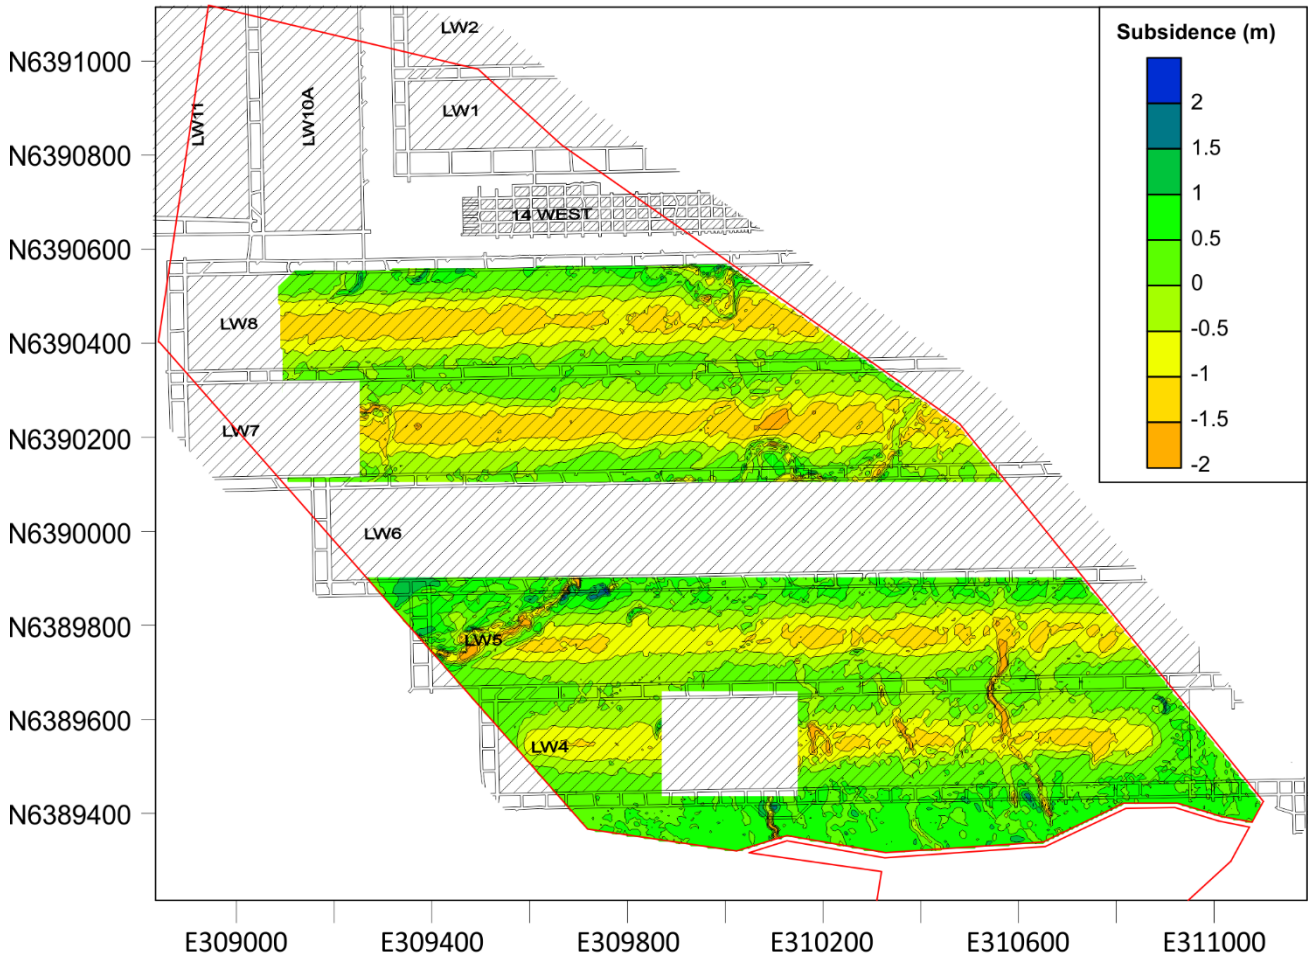
Changes in water level in dams and other changes in level are also evident.

Figure 8: Subsidence Contours

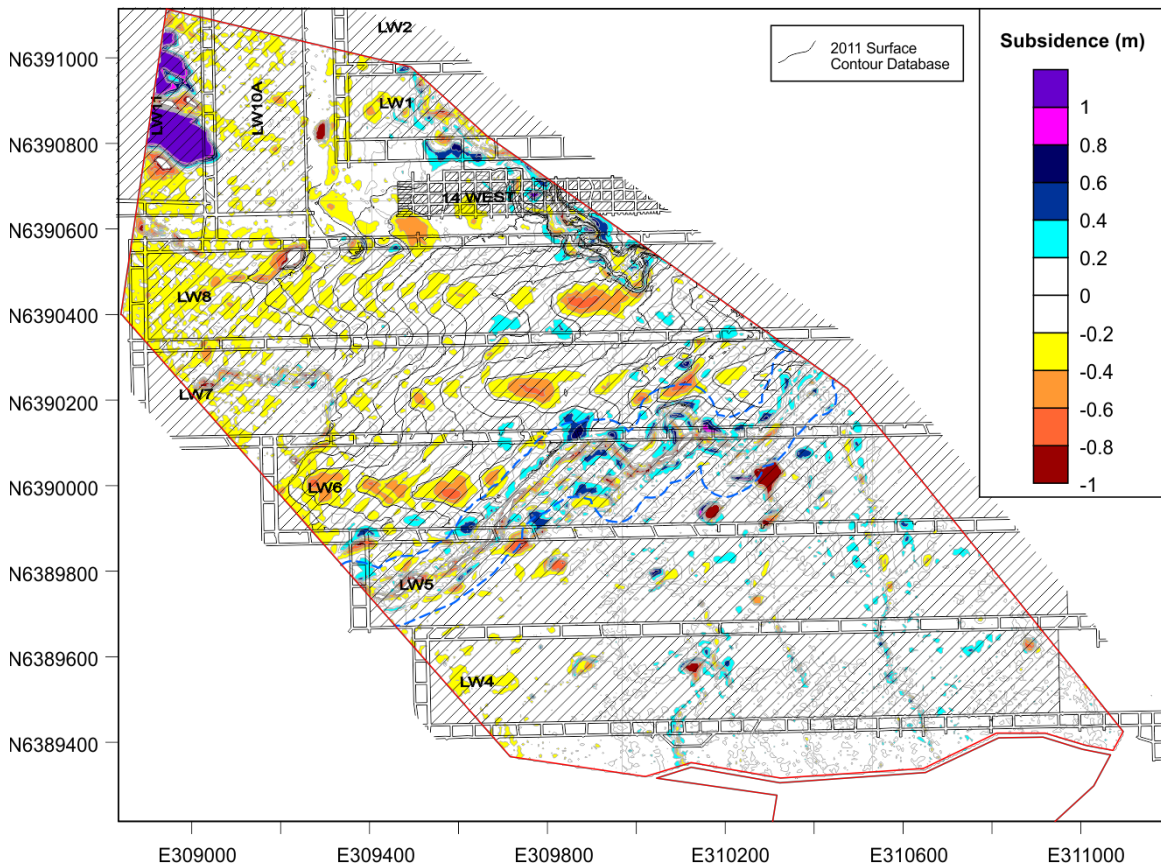
There is no additional subsidence apparent in the northeast corner of 'Kharlibe' in the period since 2011. North Wambo Mine extracted longwall panels within 240m of 'Kharlibe'. The effect of these longwall panels is clearly apparent in the broader LIDAR image, but there is no indication of further significant subsidence within 'Kharlibe' since 2011 and, therefore, from mining the North Wambo longwall panels.

Figure 9: Difference between 2011 and 2017 LIDAR surfaces (noting the 2011 surface was recreated from surface contours as shown)
