# **WAMBO COAL MINE REHABILITATION MANAGEMENT PLAN**

Prepared by Wambo Coal Pty Ltd  
Document No. WA-ENV-MP-513

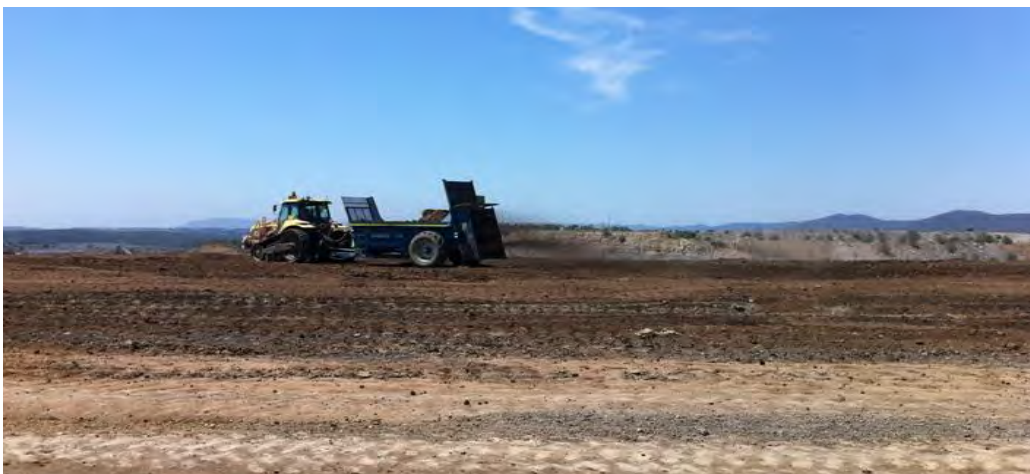
**Plate 1 – Biosolid Application on Re-profiled Waste Rock Emplacement**
